STREAM INVENTORY REPORT

Left Bank Tributary to Martin Creek

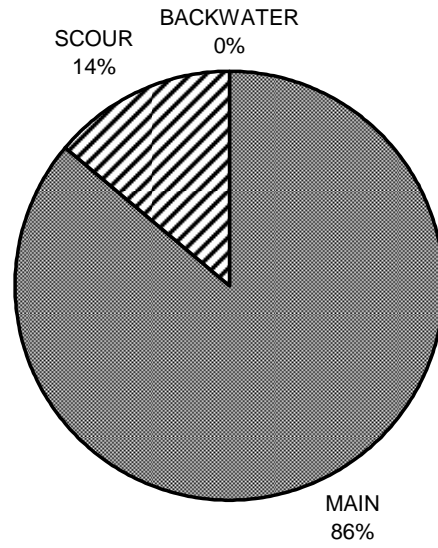
GRAPH 4

A total of 28 pools were identified (Table 3). Main channel pools were the most frequently encountered, at 86%, and comprised 78% of the total length of all pools (Graph 4).

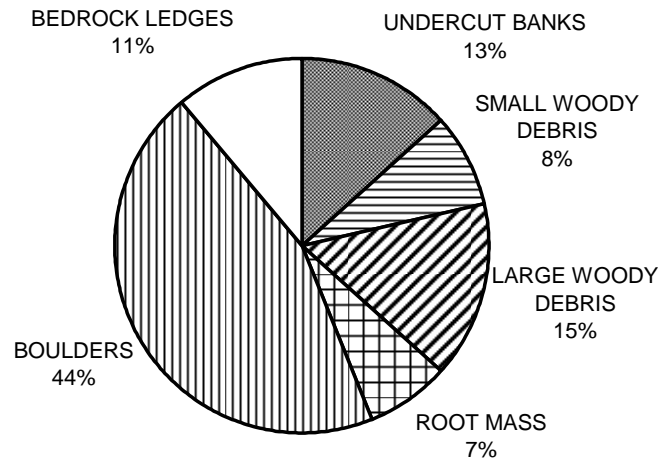
GRAPH 7

Table 5 summarizes mean percent cover by habitat type. Boulders are the dominant cover types in Left Bank Tributary to Martin Creek. Graph 7 describes the pool cover in Left Bank Tributary to Martin Creek. Boulders are the dominant pool cover type followed by large woody debris.

The mean shelter rating for pools was 25. The shelter rating in the flatwater habitats was 29. A pool shelter rating of approximately 100 is desirable. The amount of cover that now exists is being provided primarily by boulders in all habitat types. Additionally, large woody debris contributes a small amount. Log and root wad cover structures in the pool and flatwater habitats would enhance both summer and winter salmonid habitat. Log cover structure provides rearing fry with protection from predation, rest from water velocity, and also divides territorial units to reduce density related competition.

- 4) Increase woody cover in the pools and flatwater habitat units. Most of the existing cover is from boulders. Adding high quality complexity with log and root wad cover is desirable.

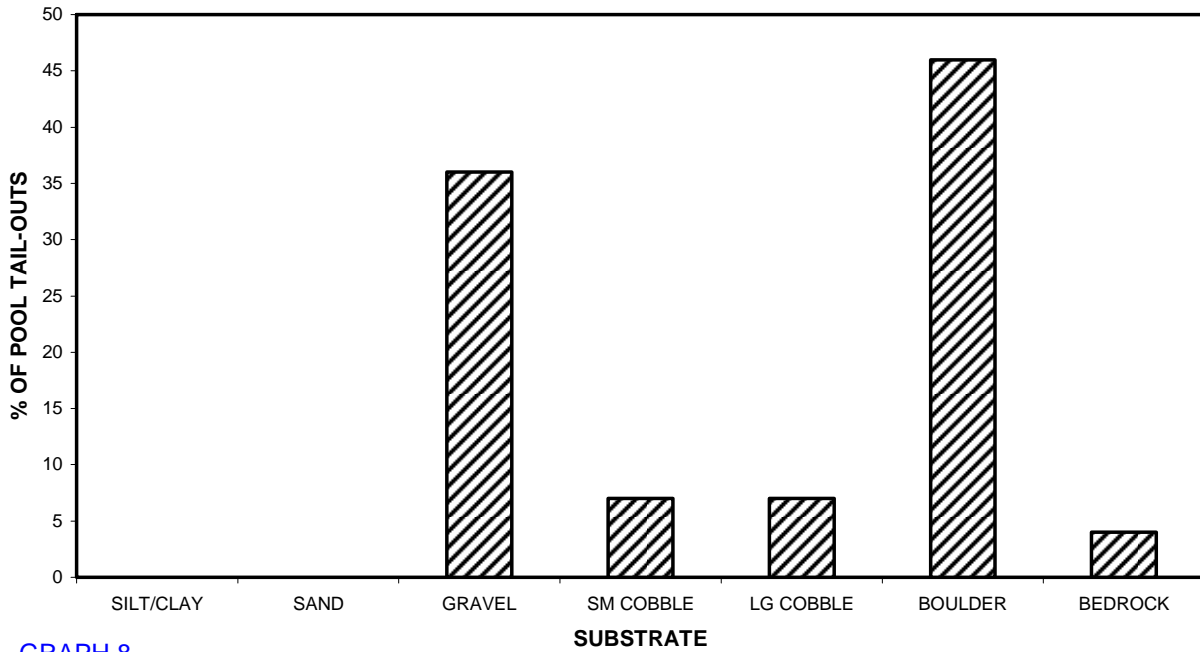
GRAPH 8

Table 6 summarizes the dominant substrate by habitat type. Graph 8 depicts the dominant substrate observed in pool tail-outs. Boulders were the dominant substrate observed in 46% of pool tail-outs while gravel was the next most frequently observed substrate type, at 36%.

Twenty-four of the 28 pool tail-outs measured had sand/silt/clay, large cobble, boulders or bedrock as the dominant substrate. This is generally considered unsuitable for spawning salmonids.

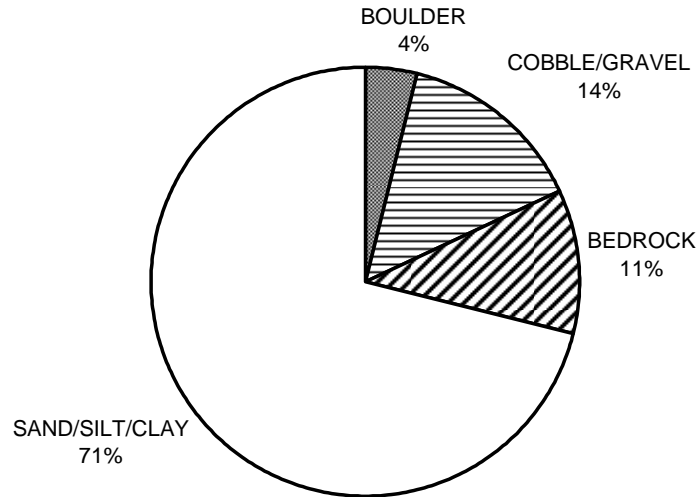
GRAPH 10

For the stream reach surveyed, the mean percent right bank vegetated was 58%. The mean percent left bank vegetated was 65%. The dominant elements composing the structure of the stream banks consisted of 71% sand/silt/clay, 14% cobble/gravel, 11% bedrock, and 4% boulder (Graph 10). Coniferous trees were the dominant vegetation type observed in 86% of the units surveyed. Additionally, 14% of the units surveyed had brush as the dominant vegetation type (Graph 11).

The percentage of right and left bank covered with vegetation was moderate at 58% and 65%, respectively. In areas of stream bank erosion or where bank vegetation is not at acceptable levels, planting endemic species of coniferous and deciduous trees, in conjunction with bank stabilization, is recommended.
