STREAM INVENTORY REPORT

Martin Creek

A stream inventory was conducted beginning July 10 and ending July 29, 2002 on Martin Creek and its tributaries. The survey began at the confluence with Big River and extended upstream 3.78 miles. Stream inventories and sub-sections to this report were also completed for three tributaries to Martin Creek:

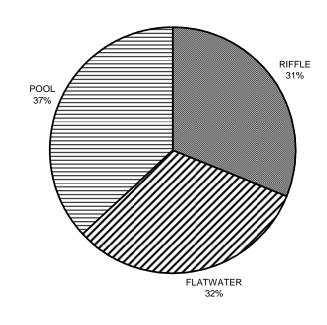
MARTIN CREEK HABITAT TYPES BY PERCENT OCCURRENCE

Table 1 summarizes the Level II riffle, flatwater, and pool habitat types. Based on frequency of occurrence there were 37% pool units, 32% flatwater units, and 31% riffle units (Graph 1). Based on total length of Level II habitat types there were 53% flatwater units, 29% riffle units, and 19% pool units (Graph 2).

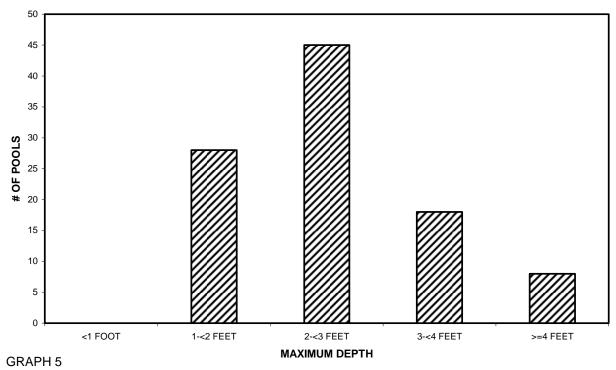
MARTIN CREEK MAXIMUM DEPTH IN POOLS

Table 4 is a summary of maximum pool depths by pool habitat types. Pool quality for salmonids increases with depth. Seventy-six of the 99 pools (77%) had a depth of two feet or greater (Graph 5).

Flatwater habitat types comprised 53% of the total length of this survey, riffles 29%, and pools 9%. The pools are relatively deep, with 76 of the 99 (77%) pools having a maximum depth greater than 2 feet. In general, pool enhancement projects are considered when primary pools comprise less than 40% of the length of total stream habitat.

- 4) Where feasible, design and engineer pool enhancement structures to increase the number of pools. This must be done where the banks are stable or in conjunction with stream bank armor to prevent erosion.

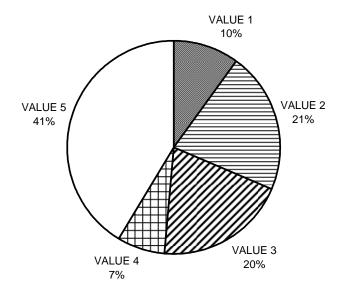
MARTIN CREEK PERCENT EMBEDDEDNESS

The depth of cobble embeddedness was estimated at pool tail-outs. Of the 99 pool tail-outs measured, 10 had a value of 1 (10%); 21 had a value of 2 (21%); 20 had a value of 3 (20%); 7 had a value of 4 (7%); and 41 had a value of 5 (41%) (Graph 6). On this scale, a value of 1 indicates the highest quality of spawning substrate.

Thirty-one of the 99 pool tail-outs measured had embeddedness ratings of 1 or 2. Twenty-seven of the pool tail-outs had embeddedness ratings of 3 or 4. Forty-one of the pool tail-outs had a rating of 5, which is considered unsuitable for spawning. Cobble embeddedness measured to be 25% or less, a rating of 1, is considered to indicate good quality spawning substrate for salmon and steelhead. Sediment sources in Martin Creek should be mapped and rated according to their potential sediment yields, and control measures should be taken.

- 6) Active and potential sediment sources need to be identified, mapped, and treated according to their potential for sediment yield to the stream and its tributaries.

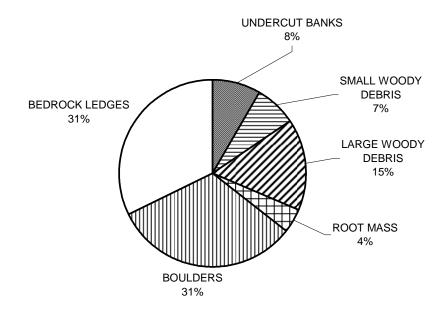
GRAPH 7

Table 5 summarizes mean percent cover by habitat type. Boulders are the dominant cover types in Martin Creek. Graph 7 describes the pool cover in Martin Creek. Boulders are the dominant pool cover type followed by bedrock ledges.

The mean shelter rating for pools was 24. The shelter rating in the flatwater habitats was 24. A pool shelter rating of approximately 100 is desirable. The amount of cover that now exists is being provided primarily by boulders in all habitat types. Additionally, bedrock ledges contribute a small amount. Log and root wad cover structures in the pool and flatwater habitats would enhance both summer and winter salmonid habitat. Log cover structure provides rearing fry with protection from predation, rest from water velocity, and also divides territorial units to reduce density related competition.

- 5) Increase woody cover in the pools and flatwater habitat units. Most of the existing cover is from boulders. Adding high quality complexity with log and root wad cover is desirable.

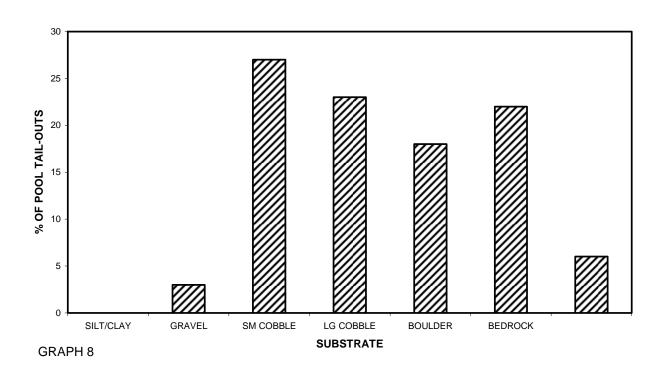
MARTIN CREEK SUBSTRATE COMPOSITION IN POOL TAIL-OUTS

Table 6 summarizes the dominant substrate by habitat type. Graph 8 depicts the dominant substrate observed in pool tail-outs. Gravel was the dominant substrate observed in 27% of pool tail-outs while small cobble was the next most frequently observed substrate type, at 22%.

Fifty of the 99 pool tail-outs measured had gravel or small cobble as the dominant substrate. This is generally considered good spawning salmonids.

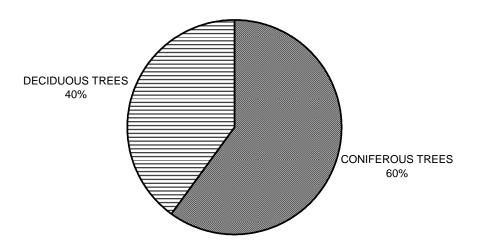
GRAPH 9

The mean percent canopy density for the surveyed length of Martin Creek was 81%. The mean percentages of deciduous and coniferous trees were 40% and 60%, respectively. Graph 9 describes the mean percent canopy in Martin Creek.

The mean percent canopy density for the stream was 81%. In general, revegetation projects are considered when canopy density is less than 80%.

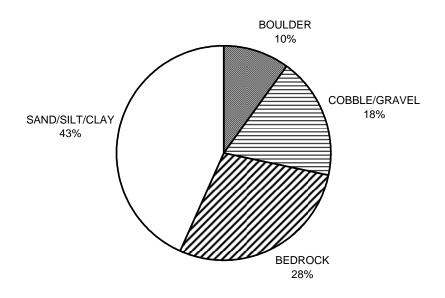
MARTIN CREEK DOMINANT BANK COMPOSITION IN SURVEY REACH

For the stream reach surveyed, the mean percent right bank vegetated was 54%. The mean percent left bank vegetated was 53%. The dominant elements composing the structure of the stream banks consisted of 43% sand/silt/clay, 28% bedrock, 18% cobble/gravel, and 10% boulder (Graph 10). Coniferous trees were the dominant vegetation type observed in 72% of the units surveyed. Additionally, 27% of the units surveyed had deciduous trees as the dominant vegetation type, and 1% had brush as the dominant vegetation (Graph 11).

The percentage of right and left bank covered with vegetation was moderate at 54% and 53%, respectively. In areas of stream bank erosion or where bank vegetation is not at acceptable levels, planting endemic species of coniferous and deciduous trees, in conjunction with bank stabilization, is recommended.
