STREAM INVENTORY REPORT

"North Fork Berry Gulch"

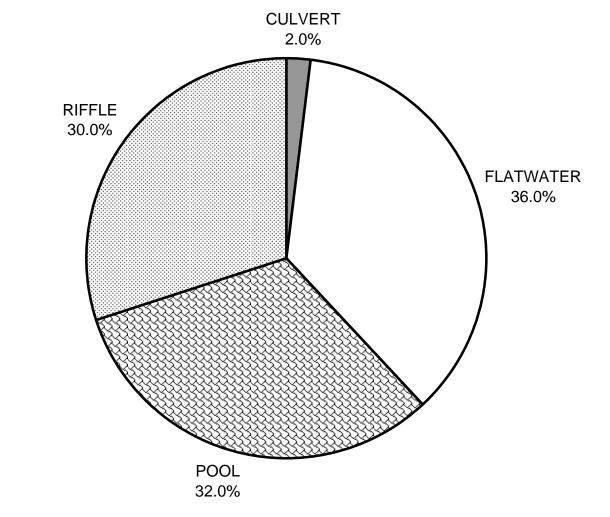
NORTH FORK BERRY GULCH 2009 HABITAT TYPES BY PERCENT OCCURRENCE

Table 1 summarizes the Level II riffle, flatwater, and pool habitat types. Based on frequency of occurrence there were 36% flatwater units, 32% pool units, and 30% riffle units (Graph 1). Based on total length of Level II habitat types there were 55% flatwater units, 21% pool units, and 20% riffle units (Graph 2).

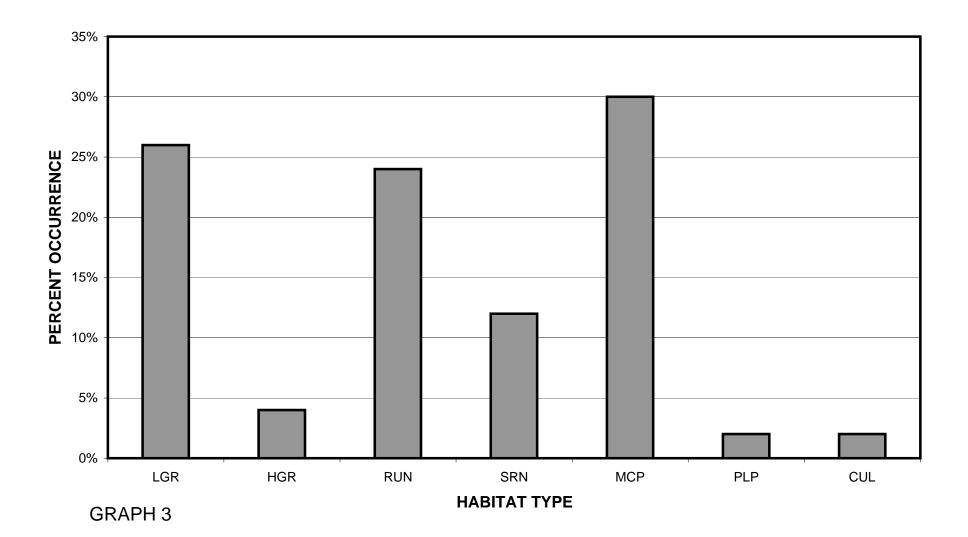
NORTH FORK BERRY GULCH 2009 HABITAT TYPES BY PERCENT OCCURRENCE

Six Level IV habitat types were identified (Table 2). The most frequent habitat types by percent occurrence were mid-channel pool units, 30%; low gradient riffle units, 26%; and run units, 24% (Graph 3). Based on percent total length, step run units made up 31%, run units 23%, and mid-channel pool units 21%.

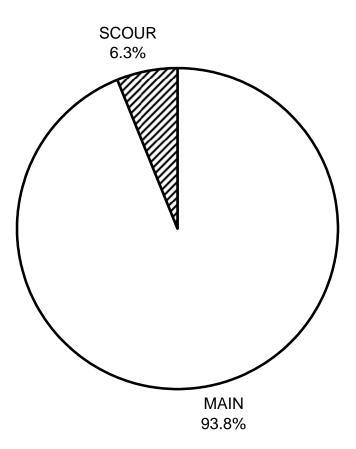
NORTH FORK BERRY GULCH 2009 POOL TYPES BY PERCENT OCCURRENCE

A total of 16 pools were identified (Table 3). Main channel pools were the most frequently encountered at 94% (Graph 4), and comprised 96% of the total length of all pools (Table 3).

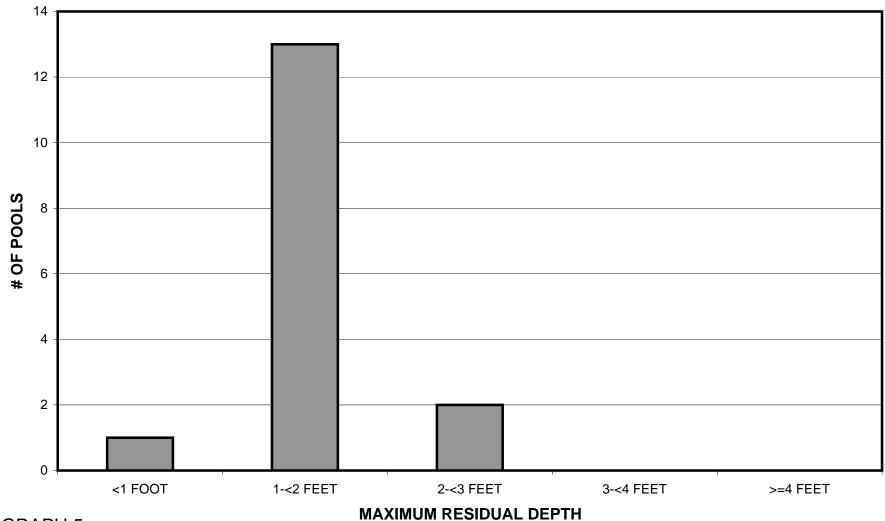
NORTH FORK BERRY GULCH 2009 MAXIMUM DEPTH IN POOLS

Table 4 is a summary of maximum residual pool depths by pool habitat types. Pool quality for salmonids increases with depth. Two of the 16 pools (12%) had a residual depth of two feet or greater (Graph 5).

Flatwater habitat types comprised 55% of the total length of this survey, riffles 20%, pools 21%, and culvert 4%. Two of the 16 (12%) pools had a maximum residual depth greater than 2 feet. In general, pool enhancement projects are considered when primary pools comprise less than 40% of the length of total stream habitat. In first and second order streams, a primary pool is defined to have a maximum residual depth of at least two feet, occupy at least half the width of the low flow channel, and be as long as the low flow channel width. Installing large wood structures that will increase or deepen pool habitat is recommended.

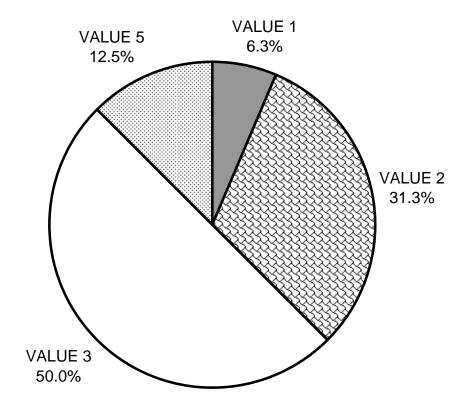
NORTH FORK BERRY GULCH 2009 PERCENT EMBEDDEDNESS

The depth of cobble embeddedness was estimated at pool tail-outs. Of the 16 pool tail-outs measured, 1 had a value of 1 (6.3%); 5 had a value of 2 (31.3%); 8 had a value of 3 (50%); 2 had a value of 5 (12.5%) (Graph 6). On this scale, a value of 1 indicates the best spawning conditions and a value of 4 the worst. Additionally, a value of 5 was assigned to tail-outs deemed unsuited for spawning due to inappropriate substrate such as bedrock, log sills, boulders, or other considerations.

Six of the 16 pool tail-outs measured had embeddedness ratings of 1 or 2. Eight of the pool tailouts had embeddedness ratings of 3 or 4. Two of the pool tail-outs had a rating of 5, which is

considered unsuitable for spawning. Cobble embeddedness measured to be 25% or less, a rating of 1, is considered to indicate good quality spawning substrate for salmon and steelhead. Sediment sources in North Fork Berry Gulch should be mapped and rated according to their potential sediment yields, and control measures should be taken.

- 5) Inventory and map sources of stream bank erosion and prioritize them according to present and potential sediment yield. Identified sites should then be treated to reduce the amount of fine sediments entering the stream.

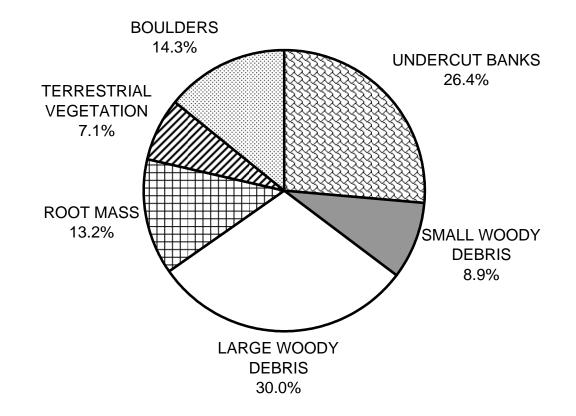
NORTH FORK BERRY GULCH 2009 MEAN PERCENT COVER TYPES IN POOLS

Table 5 summarizes mean percent cover by habitat type. Undercut banks are the dominant cover type in North Fork Berry Gulch. Graph 7 describes the pool cover in North Fork Berry Gulch. Large woody debris is the dominant pool cover type followed by undercut banks.

The mean shelter rating for pools was 39. The shelter rating in the flatwater habitats was 6. A pool shelter rating of approximately 100 is desirable. The amount of cover that now exists is being provided primarily by undercut banks in North Fork Berry Gulch. Large woody debris is the dominant cover type in pools followed by undercut banks. Log and root wad cover structures in the pool and flatwater habitats would enhance both summer and winter salmonid habitat. Log cover structure provides rearing fry with protection from predation, rest from water velocity, and also divides territorial units to reduce density related competition.

- 3) Conduct a fish passage assessment of the culvert at the confluence of North Fork Berry Creek and Berry Creek on Road 550.
- 4) Increase woody cover in the pools and flatwater habitat units. Most of the existing cover in the pools is from large woody debris. Adding high quality complexity with woody cover in the pools is desirable.

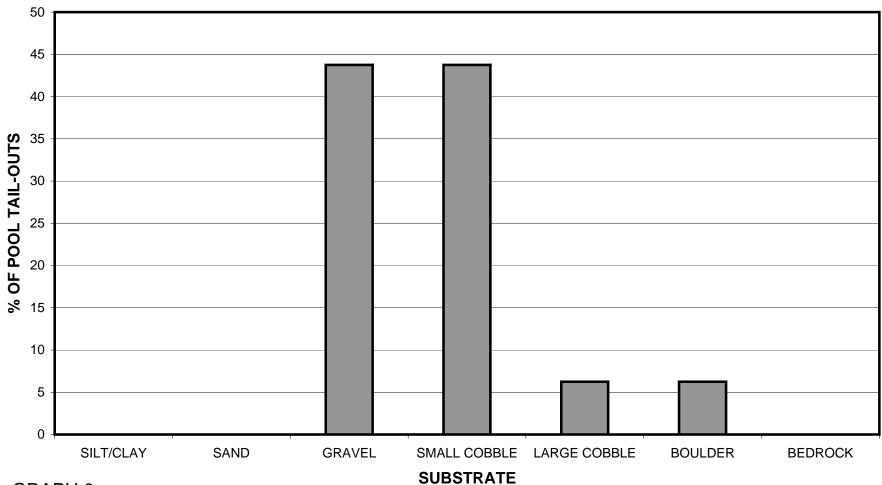
NORTH FORK BERRY GULCH 2009 SUBSTRATE COMPOSITION IN POOL TAIL-OUTS

Table 6 summarizes the dominant substrate by habitat type. Graph 8 depicts the dominant substrate observed in pool tail-outs. Gravel was the dominant substrate observed in 44% of the pool tail-outs. Small cobble was the next most frequently observed dominant substrate type and occurred in 44% of the pool tail-outs.

Fourteen of the 16 pool tail-outs measured had gravel or small cobble as the dominant substrate. This is generally considered good for spawning salmonids.

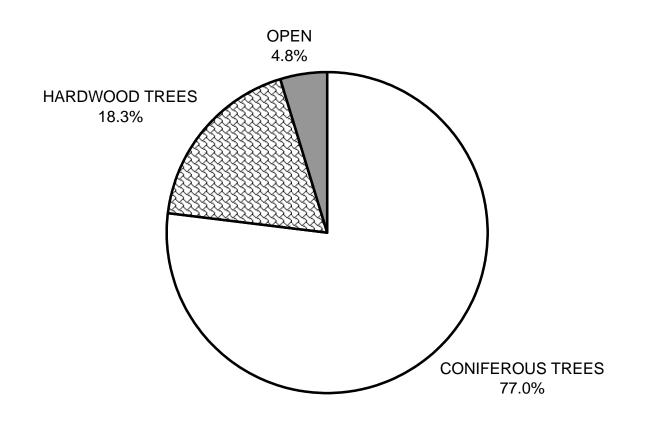
NORTH FORK BERRY GULCH 2009 MEAN PERCENT CANOPY

The mean percent canopy density for the surveyed length of North Fork Berry Gulch was 95%. Five percent of the canopy was open. Of the canopy present, the mean percentages of hardwood and coniferous trees were 19% and 81%, respectively. Graph 9 describes the mean percent canopy in North Fork Berry Gulch.

The mean percent canopy density for the stream was 95%. In general, revegetation projects are considered when canopy density is less than 80%.

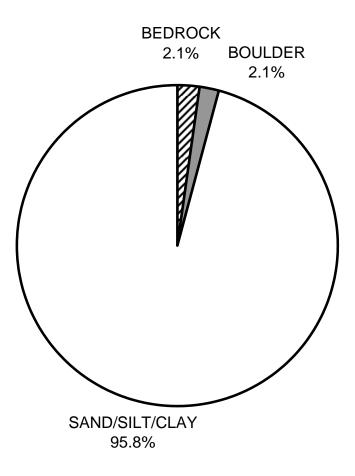
NORTH FORK BERRY GULCH 2009 DOMINANT BANK COMPOSITION IN SURVEY REACH

For the stream reach surveyed, the mean percent right bank vegetated was 93%. The mean percent left bank vegetated was 89%. The dominant elements composing the structure of the stream banks consisted of 96% sand/silt/clay, 2% bedrock, and 2% boulder (Graph 10). Coniferous trees were the dominant vegetation type observed in 72.9% of the units surveyed. Additionally, 22.9% of the units surveyed had brush as the dominant vegetation type, and 4.2% had hardwood as the dominant vegetation type (Graph 11).

The percentage of right and left bank covered with vegetation was 92% and 89%, respectively. In areas of stream bank erosion or where bank vegetation is sparse, planting endemic species of coniferous and hardwood trees, in conjunction with bank stabilization, is recommended.
