STREAM INVENTORY REPORT

North Fork Ramon Creek

A stream inventory was conducted from June 13 to June 20, 2002 on North Fork Ramon Creek. The survey began at the confluence with Ramon Creek and extended upstream 1.5 miles.

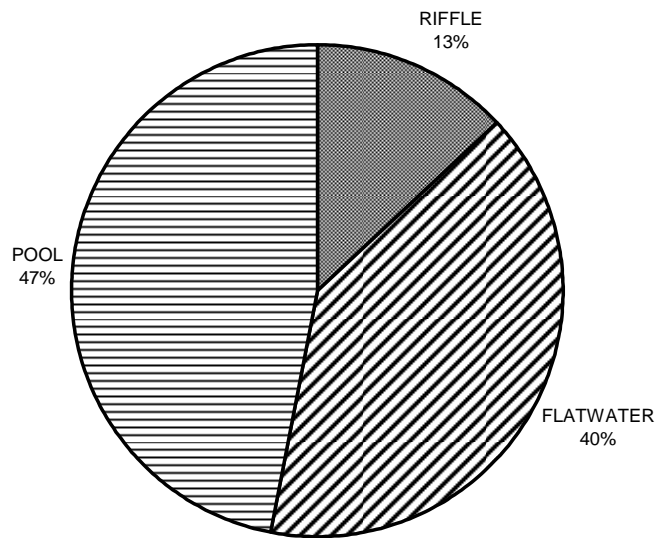
GRAPH 1

Table 1 summarizes the Level II riffle, flatwater, and pool habitat types. Based on frequency of occurrence there were 47% pool units, 40% flatwater units, and 13% riffle units (Graph 1). Based on total length of Level II habitat types there were 69% flatwater units, 19% pool units, and 11% riffle units (Graph 2).

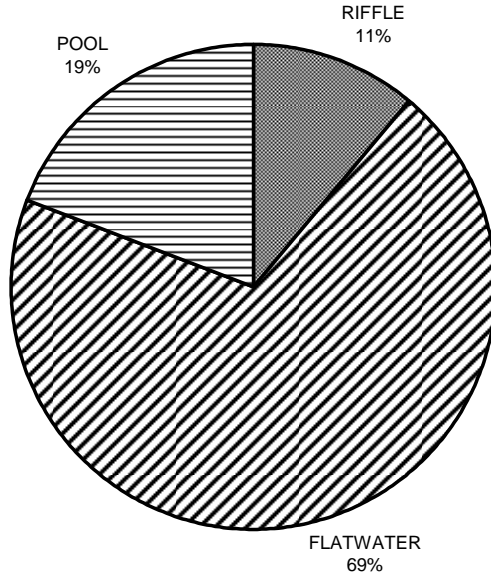
GRAPH 2

Flatwater habitat types comprised 69% of the total length of this survey, pools 19%, and riffles 11%. The pools are relatively shallow, with 11 of the 73 (15%) pools having a maximum depth greater than 2 feet. In general, pool enhancement projects are considered when primary pools comprise less than 40% of the length of total stream habitat. In first and second order streams, a primary pool is defined to have a maximum depth of at least two feet, occupy at least half the width of the low flow channel, and be as long as the low flow channel width. Installing structures that will increase or deepen pool habitat is recommended for locations where their installation will not be threatened by high stream energy, or where their installation will not conflict with the modification of the numerous log debris accumulations (LDA's) in the stream.

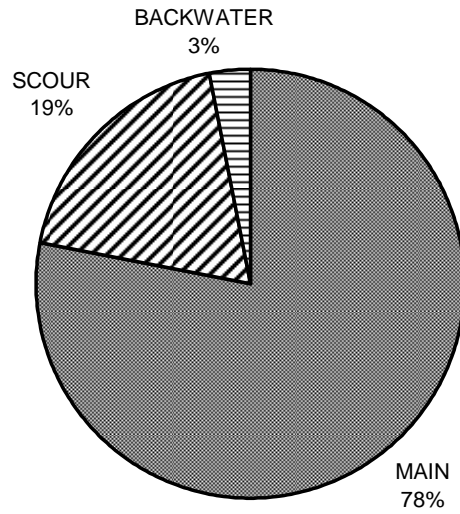
GRAPH 4

A total of 73 pools were identified (Table 3). Main channel pools were the most frequently encountered, at 78%, and comprised 83% of the total length of all pools (Graph 4).

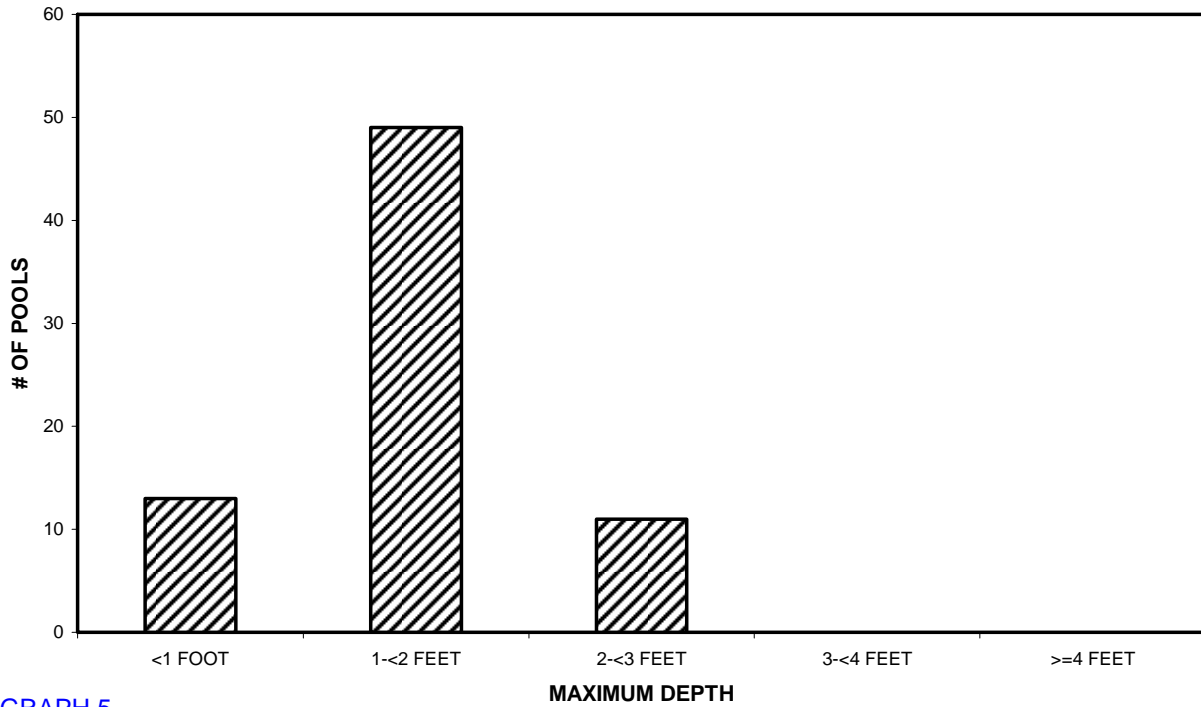
GRAPH 5

Table 4 is a summary of maximum pool depths by pool habitat types. Pool quality for salmonids increases with depth. Eleven of the 73 pools (15%) had a depth of two feet or greater (Graph 5).

- 3) Where feasible, design and engineer pool enhancement structures to increase the number of pools. This must be done where the banks are stable or in conjunction with stream bank armor to prevent erosion.

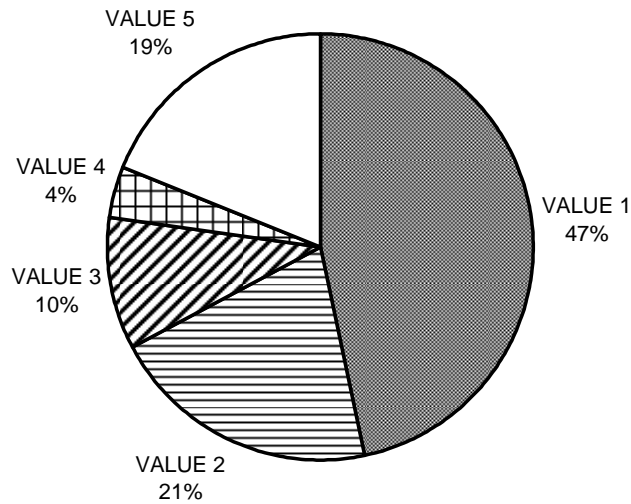
GRAPH 6

The depth of cobble embeddedness was estimated at pool tail-outs. Of the 73 pool tail-outs measured, 34 had a value of 1 (47%); 15 had a value of 2 (21%); 7 had a value of 3 (10%); 3 had a value of 4 (4%); and 14 had a value of 5 (19%) (Graph 6). On this scale, a value of 1 indicates the best spawning conditions and a value of 4 the worst. Additionally, a value of 5 was assigned to tail-outs deemed unsuited for spawning due to inappropriate substrate such as bedrock, log sills, boulders, or other considerations.

Forty-nine of the 73 pool tail-outs measured had embeddedness ratings of 1 or 2. Ten of the pool tail-outs had embeddedness ratings of 3 or 4. Cobble embeddedness measured to be 25% or less, a rating of 1, is considered to indicate good quality spawning substrate for salmon and steelhead.

- 5) Inventory and map sources of stream bank erosion and prioritize them according to present and potential sediment yield. Identified sites should then be treated to reduce the amount of fine sediments entering the stream.

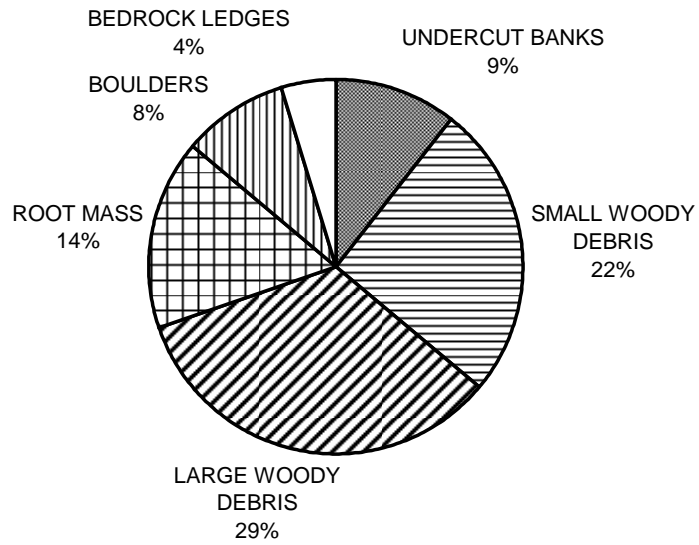
GRAPH 7

Table 5 summarizes mean percent cover by habitat type. Large woody debris is the dominant cover type in North Fork Ramon Creek. Graph 7 describes the pool cover in North Fork Ramon Creek. Large woody debris is the dominant pool cover type followed by small woody debris.

The mean shelter rating for pools was 37. The shelter rating in the flatwater habitats was 15. A pool shelter rating of approximately 100 is desirable. The amount of cover that now exists is being provided primarily by large woody debris in all habitat types. Additionally, small woody debris contributes a small amount.

- 4) Increase woody cover in the pools and flatwater habitat units. Most of the existing cover in the pools is from large woody debris. Adding high quality complexity with woody cover in the pools is desirable.

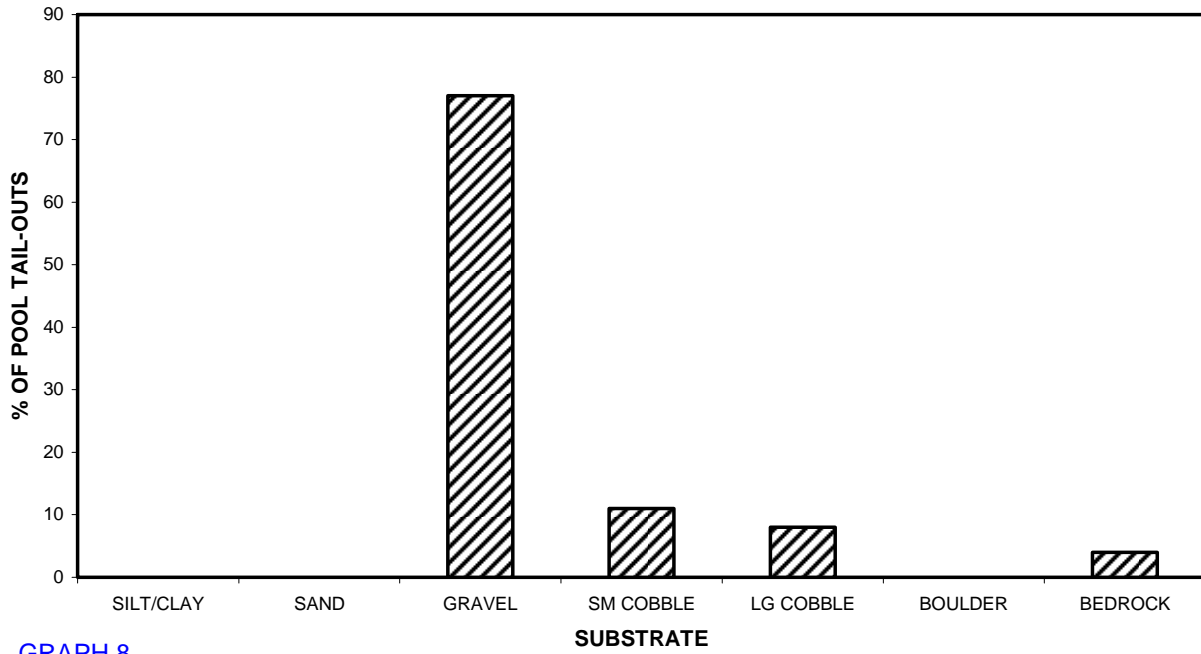
GRAPH 8

Table 6 summarizes the dominant substrate by habitat type. Graph 8 depicts the dominant substrate observed in pool tail-outs. Gravel was the dominant substrate observed in 77% of the pool tail-outs. Small cobble was the next most frequently observed dominant substrate type and occurred in 11% of the pool tail-outs.

Sixty-four of the 73 pool tail-outs measured had gravel or small cobble as the dominant substrate. This is generally considered good spawning salmonids.

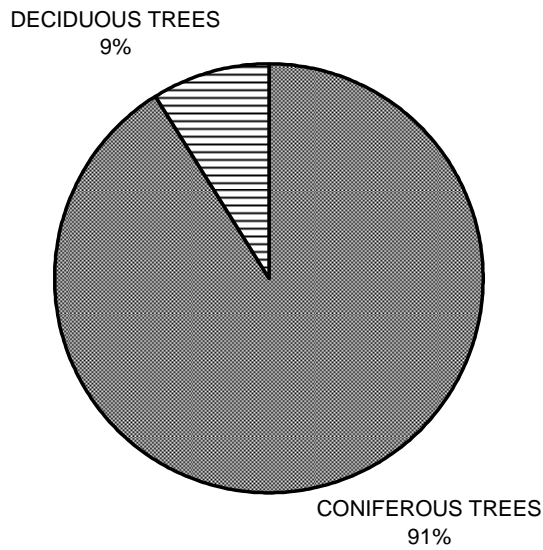
GRAPH 9

The mean percent canopy density for the surveyed length of North Fork Ramon Creek was 76%. Thirteen percent of the canopy was open. In the closed canopy, the mean percentages of deciduous and coniferous trees were 9% and 91%, respectively. Graph 9 describes the mean percent canopy in North Fork Ramon Creek.

The mean percent canopy density for the stream was 76%. In general, revegetation projects are considered when canopy density is less than 80%.

- 7) Increase the canopy on North Fork Ramon Creek by planting appropriate native vegetation like willow, alder, redwood, and Douglas fir along the stream where shade canopy is not at acceptable levels. The reaches above this survey section should be inventoried and treated as well, since the water flowing here is affected from upstream. In many cases, planting will need to be coordinated to follow bank stabilization or upslope erosion control projects.

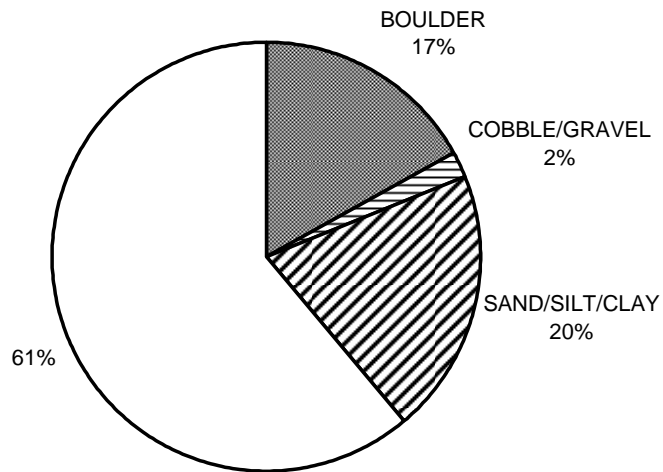
GRAPH 10

For the stream reach surveyed, the mean percent right bank vegetated was 43%. The mean percent left bank vegetated was 39%. The dominant elements composing the structure of the stream banks consisted of 61% sand/silt/clay, 20% cobble/gravel, 17% bedrock, and 2% boulder (Graph 10). Coniferous trees were the dominant vegetation type observed in 33% of the units surveyed. Additionally, 22% of the units surveyed had deciduous trees as the dominant vegetation type, and 20% had brush as the dominant vegetation (Graph 11).

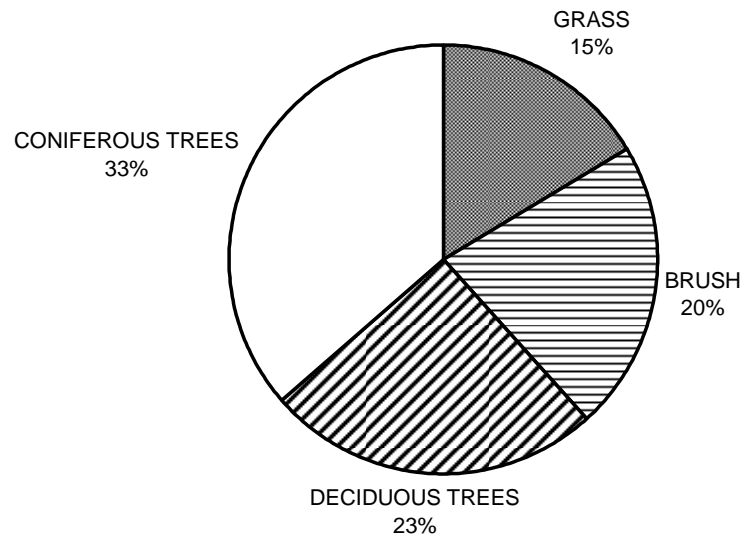
GRAPH 11

The percentage of right and left bank covered with vegetation was low at 43% and 39%, respectively. In areas of stream bank erosion or where bank vegetation is not at acceptable levels, planting endemic species of coniferous and deciduous trees, in conjunction with bank stabilization, is recommended.
