STREAM INVENTORY REPORT

Ramon Creek

A stream inventory was conducted from June 13 to June 20, 2002 on Ramon Creek. The survey began at the confluence with South Fork Big River and extended upstream 3.95 miles. A stream inventory and sub-section to this report was also completed for North Fork Ramon Creek.

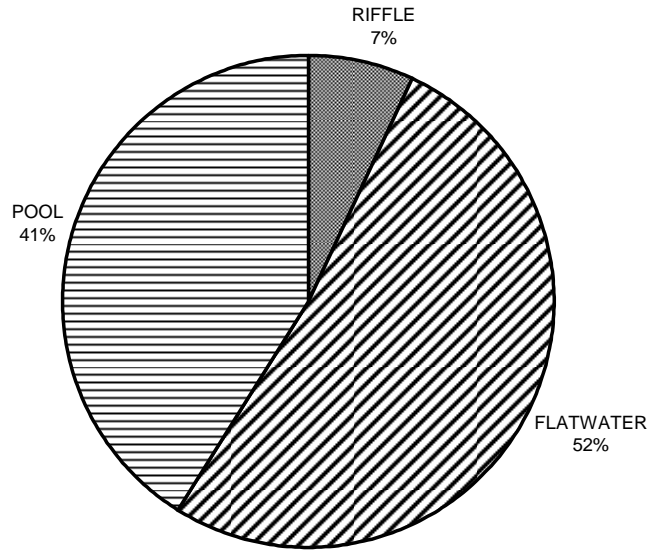
GRAPH 1

Table 1 summarizes the Level II riffle, flatwater, and pool habitat types. Based on frequency of occurrence there were 52% flatwater units, 41% pool units, and 7 % riffle units (Graph 1). Based on total length of Level II habitat types there were 86% flatwater units, 12% pool units, and 2% riffle units (Graph 2).

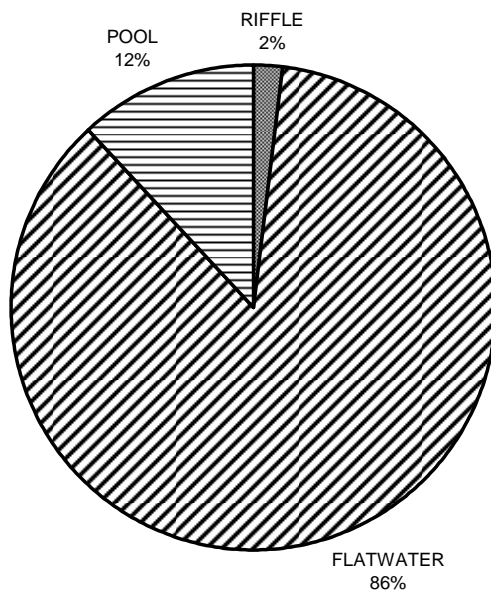
GRAPH 2

Flatwater habitat types comprised 86% of the total length of this survey, pools 12%, and riffles 2%. The pools are relatively shallow, with 37 of the 94 (39%) pools having a maximum depth greater than 2 feet. In general, pool enhancement projects are considered when primary pools comprise less than 40% of the length of total stream habitat. In first and second order streams, a primary pool is defined to have a maximum depth of at least two feet, occupy at least half the width of the low flow channel, and be as long as the low flow channel width. Installing structures that will increase or deepen pool habitat is recommended for locations where their installation will not be threatened by high stream energy, or where their installation will not conflict with the modification of the numerous log debris accumulations (LDA's) in the stream.

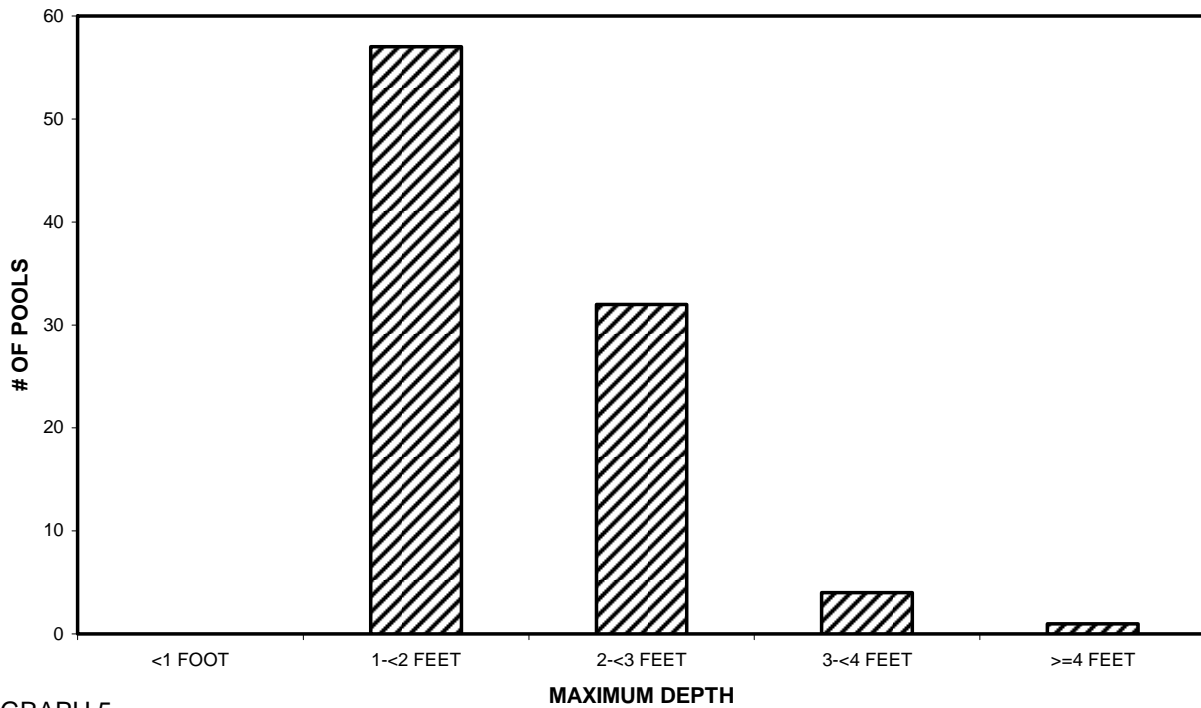
GRAPH 5

Table 4 is a summary of maximum pool depths by pool habitat types. Pool quality for salmonids increases with depth. Thirty-seven of the 94 pools (39%) had a depth of two feet or greater (Graph 5).

- 5) Where feasible, design and engineer pool enhancement structures to increase the number of pools. This must be done where the banks are stable or in conjunction with stream bank armor to prevent erosion.

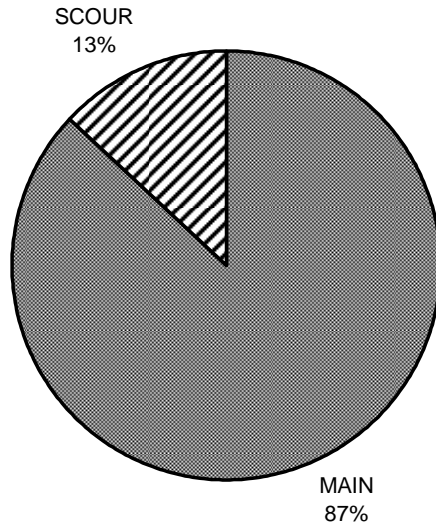
GRAPH 4

A total of 94 pools were identified (Table 3). Main channel pools were the most frequently encountered, at 87%, and comprised 84% of the total length of all pools (Graph 4).

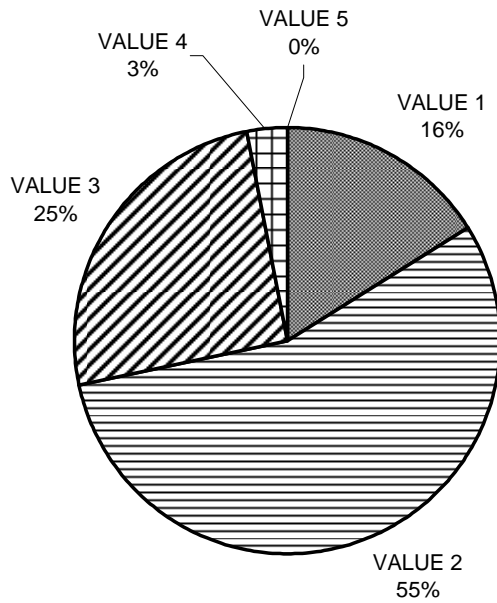
GRAPH 6

The depth of cobble embeddedness was estimated at pool tail-outs. Of the 94 pool tail-outs measured, 15 had a value of 1 (16%); 52 had a value of 2 (55%); 24 had a value of 3 (24%); and 3 had a value of 4 (3%) (Graph 6). On this scale, a value of 1 indicates the highest quality of spawning substrate.

Sixty-seven of the 94 pool tail-outs measured had embeddedness ratings of 1 or 2. Twenty-seven of the pool tail-outs had embeddedness ratings of 3 or 4. Cobble embeddedness measured to be 25% or less, a rating of 1, is considered to indicate good quality spawning substrate for salmon and steelhead.

- 4) Active and potential sediment sources need to be identified, mapped, and treated according to their potential for sediment yield to the stream and its tributaries.

- 7) Inventory and map sources of stream bank erosion and prioritize them according to present and potential sediment yield. Identified sites should then be treated to reduce the amount of fine sediments entering the stream.

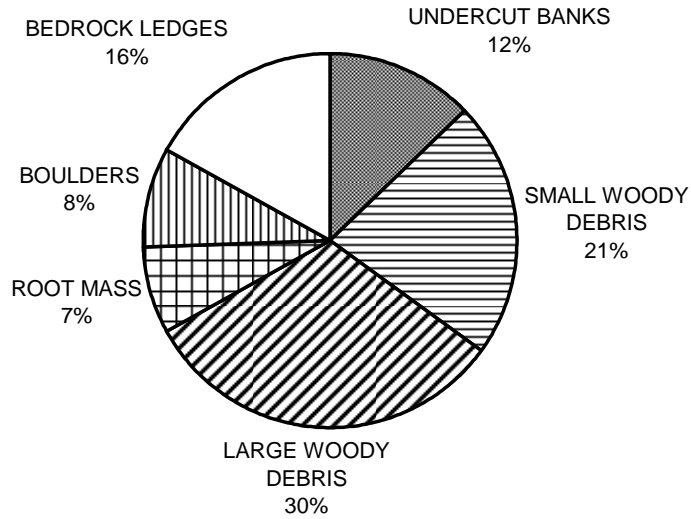
GRAPH 7

Table 5 summarizes mean percent cover by habitat type. Large woody debris is the dominant cover type in Ramon Creek. Graph 7 describes the pool cover in Ramon Creek. Large woody debris is the dominant pool cover type followed by small woody debris.

The mean shelter rating for pools was 34. The shelter rating in the flatwater habitats was 19. A pool shelter rating of approximately 100 is desirable. The amount of cover that now exists is being provided primarily by large woody debris in all habitat types. Additionally, small woody debris contributes a small amount.

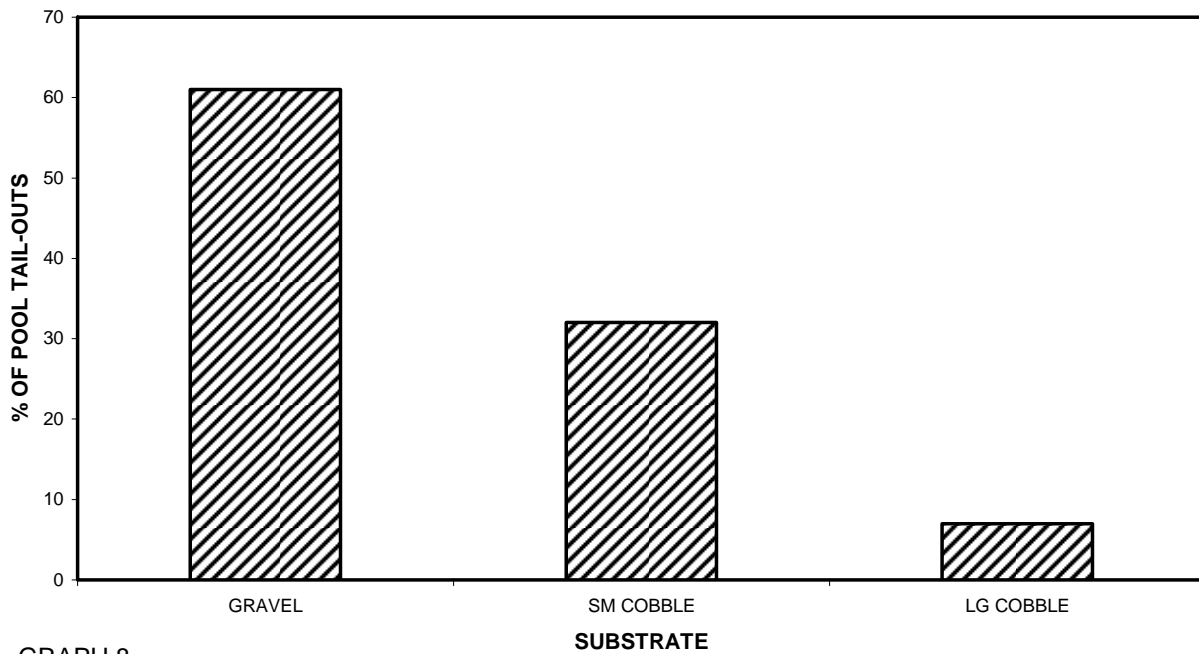
GRAPH 8

Table 6 summarizes the dominant substrate by habitat type. Graph 8 depicts the dominant substrate observed in pool tail-outs. Gravel was the dominant substrate observed in 61% of the pool tail-outs. Small cobble was the next most frequently observed dominant substrate type and occurred in 32%.

Eighty-seven of the 94 pool tail-outs measured had gravel or small cobble as the dominant substrate. This is generally considered good spawning salmonids.

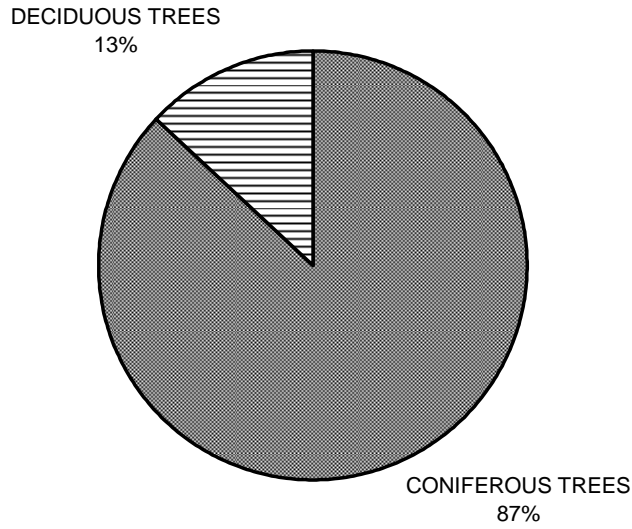
GRAPH 9

The mean percent canopy density for the surveyed length of Ramon Creek was 77%. Thirteen percent of the canopy was open. Of the canopy present, the mean percentages of deciduous and coniferous trees were 12% and 88%, respectively. Graph 9 describes the mean percent canopy in Ramon Creek.

The mean percent canopy density for the stream was 77%. Reach 1 had a canopy density of 68%, Reach 2 had a canopy density of 75%, and Reach 3 had a canopy density of 89%. In general, revegetation projects are considered when canopy density is less than 80%.

- 3) Increase the canopy Reach 1 and Reach 2 on Ramon Creek by planting willow, alder, redwood, and Douglas fir along the stream where shade canopy is not at acceptable levels. The reaches above this survey section should be inventoried and treated as well, since the water flowing here is affected from upstream. In many cases, planting will need to be coordinated to follow bank stabilization or upslope erosion control projects.

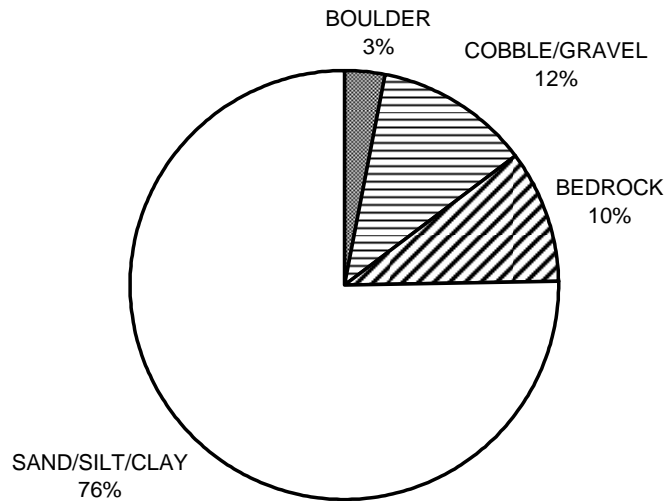
GRAPH 10

For the stream reach surveyed, the mean percent right bank vegetated was 69%. The mean percent left bank vegetated was 69%. The dominant elements composing the structure of the stream banks consisted of 76% sand/silt/clay, 12% cobble/gravel, 10% bedrock, and 3% boulder

(Graph 10). Coniferous trees were the dominant vegetation type observed in 72% of the units surveyed. Additionally, 17% of the units surveyed had brush as the dominant vegetation type, and 8% had deciduous trees as the dominant vegetation (Graph 11).

The percentage of right and left bank covered with vegetation was moderate at 69% and 69%, respectively. In areas of stream bank erosion or where bank vegetation is not at acceptable levels, planting endemic species of coniferous and deciduous trees, in conjunction with bank stabilization, is recommended.
