STREAM INVENTORY REPORT

Right Bank Tributary One to Martin Creek

A stream inventory was conducted beginning July 24 and ending July 25, 2002 on Right Bank Tributary One to Martin Creek. The survey began at the confluence with Martin Creek and extended upstream 1.47 miles.

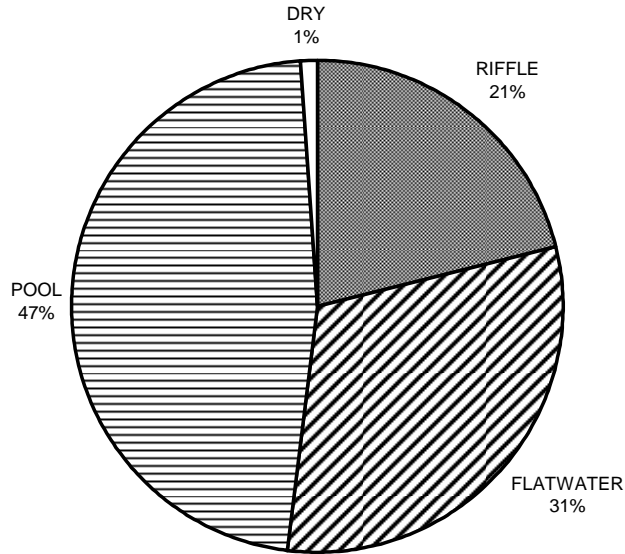
GRAPH 1

Table 1 summarizes the Level II riffle, flatwater, and pool habitat types. Based on frequency of occurrence there were 47% pool units, 31% flatwater units, 21% riffle units, and 1% dry units (Graph 1). Based on total length of Level II habitat types there were 70% flatwater units, 16% pool units, and 14% riffle units (Graph 2).

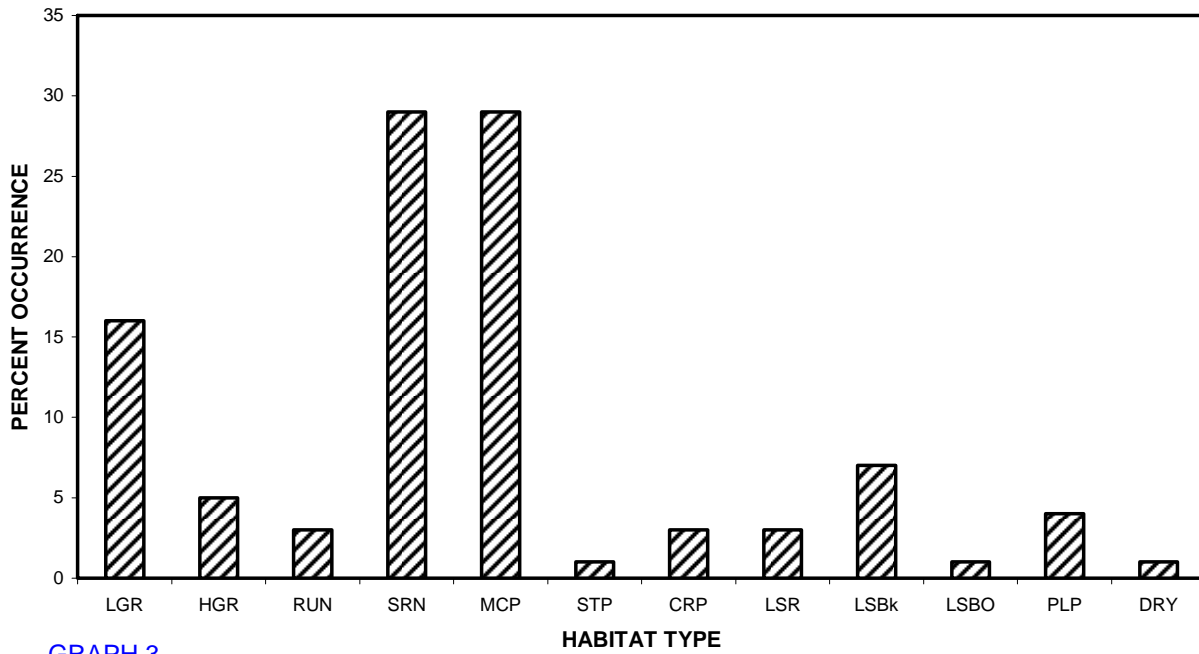
GRAPH 3

Twelve Level IV habitat types were identified (Table 2). The most frequent habitat types by percent occurrence were mid-channel pools, 29%; step runs, 29%; and low gradient riffles, 16% (Graph 3). Based on percent total length, step runs made up 68%, mid channel pools 10%, and low gradient riffles 9%.

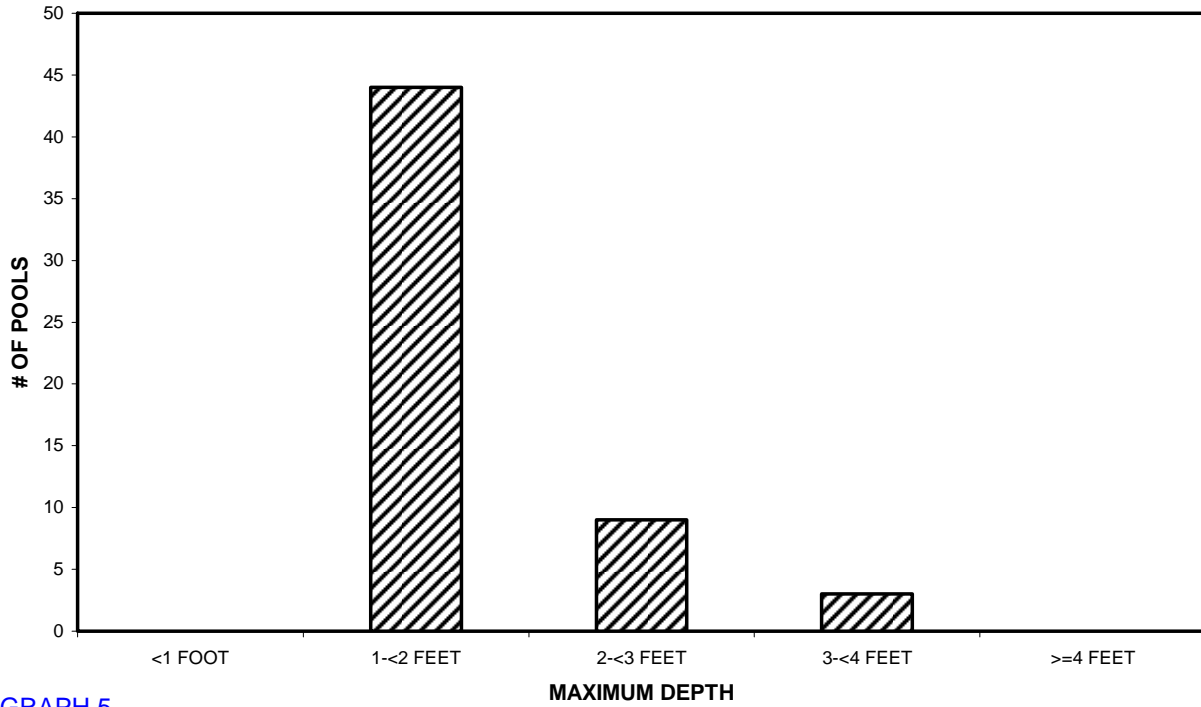
GRAPH 5

Table 4 is a summary of maximum pool depths by pool habitat types. Pool quality for salmonids increases with depth. Twelve of the 56 pools (21%) had a depth of two feet or greater (Graph 5).

Flatwater habitat types comprised 70% of the total length of this survey, pools 26%, and riffles 14%. The pools are relatively shallow, with 12 of the 56 (21%) pools having a maximum depth greater than 2 feet. In general, pool enhancement projects are considered when primary pools comprise less than 40% of the length of total stream habitat. In first and second order streams, a primary pool is defined to have a maximum depth of at least two feet, occupy at least half the width of the low flow channel, and be as long as the low flow channel width. Installing structures that will increase or deepen pool habitat is recommended for locations where their installation will not be threatened by high stream energy, or where their installation will not conflict with the modification of the numerous log debris accumulations (LDA's) in the stream.

- 3) Where feasible, design and engineer pool enhancement structures to increase the number of pools. This must be done where the banks are stable or in conjunction with stream bank armor to prevent erosion.

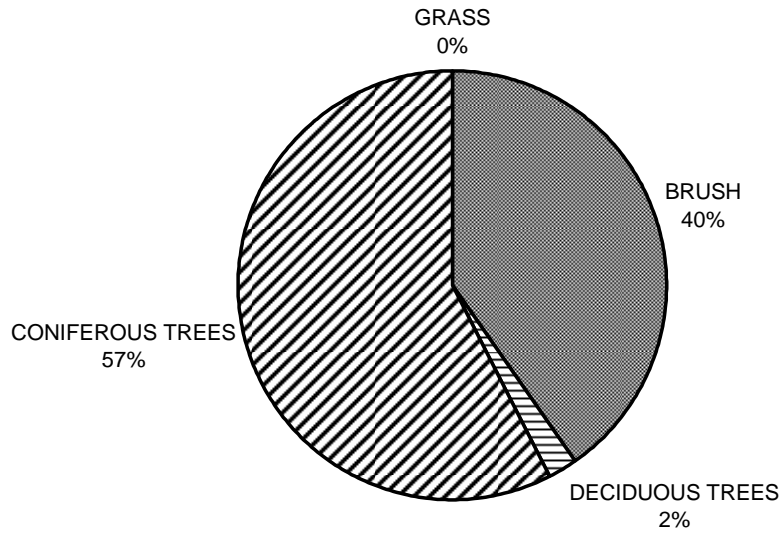
GRAPH 11

For the stream reach surveyed, the mean percent right bank vegetated was 68%. The mean percent left bank vegetated was 61%. The dominant elements composing the structure of the stream banks consisted of 48% sand/silt/clay, 26% cobble/gravel, 19% bedrock, and 7% boulder (Graph 10). Coniferous trees were the dominant vegetation type observed in 57% of the units surveyed. Additionally, 40% of the units surveyed had brush as the dominant vegetation type (Graph 11).

The percentage of right and left bank covered with vegetation was moderate at 68% and 61%, respectively. In areas of stream bank erosion or where bank vegetation is not at acceptable levels, planting endemic species of coniferous and deciduous trees, in conjunction with bank stabilization, is recommended.
