# **STREAM INVENTORY REPORT**

## **Right Bank Tributary One to Martin Creek**

A stream inventory was conducted beginning July 24 and ending July 25, 2002 on Right Bank Tributary One to Martin Creek. The survey began at the confluence with Martin Creek and extended upstream 1.47 miles.

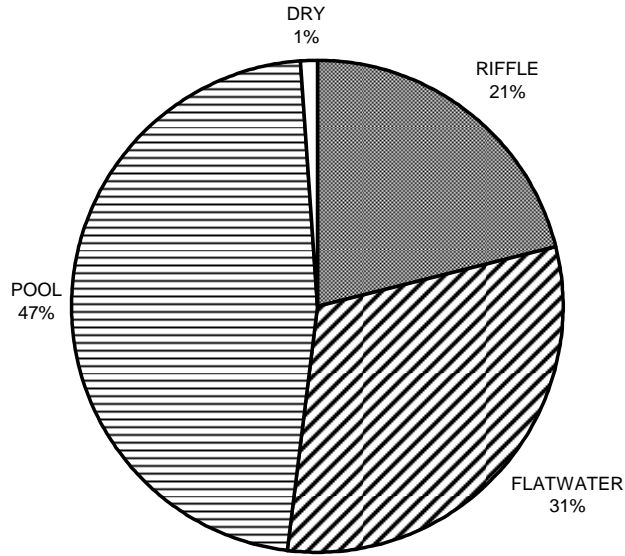
GRAPH 1

Table 1 summarizes the Level II riffle, flatwater, and pool habitat types. Based on frequency of occurrence there were 47% pool units, 31% flatwater units, 21% riffle units, and 1% dry units (Graph 1). Based on total length of Level II habitat types there were 70% flatwater units, 16% pool units, and 14% riffle units (Graph 2).

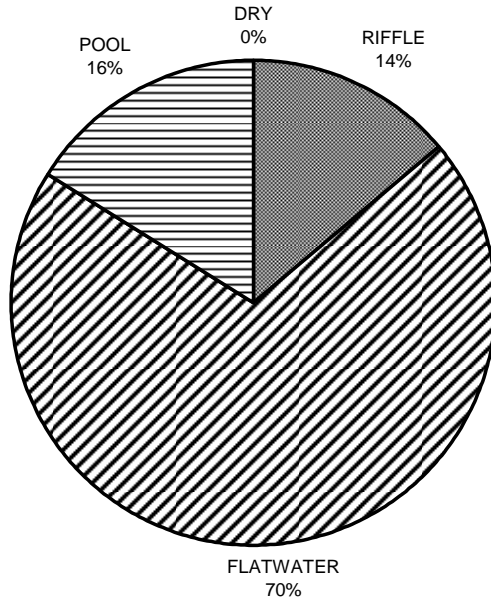
GRAPH 2

Flatwater habitat types comprised 70% of the total length of this survey, pools 26%, and riffles 14%. The pools are relatively shallow, with 12 of the 56 (21%) pools having a maximum depth greater than 2 feet. In general, pool enhancement projects are considered when primary pools comprise less than 40% of the length of total stream habitat. In first and second order streams, a primary pool is defined to have a maximum depth of at least two feet, occupy at least half the width of the low flow channel, and be as long as the low flow channel width. Installing structures that will increase or deepen pool habitat is recommended for locations where their installation will not be threatened by high stream energy, or where their installation will not conflict with the modification of the numerous log debris accumulations (LDA's) in the stream.

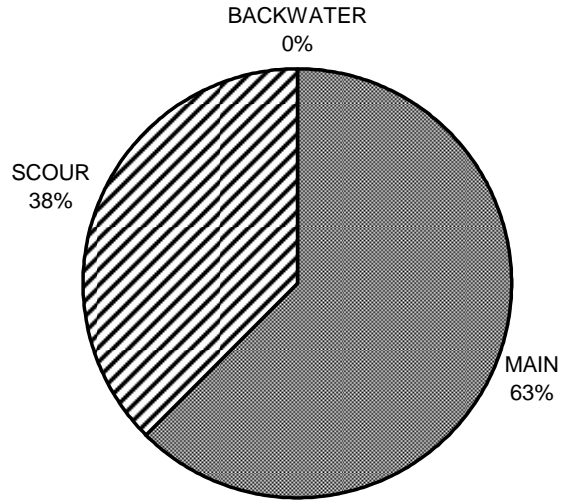
GRAPH 4

A total of 56 pools were identified (Table 3). Main channel pools were the most frequently encountered, at 63%, and comprised 62% of the total length of all pools (Graph 4).

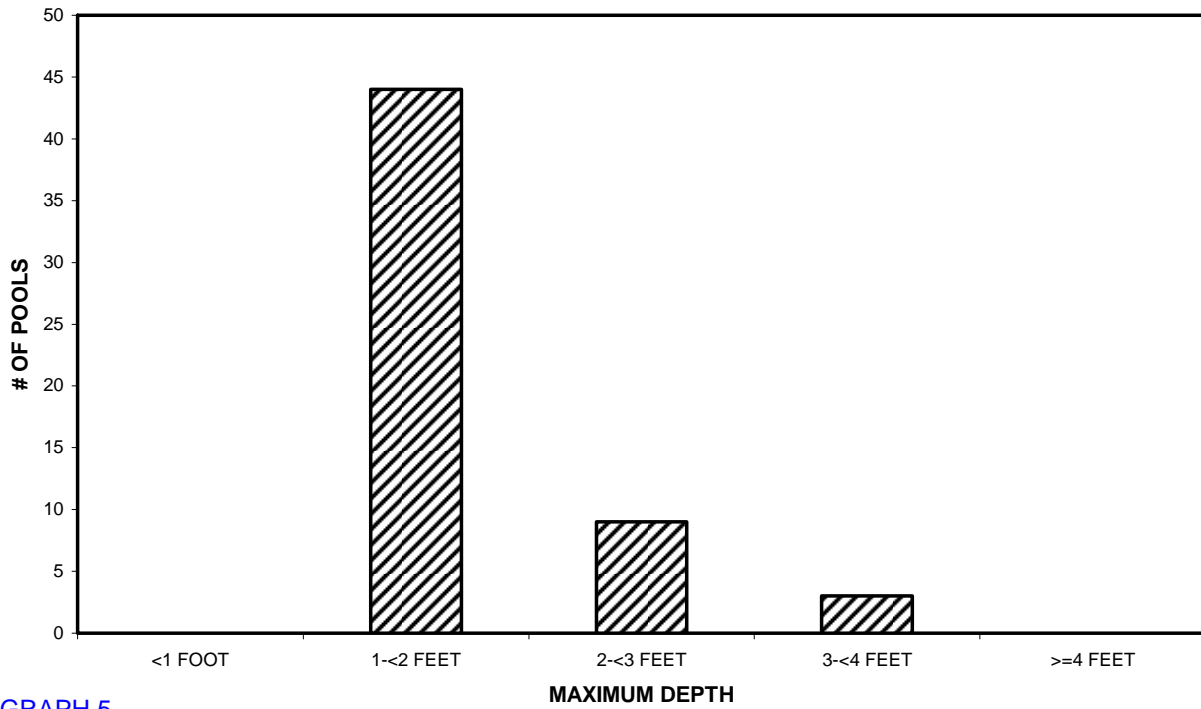
GRAPH 5

Table 4 is a summary of maximum pool depths by pool habitat types. Pool quality for salmonids increases with depth. Twelve of the 56 pools (21%) had a depth of two feet or greater (Graph 5).

- 3) Where feasible, design and engineer pool enhancement structures to increase the number of pools. This must be done where the banks are stable or in conjunction with stream bank armor to prevent erosion.

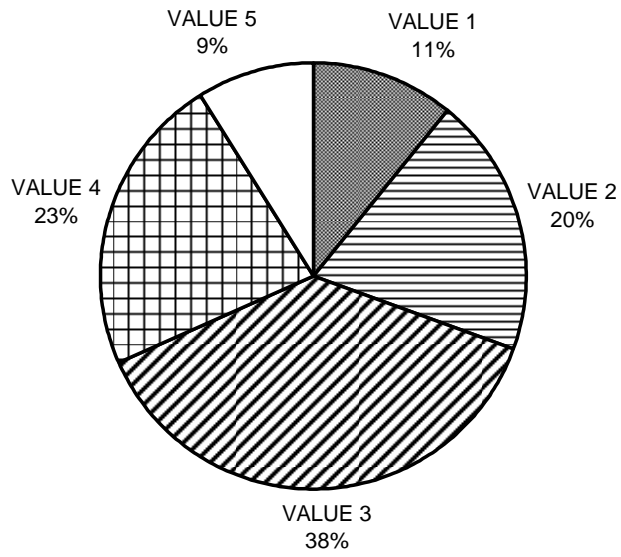
GRAPH 6

The depth of cobble embeddedness was estimated at pool tail-outs. Of the 56 pool tail-outs measured, 6 had a value of 1 (11%); 11 had a value of 2 (20%); 21 had a value of 3 (38%); 3 had a value of 4 (23%); and 5 had a value of 5 (9%) (Graph 6). On this scale, a value of 1 indicates

Seventeen of the 56 pool tail-outs measured had embeddedness ratings of 1 or 2. Thirty-four of the pool tail-outs had embeddedness ratings of 3 or 4. Five of the pool tail-outs had a rating of 5, which is considered unsuitable for spawning. Cobble embeddedness measured to be 25% or less, a rating of 1, is considered to indicate good quality spawning substrate for salmon and steelhead. Sediment sources in Right Bank Tributary One to Martin Creek should be mapped and rated according to their potential sediment yields, and control measures should be taken.

- 5) Inventory and map sources of stream bank erosion and prioritize them according to present and potential sediment yield. Identified sites should then be treated to reduce the amount of fine sediments entering the stream.

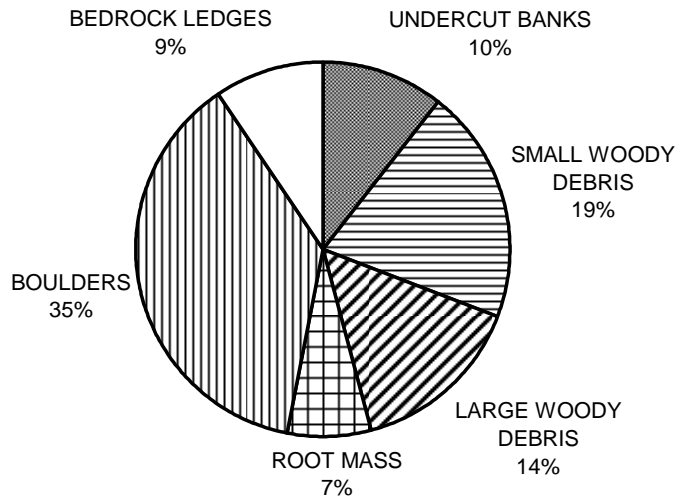
GRAPH 7

Table 5 summarizes mean percent cover by habitat type. Boulders are the dominant cover types in Right Bank Tributary One to Martin Creek. Graph 7 describes the pool cover in Right Bank Tributary One to Martin Creek. Boulders are the dominant pool cover type followed by small woody debris.

The mean shelter rating for pools was 26. The shelter rating in the flatwater habitats was 19. A pool shelter rating of approximately 100 is desirable. The amount of cover that now exists is being provided primarily by boulders in all habitat types. Additionally, small woody debris contributes a small amount. Log and root wad cover structures in the pool and flatwater habitats would enhance both summer and winter salmonid habitat. Log cover structure provides rearing fry with protection from predation, rest from water velocity, and also divides territorial units to reduce density related competition.

- 4) Increase woody cover in the pools and flatwater habitat units. Most of the existing cover is from boulders. Adding high quality complexity with log and root wad cover is desirable.

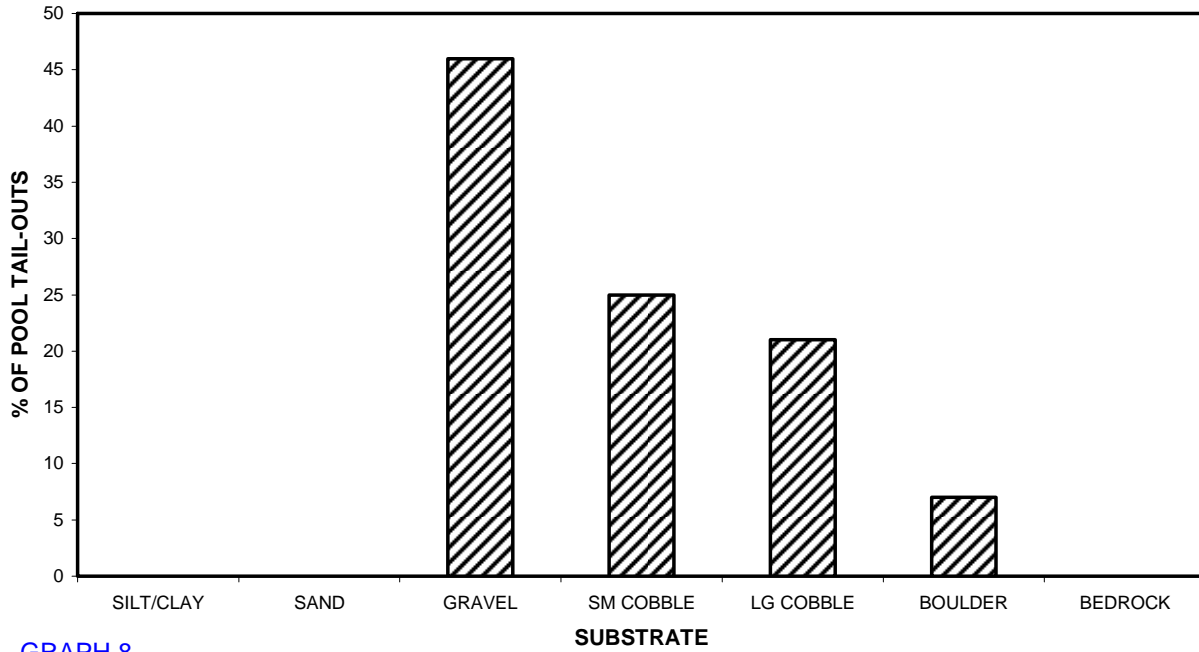
GRAPH 8

Table 6 summarizes the dominant substrate by habitat type. Graph 8 depicts the dominant substrate observed in pool tail-outs. Gravel was the dominant substrate observed in 46% of pool tail-outs while small cobble was the next most frequently observed substrate type, at 25%.

Forty of the 56 pool tail-outs measured had gravel and small cobble as the dominant substrate. This is generally considered good for spawning salmonids.

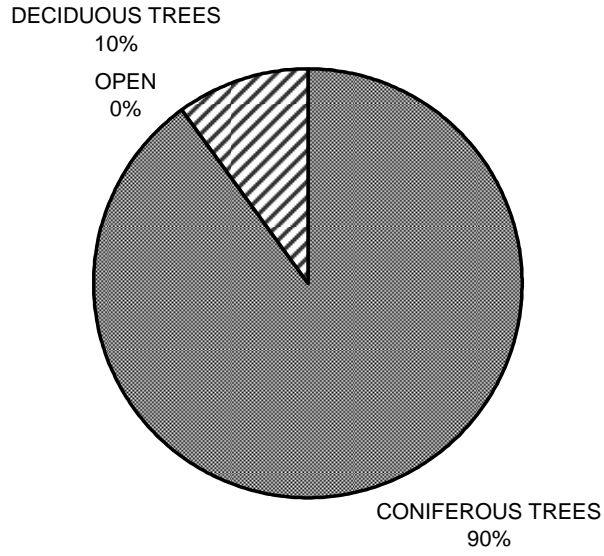
GRAPH 9

The mean percent canopy density for the surveyed length of Right Bank Tributary One to Martin Creek was 83%. The mean percentages of deciduous and coniferous trees were 10% and 90%, respectively. Graph 9 describes the mean percent canopy in Right Bank Tributary One to Martin Creek.

The mean percent canopy density for the stream was 83%. In general, revegetation projects are considered when canopy density is less than 80%.

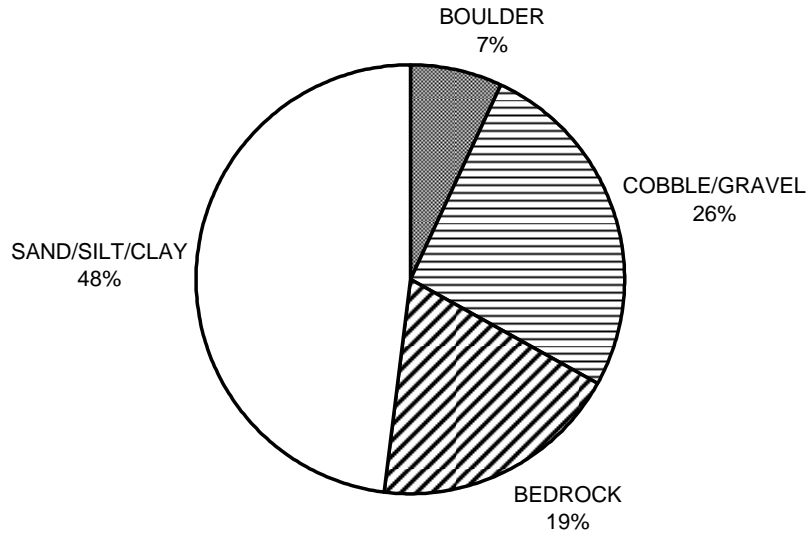
GRAPH 10

For the stream reach surveyed, the mean percent right bank vegetated was 68%. The mean percent left bank vegetated was 61%. The dominant elements composing the structure of the stream banks consisted of 48% sand/silt/clay, 26% cobble/gravel, 19% bedrock, and 7% boulder (Graph 10). Coniferous trees were the dominant vegetation type observed in 57% of the units surveyed. Additionally, 40% of the units surveyed had brush as the dominant vegetation type (Graph 11).

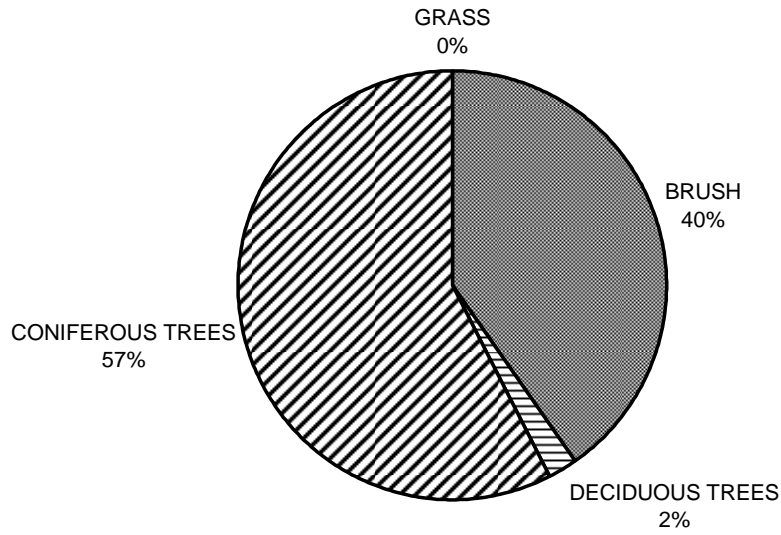
GRAPH 11

The percentage of right and left bank covered with vegetation was moderate at 68% and 61%, respectively. In areas of stream bank erosion or where bank vegetation is not at acceptable levels, planting endemic species of coniferous and deciduous trees, in conjunction with bank stabilization, is recommended.
