STREAM INVENTORY REPORT

Right Bank Tributary Two to Martin Creek

A stream inventory was conducted July 29, 2002 on Right Bank Tributary Two to Martin Creek. The survey began at the confluence with Martin Creek and extended upstream 0.60 miles.

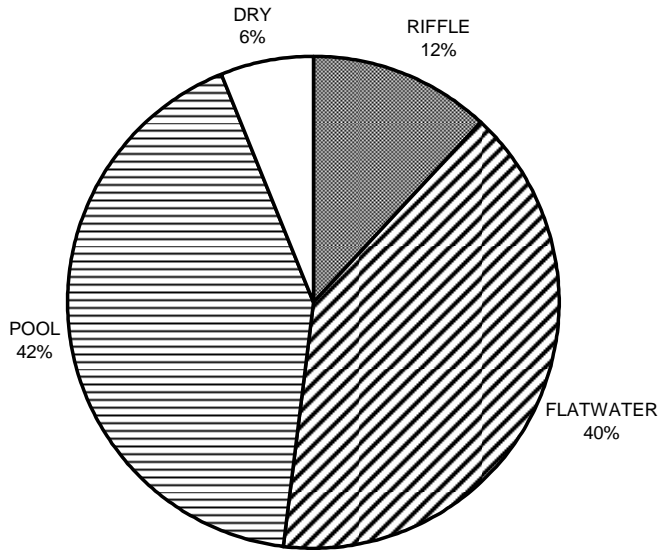
GRAPH 1

Table 1 summarizes the Level II riffle, flatwater, and pool habitat types. Based on frequency of occurrence there were 42% pool units, 40% flatwater units, 12% riffle units, and 6% dry units (Graph 1). Based on total length of Level II habitat types there were 77% flatwater units, 14% pool units, 8% riffle units, and 1% dry units (Graph 2).

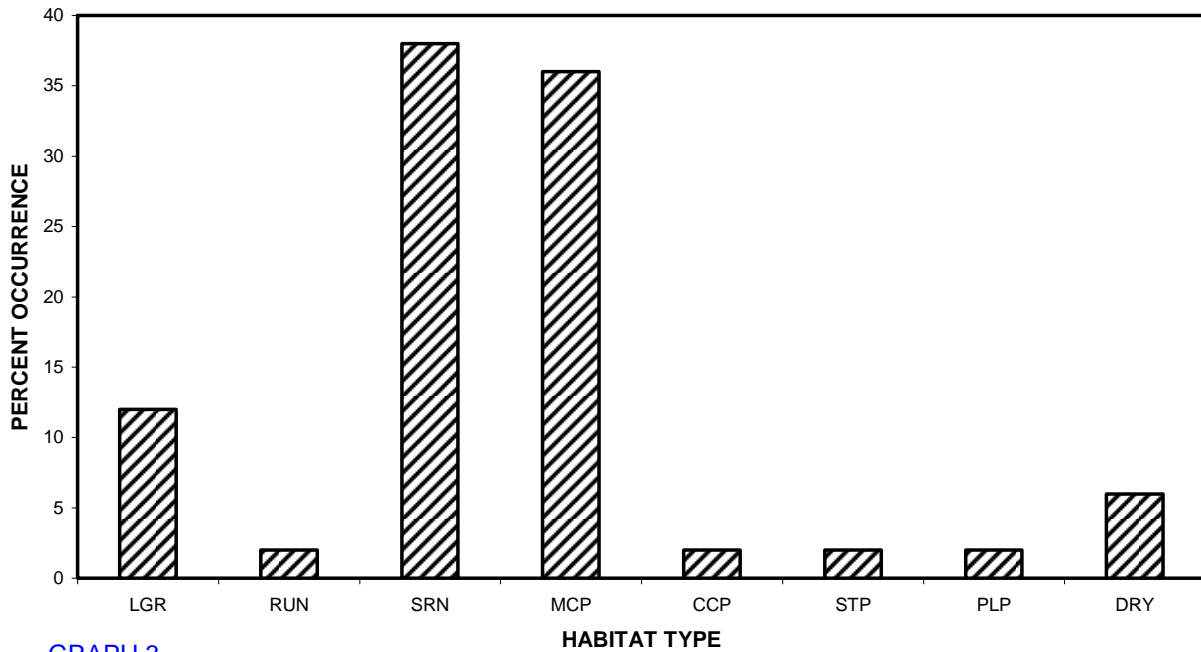
GRAPH 3

Eight Level IV habitat types were identified (Table 2). The most frequent habitat types by percent occurrence were step runs, 38%; mid-channel pools, 36%; and low gradient riffles, 12% (Graph 3). Based on percent total length, step runs made up 77%, mid channel pools 12%, and low gradient riffles 8%.

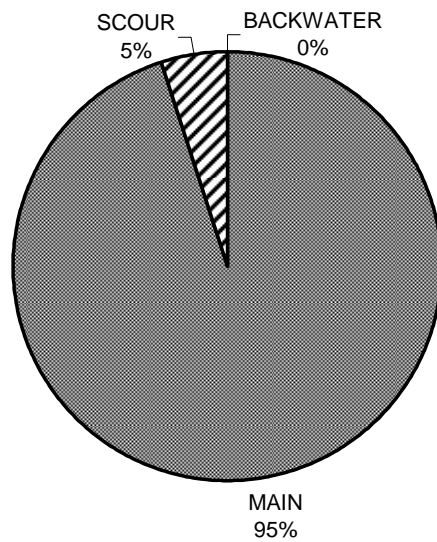
GRAPH 4

A total of 21 pools were identified (Table 3). Main channel pools were the most frequently encountered, at 95%, and comprised 98% of the total length of all pools (Graph 4).

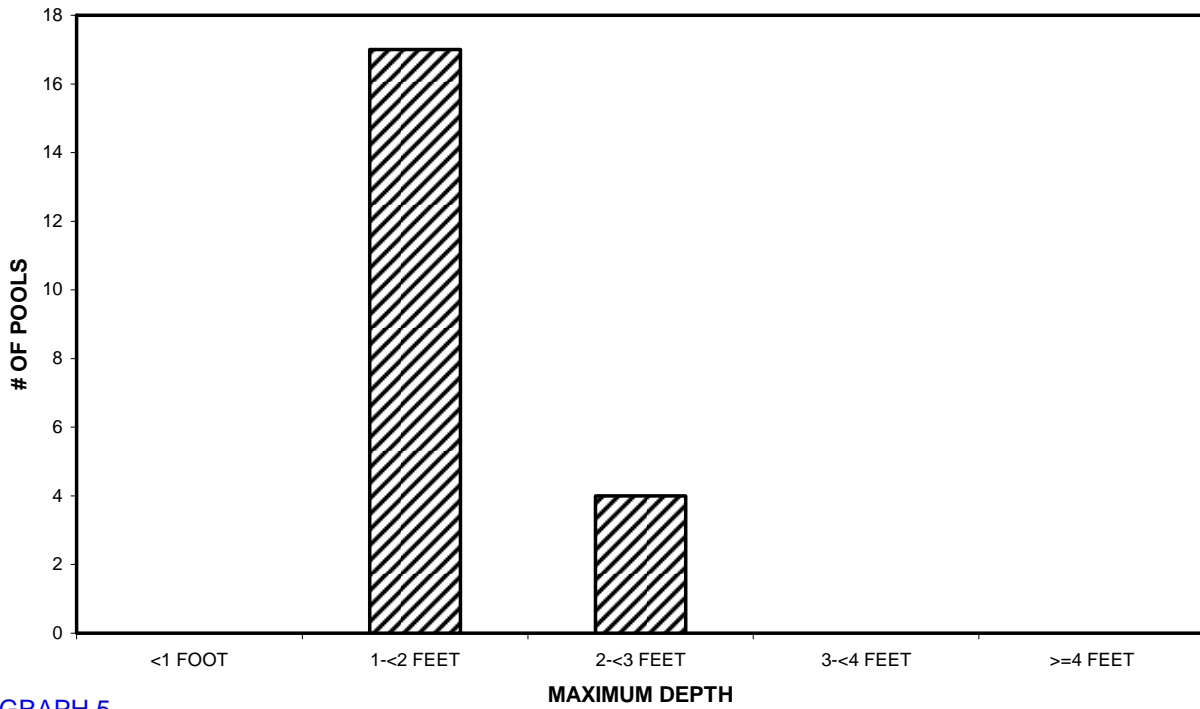
GRAPH 5

Table 4 is a summary of maximum pool depths by pool habitat types. Pool quality for salmonids increases with depth. Four of the 21 pools (19%) had a depth of two feet or greater (Graph 5). The depth of cobble embeddedness was estimated at pool tail-outs. Of the 21 pool tail-outs measured, 0 had a value of 1 (0%); 0 had a value of 2 (0%); 12 had a value of 3 (57%); 7 had a value of 4 (33%); and 2 had a value of 5 (10%) (Graph 6). On this scale, a value of 1 indicates

Flatwater habitat types comprised 77% of the total length of this survey, pools 14%, and riffles 8%. The pools are relatively shallow, with 4 of the 21 (19%) pools having a maximum depth greater than 2 feet. In general, pool enhancement projects are considered when primary pools comprise less than 40% of the length of total stream habitat. In first and second order streams, a primary pool is defined to have a maximum depth of at least two feet, occupy at least half the width of the low flow channel, and be as long as the low flow channel width. Installing structures that will increase or deepen pool habitat is recommended for locations where their installation will not be threatened by high stream energy, or where their installation will not conflict with the modification of the numerous log debris accumulations (LDA's) in the stream.

- 3) Where feasible, design and engineer pool enhancement structures to increase the number of pools. This must be done where the banks are stable or in conjunction with stream bank armor to prevent erosion.

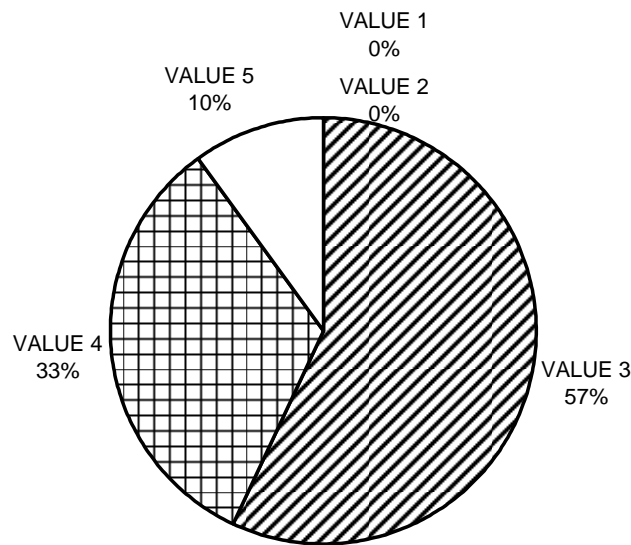
GRAPH 6

None of the 21 pool tail-outs measured had embeddedness ratings of 1 or 2. Nineteen of the pool tail-outs had embeddedness ratings of 3 or 4. Two of the pool tail-outs had a rating of 5, which is considered unsuitable for spawning. Cobble embeddedness measured to be 25% or less, a rating of 1, is considered to indicate good quality spawning substrate for salmon and steelhead. Sediment sources in Right Bank Tributary Two to Martin Creek should be mapped and rated according to their potential sediment yields, and control measures should be taken.

- 4) Inventory and map sources of stream bank erosion and prioritize them according to present and potential sediment yield. Identified sites should then be treated to reduce the amount of fine sediments entering the stream.

- 5) Active and potential sediment sources need to be identified, mapped, and treated according to their potential for sediment yield to the stream and its tributaries.

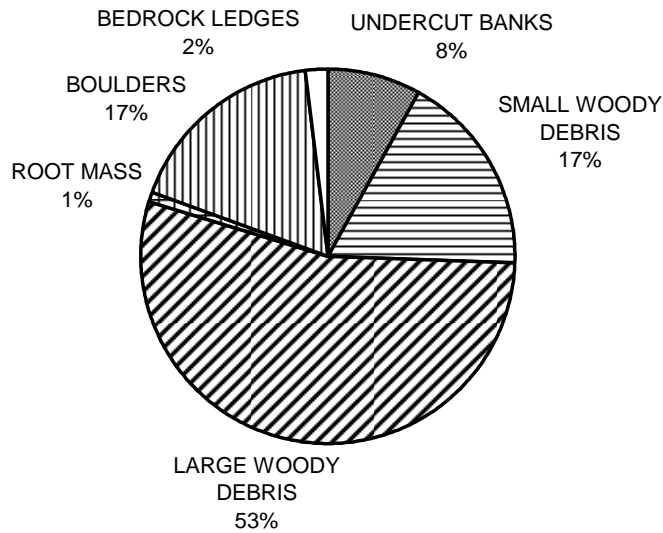
GRAPH 7

Table 5 summarizes mean percent cover by habitat type. Large woody debris is the dominant cover types in Right Bank Tributary Two to Martin Creek. Graph 7 describes the pool cover in Right Bank Tributary Two to Martin Creek. Large woody debris is the dominant pool cover type followed by small woody debris.

The mean shelter rating for pools was 34. The shelter rating in the flatwater habitats was 100. A pool shelter rating of approximately 100 is desirable. The amount of cover that now exists is being provided primarily by large woody debris in all habitat types. Additionally, small woody debris contributes a small amount. Log and root wad cover structures in the pool and flatwater habitats would enhance both summer and winter salmonid habitat. Log cover structure provides rearing fry with protection from predation, rest from water velocity, and also divides territorial units to reduce density related competition.

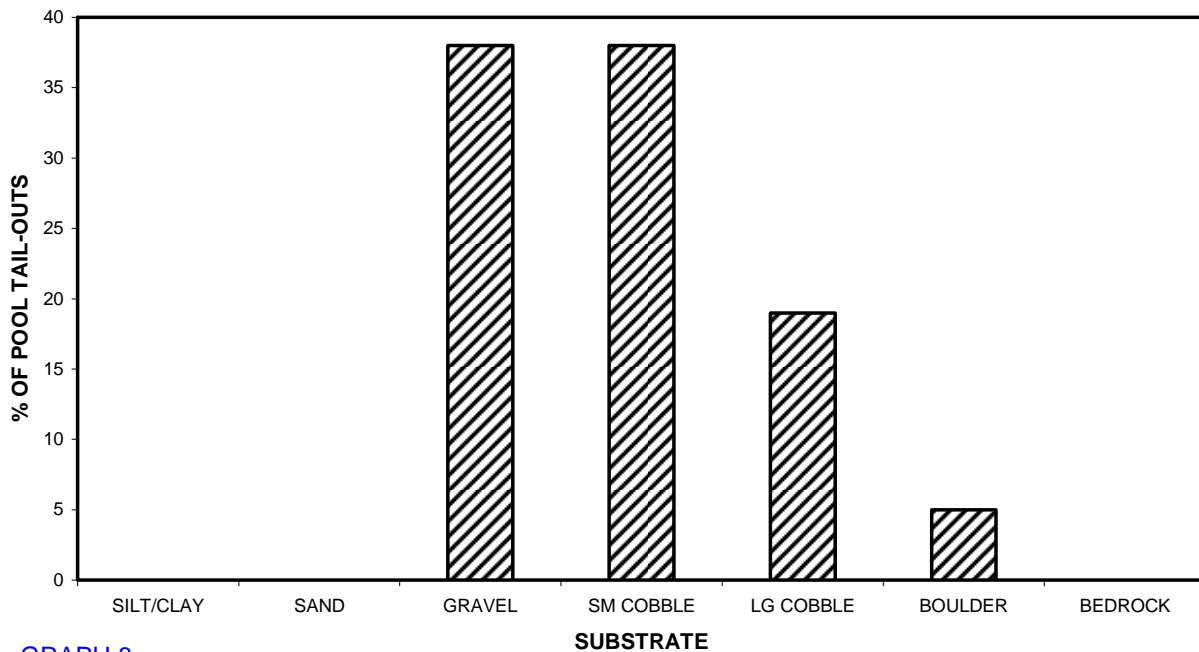
GRAPH 8

Table 6 summarizes the dominant substrate by habitat type. Graph 8 depicts the dominant substrate observed in pool tail-outs. Gravel was the dominant substrate observed in 38% of pool tail-outs while small cobble was an equally observed substrate type, at 38%.

Nineteen of the 21 pool tail-outs measured had gravel and small cobble as the dominant substrate. This is generally considered good for spawning salmonids.

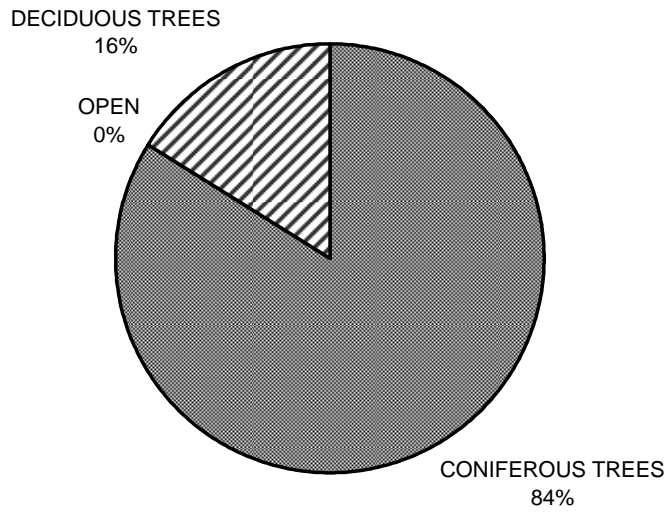
GRAPH 9

The mean percent canopy density for the surveyed length of Right Bank Tributary Two to Martin Creek was 86%. The mean percentages of deciduous and coniferous trees were 16% and 84%, respectively. Graph 9 describes the mean percent canopy in Right Bank Tributary Two to Martin Creek.

The mean percent canopy density for the stream was 85%. In general, revegetation projects are considered when canopy density is less than 80%.

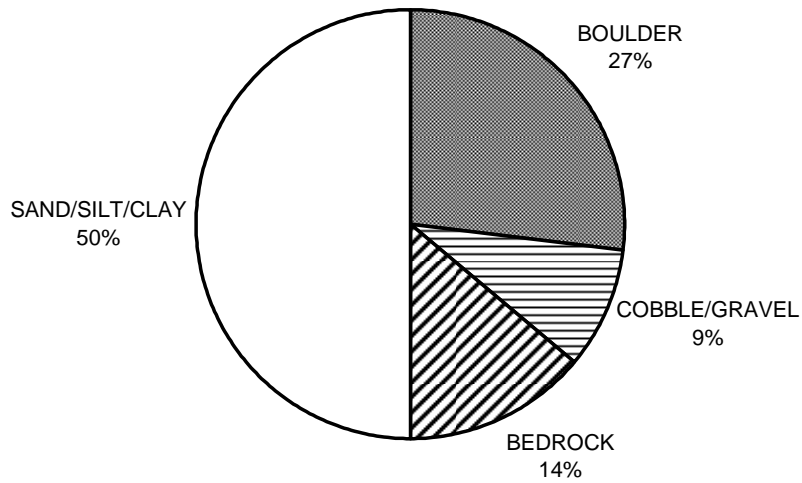
GRAPH 10

For the stream reach surveyed, the mean percent right bank vegetated was 30%. The mean percent left bank vegetated was 24%. The dominant elements composing the structure of the stream banks consisted of 50% sand/silt/clay, 14% bedrock, 27% boulder, and 9% cobble/gravel (Graph 10). Coniferous trees were the dominant vegetation type observed in 95% of the units surveyed. Additionally, 5% of the units surveyed had deciduous trees as the dominant vegetation type (Graph 11).

The percentage of right and left bank covered with vegetation was moderate at 30% and 24%, respectively. In areas of stream bank erosion or where bank vegetation is not at acceptable levels, planting endemic species of coniferous and deciduous trees, in conjunction with bank stabilization, is recommended.
