# STREAM INVENTORY REPORT

## Tramway Gulch

A stream inventory was conducted from July 11 to July 13, 2011 on Tramway Gulch. The survey began at the confluence with Big River and extended upstream 0.7 miles.

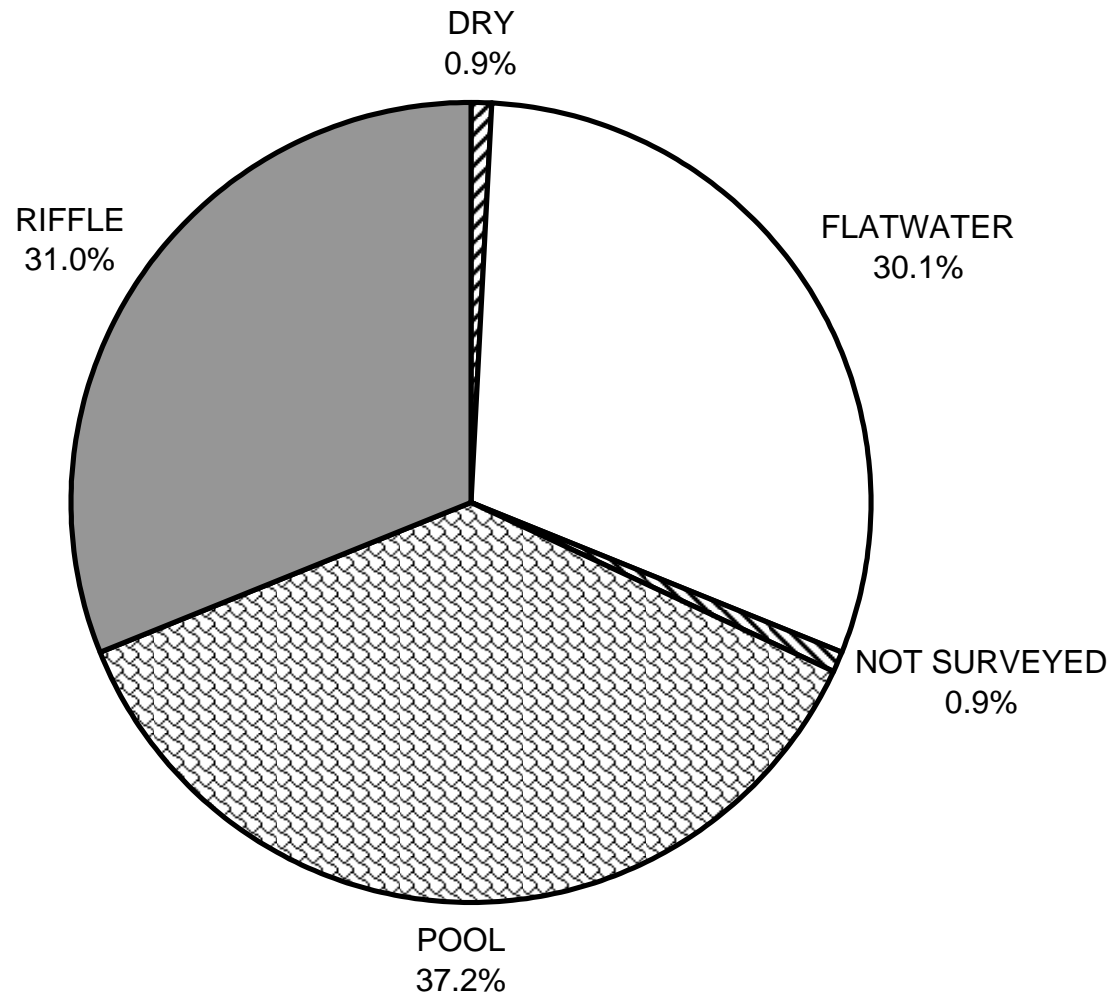
GRAPH 1

Table 1 summarizes the Level II riffle, flatwater, and pool habitat types. Based on frequency of occurrence there were 37% pool units, 31% riffle units, 30% flatwater units, 1% dry units, and 1% no survey units (Graph 1). Based on total length of Level II habitat types there were 45% flatwater units, 30% riffle units, 24% pool units, 1% no survey units, and 1% dry units (Graph 2).

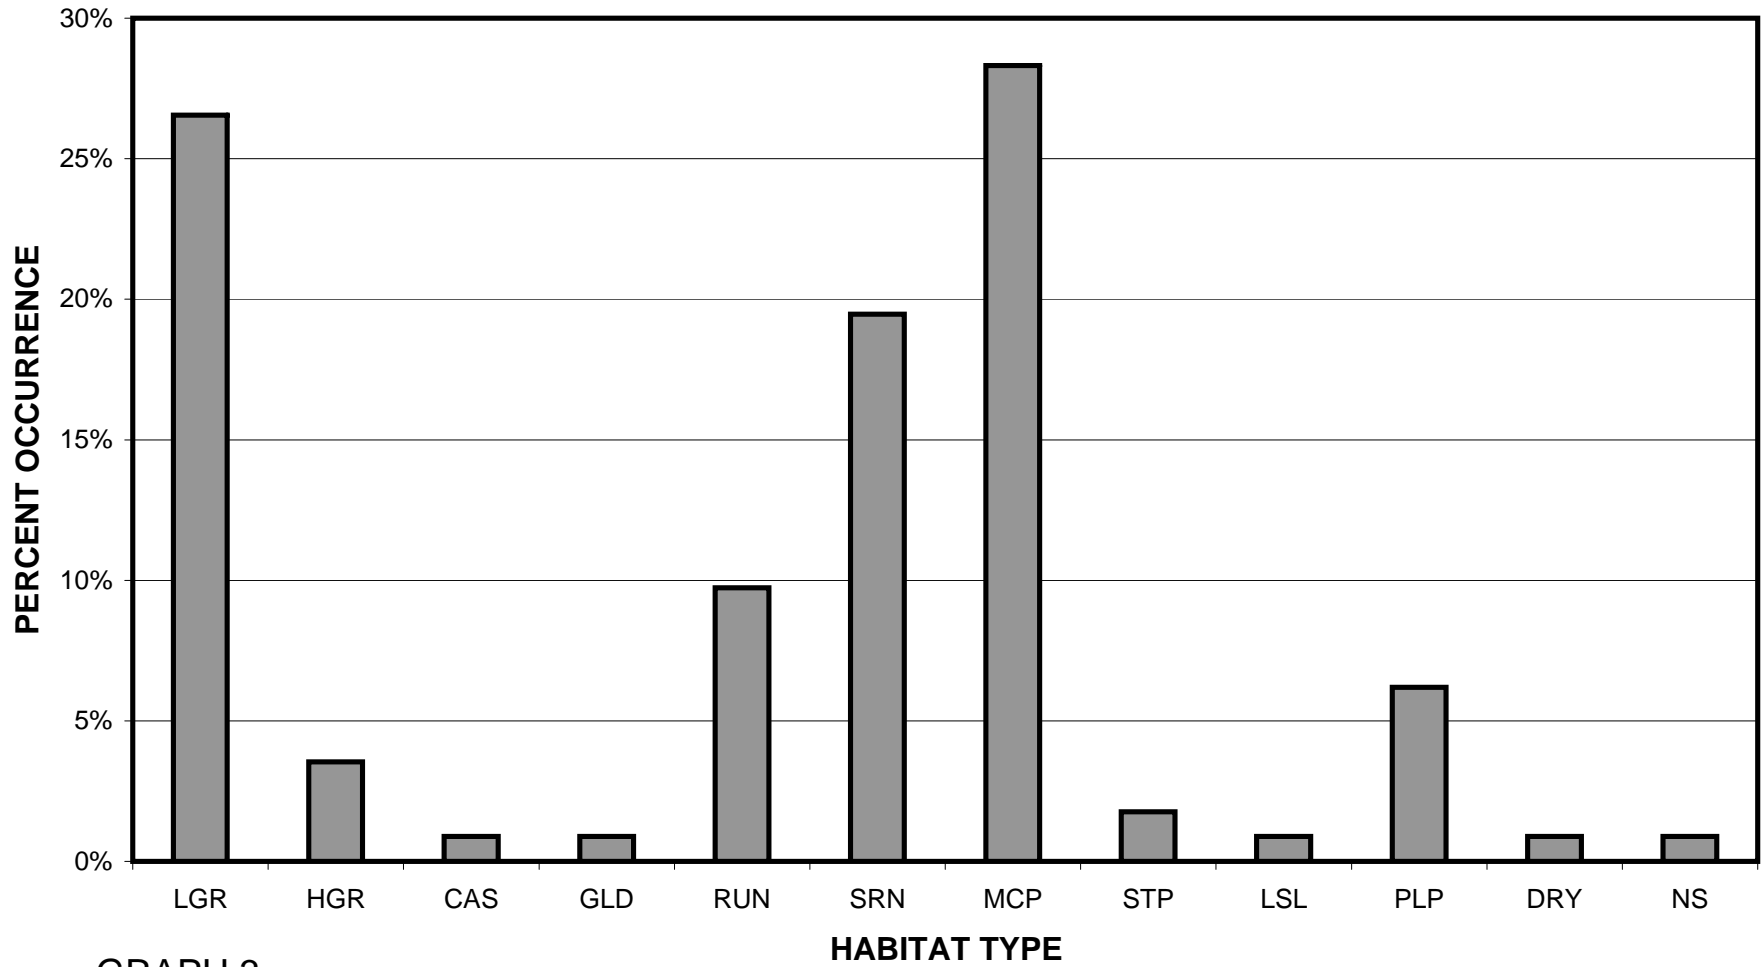
GRAPH 3

Eleven Level IV habitat types were identified (Table 2). The most frequent habitat types by percent occurrence were mid-channel pool units, 28%; low gradient riffle units, 27%; and step

run units, 20% (Graph 3). Based on percent total length, step run units made up 35%, low gradient riffle units 25%, and mid-channel pool units 17%.

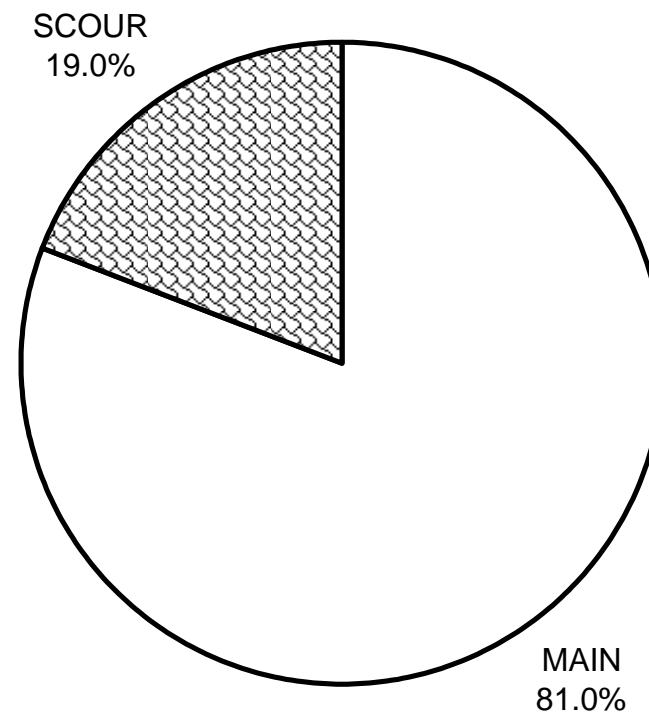
GRAPH 4

A total of 42 pools were identified (Table 3). Main channel pools were the most frequently encountered at 81% (Graph 4), and comprised 80% of the total length of all pools (Table 3).

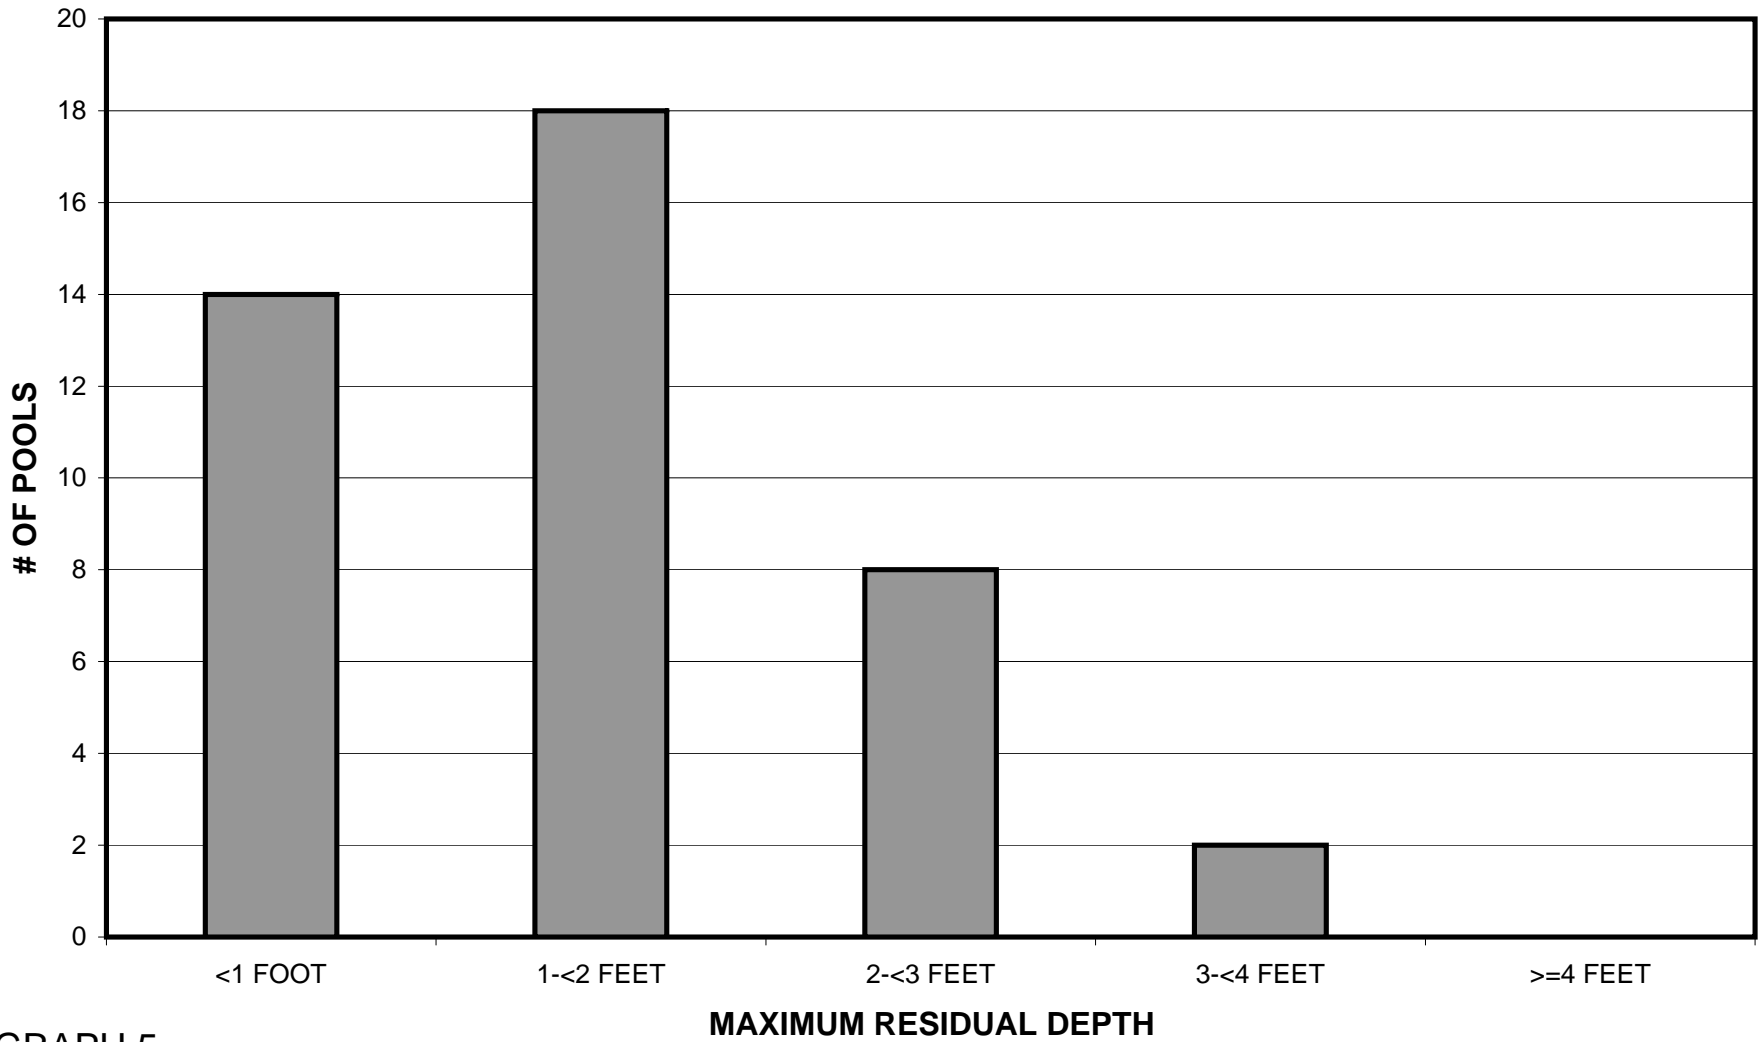
GRAPH 5

Table 4 is a summary of maximum residual pool depths by pool habitat types. Pool quality for salmonids increases with depth. Ten of the 42 pools (24%) had a residual depth of two feet or greater (Graph 5).

Flatwater habitat types comprised 45% of the total length of this survey, riffles 30%, and pools 24%. Ten of the 42 (24%) pools had a maximum residual depth greater than 2 feet. In general, pool enhancement projects are considered when primary pools comprise less than 40% of the length of total stream habitat. In first and second order streams, a primary pool is defined to have a maximum residual depth of at least two feet, occupy at least half the width of the low flow channel, and be as long as the low flow channel width. Installing structures that will increase or deepen pool habitat is recommended.

- 3) Where feasible, design and engineer pool enhancement structures to increase the number of pools. This must be done where the banks are stable or in conjunction with stream bank armor to prevent erosion.

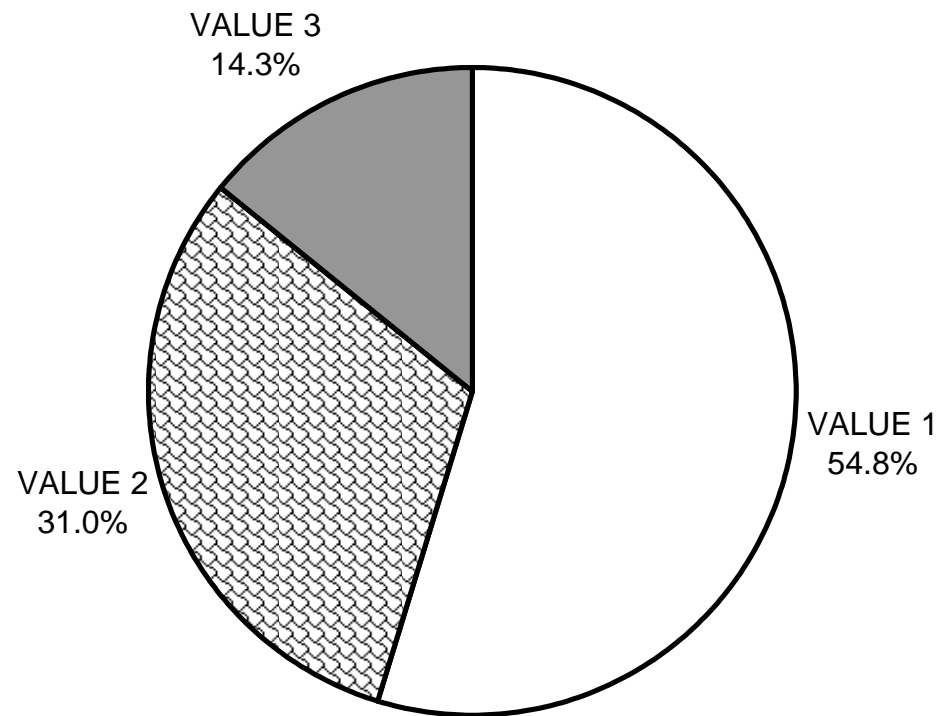
GRAPH 6

The depth of cobble embeddedness was estimated at pool tail-outs. Of the 42 pool tail-outs measured, 23 had a value of 1 (54.8%); 13 had a value of 2 (31%); and 6 had a value of 3 (14.3%); (Graph 6). On this scale, a value of 1 indicates the best spawning conditions and a value of 4 the worst. Additionally, a value of 5 was assigned to tail-outs deemed not suitable for spawning due to inappropriate substrate such as bedrock, log sills, boulders, or other considerations.

Thirty-six of the 42 pool tail-outs measured had embeddedness ratings of 1 or 2. Six of the pool tail-outs had embeddedness ratings of 3 or 4. None of the pool tail-outs had a rating of 5, which is considered unsuitable for spawning. Cobble embeddedness measured to be 25% or less, a rating of 1, is considered to indicate good quality spawning substrate for salmon and steelhead.

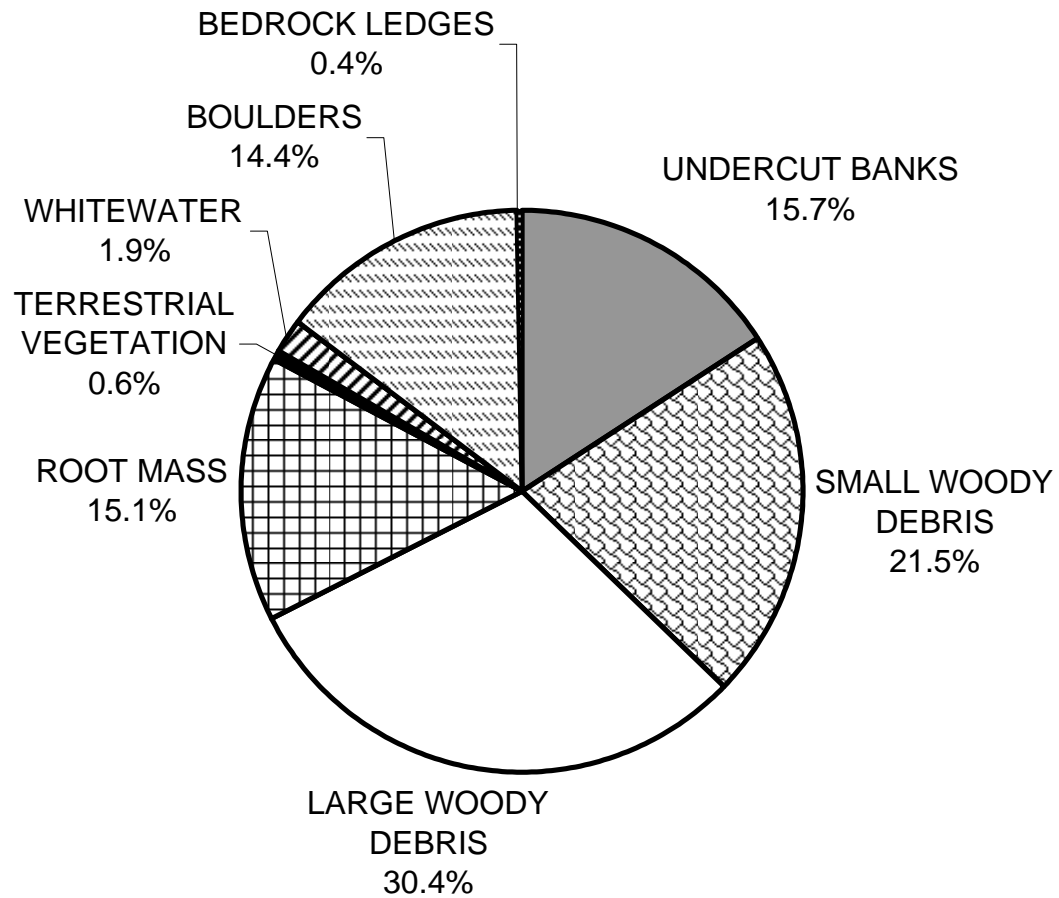
GRAPH 7

Table 5 summarizes mean percent cover by habitat type. Large woody debris is the dominant cover type in Tramway Gulch. Graph 7 describes the pool cover in Tramway Gulch. Large woody debris is the dominant pool cover type followed by small woody debris.

The mean shelter rating for pools is 25. The shelter rating in the flatwater habitats is 4. A pool shelter rating of approximately 100 is desirable. The amount of cover that now exists is being provided primarily by large woody debris in Tramway Gulch. Large woody debris is the dominant cover type in pools followed by small woody debris. Log and root wad cover structures in the pool and flatwater habitats would enhance both summer and winter salmonid habitat. Log cover structures provide rearing fry with protection from predation, rest from water velocity, and also divide territorial units to reduce density related competition.

- 4) Increase woody cover in the pools and flatwater habitat units. Most of the existing cover in the pools is from large woody debris. Adding high quality complexity with woody cover in the pools is desirable.

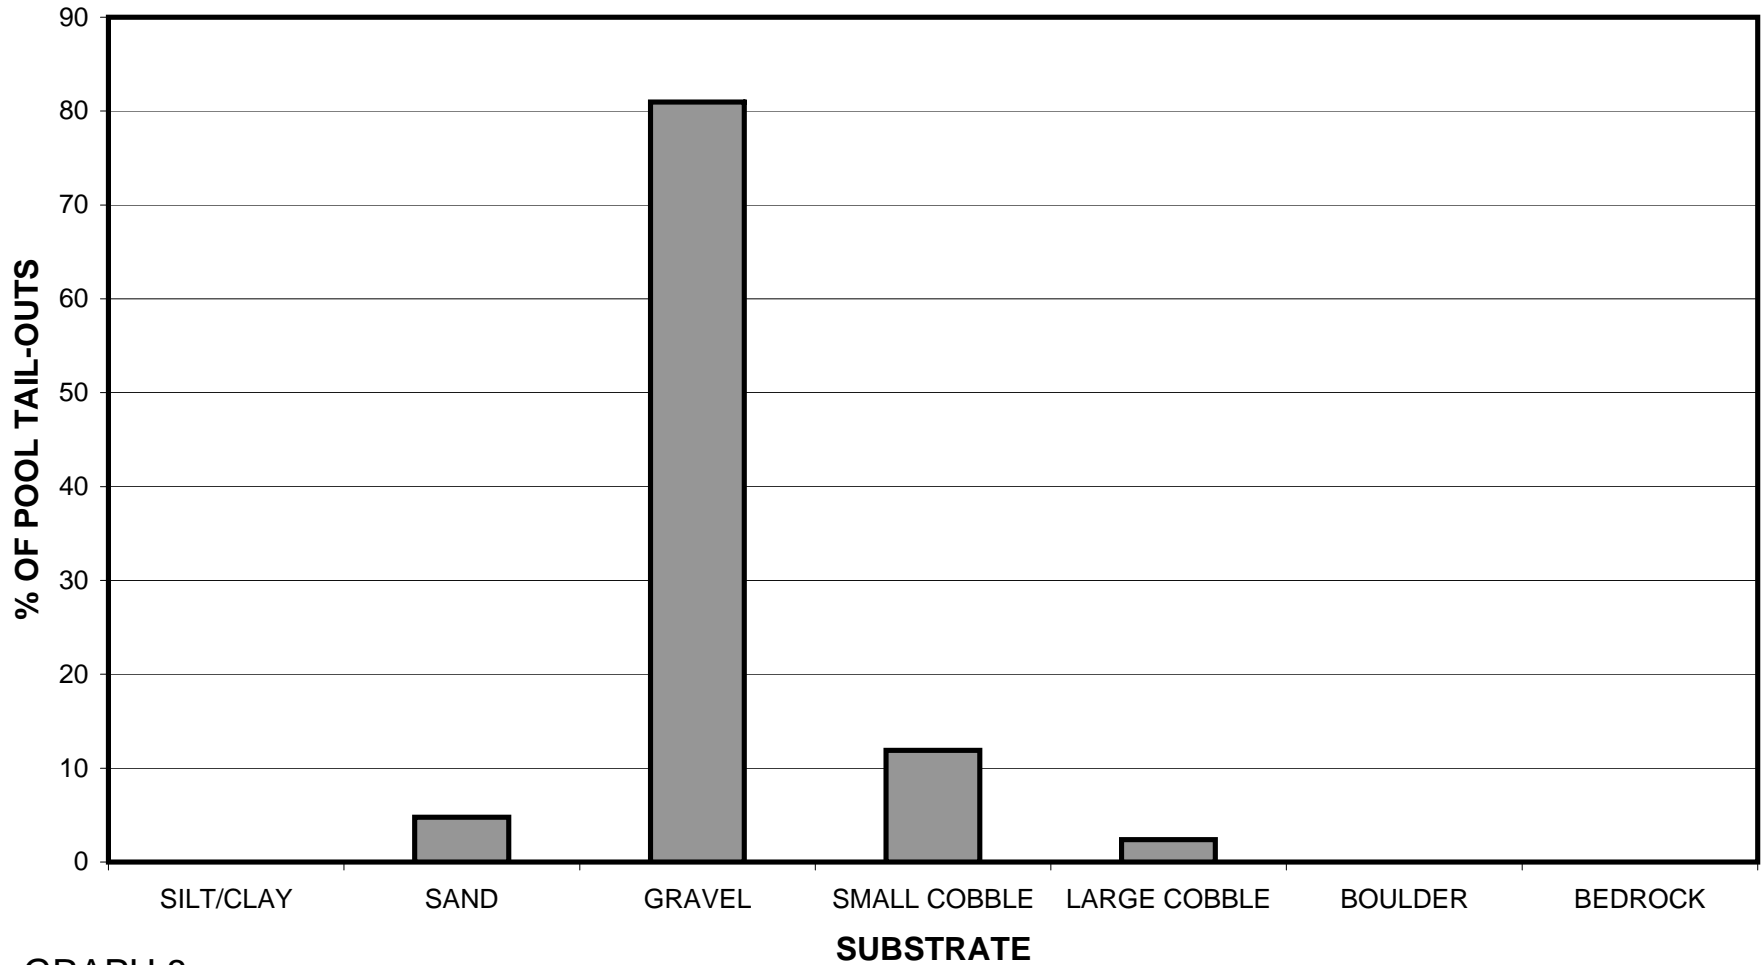
GRAPH 8

Table 6 summarizes the dominant substrate by habitat type. Graph 8 depicts the dominant substrate observed in pool tail-outs. Gravel was the dominant substrate observed in 81% of the pool tail-outs. Small cobble was the next most frequently observed dominant substrate type and occurred in 12% of the pool tail-outs.

Thirty-nine of the 42 pool tail-outs measured had gravel or small cobble as the dominant substrate. This is generally considered good for spawning salmonids.

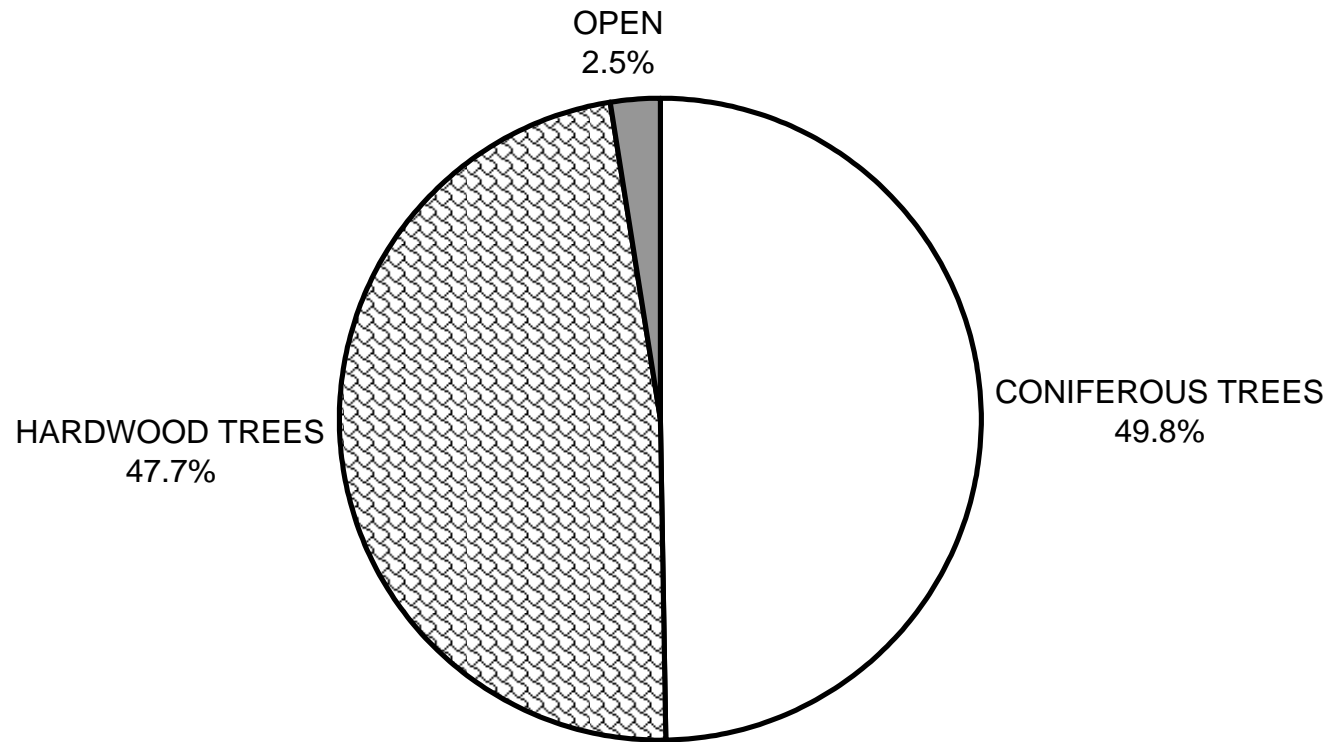
GRAPH 9

The mean percent canopy density for the surveyed length of Tramway Gulch was 97%. Three percent of the canopy was open. Of the canopy present, the mean percentages of hardwood and coniferous trees were 49% and 51%, respectively. Graph 9 describes the mean percent canopy in Tramway Gulch.

The mean percent canopy density for the stream was 97%. Reach 1 had a canopy density of 97%, Reach 2 had a canopy density of 100%, and Reach 3 had a canopy density of 98%. In general, revegetation projects are considered when canopy density is less than 80%. The percentage of right and left bank covered with vegetation was 93% and 93%, respectively. In areas of stream bank erosion or where bank vegetation is sparse, planting endemic species of coniferous and hardwood trees, in conjunction with bank stabilization, is recommended.

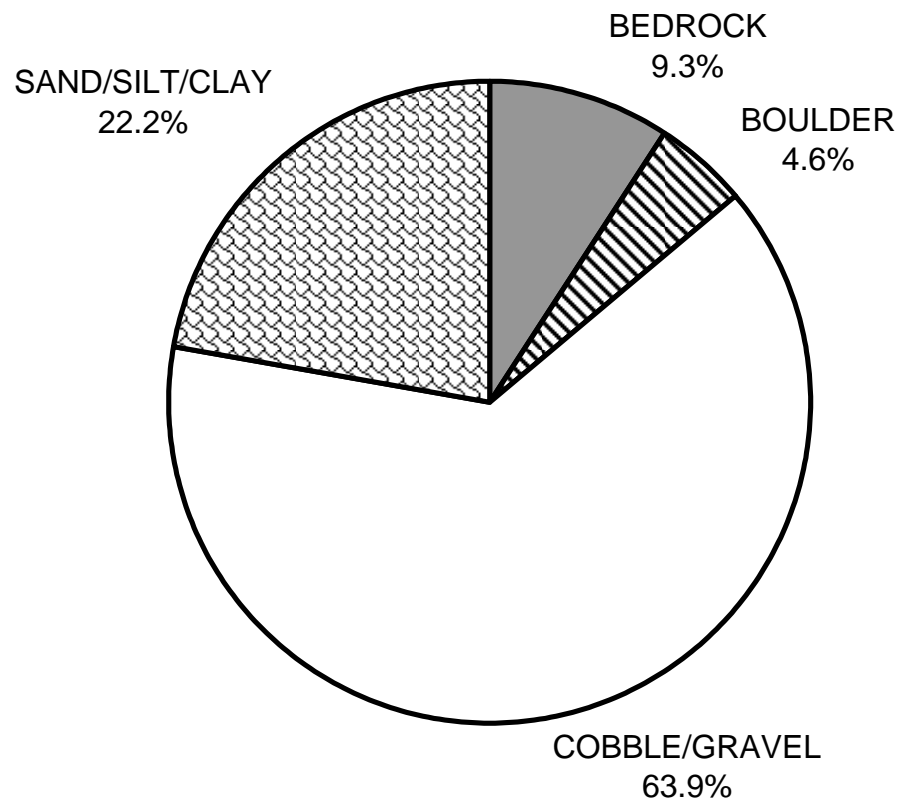
GRAPH 10

For the stream reach surveyed, the mean percent right bank vegetated was 93%. The mean percent left bank vegetated was 93%. The dominant elements composing the structure of the stream banks consisted of 64% cobble/gravel, 22% sand/silt/clay, 9% bedrock, and 5% boulder (Graph 10). Coniferous trees were the dominant vegetation type observed in 60% of the units surveyed. Additionally, 32% of the units surveyed had deciduous trees as the dominant vegetation type, and 6% had grass as the dominant vegetation type (Graph 11).
