# STREAM INVENTORY REPORT

## Brush Creek

A stream inventory was conducted from June 28 to October 25, 2005 on Brush Creek. The survey began at the confluence with the Pacific Ocean and extended upstream 13.3 miles. A stream inventory and subsection to this report was also completed for one tributary to Brush Creek.

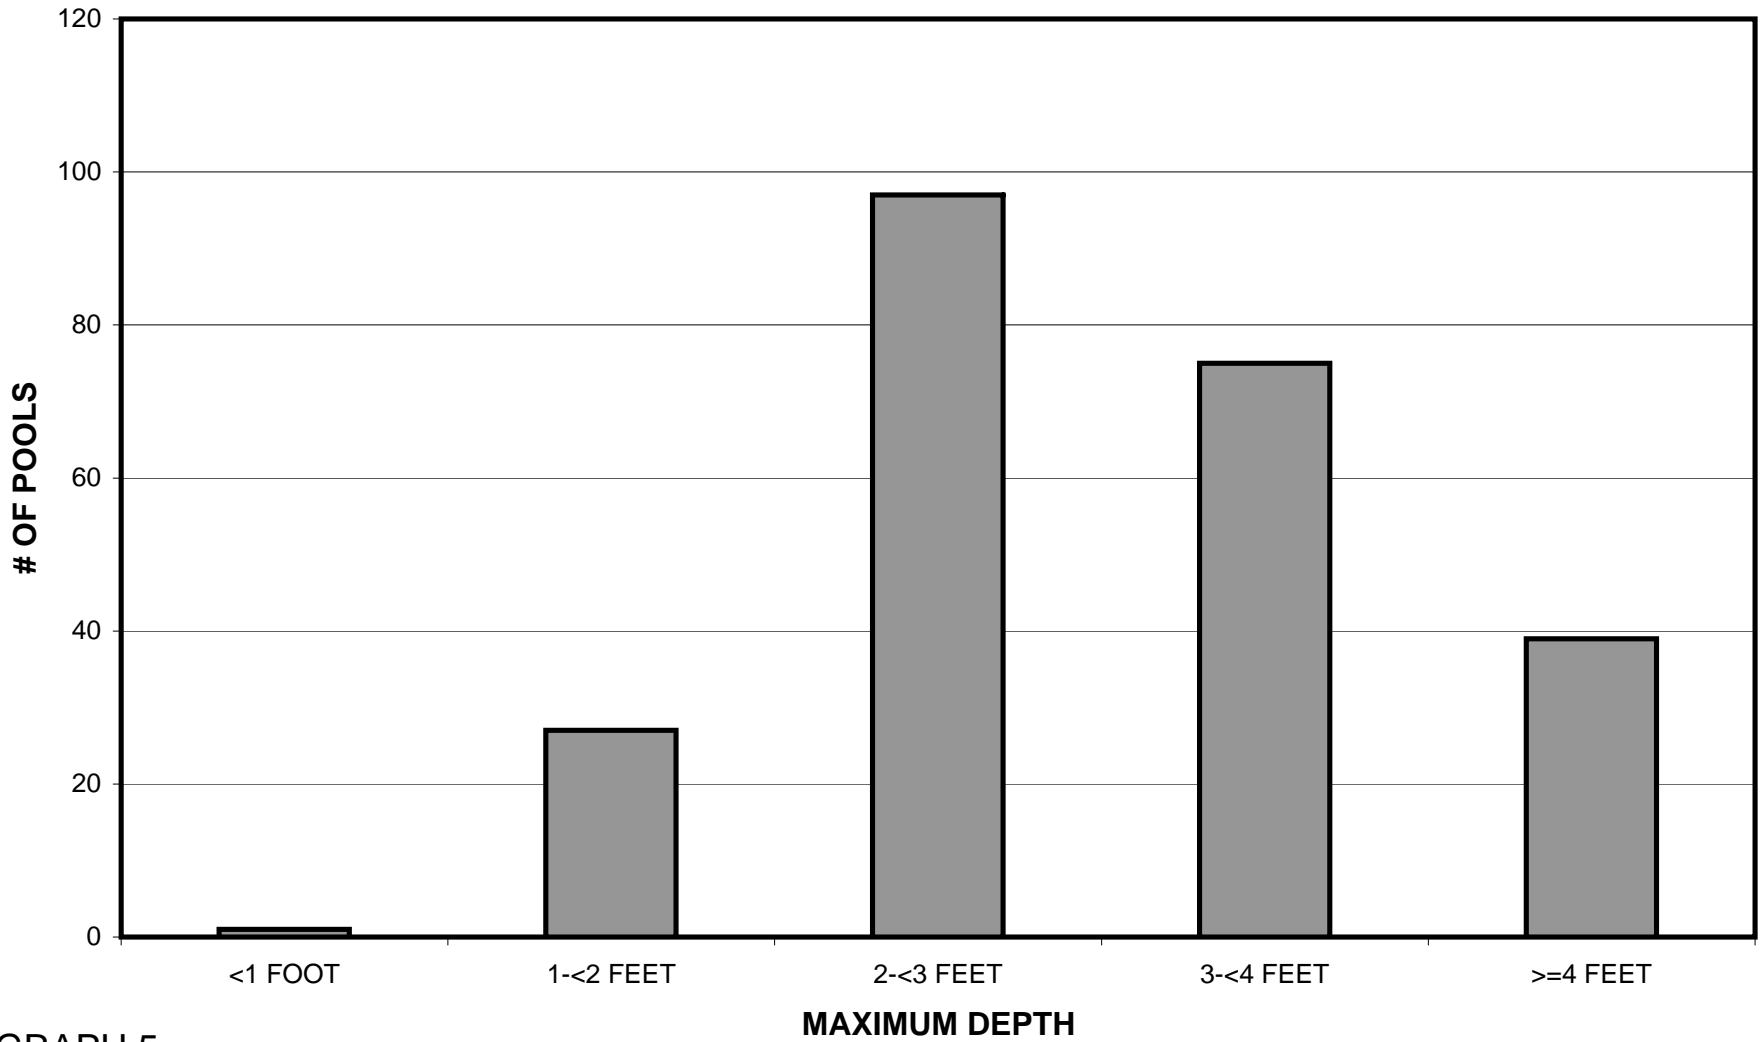
GRAPH 5

Table 4 is a summary of maximum residual pool depths by pool habitat types. Pool quality for salmonids increases with depth. One hundred fourteen of the 239 pools (48%) had a residual depth of three feet or greater (Graph 5).

Flatwater habitat types comprised 36% of the total length of this survey, riffles 33%, and pools 19%. The pools are relatively deep, with 114 of the 239 (47%) pools having a maximum residual depth greater than three feet. In general, pool enhancement projects are considered when primary pools comprise less than 40% of the length of total stream habitat. In third and fourth order streams, a primary pool is defined to have a maximum residual depth of at least three feet, occupy at least half the width of the low flow channel, and be as long as the low flow channel width. Installing structures that will increase or deepen pool habitat is recommended for locations where their installation will not be threatened by high stream energy, or where their installation will not conflict with the modification of the numerous log debris accumulations (LDA's) in the stream.

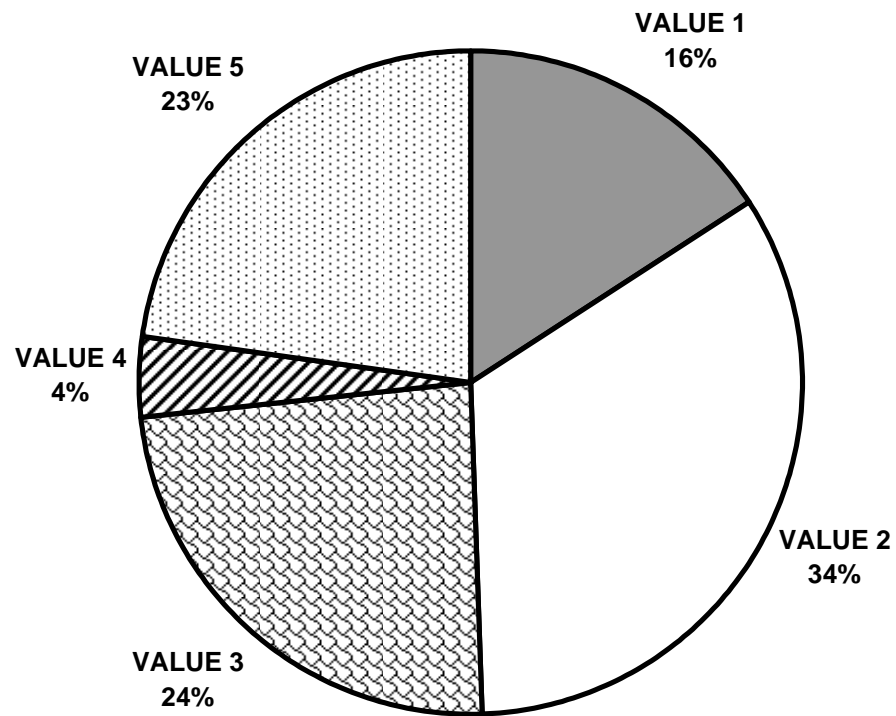
GRAPH 6

The depth of cobble embeddedness was estimated at pool tail-outs. Of the 240 pool tail-outs measured, 38 had a value of 1 (16%); 81 had a value of 2 (34%); 57 had a value of 3 (24%); 9

had a value of 4 (4%); 55 had a value of 5 (23%); (Graph 6). On this scale, a value of 1 indicates the best spawning conditions and a value of 4 the worst. Additionally, a value of 5 was assigned to tail-outs deemed unsuited for spawning due to inappropriate substrate such as bedrock, log sills, boulders, or other considerations.

One hundred nineteen of the 240 pool tail-outs measured had embeddedness ratings of 1 or 2. Sixty-six of the pool tail-outs had embeddedness ratings of 3 or 4. Fifty-five of the pool tail-outs had a rating of 5, which is considered unsuitable for spawning. Cobble embeddedness measured to be 25% or less, a rating of 1, is considered to indicate good quality spawning substrate for salmon and steelhead. Sediment sources in Brush Creek should be mapped and rated according to their potential sediment yields, and control measures should be taken.

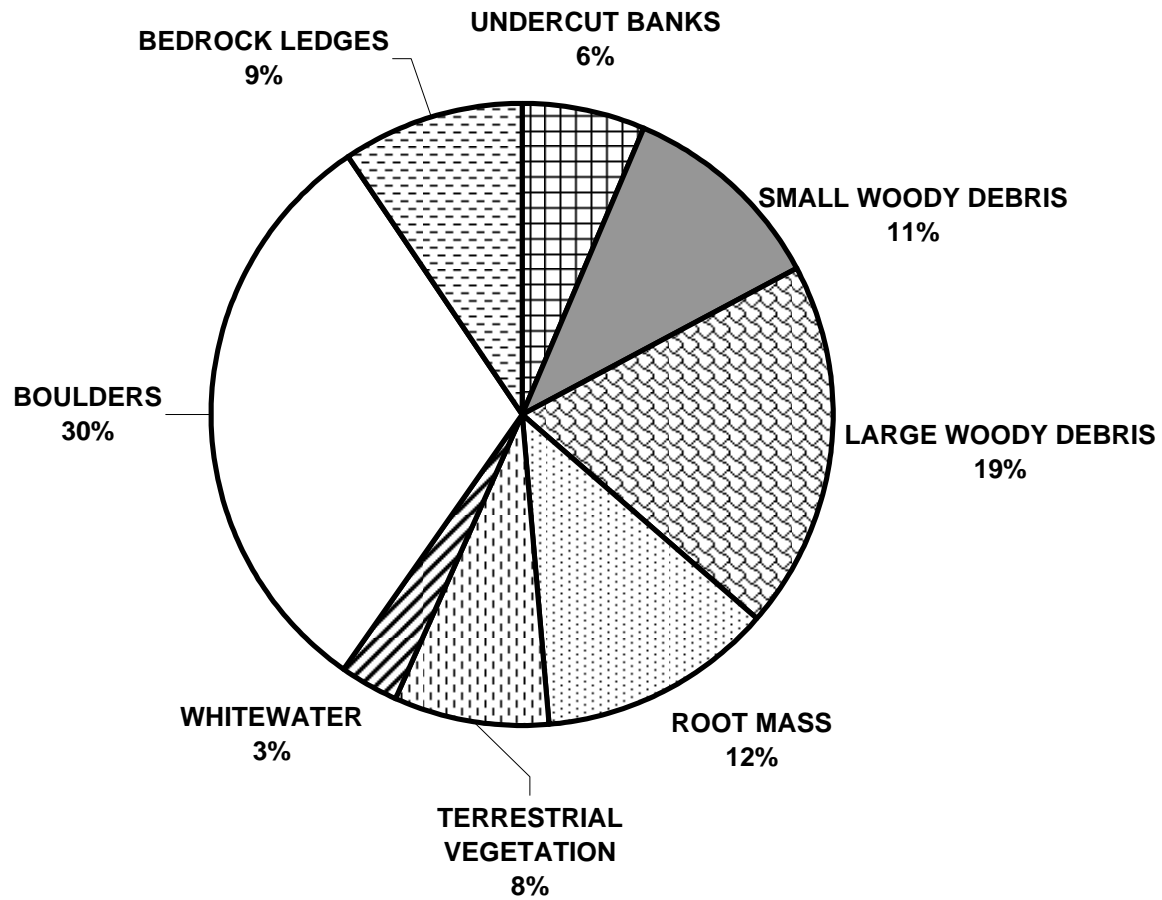
GRAPH 7

Table 5 summarizes mean percent cover by habitat type. Boulders are the dominant cover type in Brush Creek. Graph 7 describes the pool cover in Brush Creek. Boulders are the dominant pool cover type followed by large woody debris.

The mean shelter rating for pools is 50. The shelter rating in the flatwater habitats was 27. A pool shelter rating of approximately 100 is desirable. The amount of cover that now exists is being provided primarily by boulders in Brush Creek. Boulders are the dominant cover type in pools followed by large woody debris. Log and root wad cover structures in the pool and flatwater habitats would enhance both summer and winter salmonid habitat. Log cover structures provides rearing fry with protection from predation, rest from water velocity, and also divides territorial units to reduce density related competition.

- 3) Increase woody cover in the pools and flatwater habitat units. Most of the existing cover in the pools is from boulders. Adding high quality complexity with woody cover in the pools is desirable.
- 4) Inventory and map sources of stream bank erosion and prioritize them according to present and potential sediment yield. Identified sites should then be treated to reduce the amount of fine sediments entering the stream.
- 5) There are several log debris accumulations present on Brush Creek that are retaining large quantities of fine sediment. The modification of these debris accumulations is desirable, but must be done carefully, over time, to avoid excessive sediment loading in downstream reaches.
- 6) There are sections where the stream is being impacted from cattle trampling the riparian zone. Alternatives should be explored with the grazier and developed if possible.

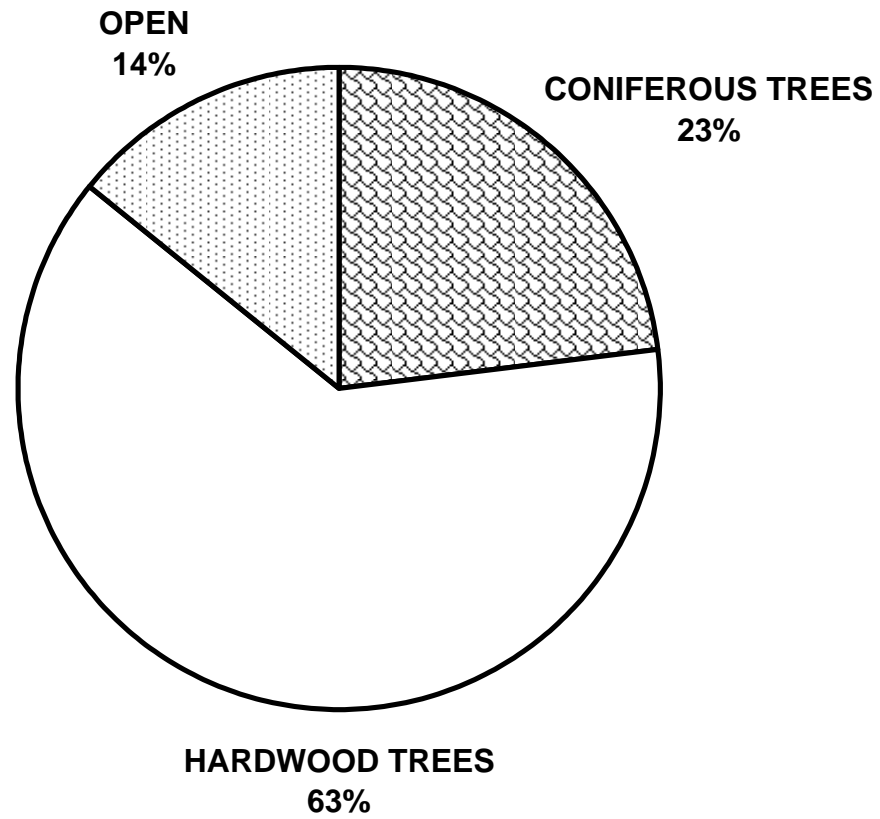
GRAPH 9

The mean percent canopy density for the surveyed length of Brush Creek was 86%. Of the canopy present, the mean percentages of hardwood and coniferous trees were 63% and 23%, respectively. 14% of the canopy was open. Graph 9 describes the mean percent canopy in Brush Creek.

The mean percent canopy density for the stream was 86%. In general, revegetation projects are considered when canopy density is less than 80%.
