STREAM INVENTORY REPORT

Unnamed Tributary to Dunn Creek

A stream inventory was conducted from September 9 to September 10, 2008 on an unnamed tributary to Dunn Creek. The survey began at the confluence with Dunn Creek and extended upstream 0.6 miles.

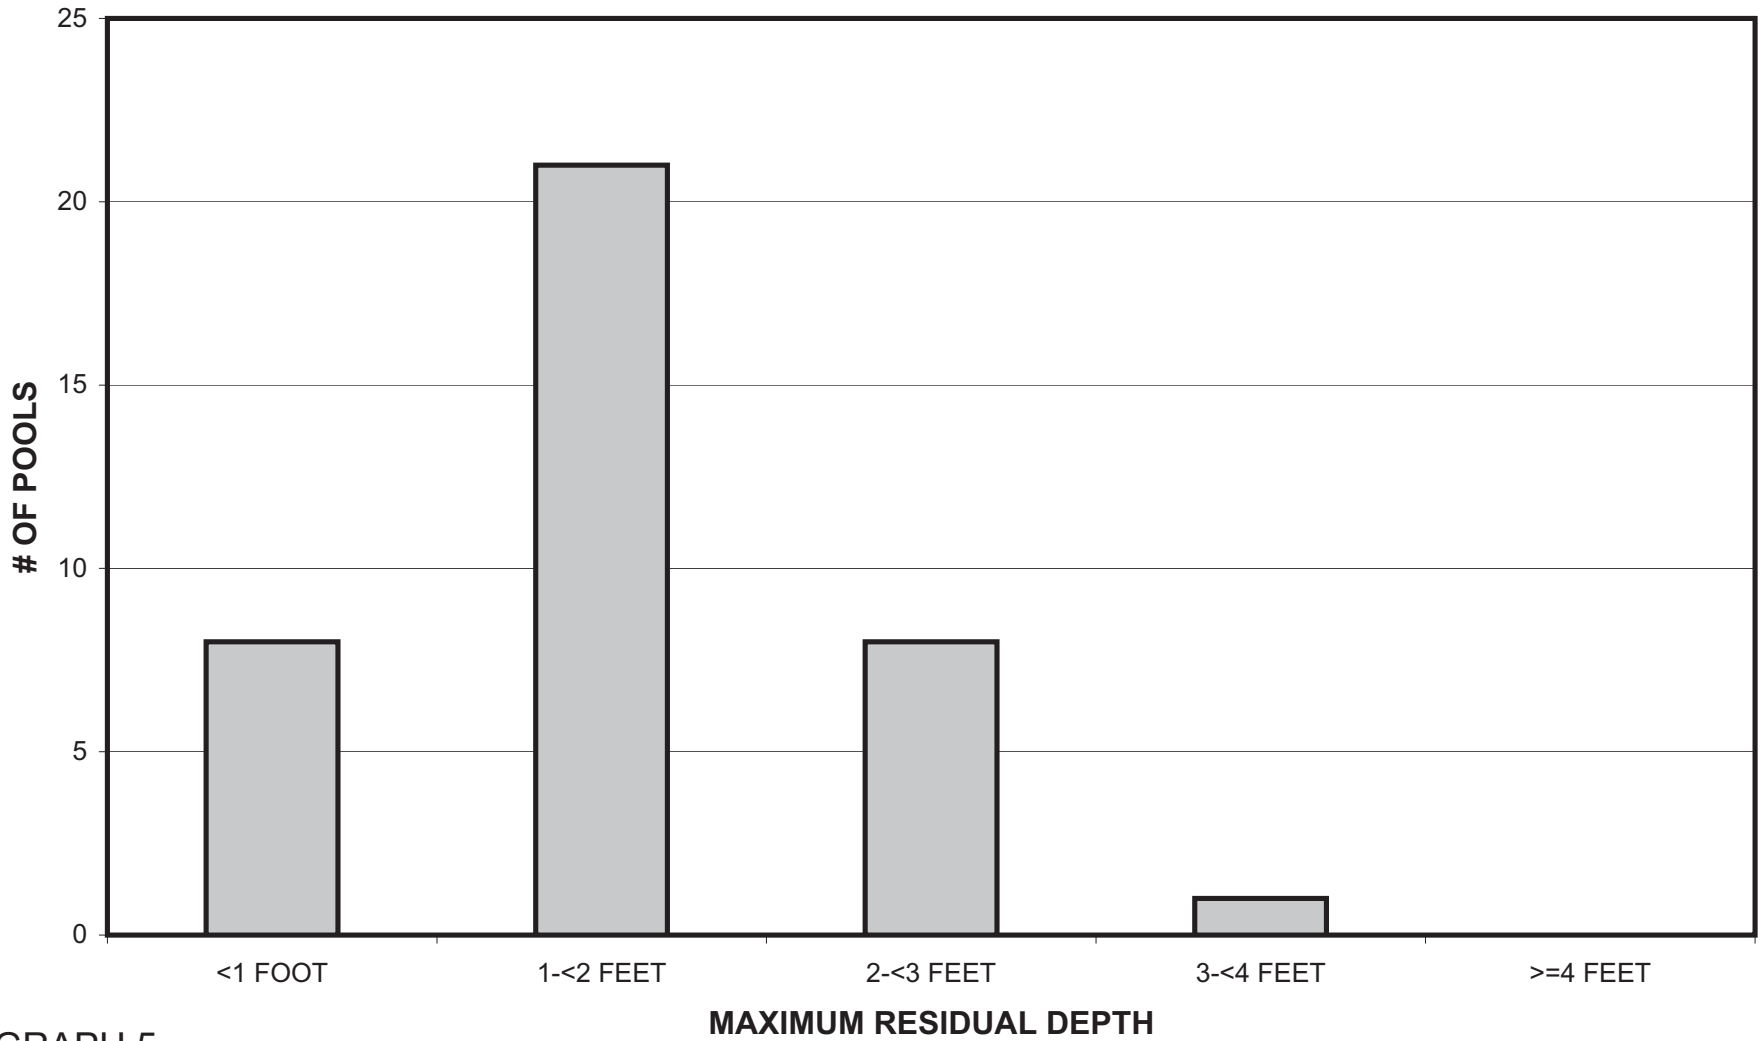
GRAPH 5

Table 4 is a summary of maximum residual pool depths by pool habitat types. Pool quality for salmonids increases with depth. Nine of the 38 pools (24%) had a residual depth of two feet or greater (Graph 5).

Flatwater habitat types comprised 52% of the total length of this survey, riffles 16%, and pools 22%. The pools are relatively shallow, with 9 of the 38 (24%) pools having a maximum residual depth greater than 2 feet. In general, pool enhancement projects are considered when primary pools comprise less than 40% of the length of total stream habitat. In first and second order streams, a primary pool is defined to have a maximum residual depth of at least two feet, occupy at least half the width of the low flow channel, and be as long as the low-flow channel width. Installing large wood that will increase or deepen pool habitat is recommended.

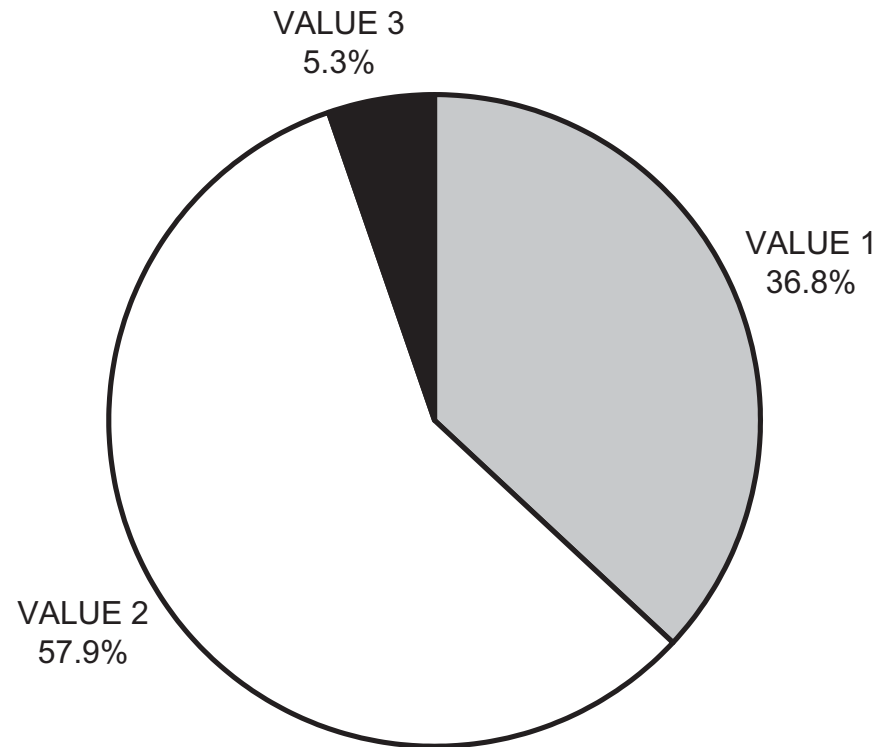
GRAPH 6

The depth of cobble embeddedness was estimated at pool tail-outs. Of the 38 pool tail-outs measured, 14 had a value of 1 (36.8%); 22 had a value of 2 (57.9%); 2 had a value of 3 (5.3%) (Graph 6). On this scale, a value of 1 indicates the best spawning conditions and a value of 4 the worst.

Thirty-six of the 38 pool tail-outs measured had embeddedness ratings of 1 or 2. Two of the pool tail-outs had embeddedness ratings of 3 or 4. None of the pool tail-outs had a rating of 5, which is considered unsuitable for spawning. Cobble embeddedness measured to be 25% or less, a rating of 1, is considered to indicate good quality spawning substrate for salmon and steelhead. Sediment sources in the unnamed creek should be mapped and rated according to their potential sediment yields, and control measures should be taken.

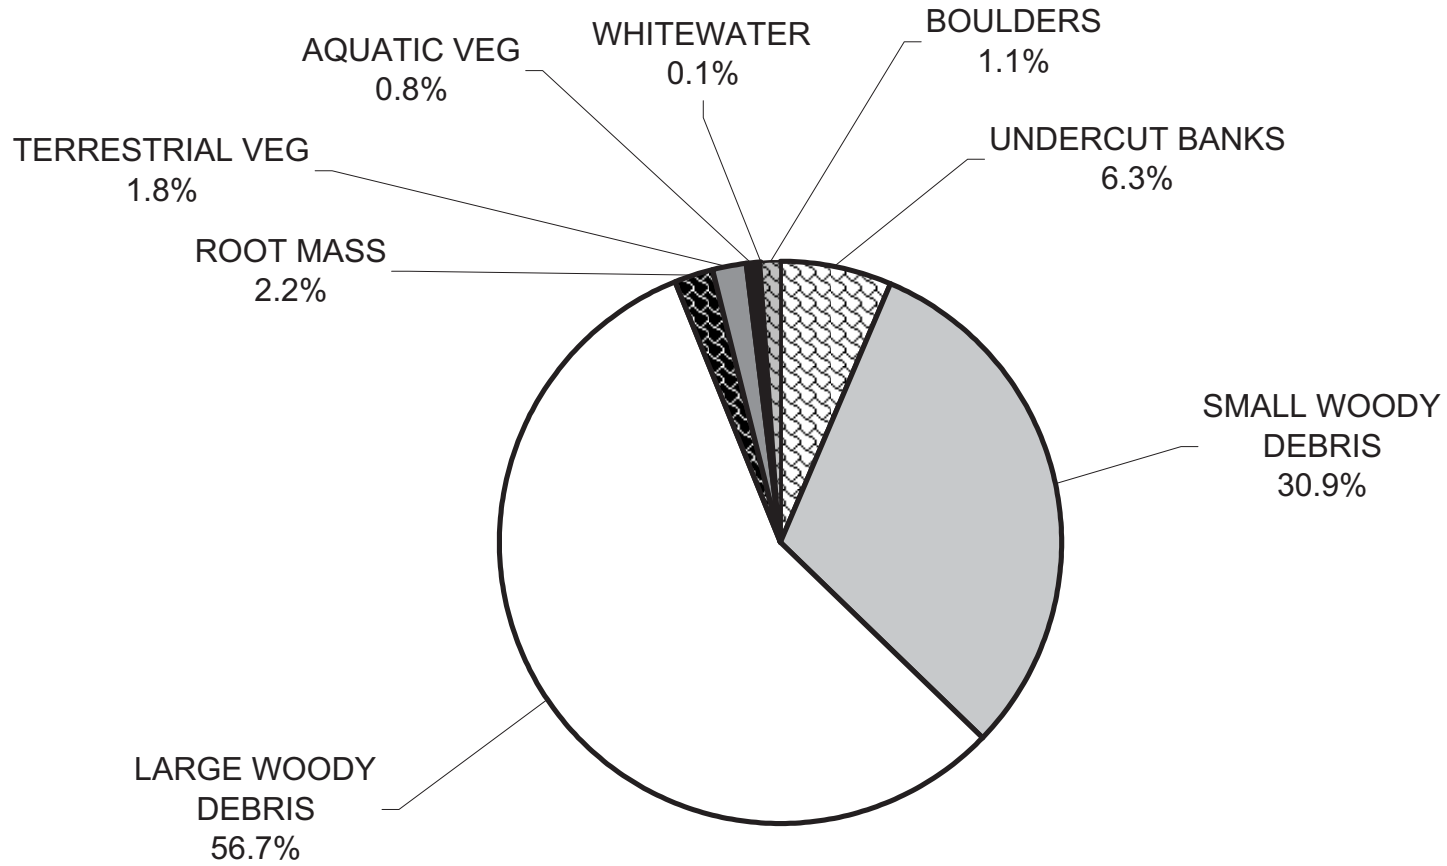
GRAPH 7

Table 5 summarizes mean percent cover by habitat type. Large woody debris is the dominant cover type in this unnamed creek. Graph 7 describes the pool cover in the unnamed creek. Large woody debris is the dominant pool cover type followed by small woody debris.

The mean shelter rating for pools was 24. The shelter rating in the flatwater habitats was 0. A pool shelter rating of approximately 100 is desirable. The amount of cover that now exists is being provided primarily by large woody debris in the unnamed creek. Large woody debris is the dominant cover type in pools followed by small woody debris. Log and root wad cover structures in the pool and flatwater habitats would enhance both summer and winter salmonid habitat. Log cover structure provides rearing fry with protection from predation, rest from water velocity, and also divides territorial units to reduce density related competition.

- 3) Increase woody cover in the pools and flatwater habitat units. Most of the existing cover in the pools is from small woody debris. Adding high quality complexity with woody cover in the pools is desirable.

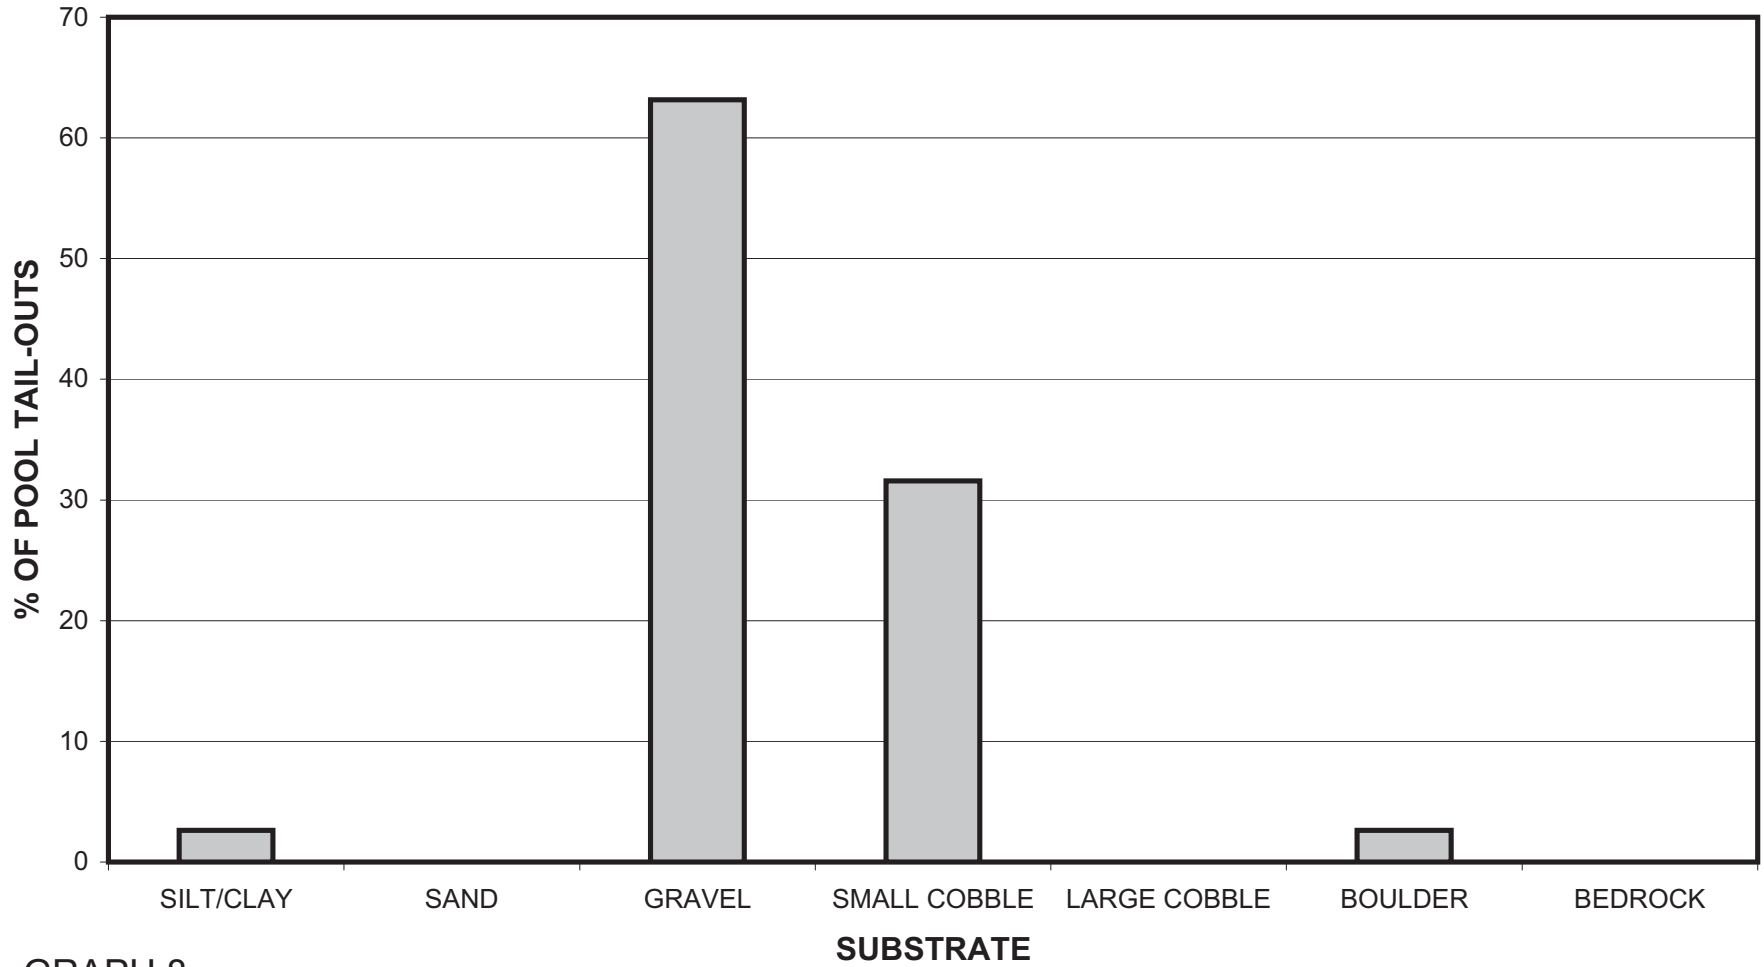
GRAPH 8

Table 6 summarizes the dominant substrate by habitat type. Graph 8 depicts the dominant substrate observed in pool tail-outs. Gravel was the dominant substrate observed in 63% of the pool tail-outs. Small cobble was the next most frequently observed dominant substrate type and occurred in 32% of the pool tail-outs.

Thirty-six of the 38 pool tail-outs measured had gravel or small cobble as the dominant substrate. This is generally considered good for spawning salmonids.

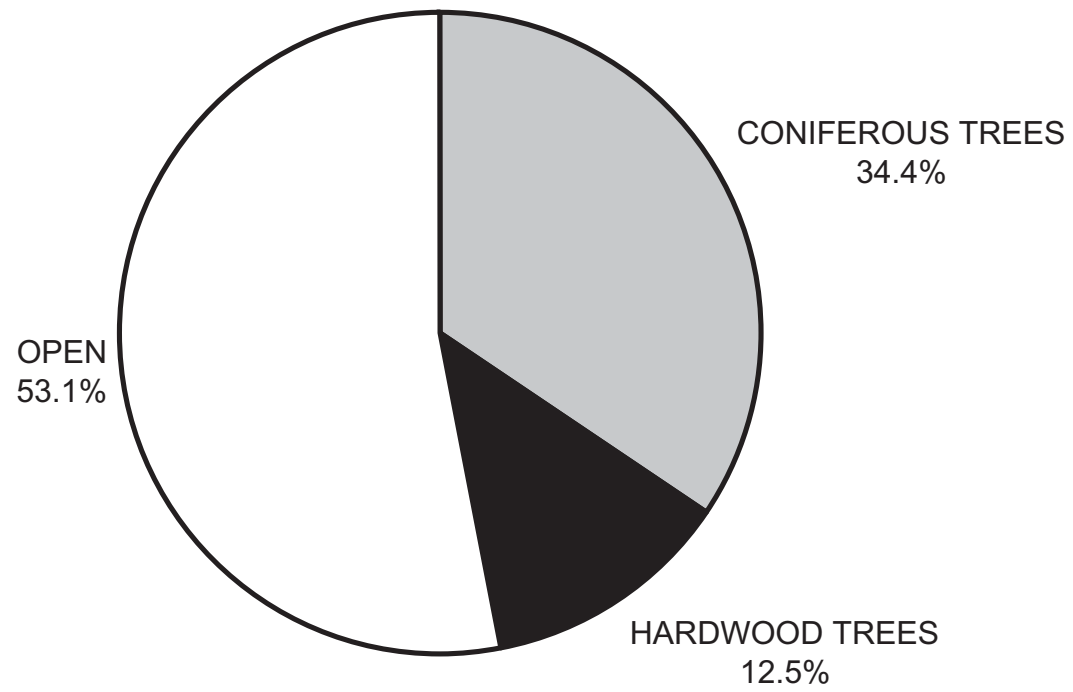
GRAPH 9

The mean percent canopy density for the surveyed length of unnamed creek was 47%. Fifty-three percent of the canopy was open. Of the canopy present, the mean percentages of hardwood and coniferous trees were 27% and 73%, respectively. Graph 9 describes the mean percent canopy in unnamed creek.

The mean percent canopy density for the stream was 47%. Reach 1 had a canopy density of 73.9%, Reach 2 had a canopy density of 43.05%. In general, revegetation projects are considered when canopy density is less than 80%.

- 5) Increase the canopy on unnamed creek by planting appropriate native vegetation like willow, alder, redwood, and Douglas fir along the stream where shade canopy is not at acceptable levels. The reaches above this survey section should be inventoried and treated as well, since the water flowing here is affected from upstream.

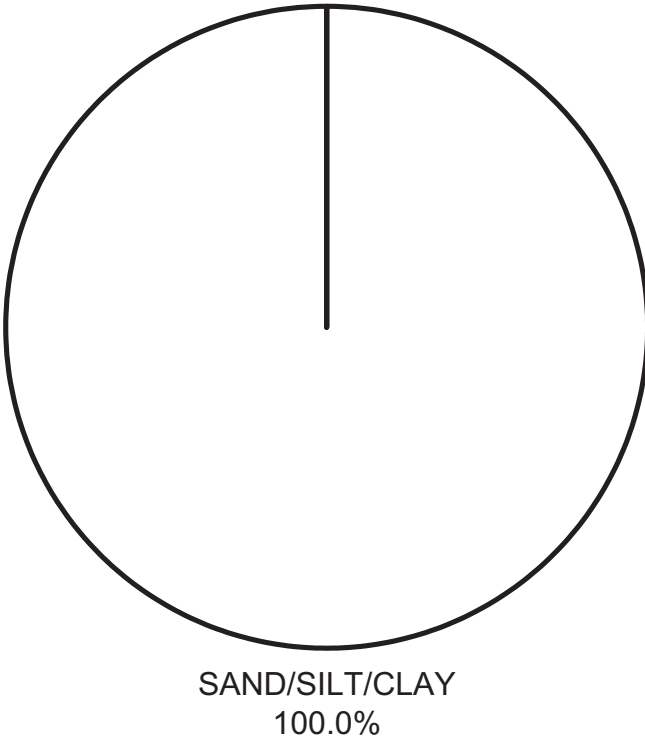
GRAPH 10

For the stream reach surveyed, the mean percent right bank vegetated was 50%. The mean percent left bank vegetated was 50%. The dominant elements composing the structure of the stream banks consisted of 100% sand/silt/clay (Graph 10). Coniferous trees were the dominant vegetation type observed in 51.2% of the units surveyed. Additionally, 37.8% of the units surveyed had hardwood trees as the dominant vegetation type, and 11% had brush as the dominant vegetation type (Graph 11).

The percentage of right and left bank covered with vegetation was 50% and 50%, respectively. In areas of stream bank erosion or where bank vegetation is sparse, planting endemic species of coniferous and hardwood trees, in conjunction with bank stabilization, is recommended.
