STREAM INVENTORY REPORT

Juan Creek

A stream inventory was conducted from June 23 to July 9, 2009 on Juan Creek. The survey began at the confluence with Pacific Ocean and extended upstream 3.6 miles. Stream inventories and reports were also completed for three tributaries to Juan Creek.

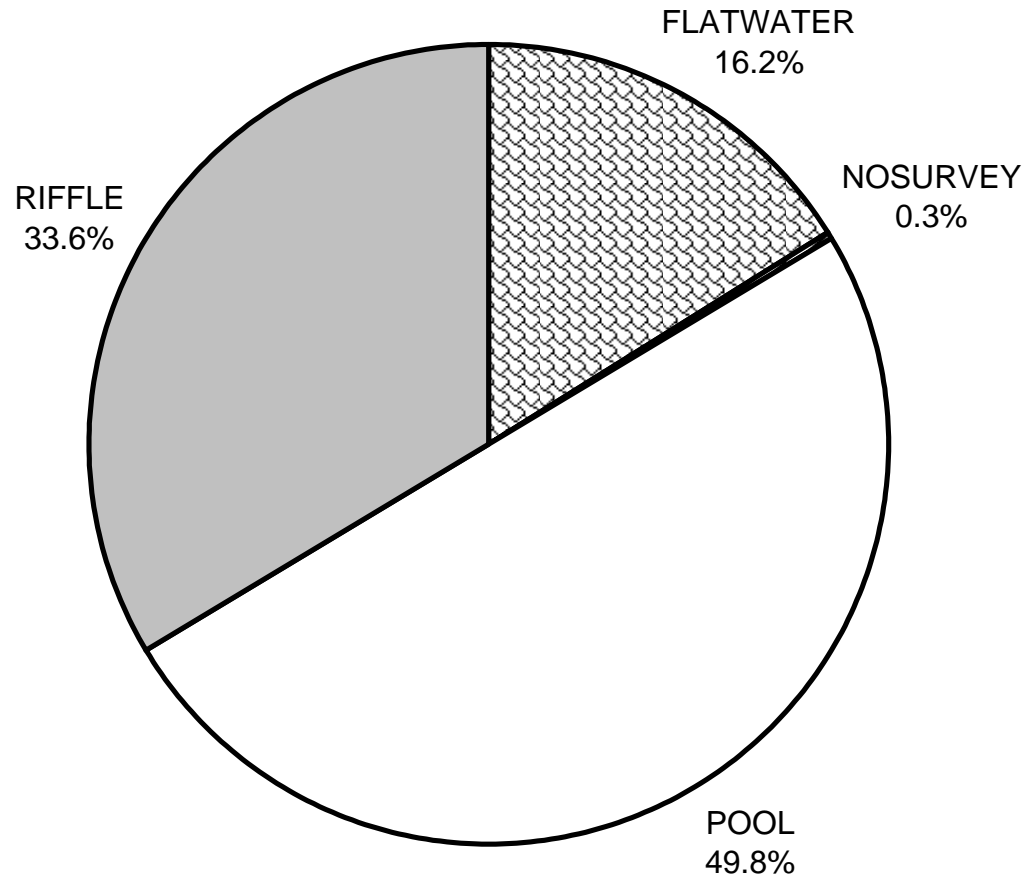
GRAPH 1

Table 1 summarizes the Level II riffle, flatwater, and pool habitat types. Based on frequency of occurrence there were 50% pool units, 34% riffle units, and 16% flatwater units (Graph 1). Based on total length of Level II habitat types there were 39% riffle units, 30% flatwater units, and 29% pool units (Graph 2).

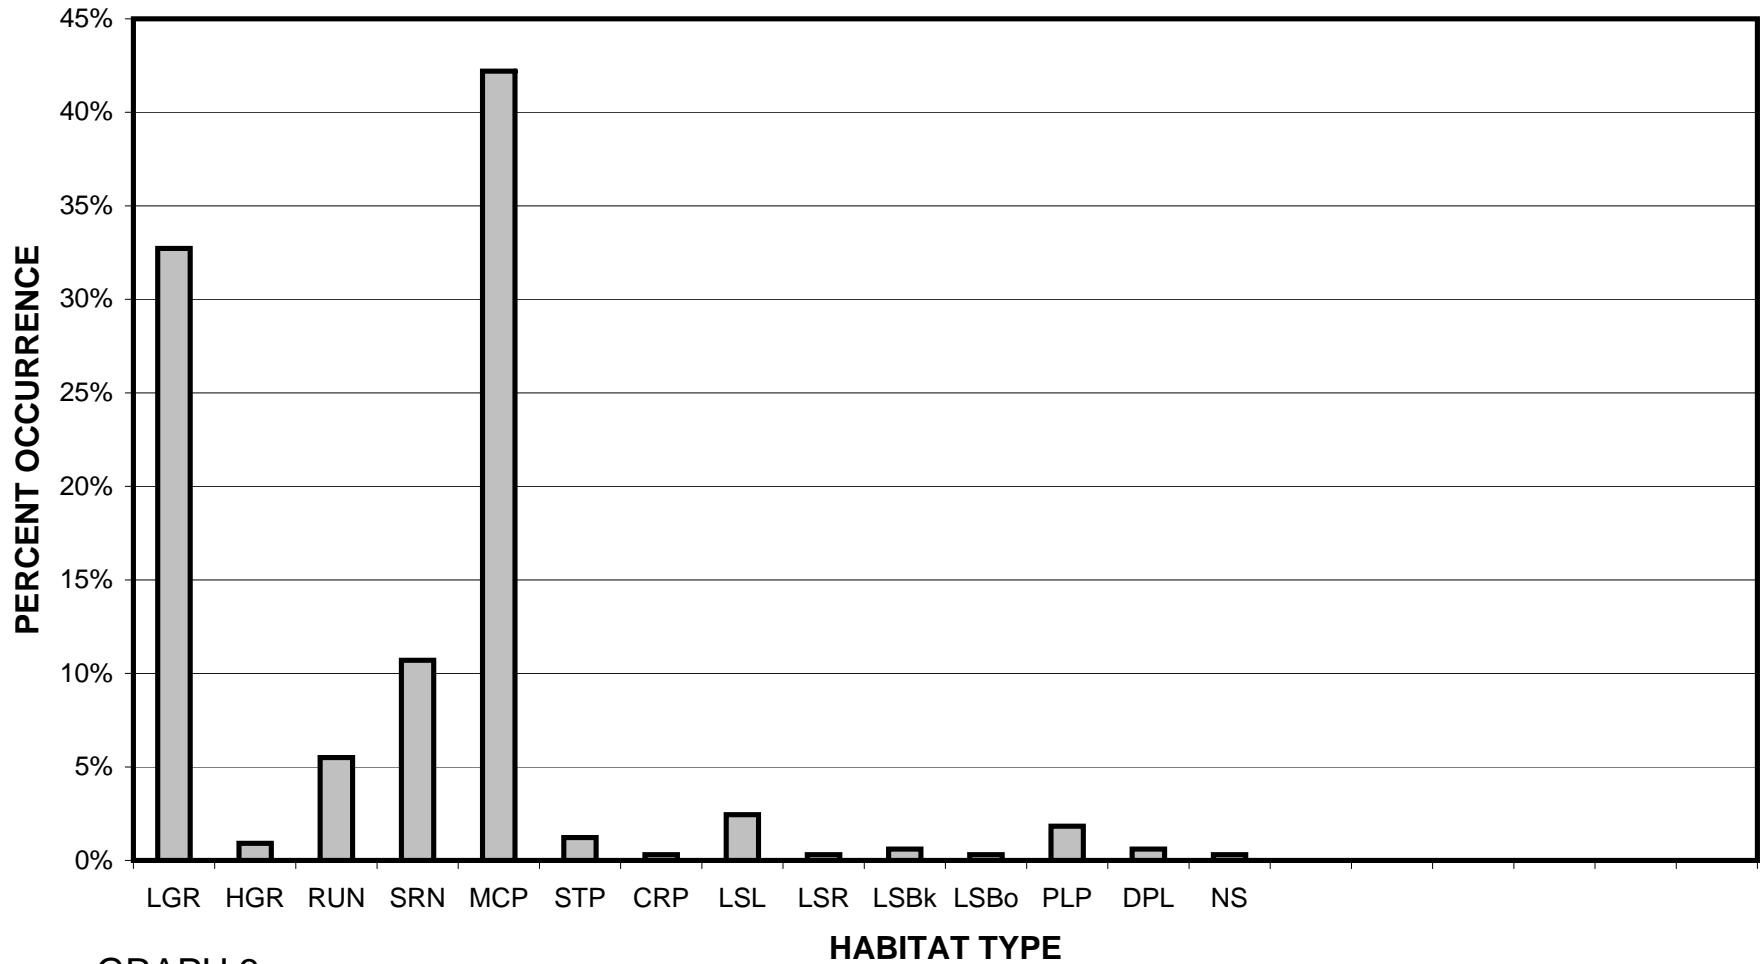
GRAPH 3

Thirteen Level IV habitat types were identified (Table 2). The most frequent habitat types by percent occurrence were mid-channel pool units, 42%; low gradient riffle units, 33%; and step run units, 11% (Graph 3). Based on percent total length, low gradient riffle units made up 38%, step run units 26%, and mid-channel pool units 25%.

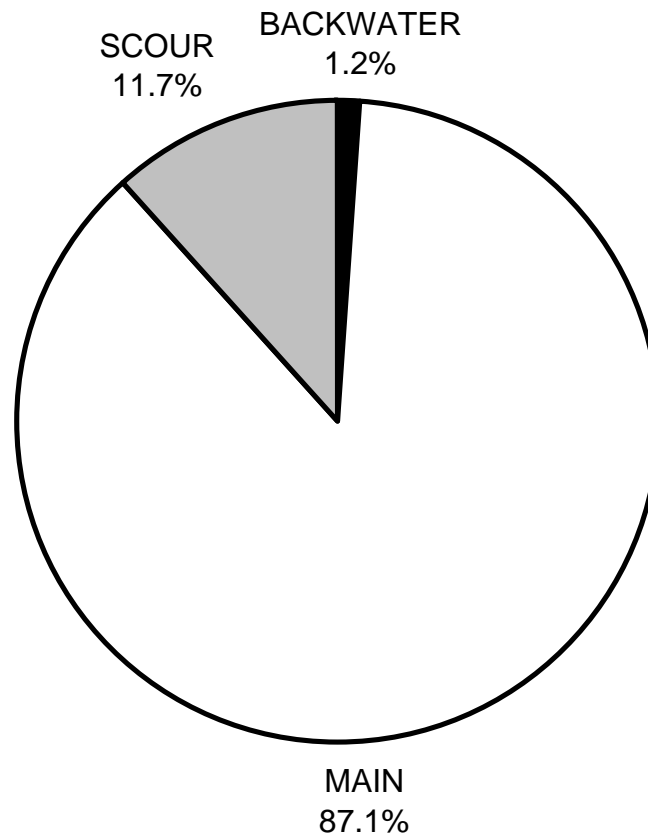
GRAPH 4

A total of 163 pools were identified (Table 3). Main channel pools were the most frequently encountered at 87% (Graph 4), and comprised 88% of the total length of all pools (Table 3).

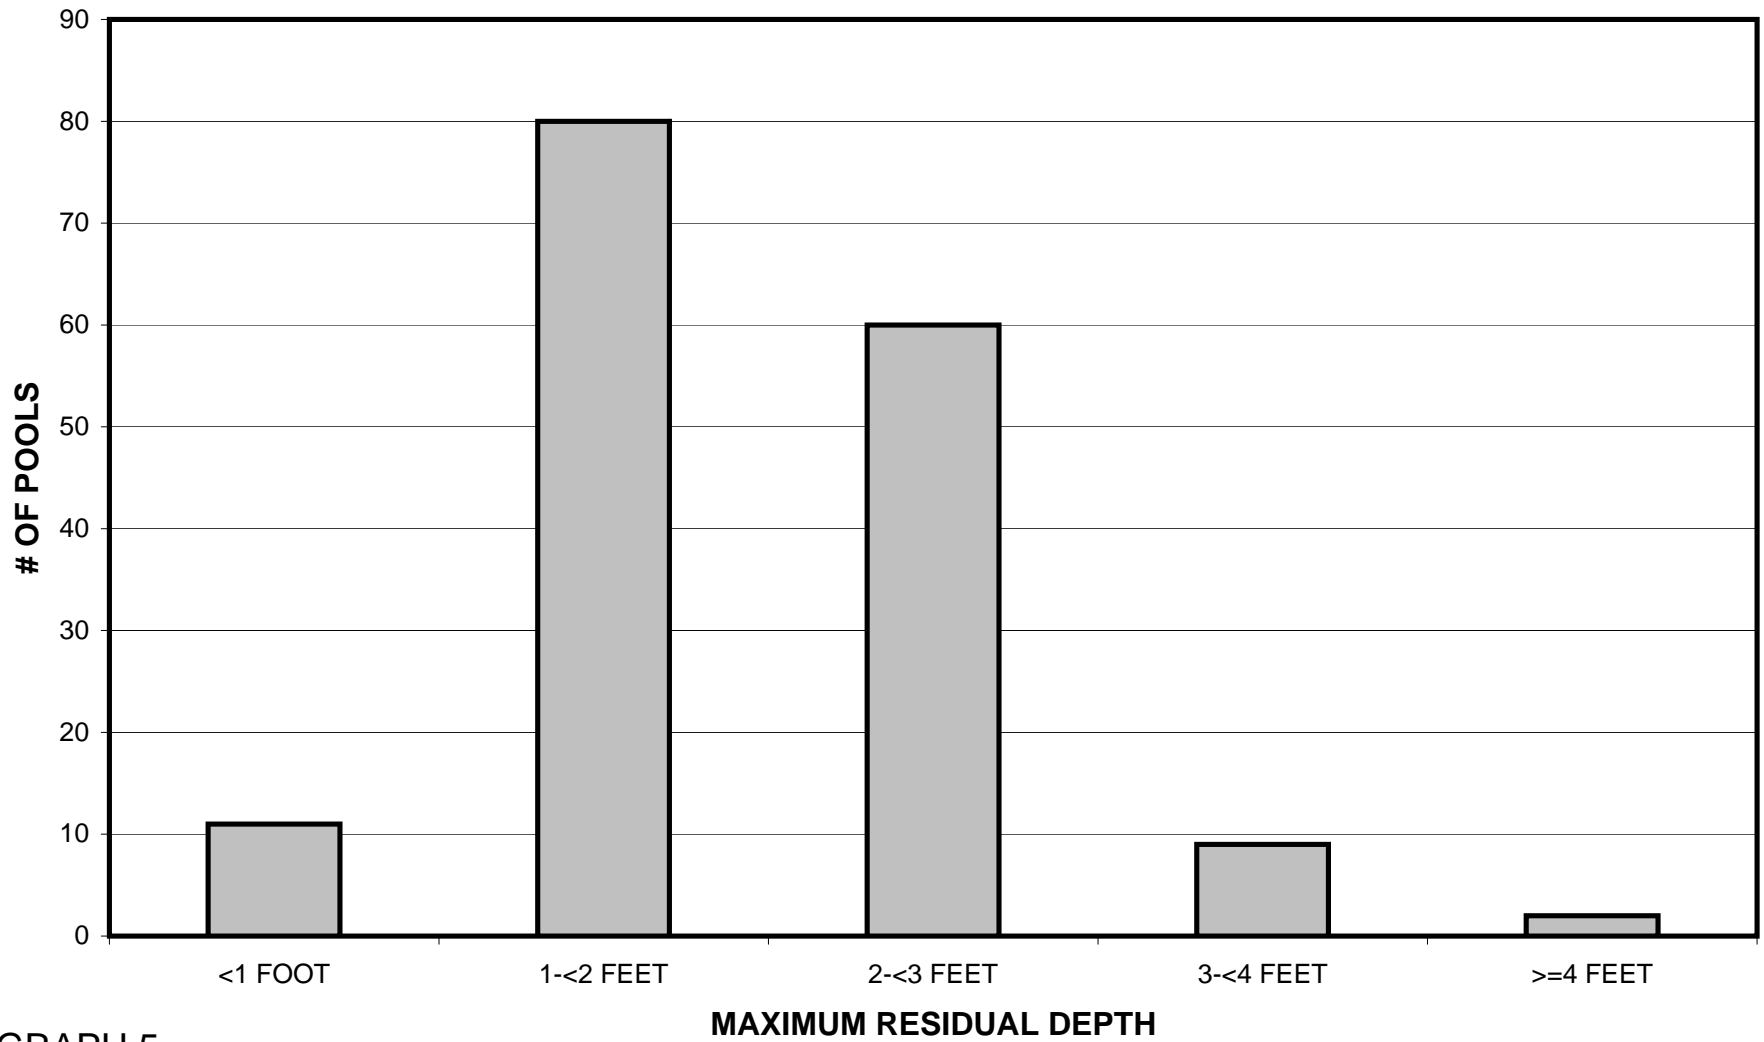
GRAPH 5

Table 4 is a summary of maximum residual pool depths by pool habitat types. Pool quality for salmonids increases with depth. Seventy-one of the 162 pools (44%) measured had a residual depth of two feet or greater (Graph 5).

Flatwater habitat types comprised 30% of the total length of this survey, riffles 39%, and pools 29%. Seventy-one of the 162 (44%) pools measured had a maximum residual depth greater than 2 feet. In general, pool enhancement projects are considered when primary pools comprise less than 40% of the length of total stream habitat. In first and second order streams, a primary pool is defined to have a maximum residual depth of at least two feet, occupy at least half the width of the low flow channel, and be as long as the low flow channel width. Installing large wood structures that will increase or deepen pool habitat is recommended.

- 3) Where feasible, design and engineer pool enhancement structures to increase the number of pools. This must be done where the banks are stable or in conjunction with stream bank armor to prevent erosion.

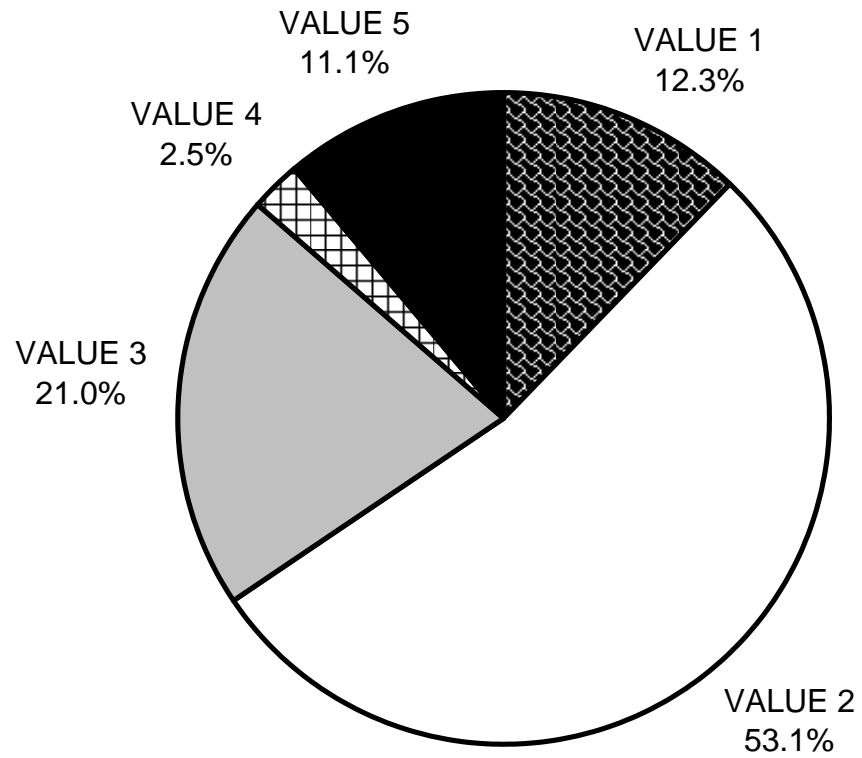
GRAPH 6

The depth of cobble embeddedness was estimated at pool tail-outs. Of the 162 pool tail-outs measured, 20 had a value of 1 (12.3%); 86 had a value of 2 (53.1%); 34 had a value of 3 (21%); 4 had a value of 4 (2.5%); and 18 had a value of 5 (11.1%); (Graph 6). On this scale, a value of 1 indicates the best spawning conditions and a value of 4 the worst. Additionally, a value of 5 was assigned to tail-outs deemed not suitable for spawning due to inappropriate substrate such as bedrock, log sills, boulders, or other considerations.

One hundred six of the 162 pool tail-outs measured had embeddedness ratings of 1 or 2. Thirty-eight of the pool tail-outs had embeddedness ratings of 3 or 4. Eighteen of the pool tail-outs had a rating of 5, which is considered unsuitable for spawning. Cobble embeddedness measured to

be 25% or less, a rating of 1, is considered to indicate good quality spawning substrate for salmon and steelhead. Sediment sources in Juan Creek should be mapped and rated according to their potential sediment yields, and control measures should be taken.

- 5) Active and potential sediment sources related to the road system need to be identified, mapped, and treated according to their potential for sediment yield to the stream and its tributaries.

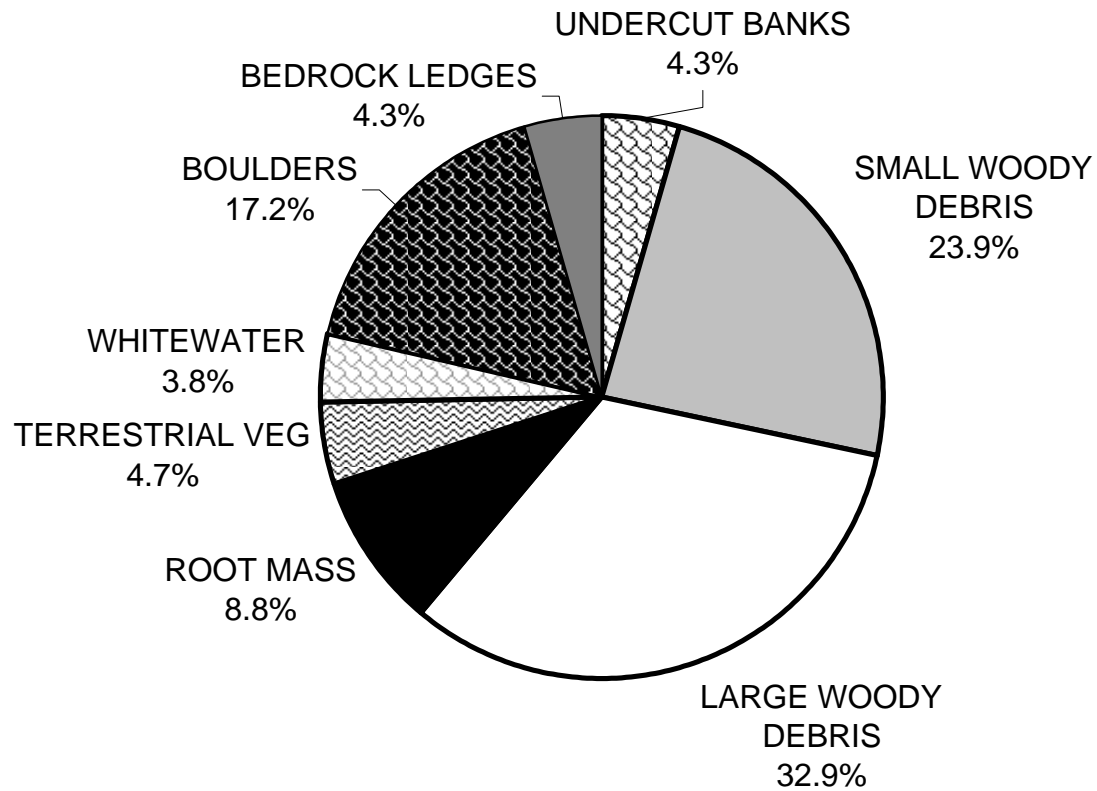
GRAPH 7

Table 5 summarizes mean percent cover by habitat type. Large woody debris is the dominant cover type in Juan Creek. Graph 7 describes the pool cover in Juan Creek. Large woody debris is the dominant pool cover type followed by small woody debris.

The mean shelter rating for pools was 33. The shelter rating in the flatwater habitats was 13. A pool shelter rating of approximately 100 is desirable. The amount of cover that now exists is being provided primarily by large woody debris in Juan Creek. Large woody debris is the dominant cover type in pools followed by small woody debris. Log and root wad cover structures in the pool and flatwater habitats would enhance both summer and winter salmonid habitat. Log cover structures provide rearing fry with protection from predation, rest from water velocity, and also divide territorial units to reduce density related competition.

- 4) Increase woody cover in the pools and flatwater habitat units. Most of the existing cover in the pools is from large woody debris. Adding high quality complexity with woody cover in the pools is desirable.

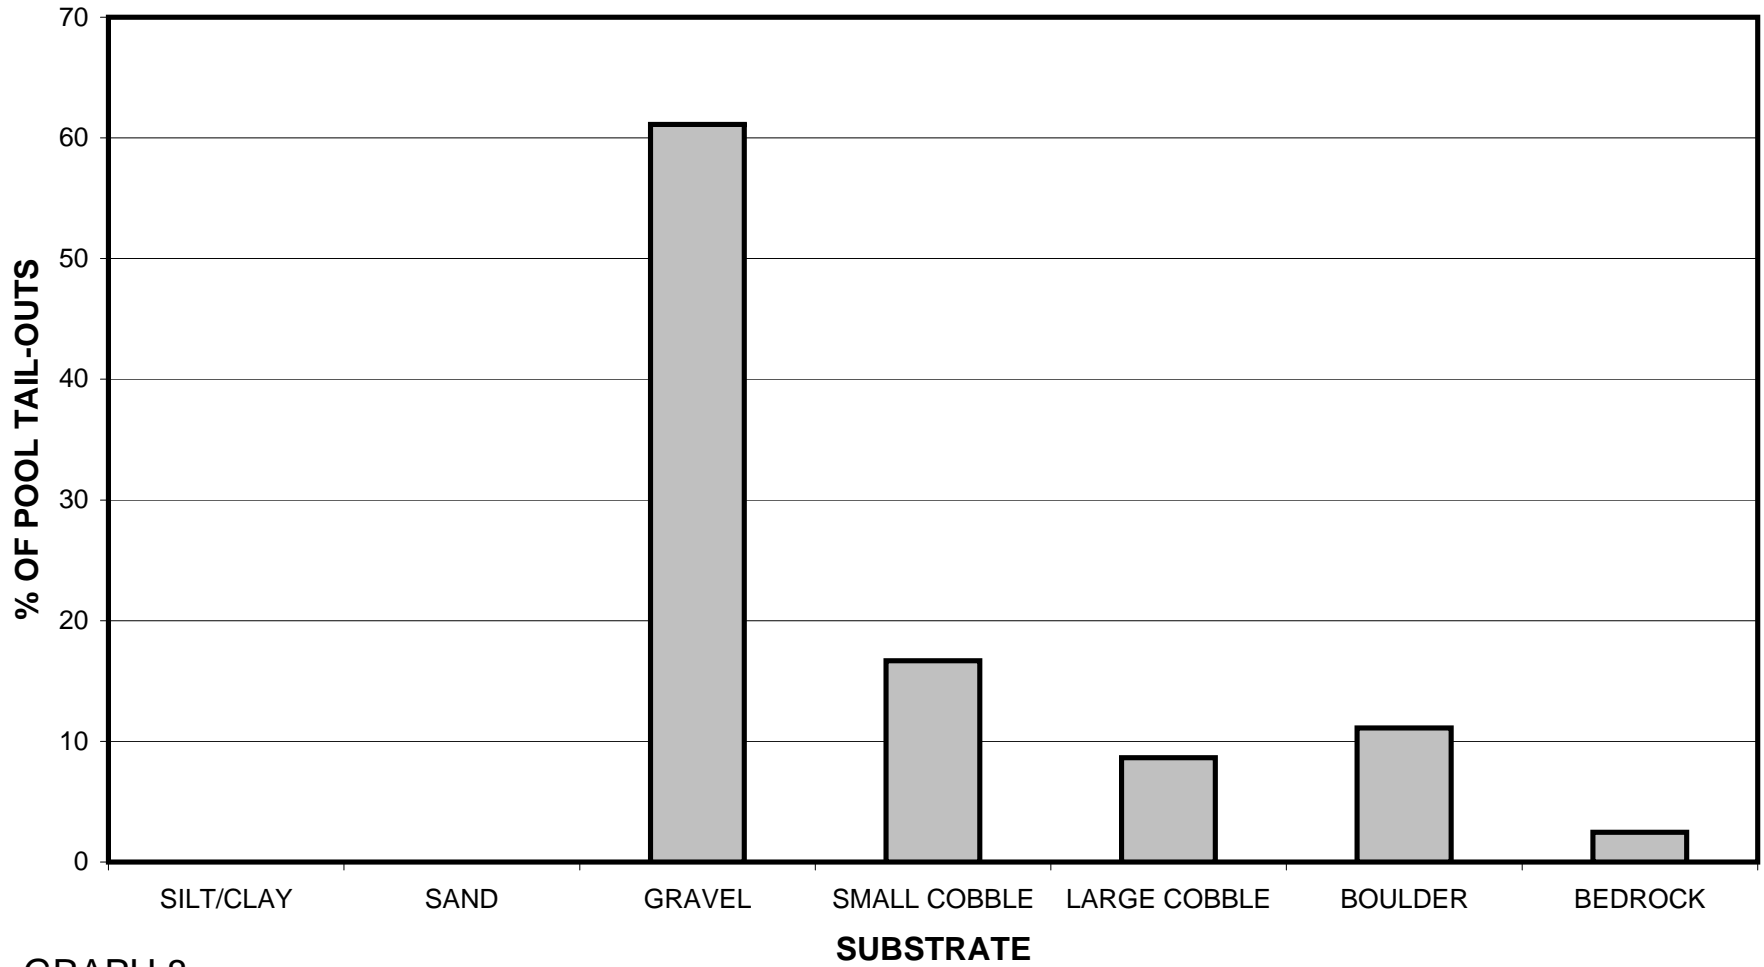
GRAPH 8

Table 6 summarizes the dominant substrate by habitat type. Graph 8 depicts the dominant substrate observed in pool tail-outs. Gravel was the dominant substrate observed in 61% of the pool tail-outs. Small cobble was the next most frequently observed dominant substrate type and occurred in 17% of the pool tail-outs.

One hundred twenty-six of the 162 pool tail-outs measured had gravel or small cobble as the dominant substrate. This is generally considered good for spawning salmonids.

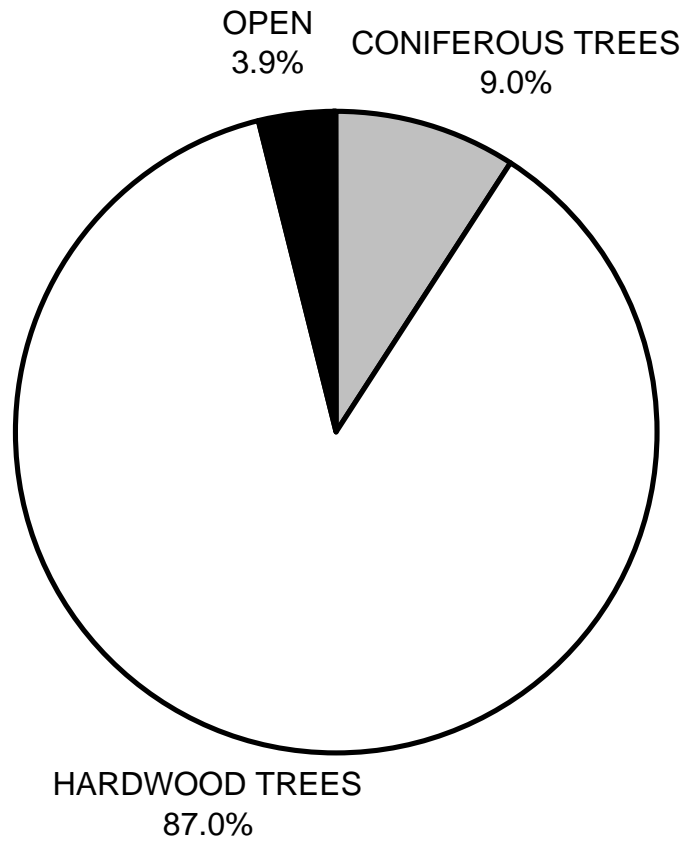
GRAPH 9

The mean percent canopy density for the surveyed length of Juan Creek was 96%. Four percent of the canopy was open. Of the canopy present, the mean percentages of hardwood and coniferous trees were 91% and 9%, respectively. Graph 9 describes the mean percent canopy in Juan Creek.

The mean percent canopy density for the stream was 96%. Reach 1 had a canopy density of 95%, Reach 2 had a canopy density of 98%, and Reach 3 had a canopy density of 96%. In general, revegetation projects are considered when canopy density is less than 80%.

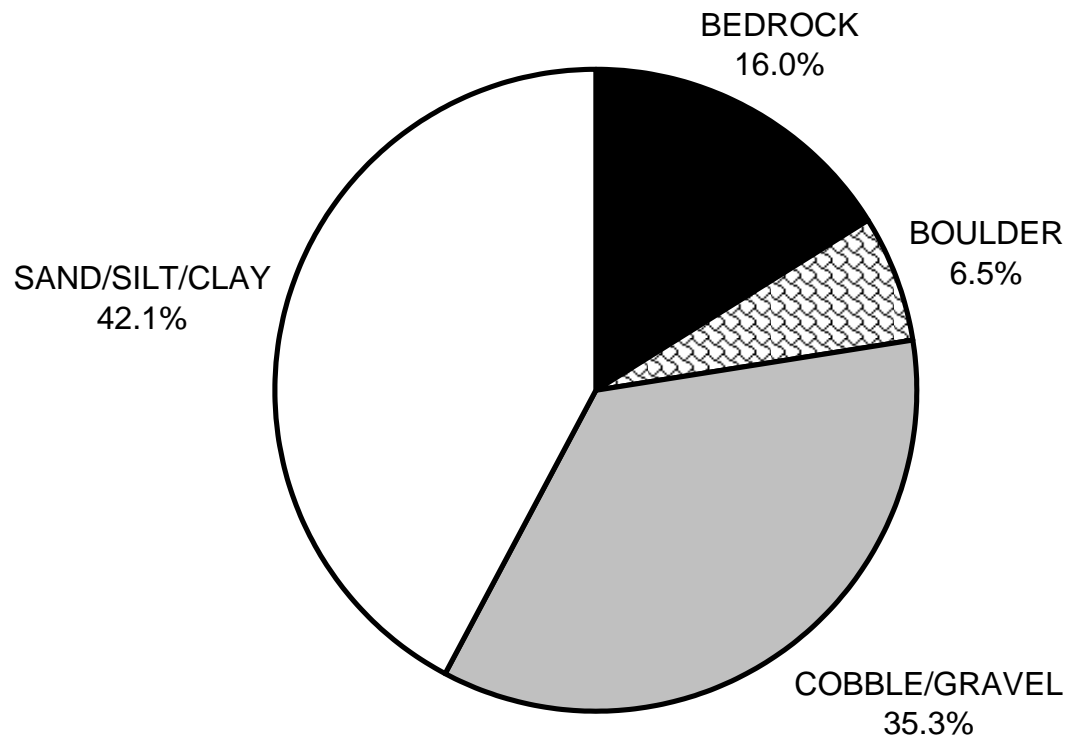
GRAPH 10

For the stream reach surveyed, the mean percent right bank vegetated was 74%. The mean percent left bank vegetated was 70%. The dominant elements composing the structure of the stream banks consisted of 42% sand/silt/clay, 35% cobble/gravel, 16% bedrock, and 7% boulder (Graph 10). Brush was the dominant vegetation type observed in 62% of the units surveyed. Additionally, 20% of the units surveyed had deciduous trees as the dominant vegetation type, and 9% had coniferous trees as the dominant vegetation type (Graph 11).

The percentage of right and left bank covered with vegetation was 74% and 70%, respectively. In areas of stream bank erosion or where bank vegetation is sparse, planting endemic species of coniferous and hardwood trees, in conjunction with bank stabilization, is recommended.
