STREAM INVENTORY REPORT

Mill Creek

A stream inventory was conducted from June 17 to June 24, 2008 on Mill Creek. The survey began at the confluence with Pacific Ocean and extended upstream 2.6 miles.

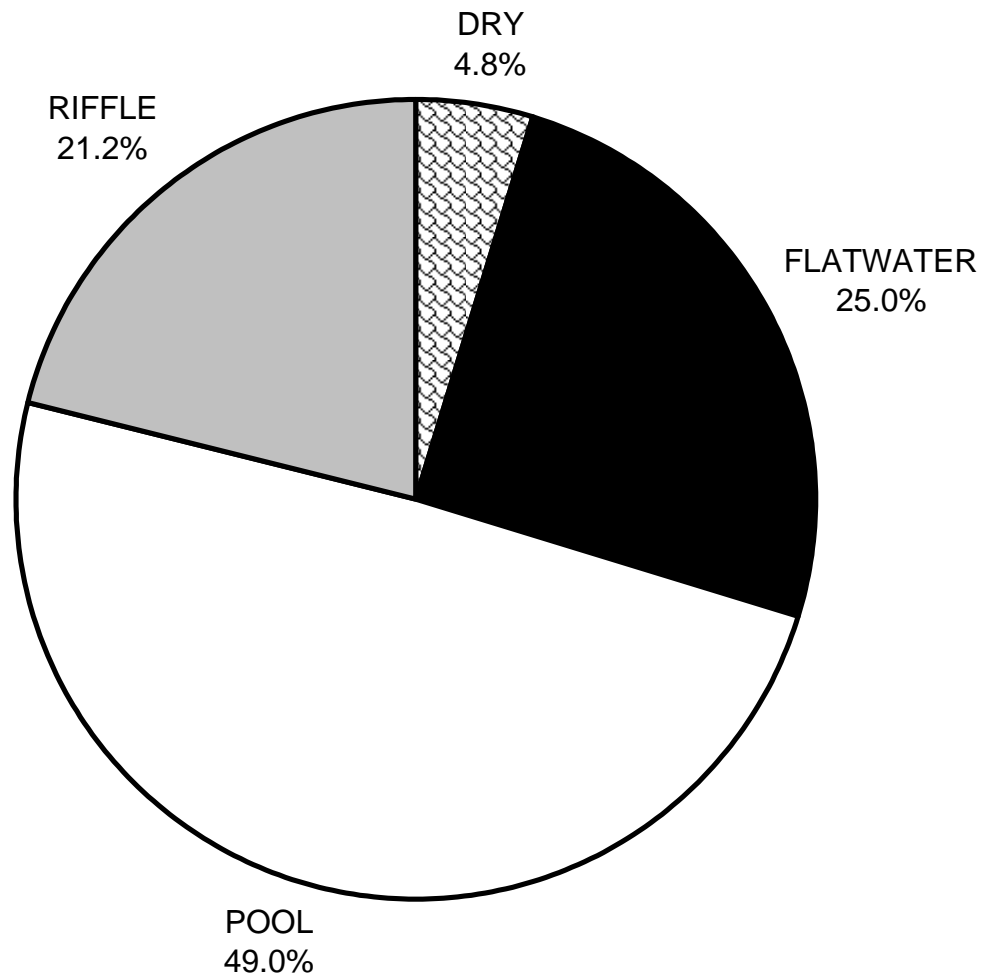
GRAPH 1

Table 1 summarizes the Level II riffle, flatwater, and pool habitat types. Based on frequency of occurrence there were 49% pool units, 25% flatwater units, and 21% riffle units (Graph 1). Based on total length of Level II habitat types there were 43% pool units, 39% flatwater units, and 17% riffle units (Graph 2).

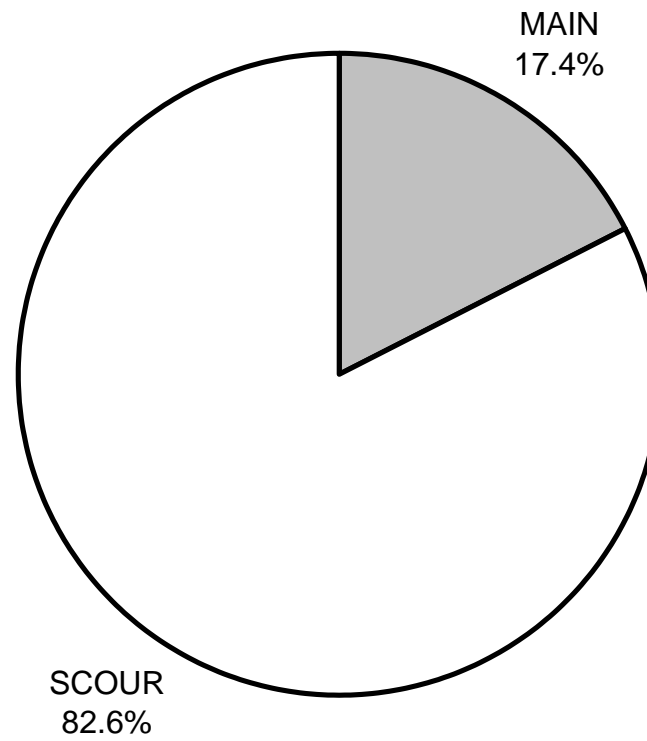
GRAPH 4

A total of 92 pools were identified (Table 3). Scour pools were the most frequently encountered at 83% (Graph 4), and comprised 76% of the total length of all pools (Table 3).

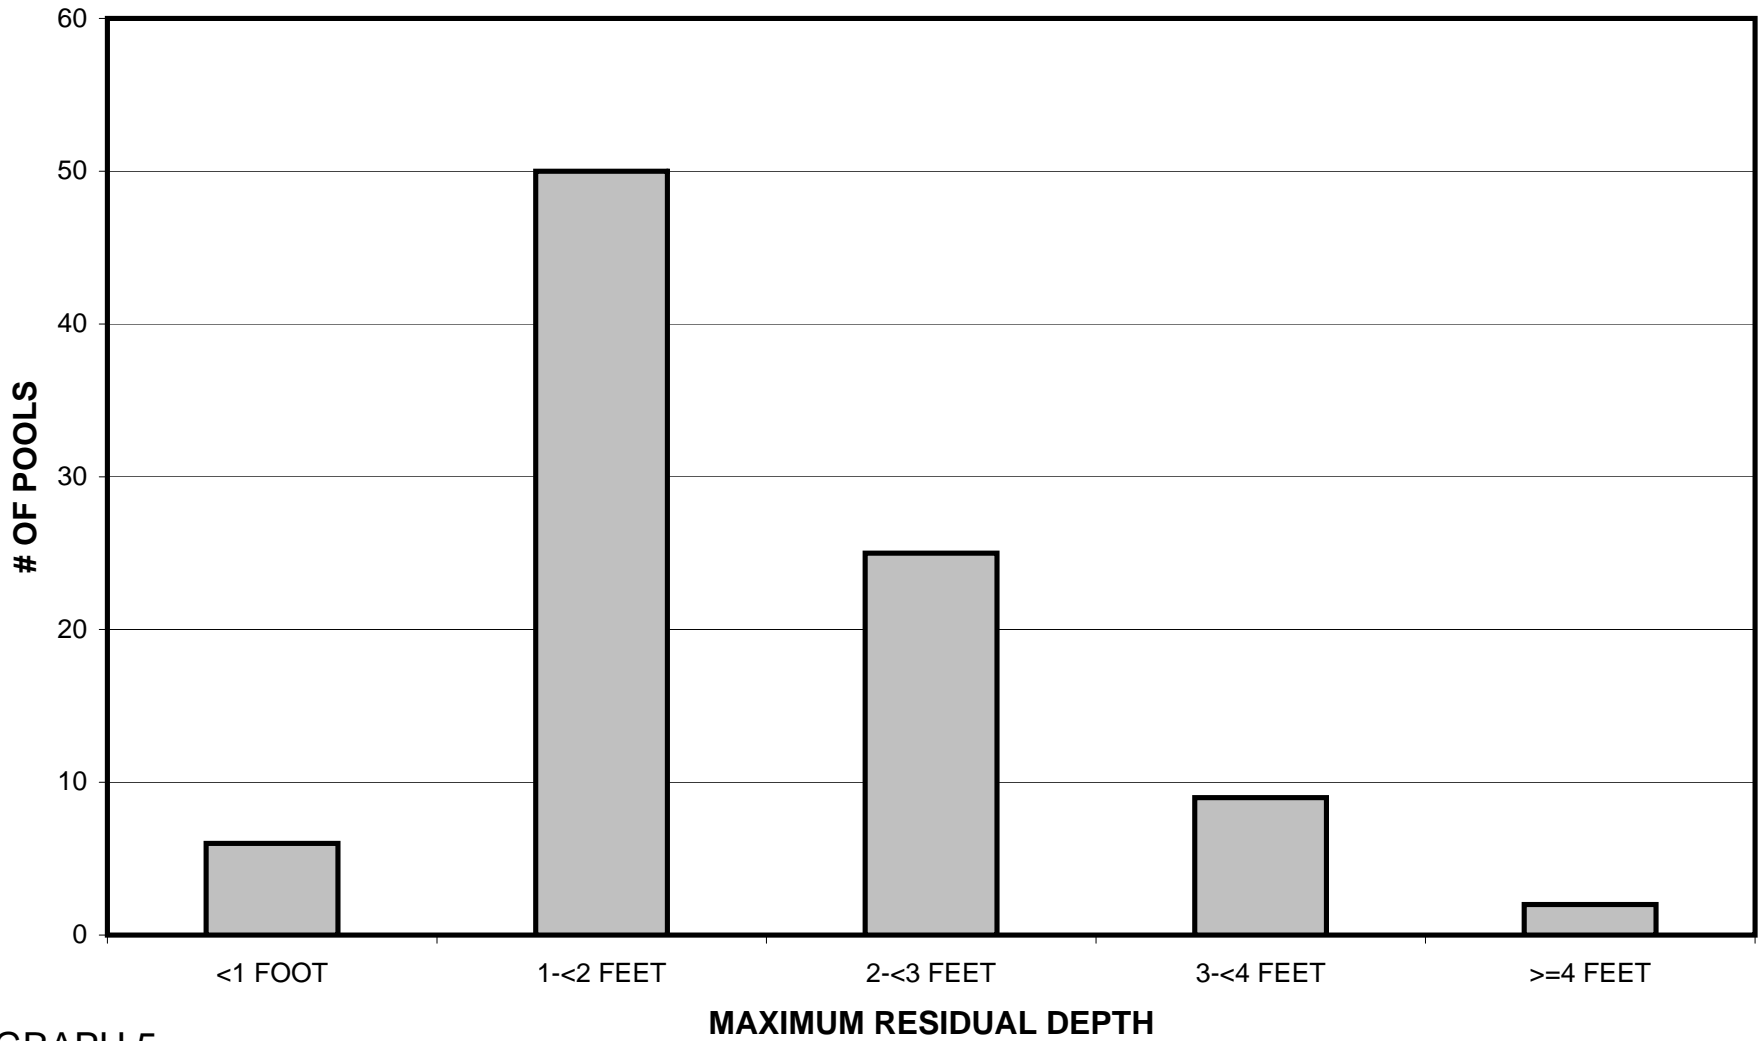
GRAPH 5

Table 4 is a summary of maximum residual pool depths by pool habitat types. Pool quality for salmonids increases with depth. Thirty-six of the 92 pools (39%) had a residual depth of two feet or greater (Graph 5).

Flatwater habitat types comprised 39% of the total length of this survey, riffles 17%, and pools 43%. Thirty-six of the 92 (39%) pools had a maximum residual depth greater than 2 feet. In general, pool enhancement projects are considered when primary pools comprise less than 40% of the length of total stream habitat. In first and second order streams, a primary pool is defined to have a maximum residual depth of at least two feet, occupy at least half the width of the low flow channel, and be as long as the low flow channel width.

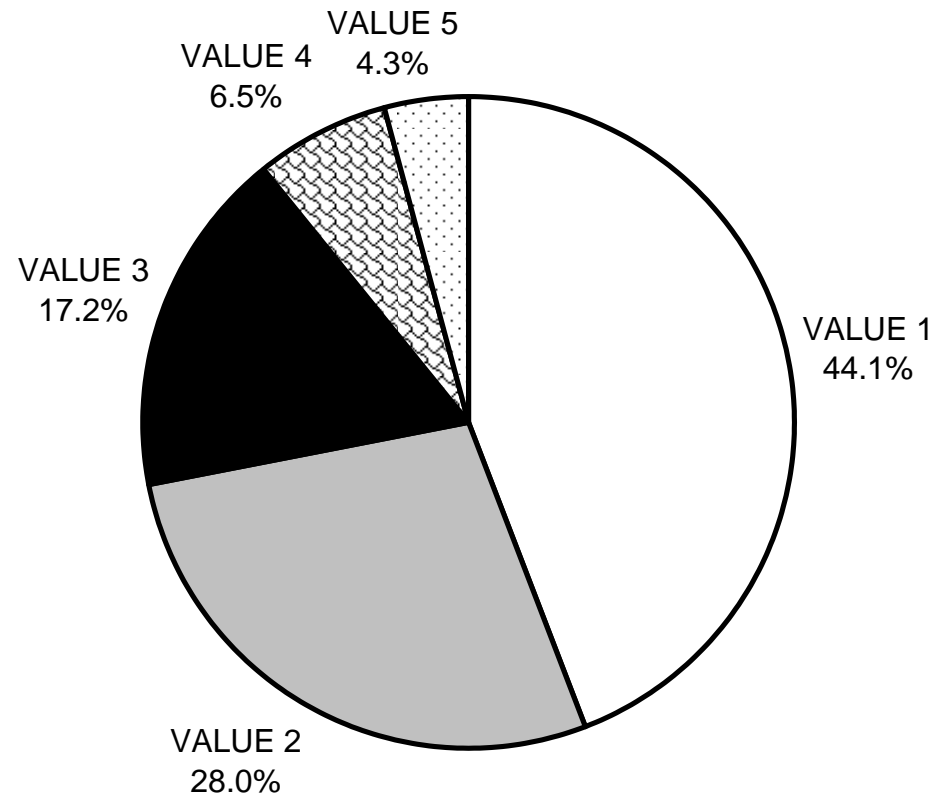
GRAPH 6

The depth of cobble embeddedness was estimated at pool tail-outs. Of the 92 pool tail-outs measured, 41 had a value of 1 (44.1%); 26 had a value of 2 (28.0%); 15 had a value of 3 (17.2%); 6 had a value of 4 (6.5%); 4 had a value of 5 (4.3%) (Graph 6). On this scale, a value of 1 indicates the best spawning conditions and a value of 4 the worst. Additionally, a value of 5 was assigned to tail-outs deemed unsuited for spawning due to inappropriate substrate such as bedrock, log sills, boulders, or other considerations.

Sixty-seven of the 92 pool tail-outs measured had embeddedness ratings of 1 or 2. Twenty-one of the pool tail-outs had embeddedness ratings of 3 or 4. Four of the pool tail-outs had a rating of 5, which is considered unsuitable for spawning. Cobble embeddedness measured to be 25% or less, a rating of 1, is considered to indicate good quality spawning substrate for salmon and steelhead.

- 5) Inventory and map sources of stream bank erosion and prioritize them according to present and potential sediment yield. Identified sites should then be treated to reduce the amount of fine sediments entering the stream.

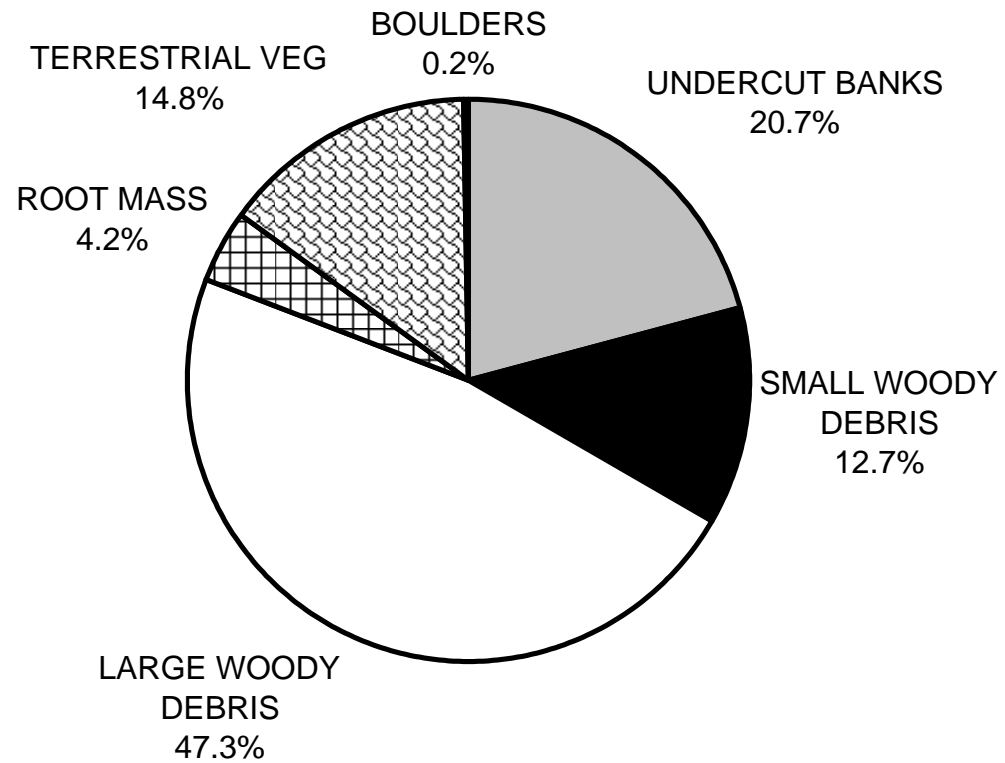
GRAPH 7

Table 5 summarizes mean percent cover by habitat type. Large woody debris is the dominant cover type in Mill Creek. Graph 7 describes the pool cover in Mill Creek. Large woody debris is the dominant pool cover type followed by undercut banks.

The mean shelter rating for pools was 66. The shelter rating in the flatwater habitats was 30. A pool shelter rating of approximately 100 is desirable. The amount of cover that now exists is being provided primarily by large woody debris in Mill Creek. Large woody debris is the dominant cover type in pools followed by undercut banks. Log and root wad cover structures in the pool and flatwater habitats would enhance both summer and winter salmonid habitat. Log cover structure provides rearing fry with protection from predation, rest from water velocity, and also divides territorial units to reduce density related competition.

- 4) Increase woody cover in the pools and flatwater habitat units. Most of the existing cover in the pools is from large woody debris. Adding high quality complexity with woody cover in the pools is desirable.

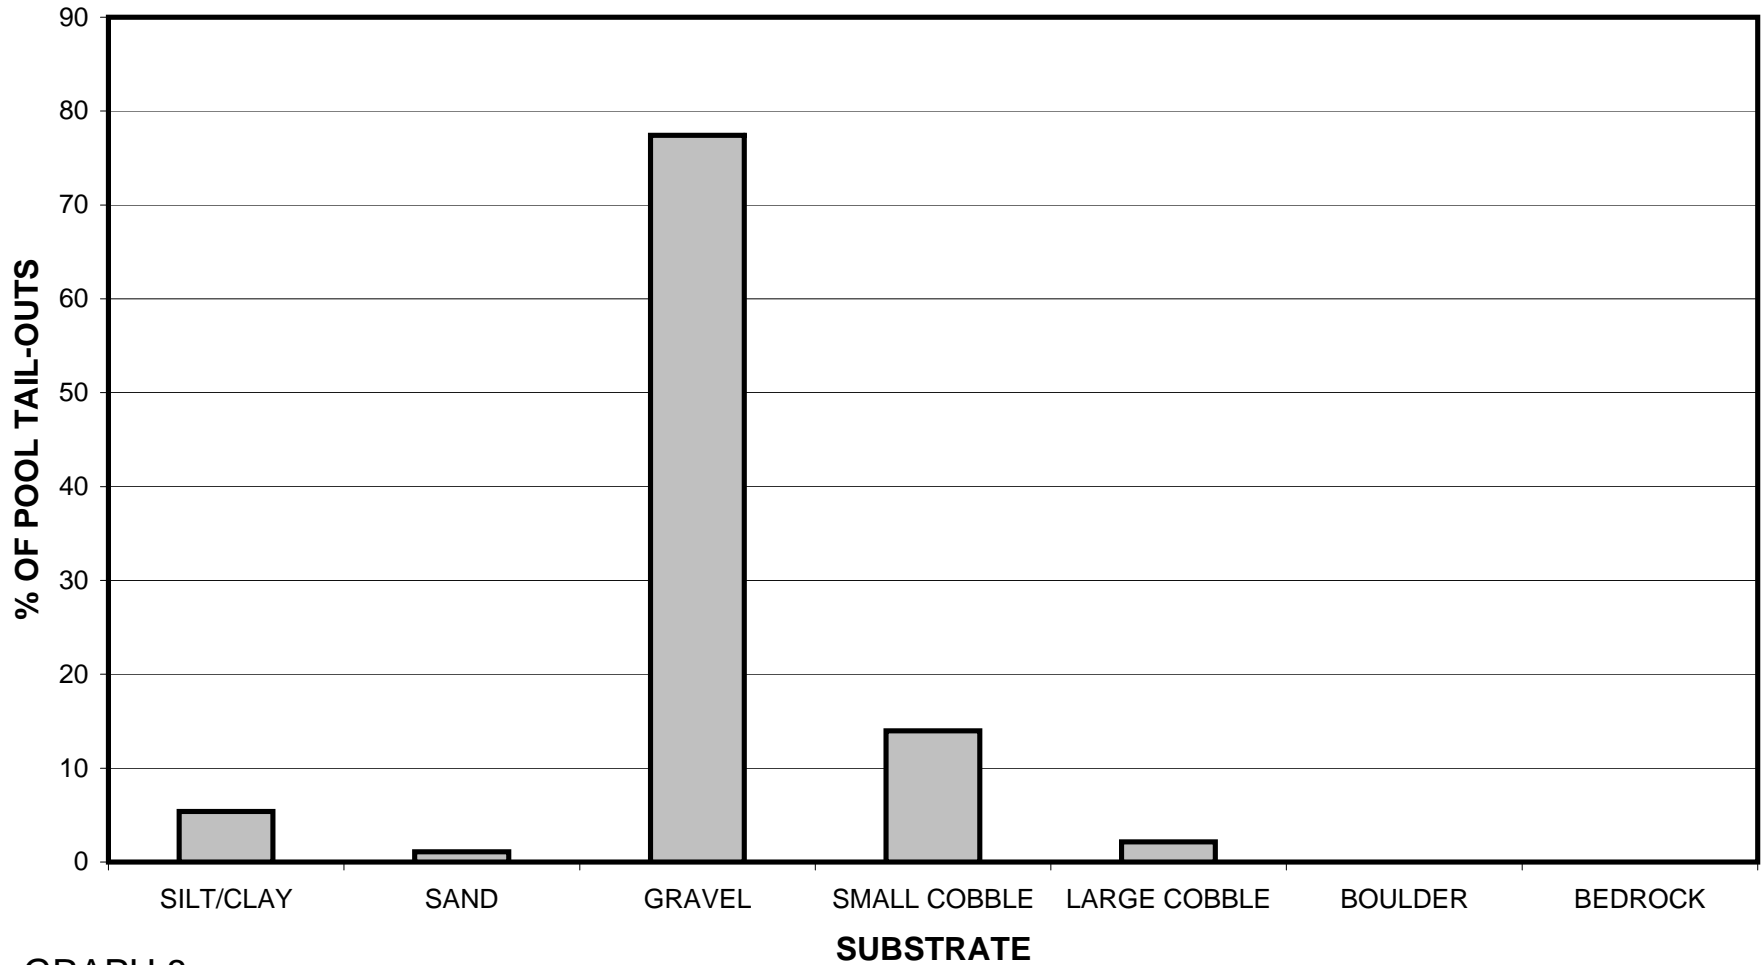
GRAPH 8

Table 6 summarizes the dominant substrate by habitat type. Graph 8 depicts the dominant substrate observed in pool tail-outs. Gravel was the dominant substrate observed in 78% of the pool tail-outs. Small cobble was the next most frequently observed dominant substrate type and occurred in 13% of the pool tail-outs.

Eighty-four of the 92 pool tail-outs measured had gravel or small cobble as the dominant substrate. This is generally considered good for spawning salmonids.

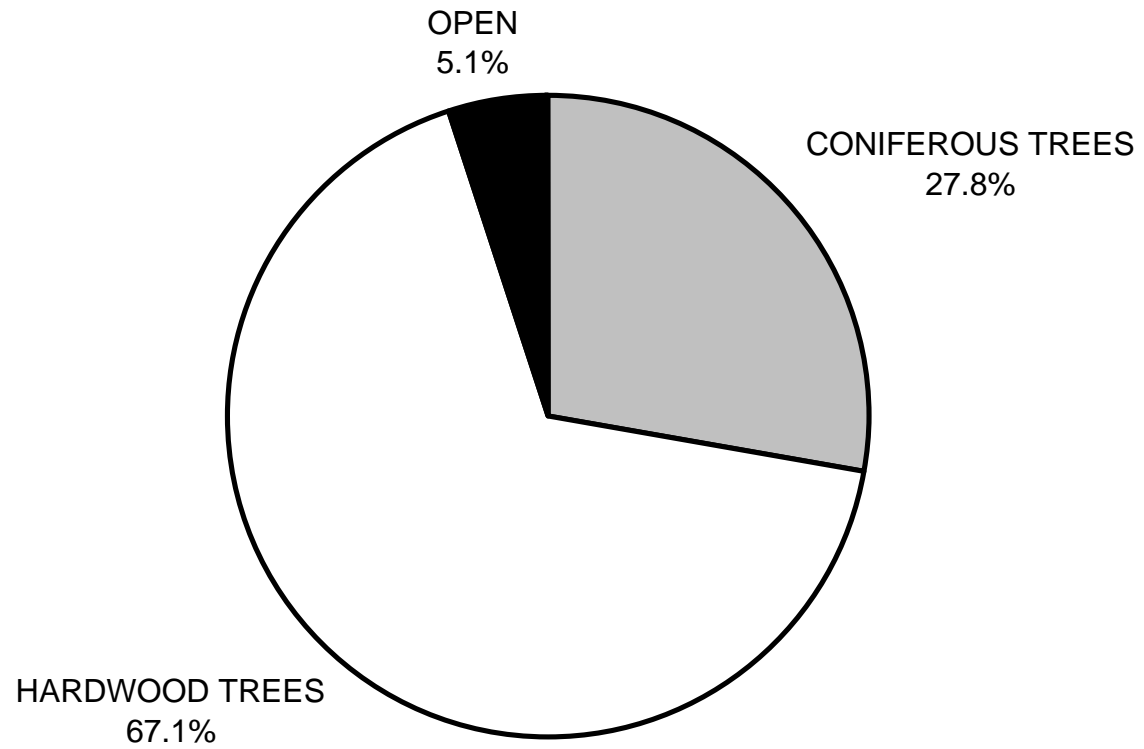
GRAPH 9

The mean percent canopy density for the surveyed length of Mill Creek was 95%. Five percent of the canopy was open. Of the canopy present, the mean percentages of hardwood and coniferous trees were 71% and 29%, respectively. Graph 9 describes the mean percent canopy in Mill Creek.

The mean percent canopy density for the stream was 95%. Reach 2 had a canopy density of 96.4%, Reach 4 had a canopy density of 97.4%, Reach 5 had a canopy density of 91.6%, and Reach 7 had a canopy density of 95.3%. In general, revegetation projects are considered when canopy density is less than 80%.
