# STREAM INVENTORY REPORT

## Ham Canyon

A stream inventory was conducted from September 28 to October 6, 2010 on Ham Canyon Creek. The survey began at the confluence with Rancheria Creek and extended upstream 2.4 miles.

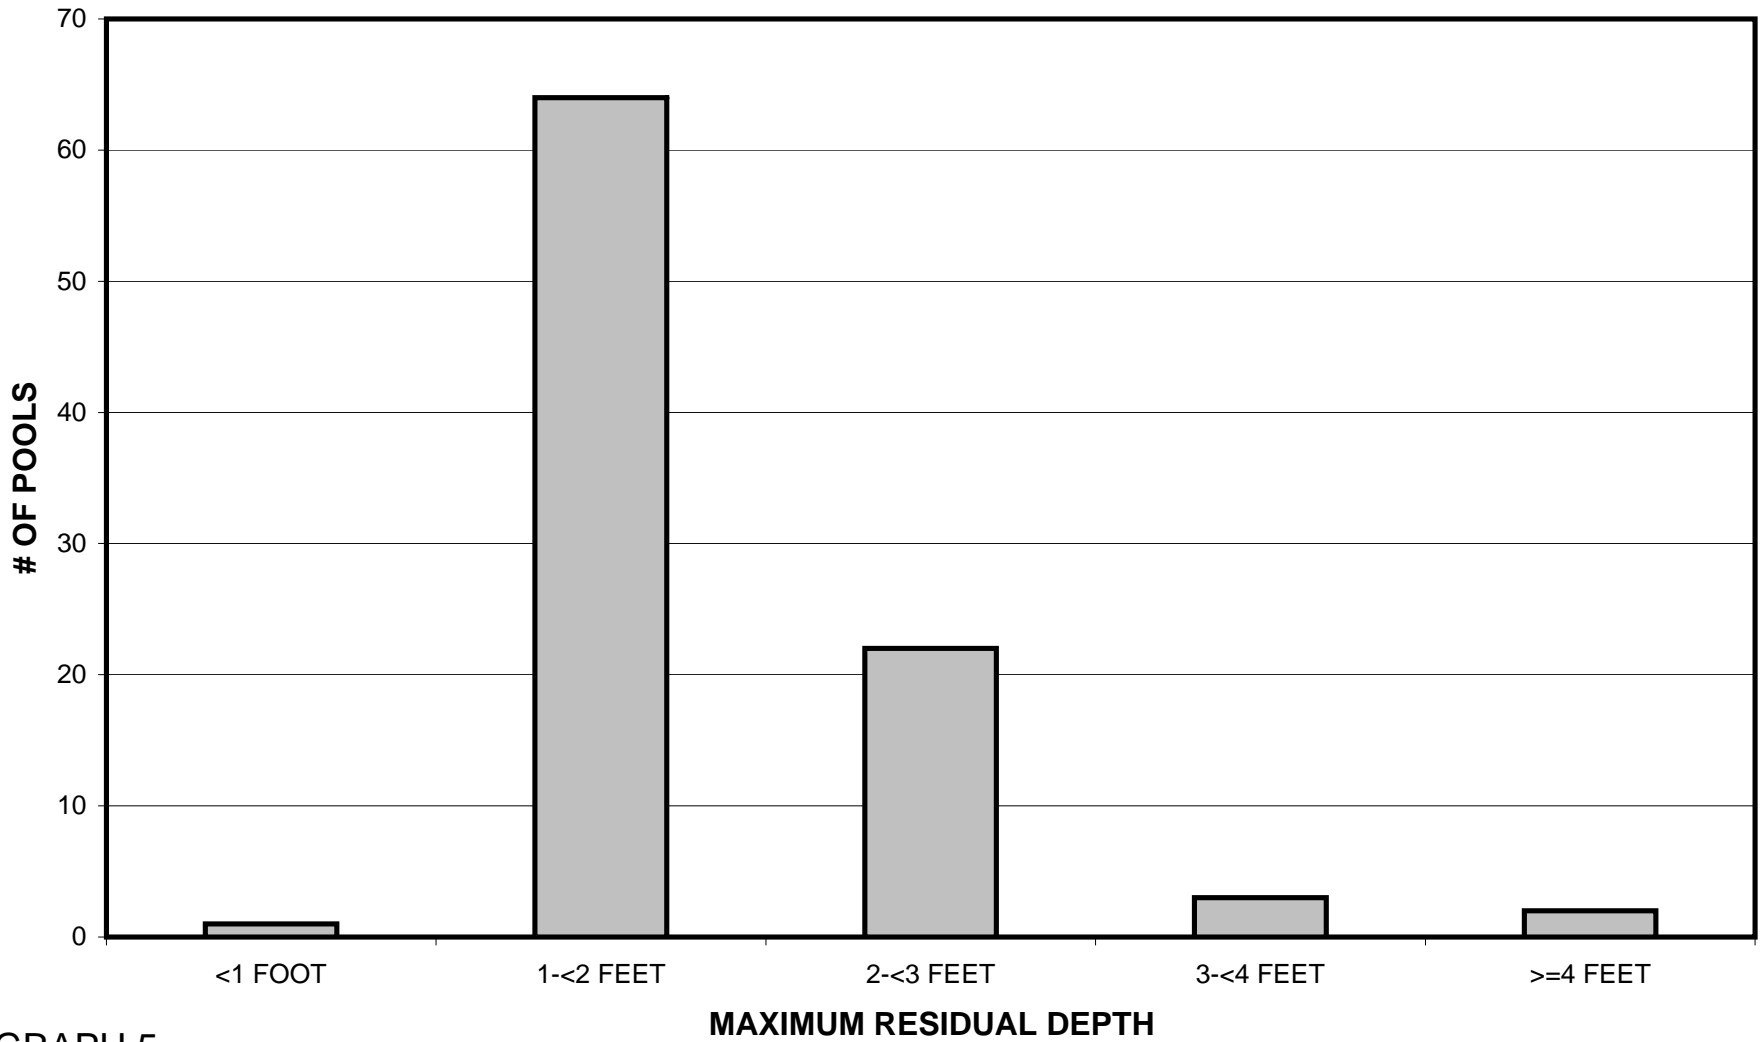
GRAPH 5

Table 4 is a summary of maximum residual pool depths by pool habitat types. Pool quality for salmonids increases with depth. Twenty-seven of the 92 pools (29%) had a residual depth of two feet or greater (Graph 5).

Flatwater habitat types comprised 41% of the total length of this survey, riffles 35%, and pools 19%. Twenty-seven of the 92 (29%) pools had a maximum residual depth greater than 2 feet. In general, pool enhancement projects are considered when primary pools comprise less than 40% of the length of total stream habitat. In first and second order streams, a primary pool is defined to have a maximum residual depth of at least two feet, occupy at least half the width of the low

flow channel, and be as long as the low flow channel width. Installing structures that will increase or deepen pool habitat is recommended.

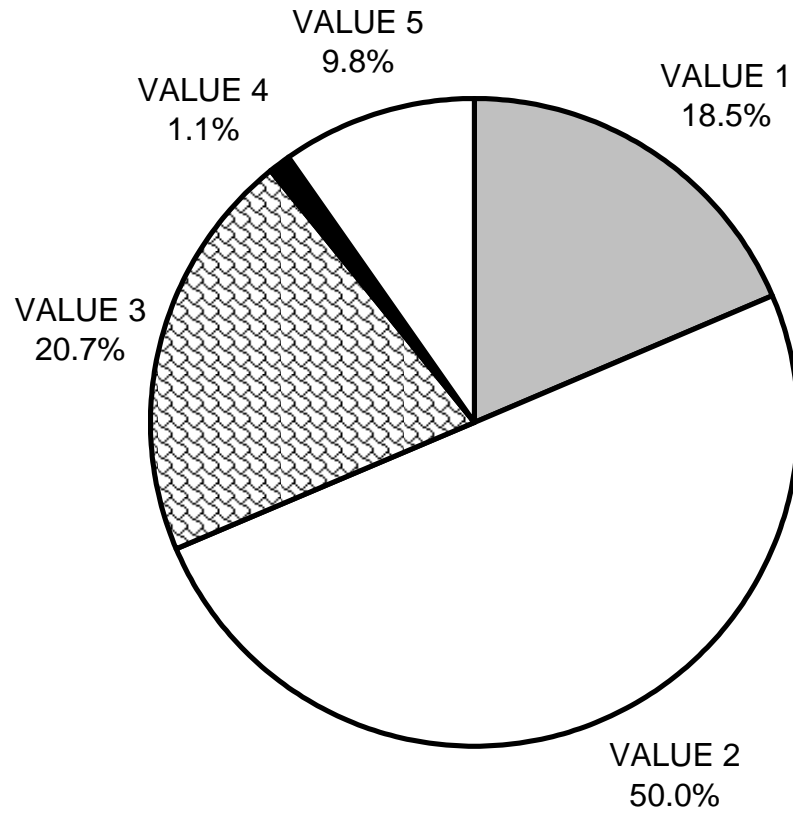
GRAPH 6

The depth of cobble embeddedness was estimated at pool tail-outs. Of the 92 pool tail-outs measured, 17 had a value of 1 (18.5%); 46 had a value of 2 (50%); 19 had a value of 3 (20.7%); 1 had a value of 4 (1.1%); 9 had a value of 5 (9.8%) (Graph 6). On this scale, a value of 1 indicates the best spawning conditions and a value of 4 the worst. Additionally, a value of 5 was assigned to tail-outs deemed unsuited for spawning due to inappropriate substrate such as bedrock, log sills, boulders, or other considerations.

Sixty-three of the 92 pool tail-outs measured had embeddedness ratings of 1 or 2. Twenty of the pool tail-outs had embeddedness ratings of 3 or 4. Nine of the pool tail-outs had a rating of 5, which is considered unsuitable for spawning. Cobble embeddedness measured to be 25% or less, a rating of 1, is considered to indicate good quality spawning substrate for salmon and steelhead. Sediment sources in Ham Canyon Creek should be mapped and rated according to their potential sediment yields, and control measures should be taken.

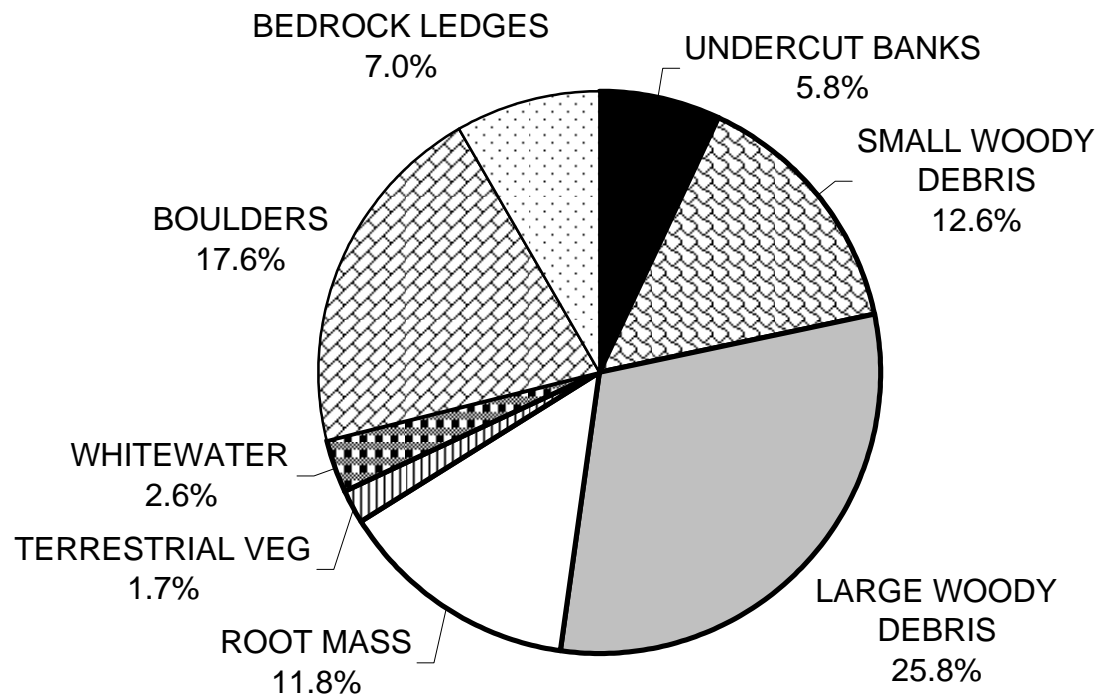
GRAPH 7

Table 5 summarizes mean percent cover by habitat type. Large woody debris is the dominant cover type in Ham Canyon Creek. Graph 7 describes the pool cover in Ham Canyon Creek. Large woody debris is the dominant pool cover type followed by boulders.

The mean shelter rating for pools is 20. The shelter rating in the flatwater habitats is 5. A pool shelter rating of approximately 100 is desirable. The amount of cover that now exists is being provided primarily by large woody debris in Ham Canyon Creek. Large woody debris is the dominant cover type in pools followed by boulders. Log and root wad cover structures in the pool and flatwater habitats would enhance both summer and winter salmonid habitat. Log cover structure provides rearing fry with protection from predation, rest from water velocity, and also divides territorial units to reduce density related competition.

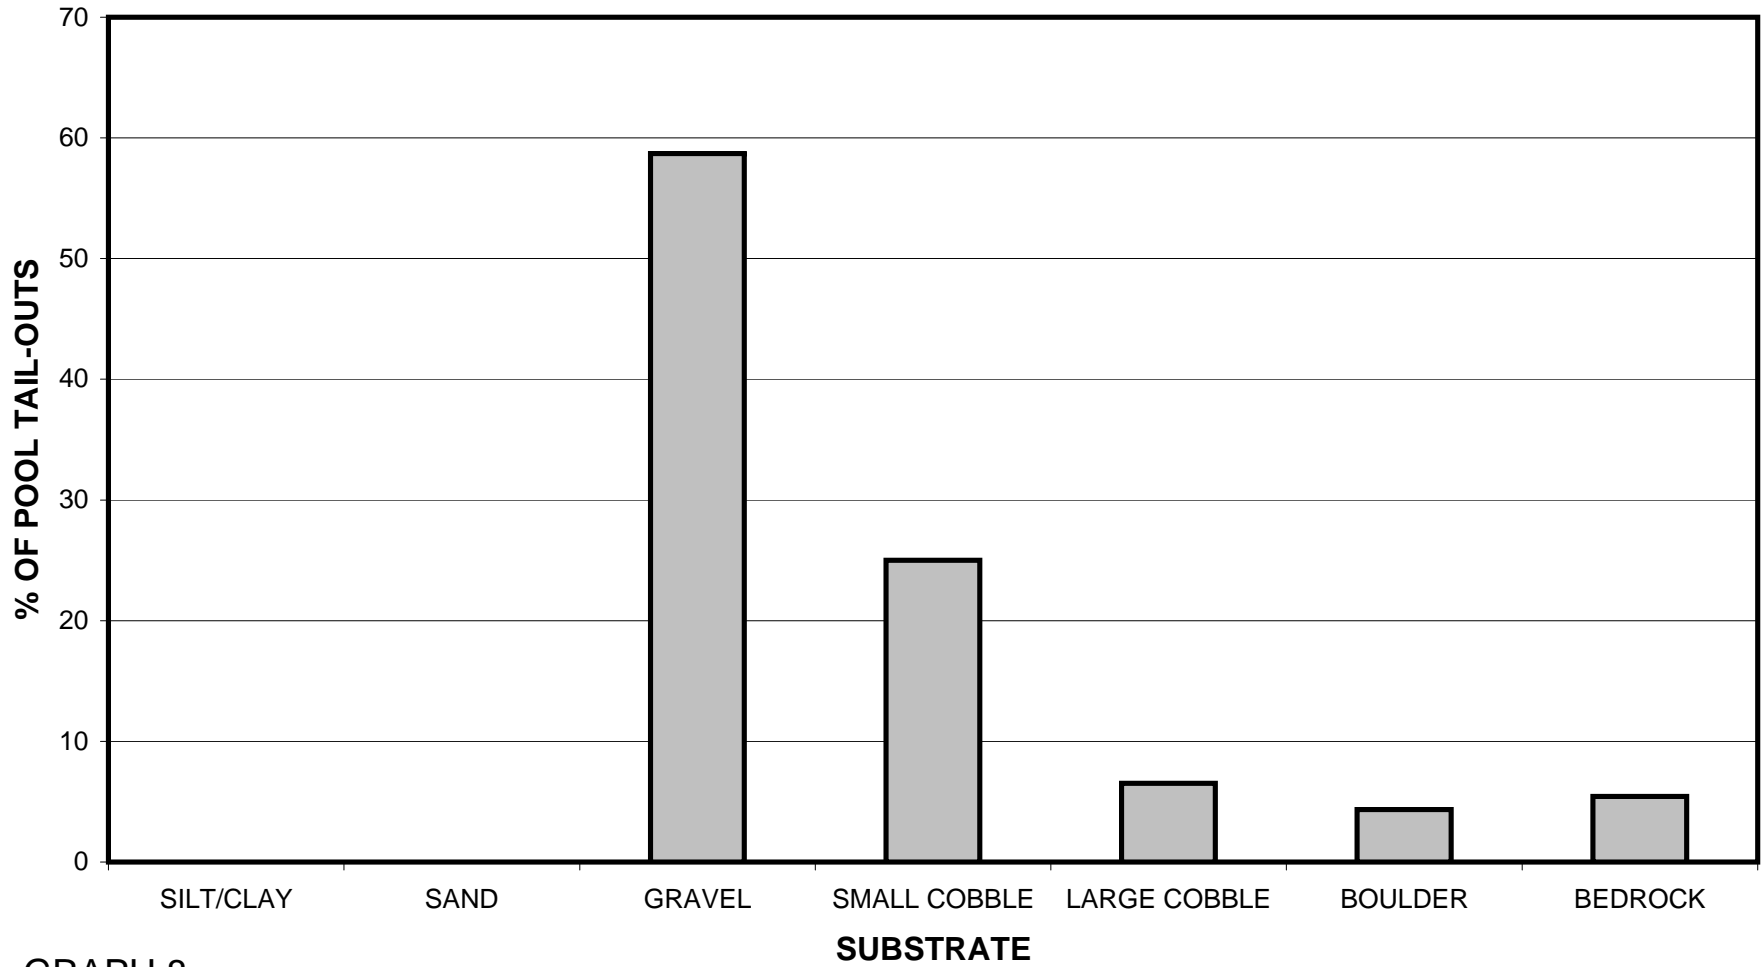
GRAPH 8

Table 6 summarizes the dominant substrate by habitat type. Graph 8 depicts the dominant substrate observed in pool tail-outs. Gravel was the dominant substrate observed in 59% of the pool tail-outs. Small cobble was the next most frequently observed dominant substrate type and occurred in 25% of the pool tail-outs.

Seventy-seven of the 92 pool tail-outs measured had gravel or small cobble as the dominant substrate. This is generally considered good for spawning salmonids.

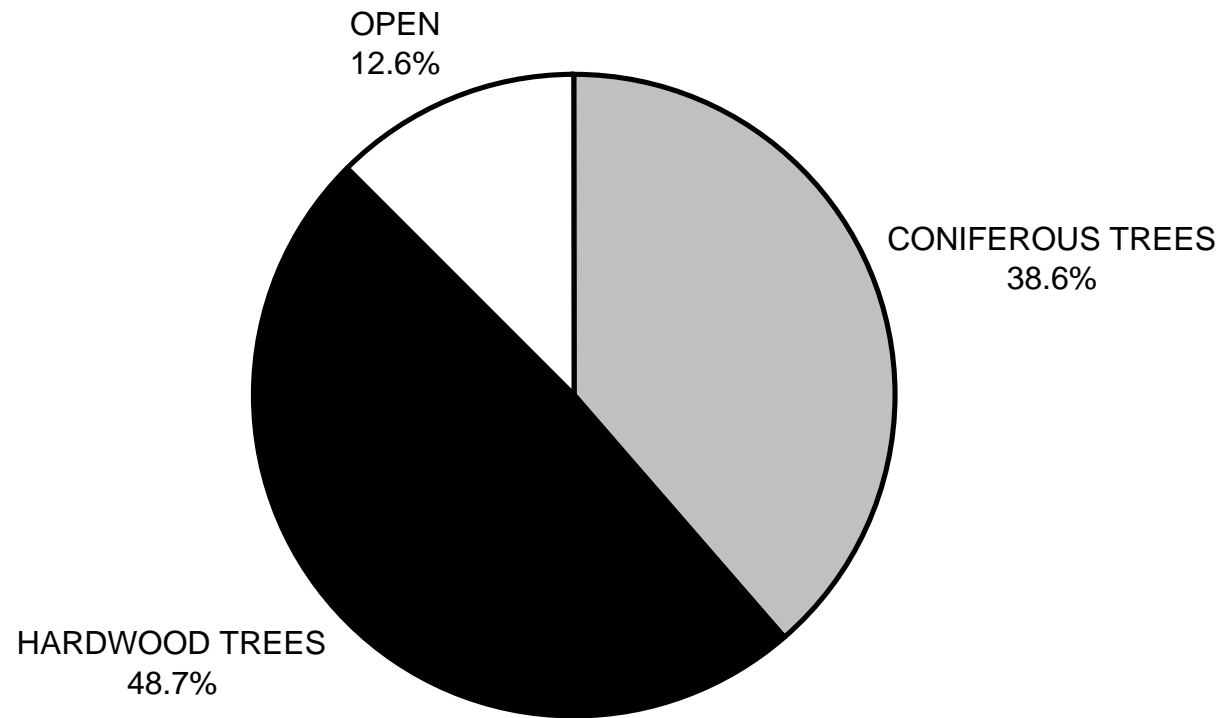
GRAPH 9

The mean percent canopy density for the surveyed length of Ham Canyon Creek was 87%. Thirteen percent of the canopy was open. Of the canopy present, the mean percentages of hardwood and coniferous trees were 56% and 44%, respectively. Graph 9 describes the mean percent canopy in Ham Canyon Creek.

The mean percent canopy density for the stream was 87%. In general, revegetation projects are considered when canopy density is less than 80%.

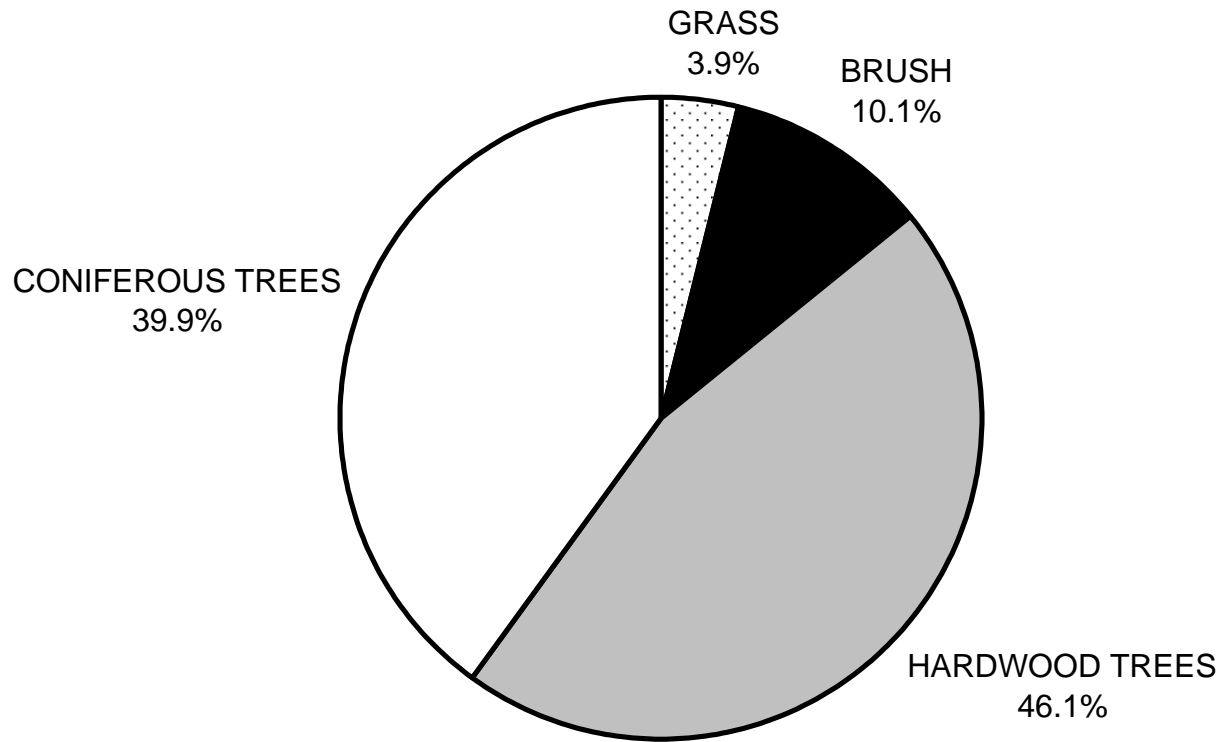
GRAPH 11

For the stream reach surveyed, the mean percent right bank vegetated was 95%. The mean percent left bank vegetated was 94%. The dominant elements composing the structure of the stream banks consisted of 46% sand/silt/clay, 31% cobble/gravel, 14% bedrock, and 8% boulder (Graph 10). Hardwood trees were the dominant vegetation type observed in 46% of the units surveyed. Additionally, 40% of the units surveyed had coniferous trees as the dominant vegetation type, and 10% had brush as the dominant vegetation type (Graph 11).

The percentage of right and left bank covered with vegetation was 95% and 94%, respectively. In areas of stream bank erosion or where bank vegetation is sparse, planting endemic species of coniferous and hardwood trees, in conjunction with bank stabilization, is recommended.
