STREAM INVENTORY REPORT

Virgin Creek

A stream inventory was conducted from June 17, 2008 to June 18, 2008 on Virgin Creek. The survey began at the confluence with Pacific Ocean and extended upstream 1.7 miles.

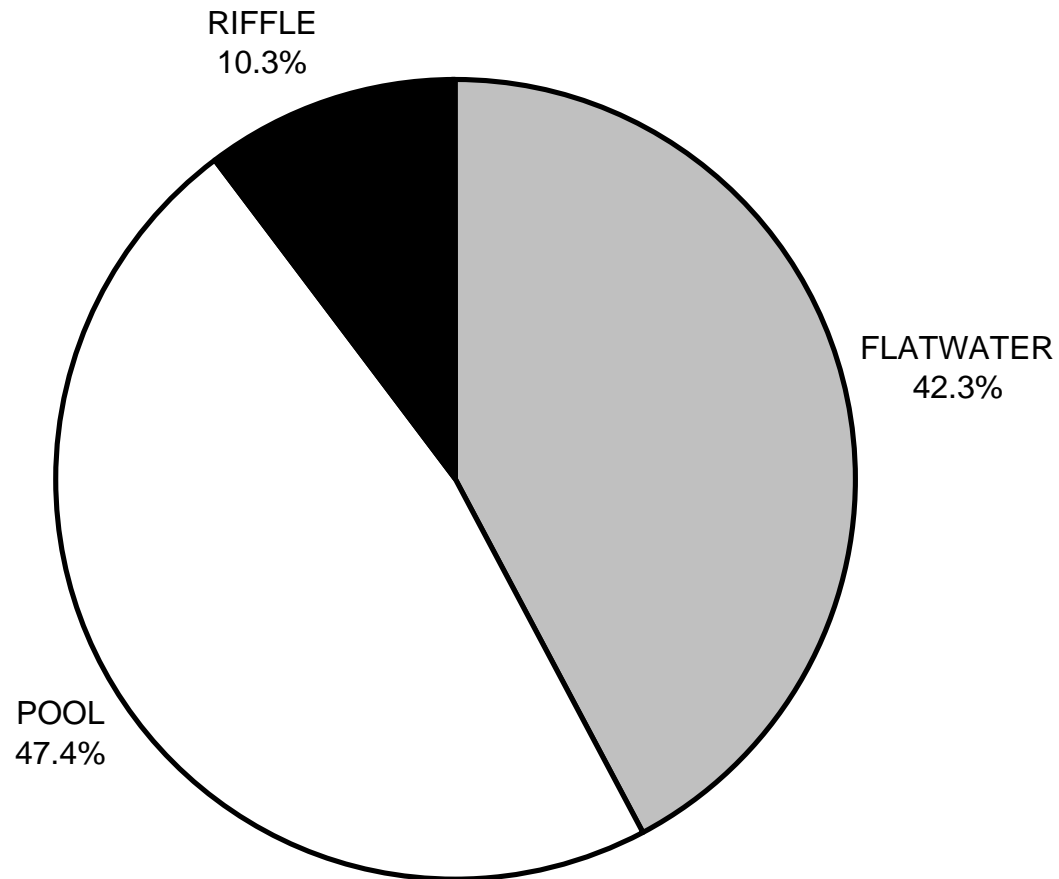
GRAPH 1

Table 1 summarizes the Level II riffle, flatwater, and pool habitat types. Based on frequency of occurrence there were 42% flatwater units, 47% pool units and 10% riffle units (Graph 1). Based on total length of Level II habitat types there were 51% flatwater units, 45% pool units, and 5% riffle units (Graph 2).

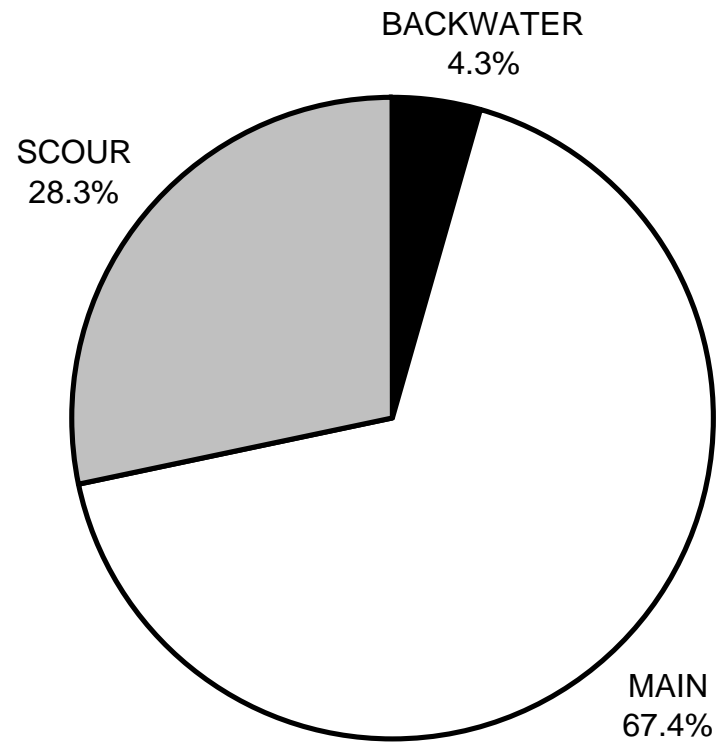
GRAPH 4

A total of 46 pools were identified (Table 3). Main channel pools were the most frequently encountered at 67% (Graph 4), and comprised 70% of the total length of all pools (Table 3).

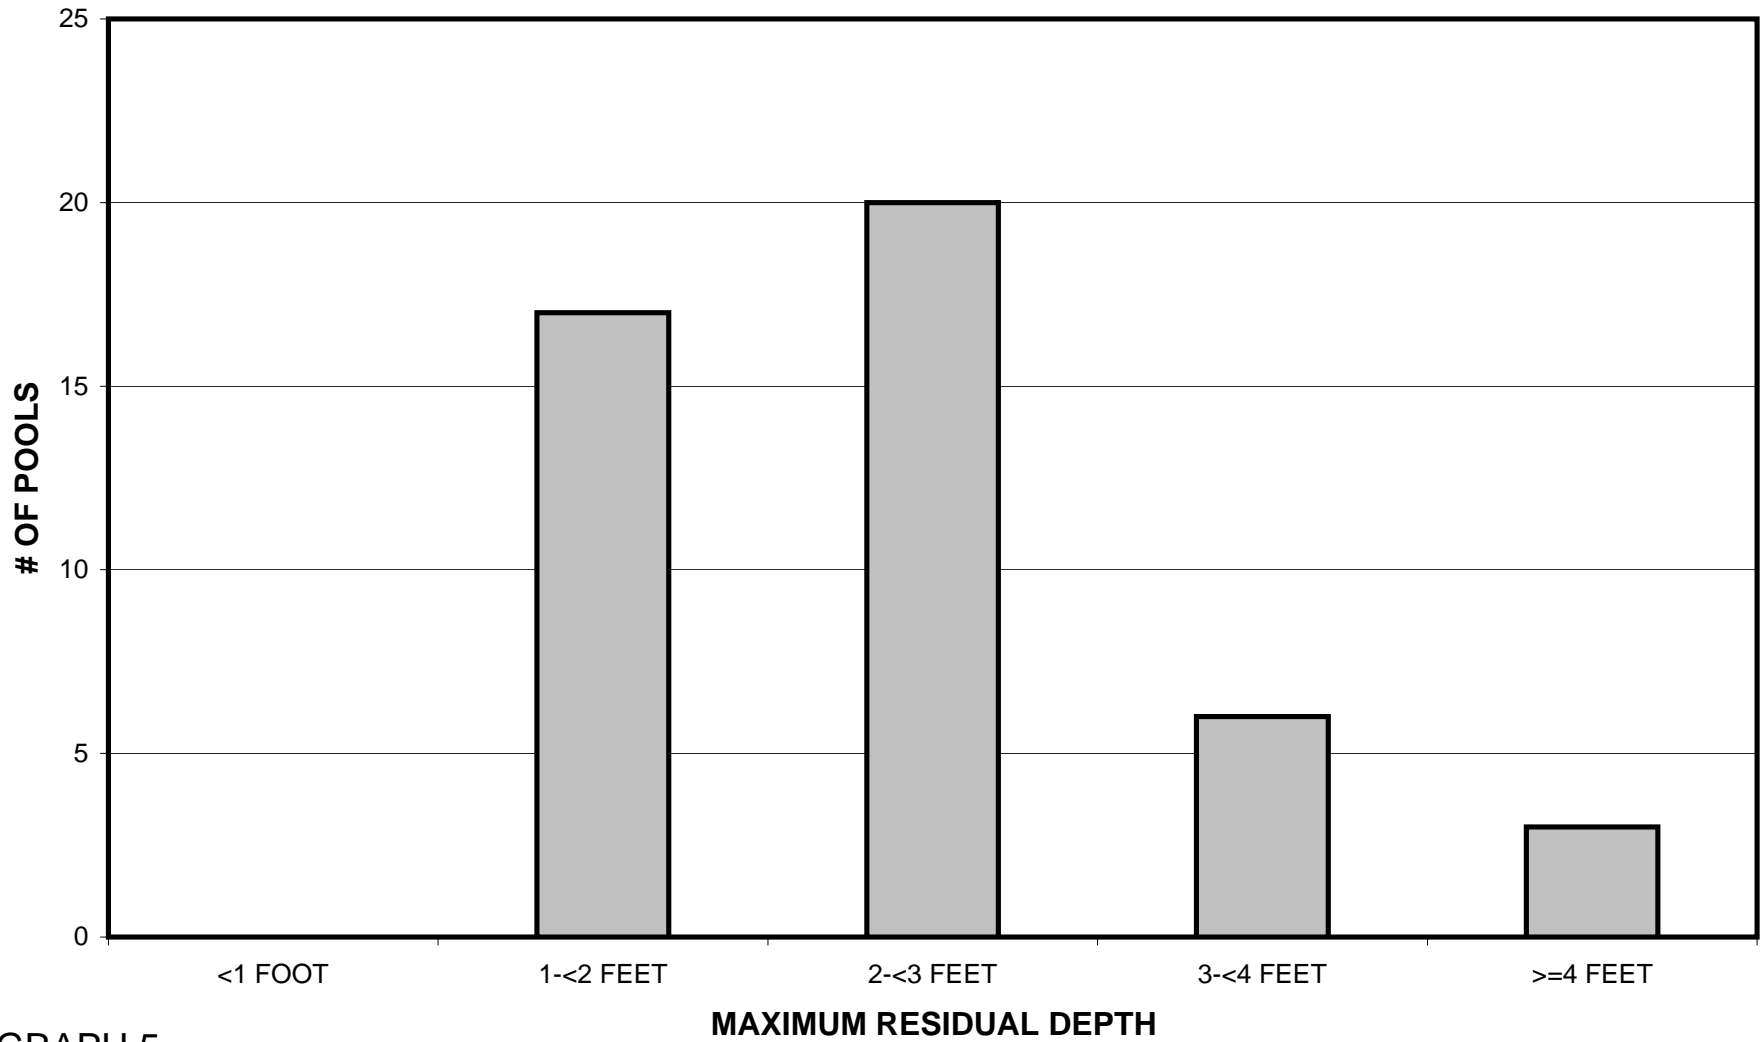
GRAPH 5

Table 4 is a summary of maximum residual pool depths by pool habitat types. Pool quality for salmonids increases with depth. Twenty-nine of the 46 pools (63%) had a residual depth of two feet or greater (Graph 5).

Flatwater habitat types comprised 51% of the total length of this survey, riffles 5%, and pools 45%. Twenty-nine of the 46 (63%) pools had a maximum residual depth greater than 2 feet. In general, pool enhancement projects are considered when primary pools comprise less than 40% of the length of total stream habitat. In first and second order streams, a primary pool is defined to have a maximum residual depth of at least two feet, occupy at least half the width of the low flow channel, and be as long as the low flow channel width. Installing large wood structures that will increase or deepen pool habitat is recommended.

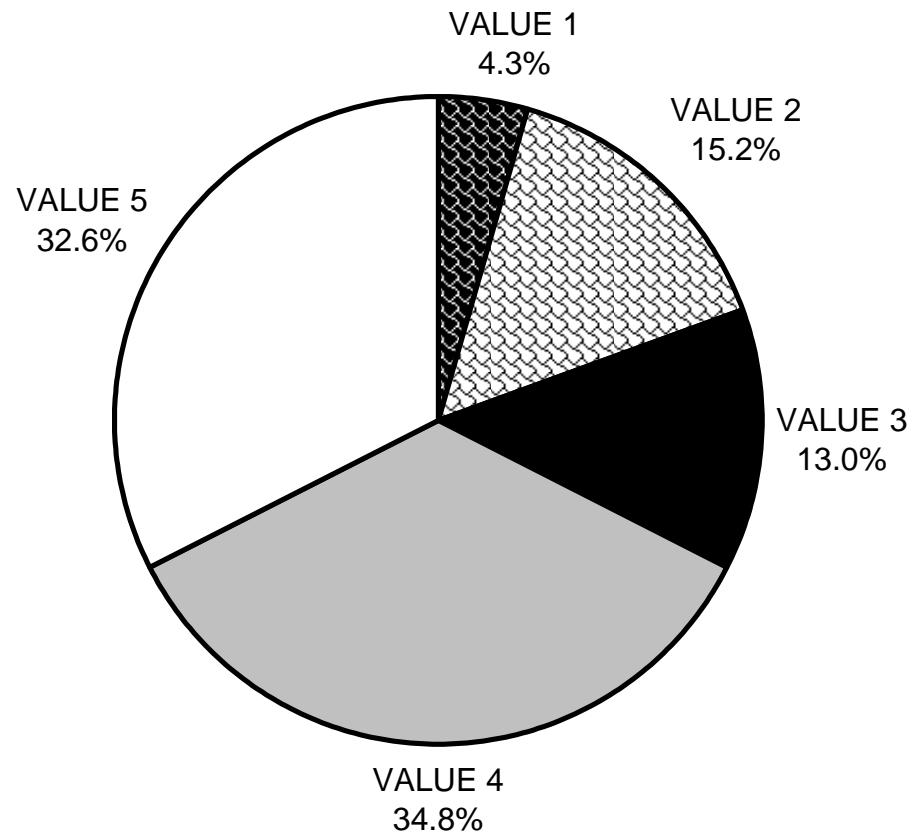
GRAPH 6

The depth of cobble embeddedness was estimated at pool tail-outs. Of the 46 pool tail-outs measured, 2 had a value of 1 (4.3%); 7 had a value of 2 (15.2%); 6 had a value of 3 (13%); 15 had a value of 4 (34.8%); 16 had a value of 5 (32.6%) (Graph 6). On this scale, a value of 1 indicates the best spawning conditions and a value of 4 the worst. Additionally, a value of 5 was assigned to tail-outs deemed unsuited for spawning due to inappropriate substrate such as bedrock, log sills, boulders, or other considerations.

Nine of the 46 pool tail-outs measured had embeddedness ratings of 1 or 2. Twenty-one of the pool tail-outs had embeddedness ratings of 3 or 4. Sixteen of the pool tail-outs had a rating of 5, which is considered unsuitable for spawning. Cobble embeddedness measured to be 25% or less, a rating of 1, is considered to indicate good quality spawning substrate for salmon and steelhead. Sediment sources in Virgin Creek should be mapped and rated according to their potential sediment yields, and control measures should be taken.

- 4) Active and potential sediment sources related to the road system need to be identified, mapped, and treated according to their potential for sediment yield to the stream and its tributaries.

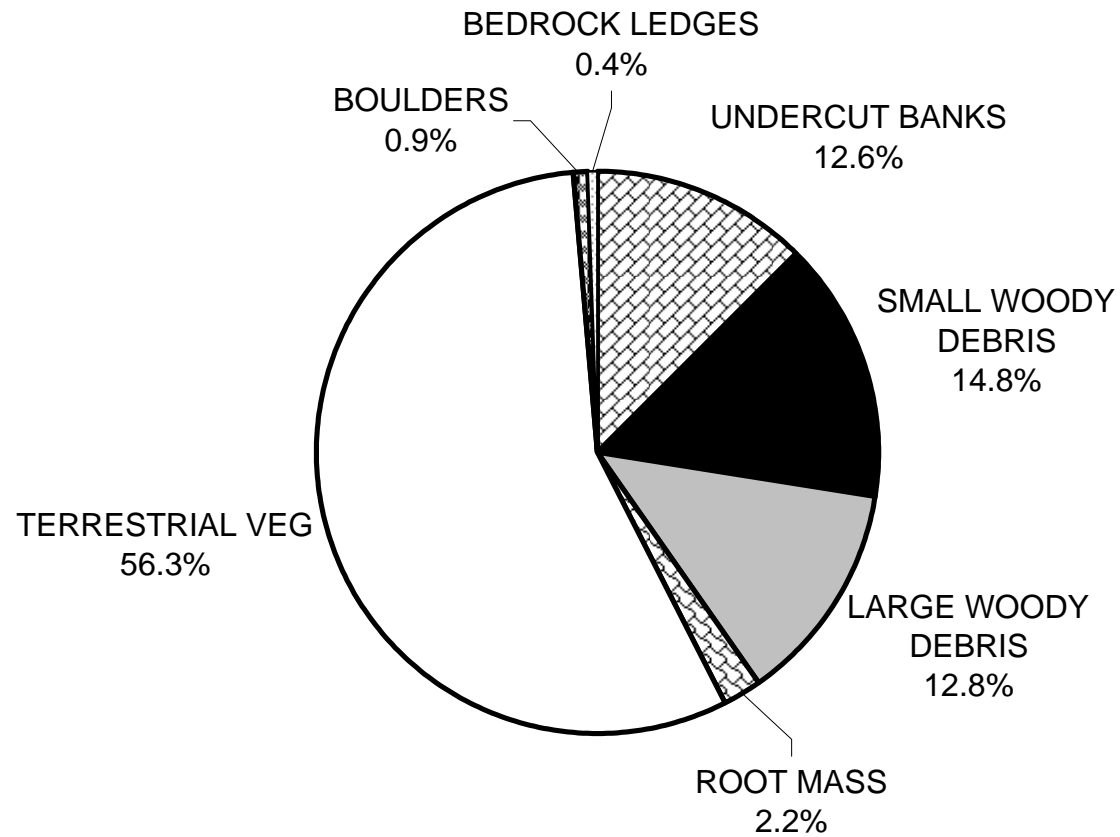
GRAPH 7

Table 5 summarizes mean percent cover by habitat type. Terrestrial vegetation is the dominant cover type in Virgin Creek. Graph 7 describes the pool cover in Virgin Creek. Terrestrial vegetation is the dominant pool cover type followed by small woody debris.

The mean shelter rating for pools was 30. The shelter rating in the flatwater habitats was 64. A pool shelter rating of approximately 100 is desirable. The amount of cover that now exists is being provided primarily by terrestrial vegetation in Virgin Creek. Terrestrial vegetation is the dominant cover type in pools followed by small woody debris. Log and root wad cover structures in the pool and flatwater habitats would enhance both summer and winter salmonid habitat. Log cover structure provides rearing fry with protection from predation, rest from water velocity, and also divides territorial units to reduce density related competition.

- 3) Increase woody cover in the pools and flatwater habitat units. Most of the existing cover in the pools is from terrestrial vegetation. Adding high quality complexity with woody cover in the pools is desirable.

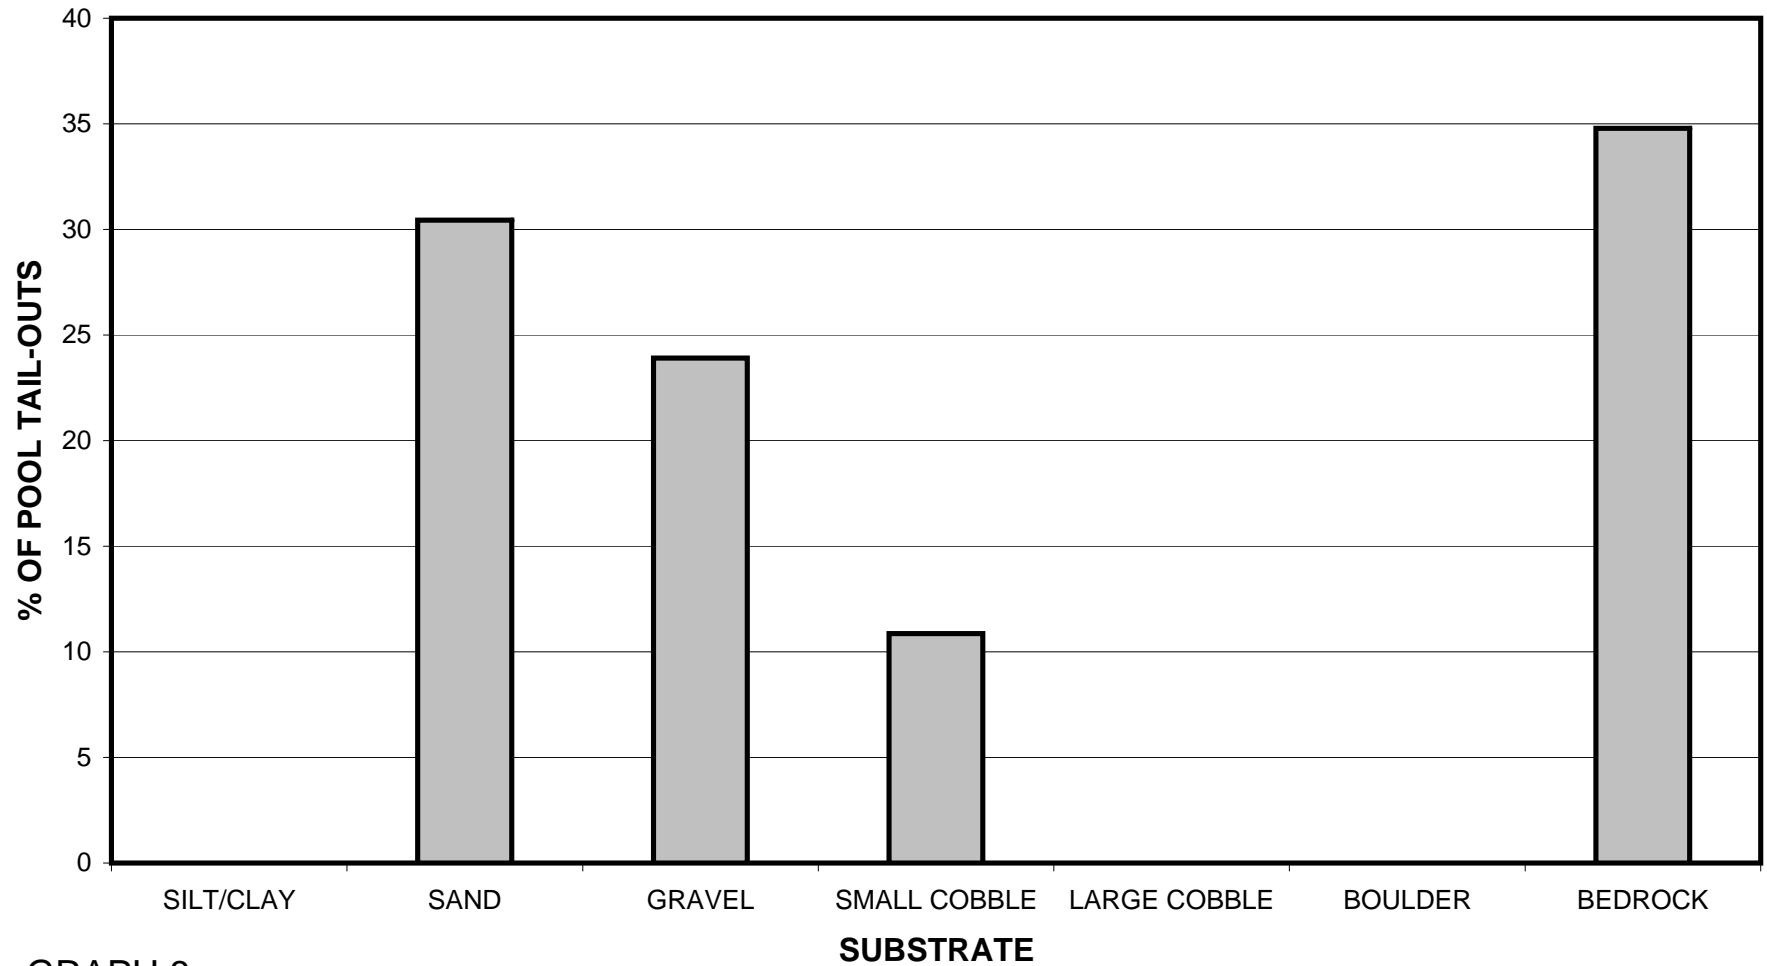
GRAPH 8

Table 6 summarizes the dominant substrate by habitat type. Graph 8 depicts the dominant substrate observed in pool tail-outs. Bedrock was the dominant substrate observed in 35% of the pool tail-outs. Sand was the next most frequently observed dominant substrate type and occurred in 31% of pool the tail-outs.

Thirty of the 46 pool tail-outs had silt, sand, large cobble, boulders or bedrock as the dominant substrate. This is generally considered unsuitable for spawning salmonids.

- 5) Suitable size spawning substrate on Virgin Creek is limited to relatively few reaches. Projects should be designed at suitable sites to trap and sort spawning gravel.

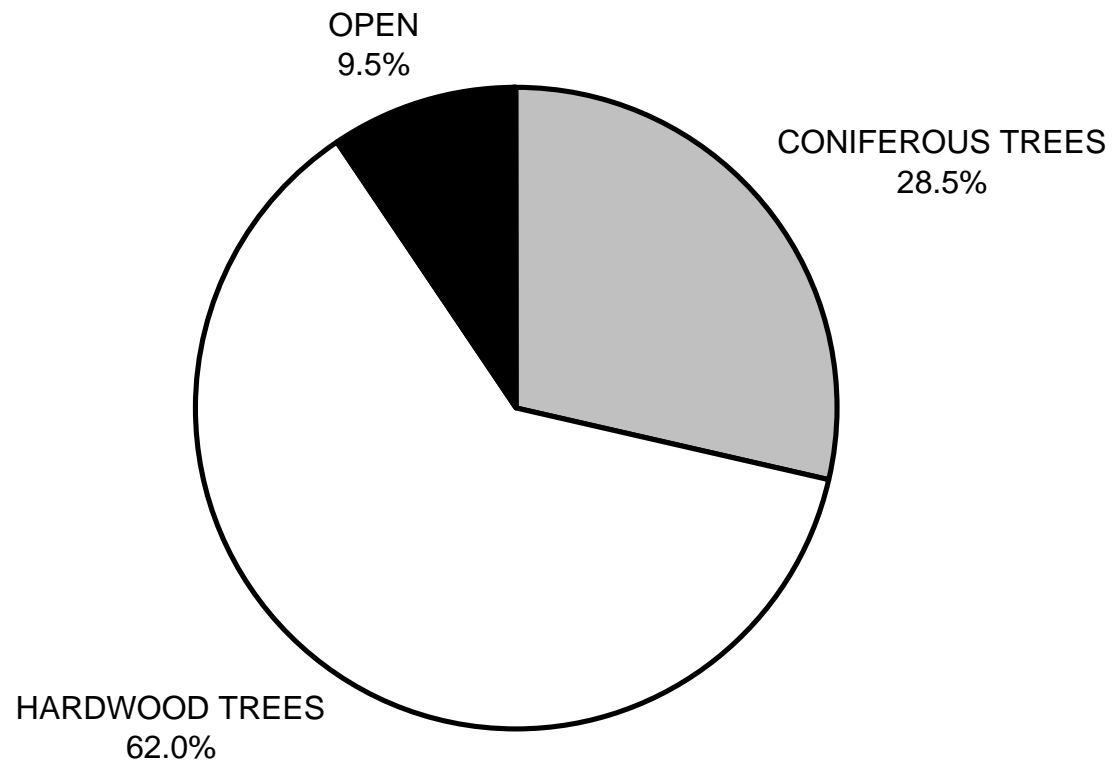
GRAPH 9

The mean percent canopy density for the surveyed length of Virgin Creek was 91%. Nine percent of the canopy was open. Of the canopy present, the mean percentages of hardwood and coniferous trees were 69% and 31%, respectively. Graph 9 describes the mean percent canopy in Virgin Creek.

The mean percent canopy density for the stream was 91%. In general, revegetation projects are considered when canopy density is less than 80%.

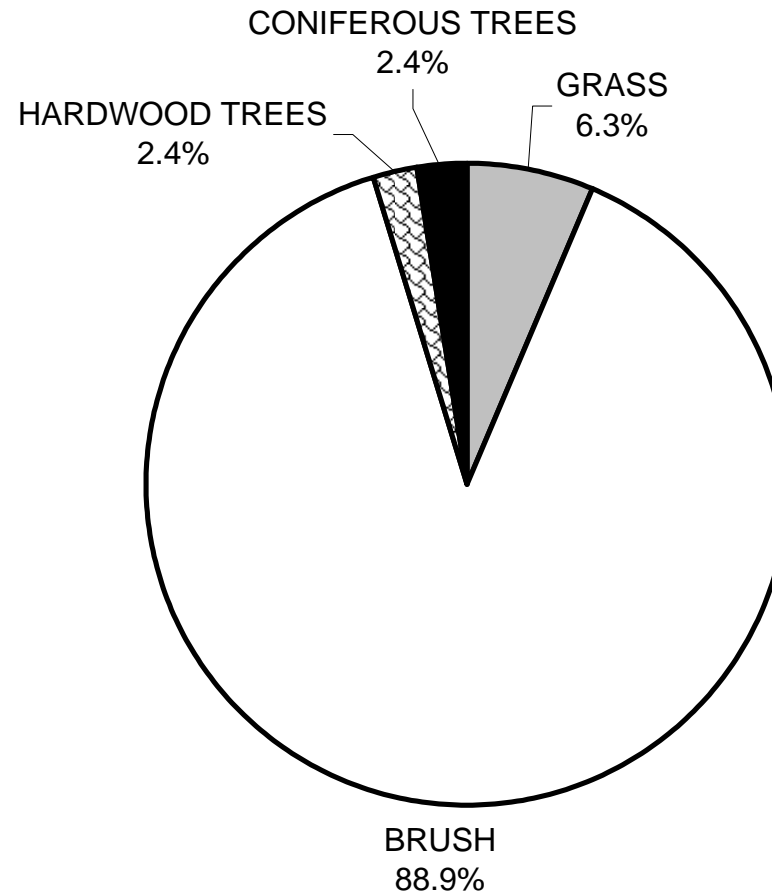
GRAPH 11

For the stream reach surveyed, the mean percent right bank vegetated was 79%. The mean percent left bank vegetated was 79%. The dominant elements composing the structure of the stream banks consisted of 85% sand/silt/clay, 13% bedrock, and 2% boulder (Graph 10). Brush was the dominant vegetation type observed in 89% of the units surveyed. Additionally, 6% of the units surveyed had grass as the dominant vegetation type, 2% had deciduous trees as the dominant vegetation type, and 2% had coniferous trees as the dominant vegetation type (Graph 11).

The percentage of right and left bank covered with vegetation was 79% and 79%, respectively. In areas of stream bank erosion or where bank vegetation is sparse, planting endemic species of coniferous and hardwood trees, in conjunction with bank stabilization, is recommended.
