STREAM INVENTORY REPORT

Virgin Creek

A stream inventory was conducted from June 17, 2008 to June 18, 2008 on Virgin Creek. The survey began at the confluence with Pacific Ocean and extended upstream 1.7 miles.

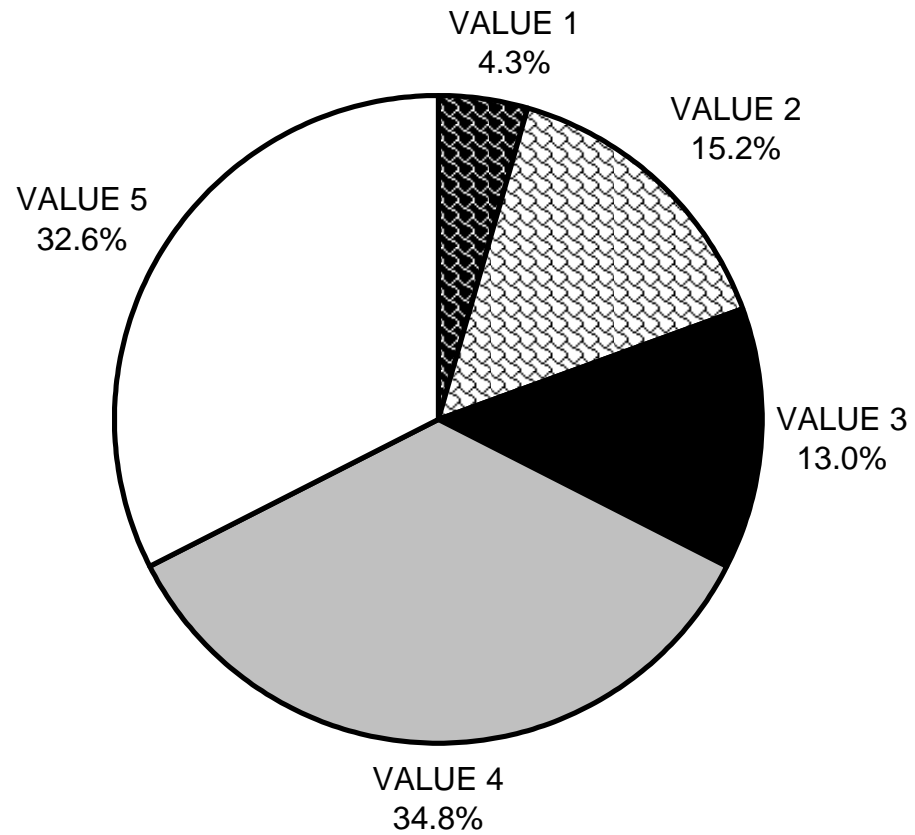
GRAPH 6

The depth of cobble embeddedness was estimated at pool tail-outs. Of the 46 pool tail-outs measured, 2 had a value of 1 (4.3%); 7 had a value of 2 (15.2%); 6 had a value of 3 (13%); 15 had a value of 4 (34.8%); 16 had a value of 5 (32.6%) (Graph 6). On this scale, a value of 1 indicates the best spawning conditions and a value of 4 the worst. Additionally, a value of 5 was assigned to tail-outs deemed unsuited for spawning due to inappropriate substrate such as bedrock, log sills, boulders, or other considerations.

Nine of the 46 pool tail-outs measured had embeddedness ratings of 1 or 2. Twenty-one of the pool tail-outs had embeddedness ratings of 3 or 4. Sixteen of the pool tail-outs had a rating of 5, which is considered unsuitable for spawning. Cobble embeddedness measured to be 25% or less, a rating of 1, is considered to indicate good quality spawning substrate for salmon and steelhead. Sediment sources in Virgin Creek should be mapped and rated according to their potential sediment yields, and control measures should be taken.

VIRGIN CREEK 2008 PERCENT EMBEDDEDNESS

- 4) Active and potential sediment sources related to the road system need to be identified, mapped, and treated according to their potential for sediment yield to the stream and its tributaries.

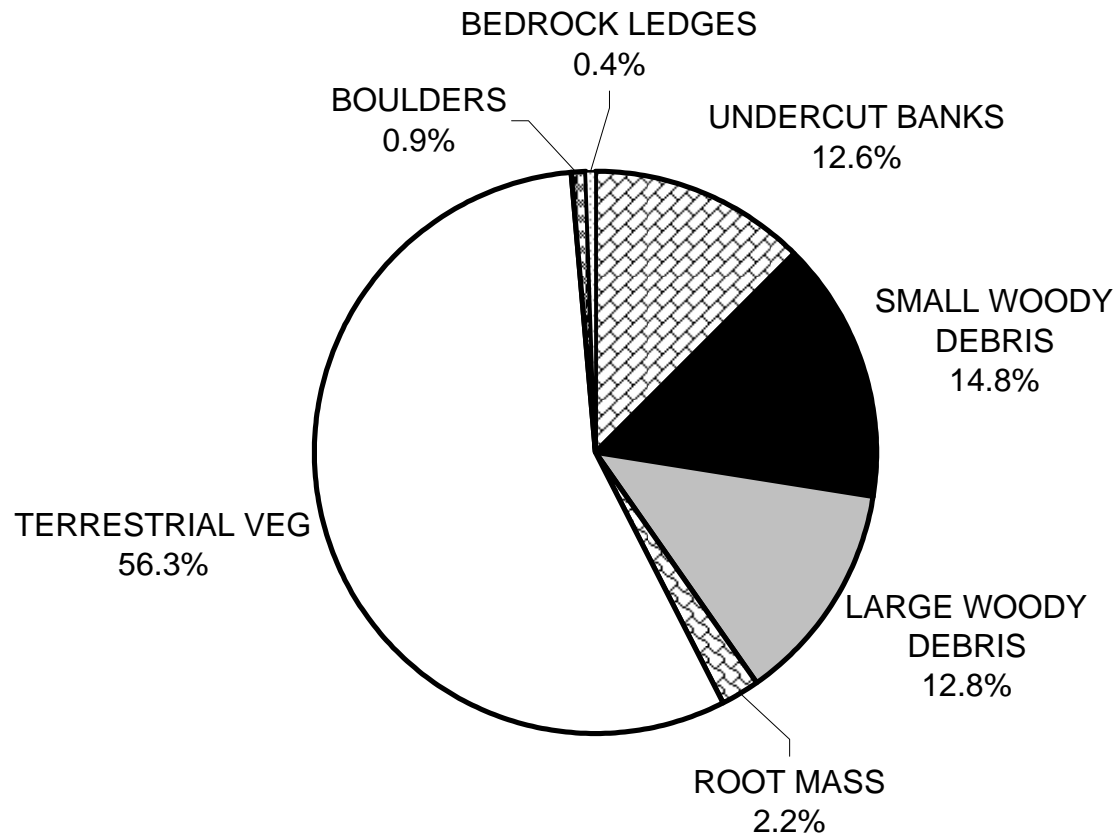
GRAPH 7

Table 5 summarizes mean percent cover by habitat type. Terrestrial vegetation is the dominant cover type in Virgin Creek. Graph 7 describes the pool cover in Virgin Creek. Terrestrial vegetation is the dominant pool cover type followed by small woody debris.

The mean shelter rating for pools was 30. The shelter rating in the flatwater habitats was 64. A pool shelter rating of approximately 100 is desirable. The amount of cover that now exists is being provided primarily by terrestrial vegetation in Virgin Creek. Terrestrial vegetation is the dominant cover type in pools followed by small woody debris. Log and root wad cover structures in the pool and flatwater habitats would enhance both summer and winter salmonid habitat. Log cover structure provides rearing fry with protection from predation, rest from water velocity, and also divides territorial units to reduce density related competition.

VIRGIN CREEK 2008 MEAN PERCENT COVER TYPES IN POOLS

- 3) Increase woody cover in the pools and flatwater habitat units. Most of the existing cover in the pools is from terrestrial vegetation. Adding high quality complexity with woody cover in the pools is desirable.

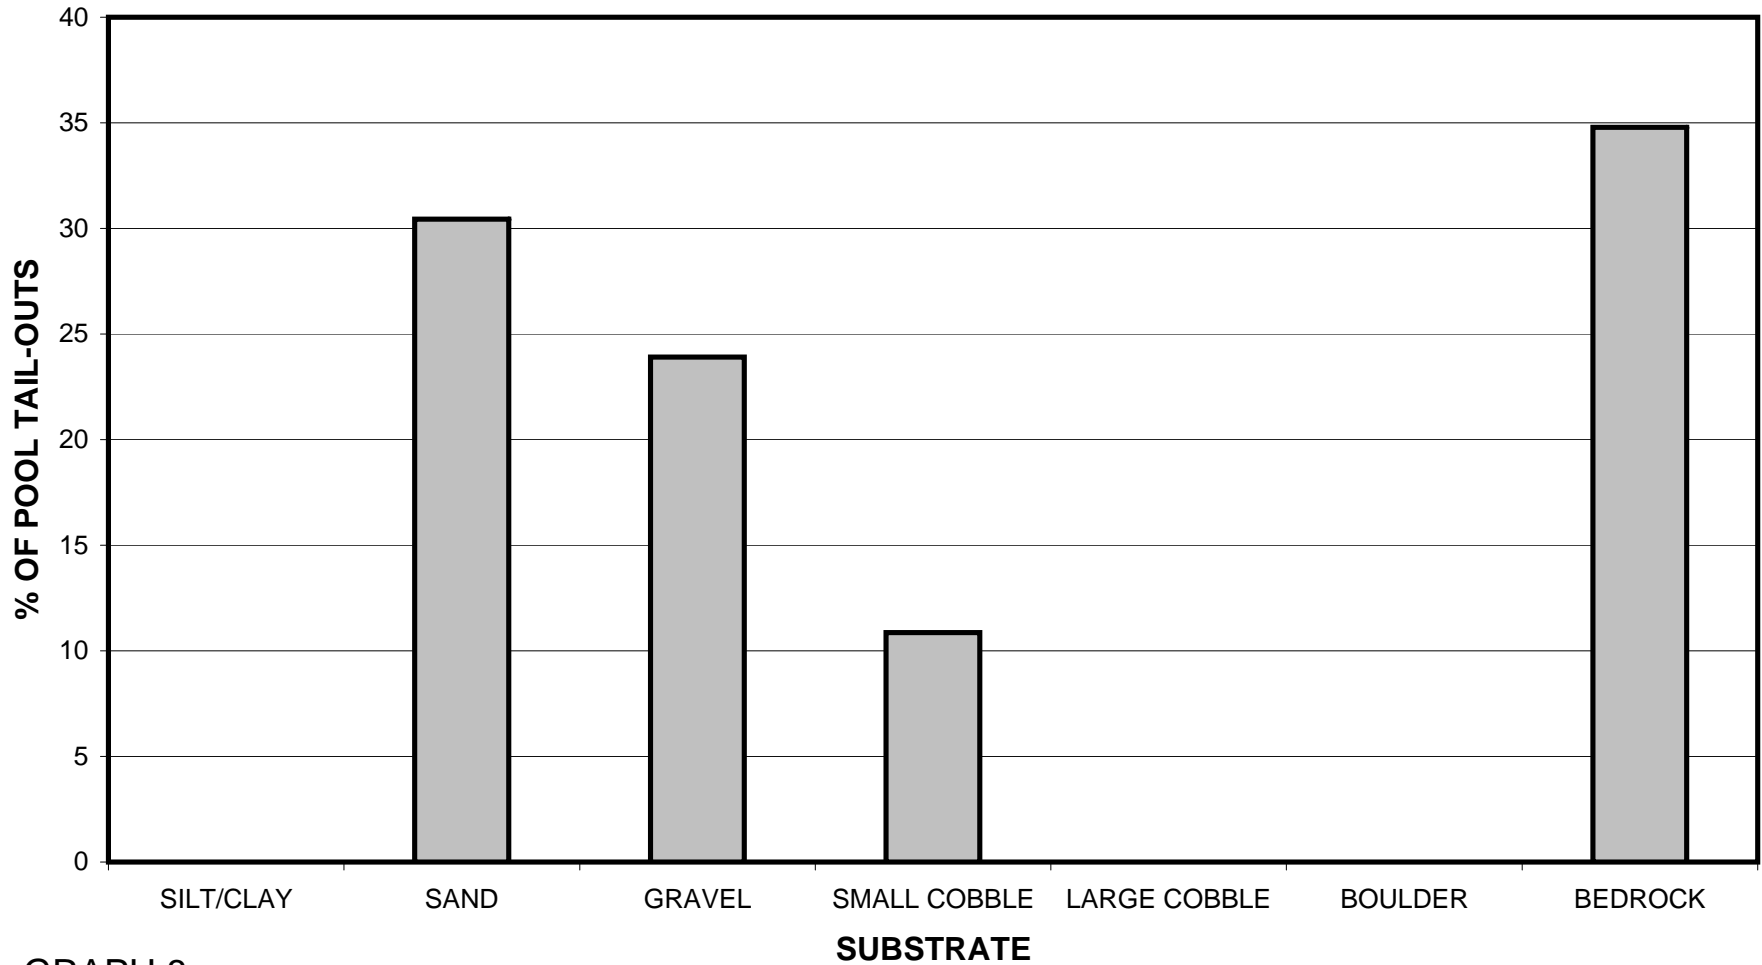
GRAPH 8

Table 6 summarizes the dominant substrate by habitat type. Graph 8 depicts the dominant substrate observed in pool tail-outs. Bedrock was the dominant substrate observed in 35% of the pool tail-outs. Sand was the next most frequently observed dominant substrate type and occurred in 31% of pool the tail-outs.

Thirty of the 46 pool tail-outs had silt, sand, large cobble, boulders or bedrock as the dominant substrate. This is generally considered unsuitable for spawning salmonids.

VIRGIN CREEK 2008 SUBSTRATE COMPOSITION IN POOL TAIL-OUTS

- 5) Suitable size spawning substrate on Virgin Creek is limited to relatively few reaches. Projects should be designed at suitable sites to trap and sort spawning gravel.
