THIRD ANNUAL RESTORATION MONITORING REPORT (YEAR 3)

SOUZA II RESTORATION PROJECT
CONTRA COSTA COUNTY, CALIFORNIA

DECEMBER 2012

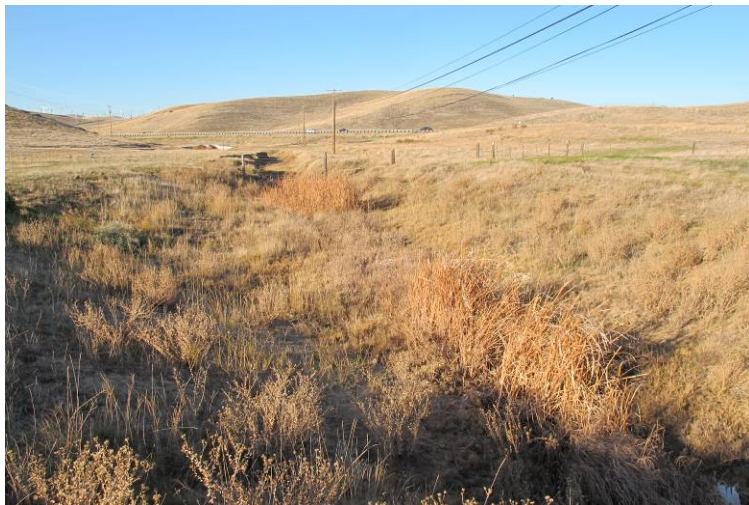
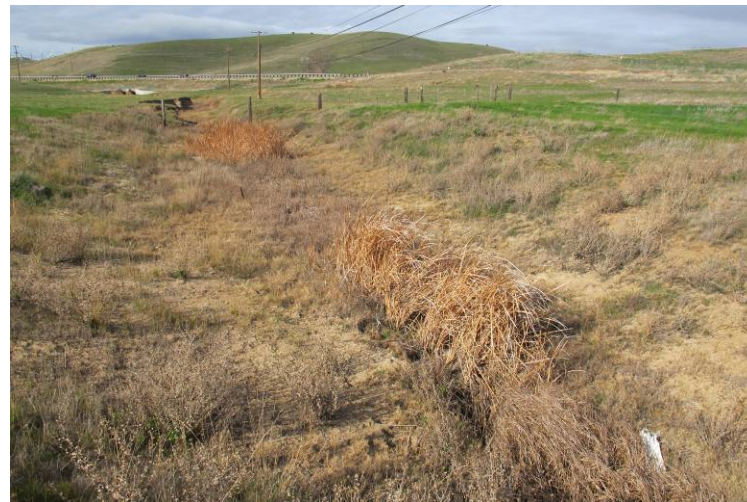
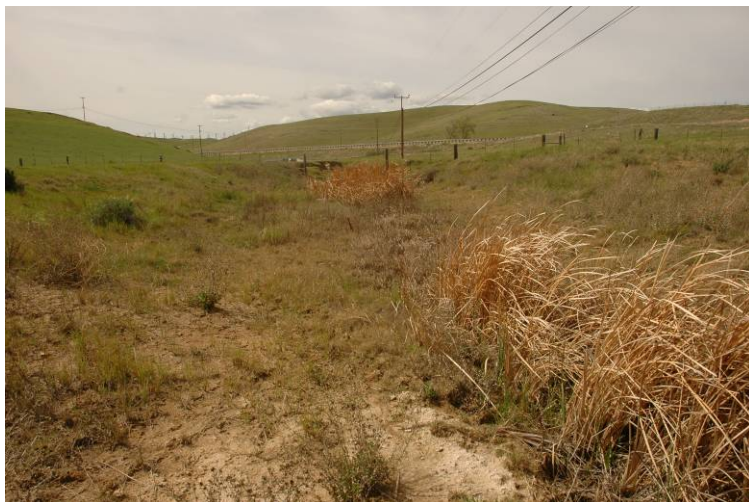
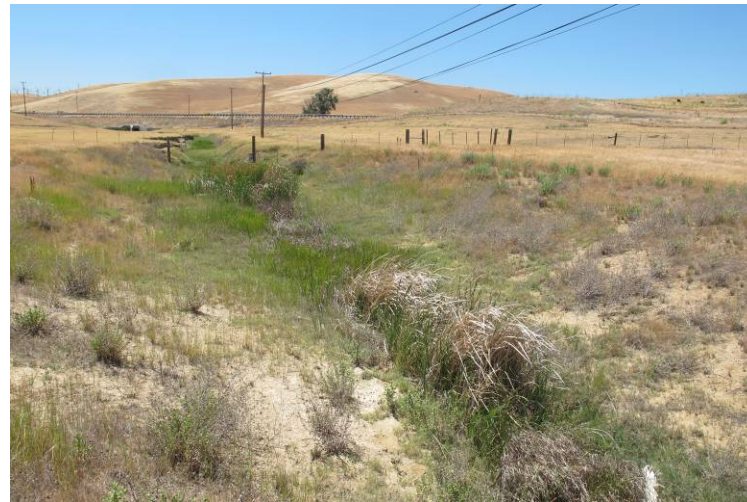
Photo Point D: West end of creek at rock weir

Water was not observed ponded behind the rock weirs that are in the channel but that is likely due to low rainfall as it has been observed ponding here in the past. Ponding was visible in the western-most portion of the tributary, at its upstream end (Photo Points D and E in Appendix B).

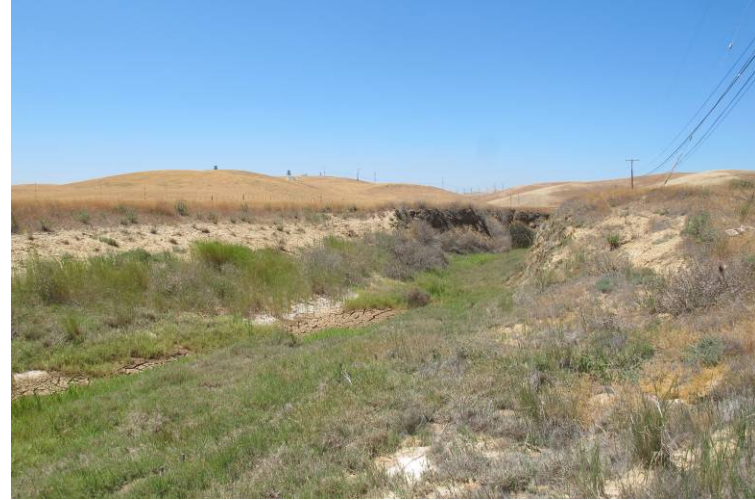
Photo Point I: Erosion monitoring

In most areas where the bank was laid back, the bank is vegetating with dense stands of saltgrass, creeping wildrye, and other vegetation (Photo Point I in Appendix B). A few areas had sparser vegetation with small amounts of erosion occurring including rills that were several inches wide (Photo Point K in Appendix B). Overall, erosion on these banks has decreased as the vegetation has become established. Areas on laid back slopes that are bare will be planted with saltgrass transplants in December 2012. Recommendations to control erosion on site are made in Section 4.

In some areas where the bank was laid back, the banks are unvegetated and erosion is occurring. We recommend continued planting of saltgrass plugs to armor the banks. The large erosional feature is scheduled for repair in 2012.

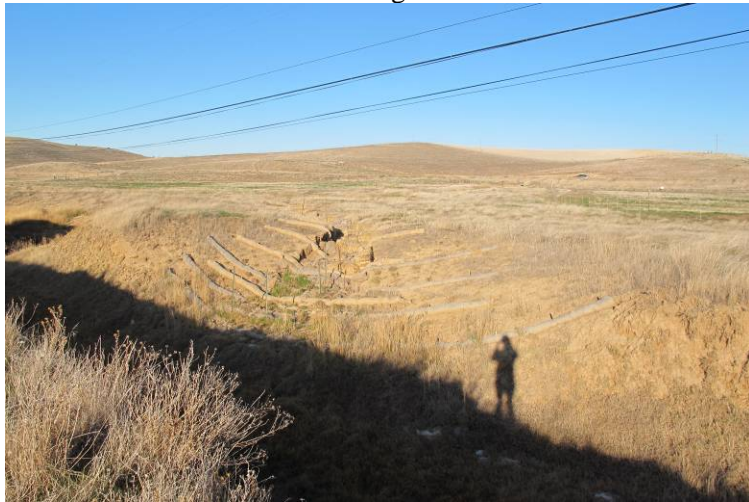
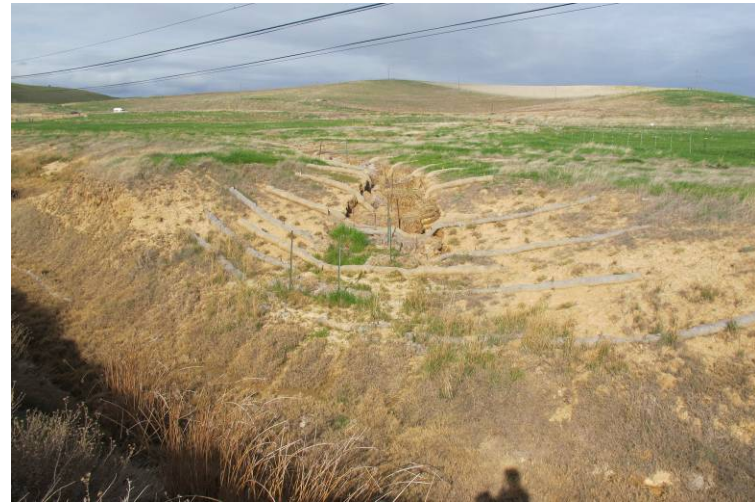
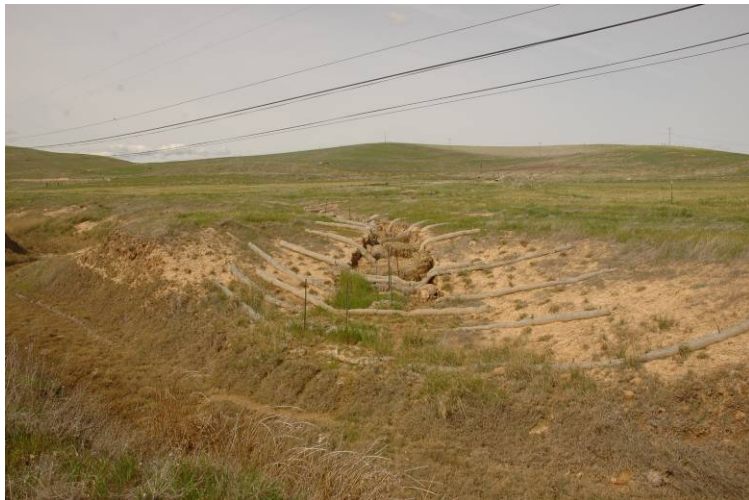
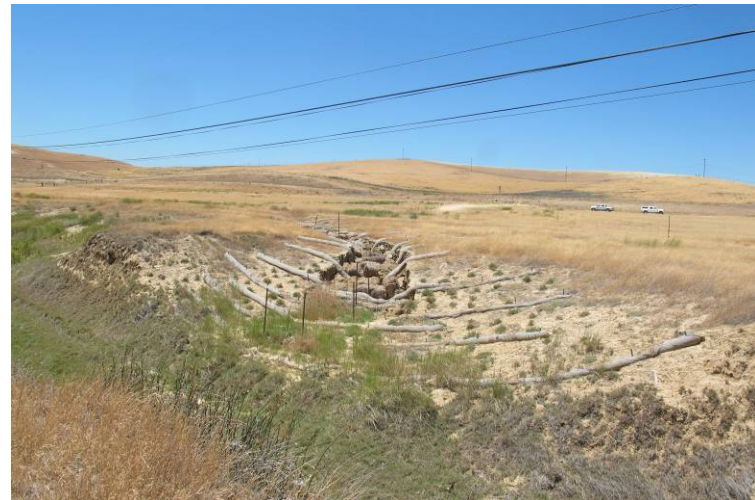
Photo Point J: Erosion monitoring

A large headcut, several feet wide and several feet deep, is present where the drainage joins the main unnamed tributary to Brushy Creek (Photo Point J in Appendix B). This erosional feature was present during Year 1 and 2 of monitoring and temporarily repaired in fall 2010 and 2011 by placing straw bales and straw wattles in the gully, however the headcut needs a permanent repair. During monitoring visits, the straw bales had silt pooled behind them upstream which shows they captured some sediment from the flowing water before it flowed into the creek. The portion of the drainage above the sediment basin is not eroding, only the portion downstream of the sediment basin is eroding.

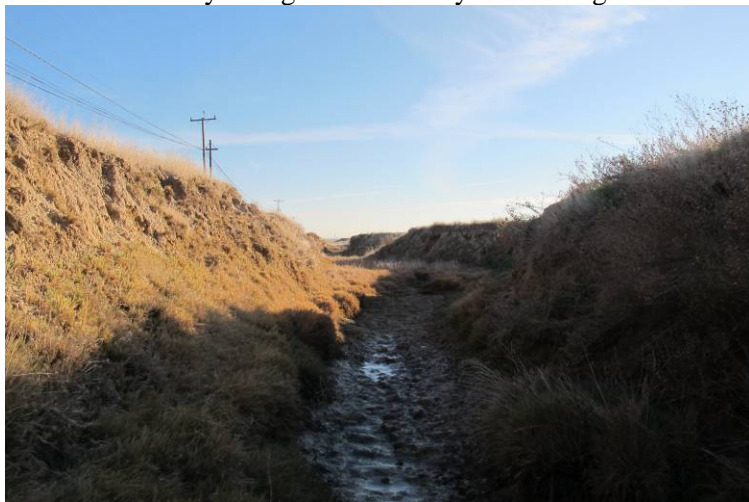
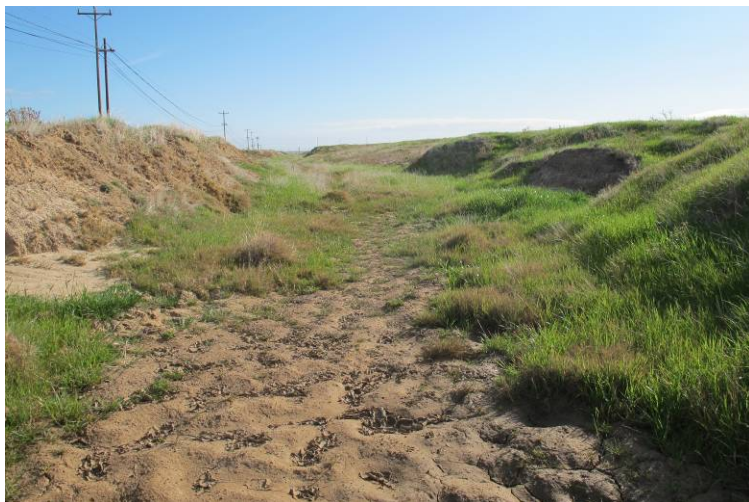
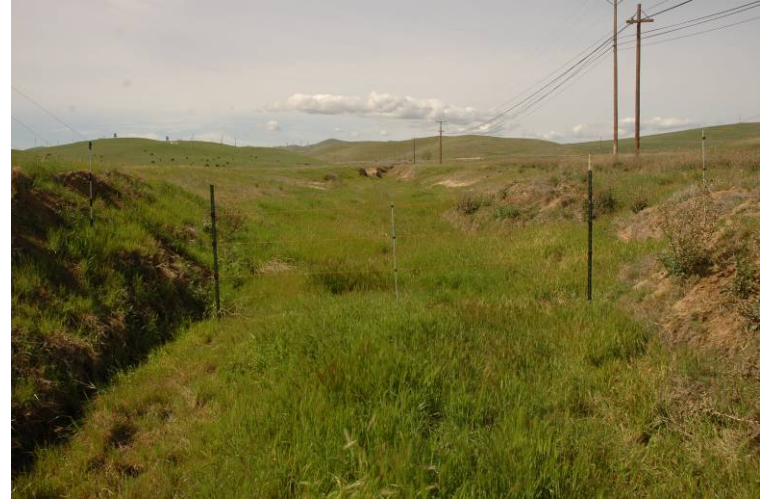
Photo Point L: Hydrologic connectivity monitoring

Hydrologic connectivity monitoring occurred at all site visits in 2012 (Photo points L, M, and N in Appendix B). Water did not flow over the constructed overflow into the northern wetland complex at any time in winter 2011-2012. In 2011 after a large storm in late March, water was observed flowing over the constructed overflow and into the northern wetland complex, however water overtopped the creek banks in other places and overtopped the northern wetland at the northeast corner, which shows how much water was flowing on site (Nomad 2011). Lowering the constructed overflow in elevation would result in water overflowing into the northern wetland complex more frequently and in a normal rain event, and not only during a large storm event like in March 2011.
