**YEAR ONE
CREATED WETLANDS MONITORING REPORT
EAST CONTRA COSTA COUNTY
HABITAT CONSERVANCY
UPPER HESS CREEK RESTORATION PROJECT
EAST CONTRA COSTA COUNTY, CALIFORNIA**

February 4, 2013

Monk & Associates, Inc.
1136 Saranap Avenue, Suite Q
Walnut Creek, California
(925) 947-4867

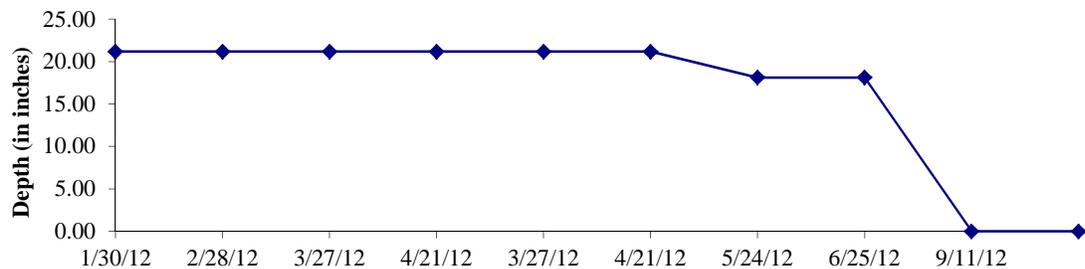
Figure 6. Monthly Maximum Water Depths (Inches) in the Stock Pond

The Main Stock Pond remained inundated throughout the year and was observed holding greater than 48 inches of water in the deepest locations well into September 2012 (Figure 6; this figure shows staff gauge depths from the southern-most portion of the pond, not the deepest portion). Seacoast bulrush (*Bolboschoenus robustus*) (OBL) (native) grows along the upper channel leading into the Main Stock Pond and this species also occurs along the pond's edges. Owing to vegetation colonization suppression from long-term inundation in the Main Stock Pond, it is likely that only the edges of the pond will colonize with vegetation although it is conceivable that seacoast bulrush could become more dominant in future years. The Main Stock Pond's wetland fringe supported a dominance of OBL and FACW vegetation. Boccone's sand-spurrey (FACW) (non-native), rabbit's foot grass (*Polypogon monspilensis*) (non-native) (FACW), and meadow barley (FACW) (native) were all dominant along the pond margin throughout the monitoring season. As the pond dried down over the course of the monitoring season, exposed areas to an extent also colonized with hydrophytic species.

Water depths recorded in the main stock pond are based on staff gauge readings made from a gauge installed in the southern portion of the pond - not the deepest portion of the pond which is at least 5 feet deep or more. The deepest portion of the pond held water throughout 2012.

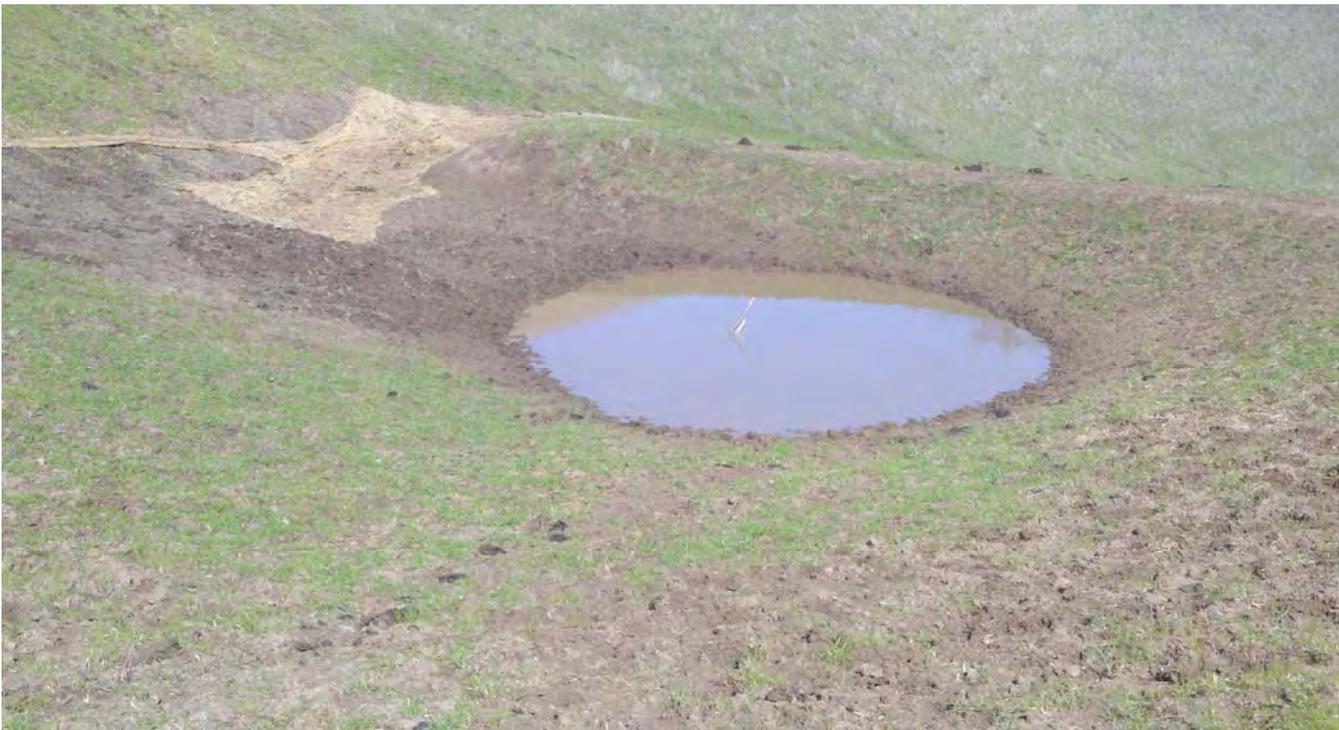
Photograph #6. CTS Pond on March 23, 2012. Pond is approximately 15 inches deep. Staff gauge bent over from cattle rubbing up against it. Pond has not reached capacity and spilled.

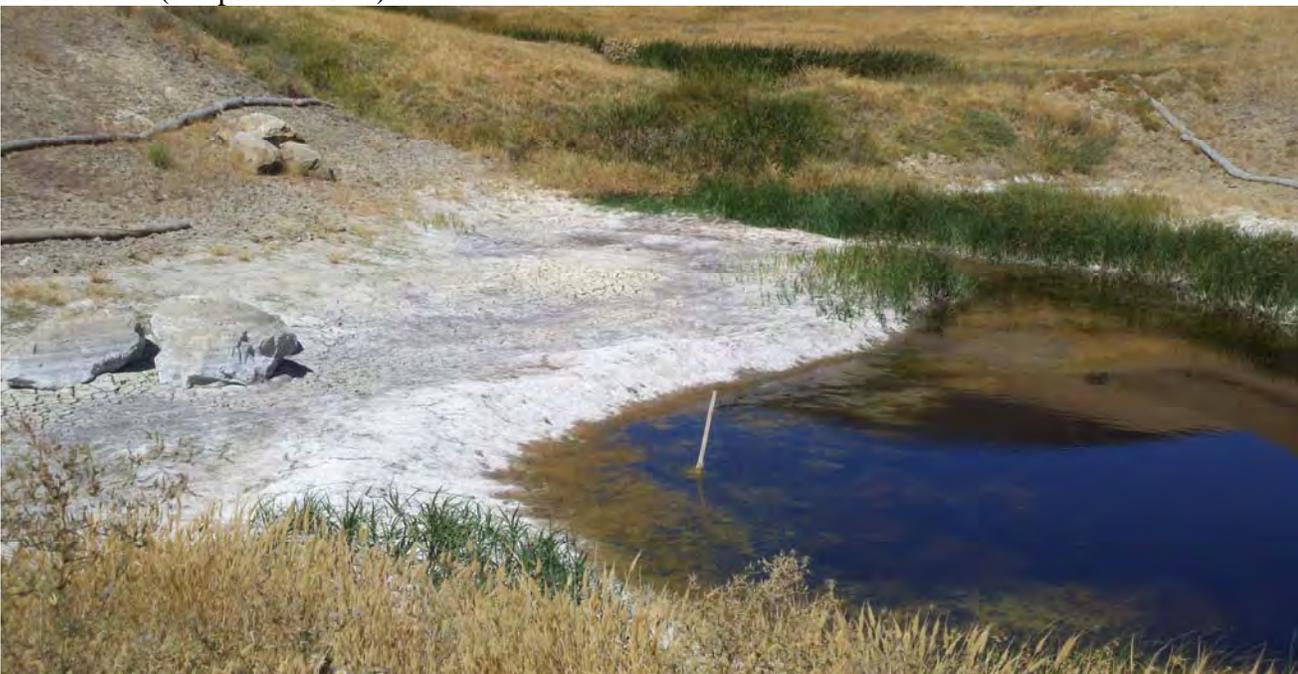
Photograph #10. Looking northwest at the Main Stock Pond on September 11, 2012. This photograph shows the exposed western bank, with water drawn down below the rocks, and a t-post (installation date unknown – prior to site restoration) that is typically under water near the deepest portion of the pond.

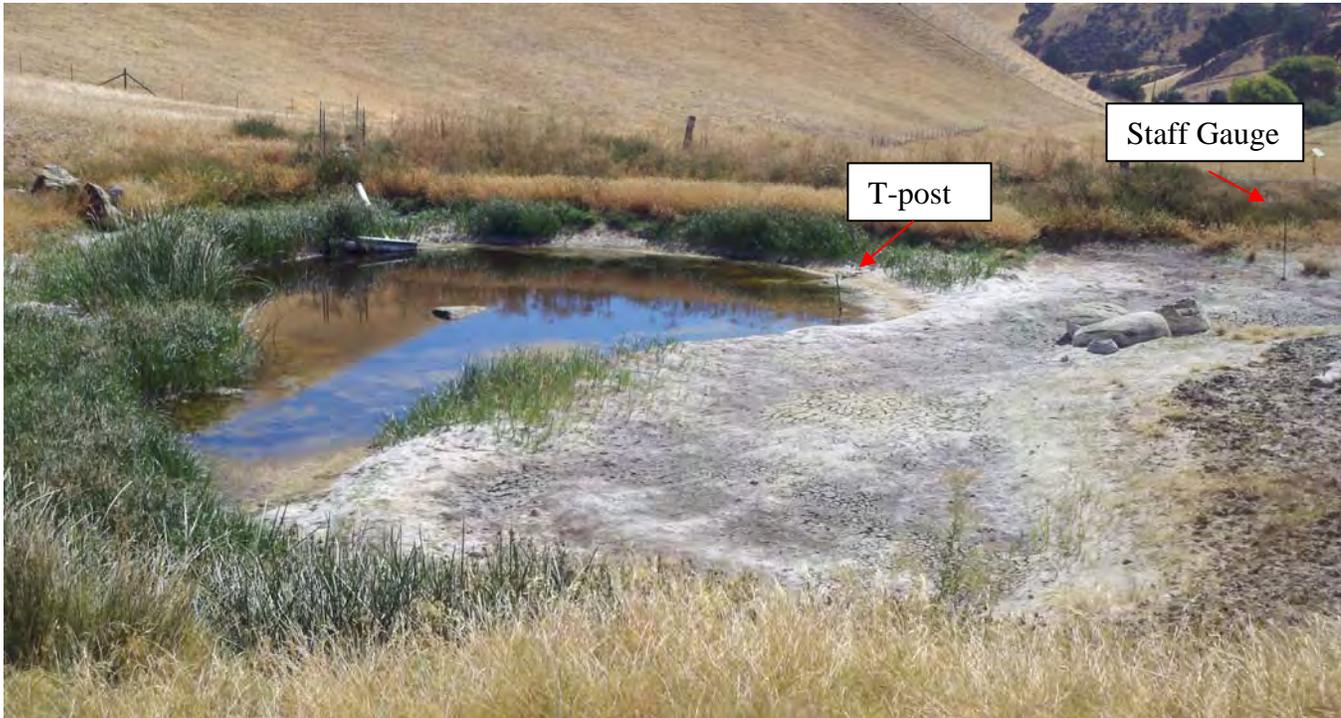
Photograph #11. Main Stock Pond looking southeast on September 11, 2012 showing pond draw down. The exposed t-post was an opportunity for M&A to install a second, 3 1/2-foot staff gauge in the pond. With the first rains of the 2012-2013 season, the newly installed staff gauge at this t-post was completely submerged.

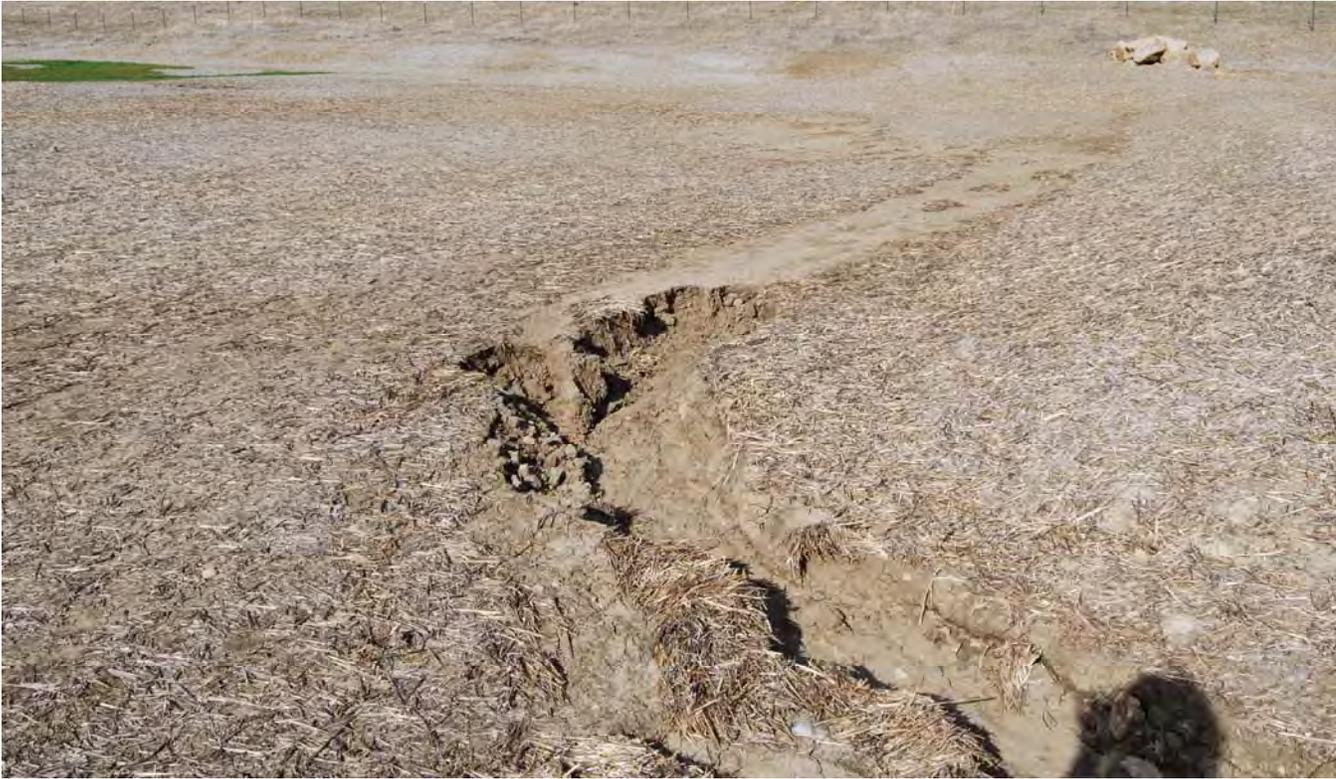
Photograph #13. January 30, 2012. Lower portion of the Alluvial Valley Wetlands leading to the Lower Channel near the property's eastern boundary. This photo shows head-cutting coming up the Lower Channel.

Balance staff considered the time allotted to complete the rehabilitation, the project budget, and the assumed quantity of materials on-site to create a design to improve conditions surrounding the upstream-most boulder structure. The concept involved mining the project site for large boulders and using them to construct an additional course of rock above the existing top course to raise the structure by approximately 1-foot. Imported Rock Slope Protection (RSP) facing and Class 2 Aggregate Base (AB) would be used to chink the voids of the added boulders, and to provide further armoring to the existing face of the structure. The right bank would be built up to prevent the structure from being undermined by flows from the side. All remaining materials would then be used to create a second drop upstream of the boulder structure to achieve the final 1.3 feet to stabilize the existing head cut in the wetland.

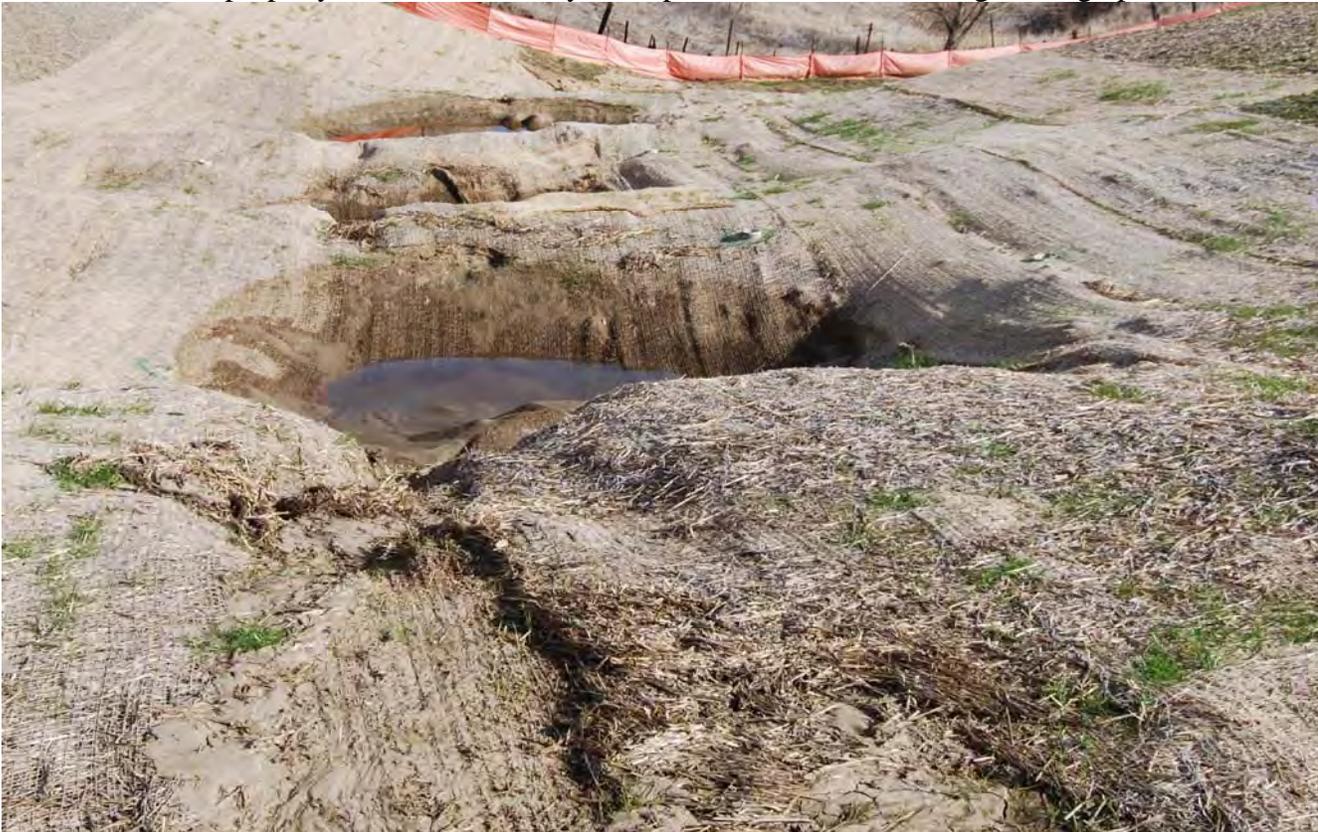
Photograph #14. Lower Channel on January 30, 2012. This channel is immediately below the head-cutting shown in Photograph #13 above.

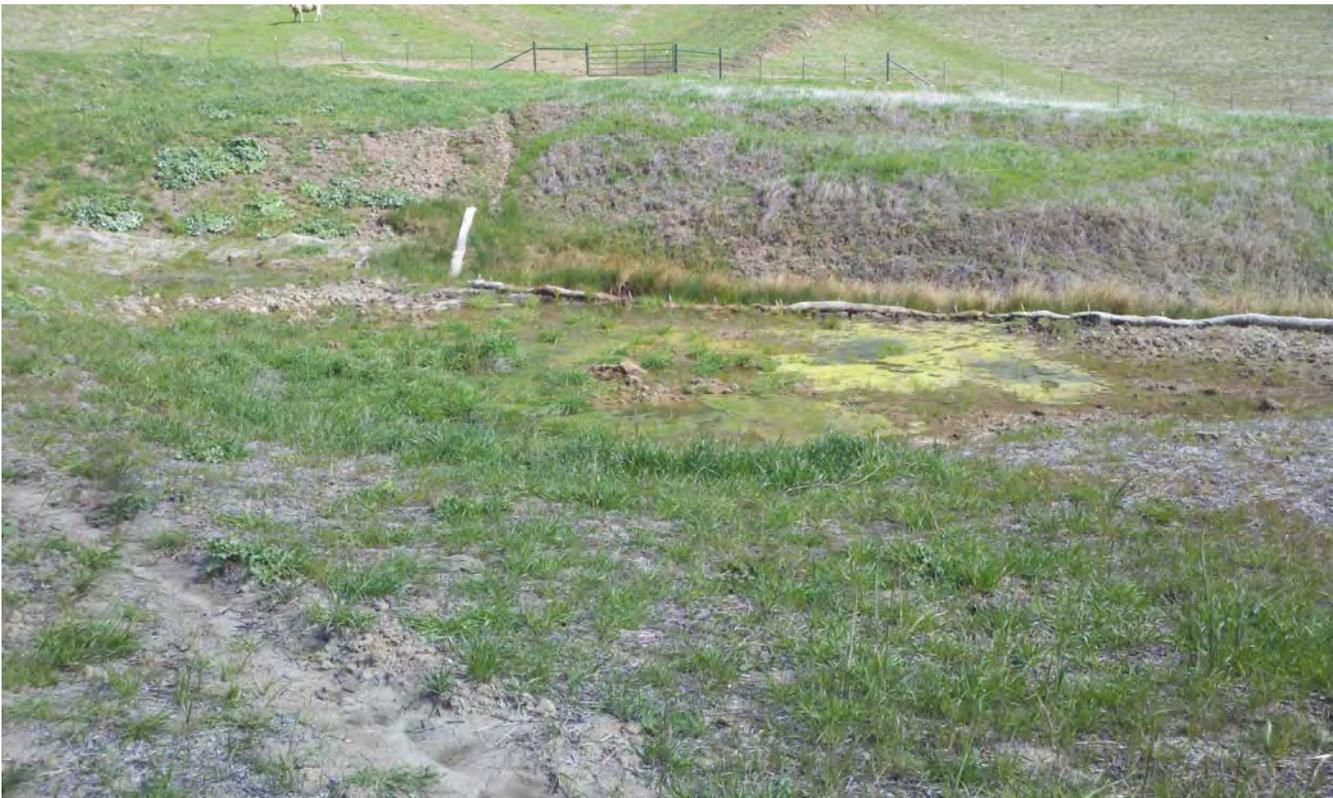
Photograph #16. March 23, 2012 photograph of the Channel Restoration Area above the Main Stock Pond. Photo looking northeast. This photo shows ponding water and wetland vegetation establishing. No signs of erosion.

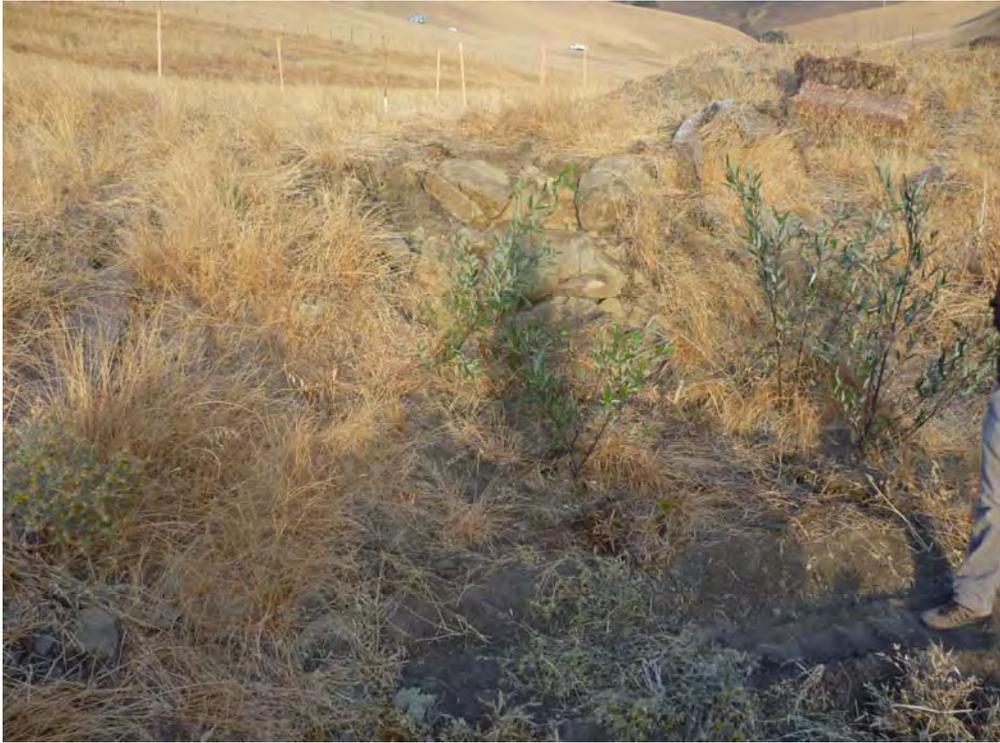
Before:

The first day of observed construction involved exploration activities to determine the extents of the existing boulders. The excavation around the existing structure showed that the boulder structure was not keyed into the left and right banks. Furthermore, there were no boulders that were found at the toe of the structure within the downstream pool. We were able to salvage several large boulders from the existing stock pile, but no material from the structure itself. And after backfilling and compacting the exploration pit at the toe of the structure, the Contractor ended the day by starting to excavate a shelf above the top row of boulders.
