# STREAM INVENTORY REPORT

## Barber Creek

A stream inventory was conducted from July 22 to July 28, 2008 on Barber Creek. The survey began at the confluence with Eel River and extended upstream 2.5 miles.

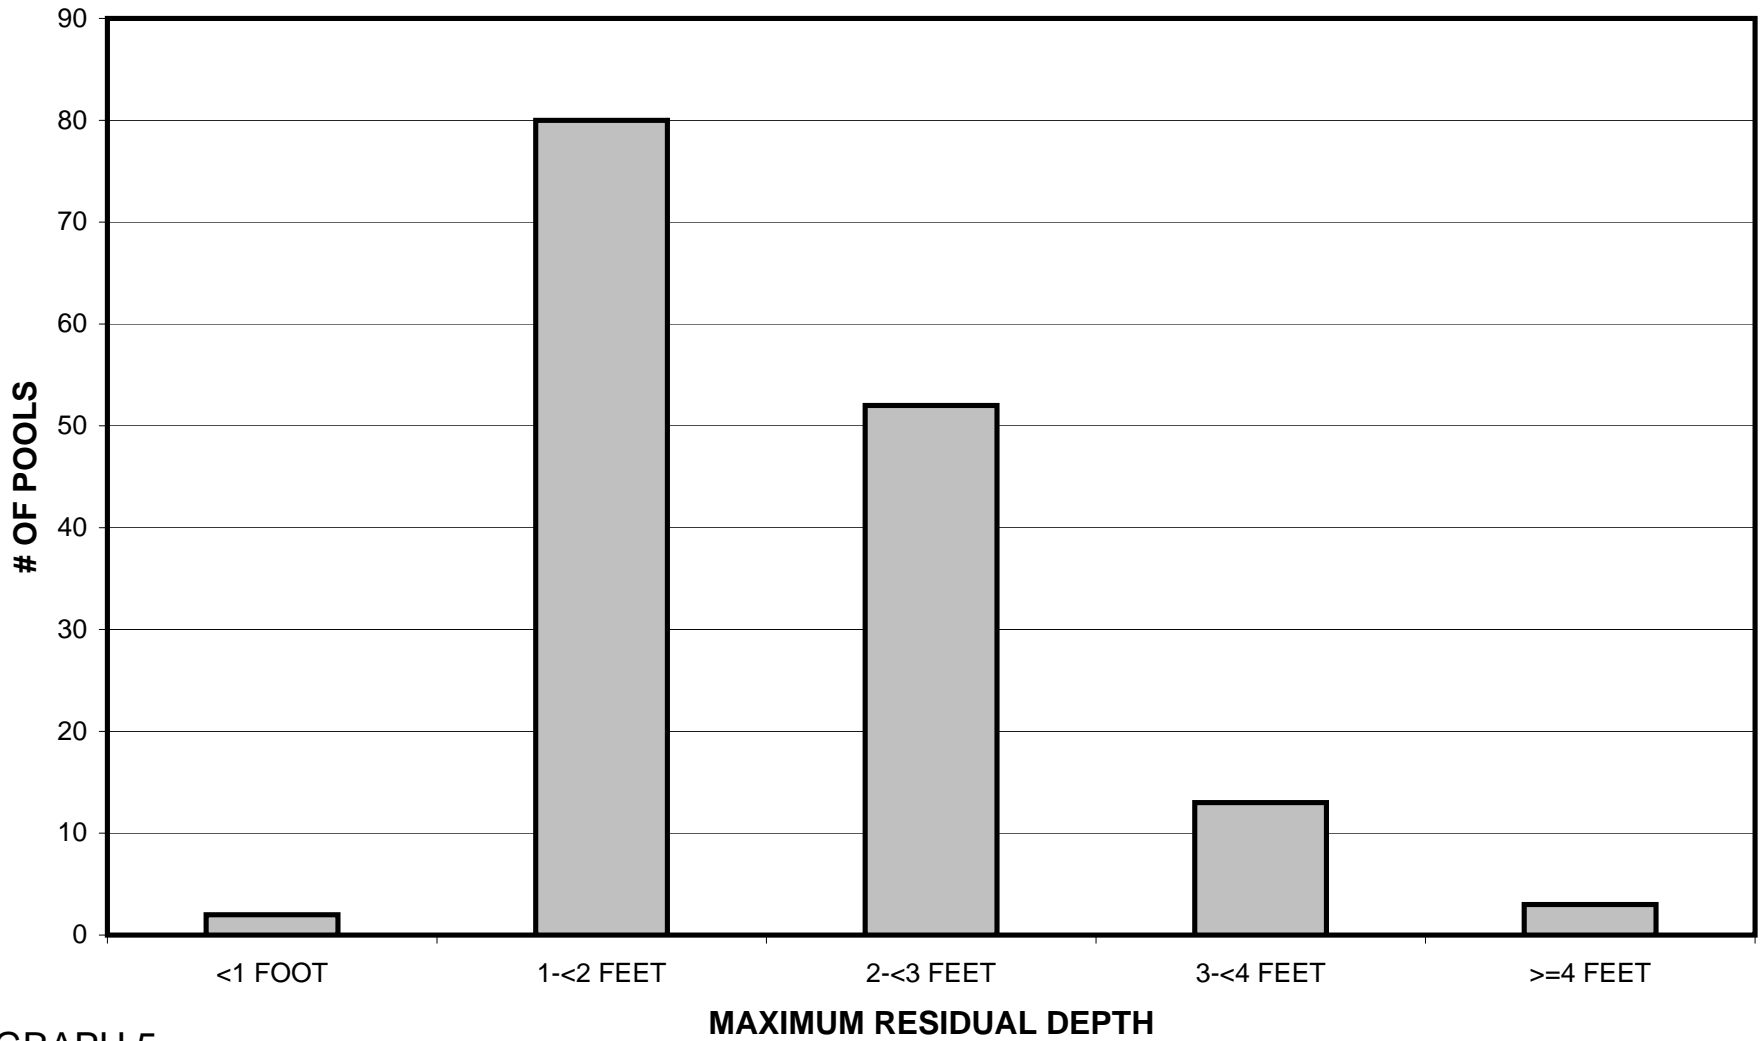
GRAPH 5

Table 4 is a summary of maximum residual pool depths by pool habitat types. Pool quality for salmonids increases with depth. Sixty-eight of the 150 pools (45%) had a residual depth of two feet or greater (Graph 5).

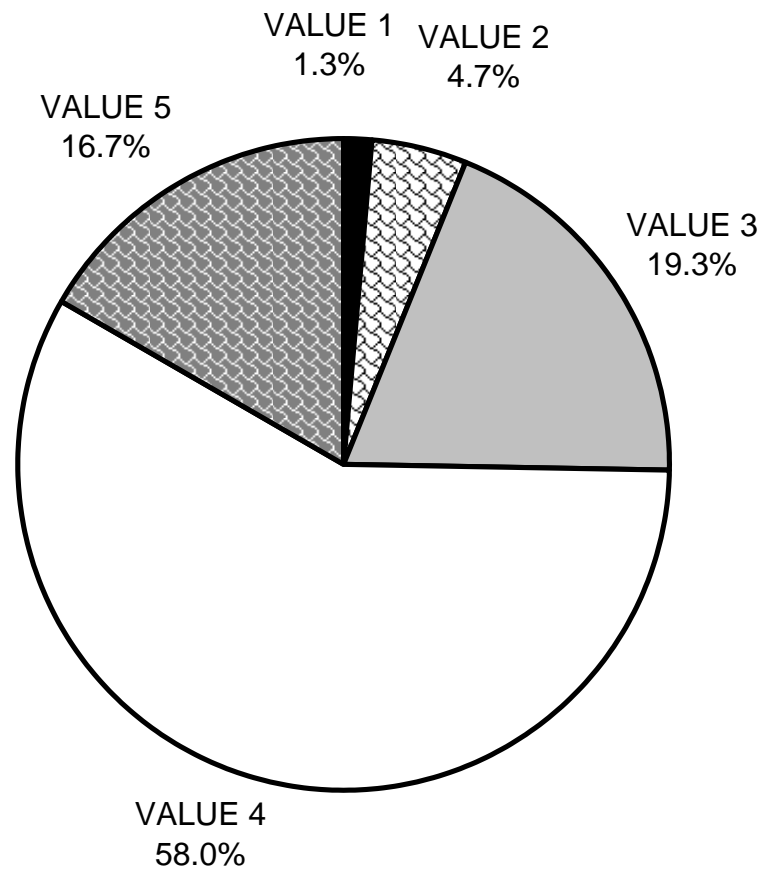
GRAPH 6

The depth of cobble embeddedness was estimated at pool tail-outs. Of the 150 pool tail-outs measured, 2 had a value of 1 (1.3%); 7 had a value of 2 (4.7%); 29 had a value of 3 (19.3%); 87 had a value of 4 (58%); 25 had a value of 5 (16.7%) (Graph 6). On this scale, a value of 1 indicates the best spawning conditions and a value of 4 the worst. Additionally, a value of 5 was assigned to tail-outs deemed unsuited for spawning due to inappropriate substrate such as bedrock, log sills, boulders, or other considerations.

Nine of the 150 pool tail-outs measured had embeddedness ratings of 1 or 2. One hundred sixteen of the pool tail-outs had embeddedness ratings of 3 or 4. Twenty-five of the pool tail-outs had a rating of 5, which is considered unsuitable for spawning. Cobble embeddedness measured to be 25% or less, a rating of 1, is considered to indicate good quality spawning substrate for salmon and steelhead. Sediment sources in Barber Creek should be mapped and rated according to their potential sediment yields, and control measures should be taken.

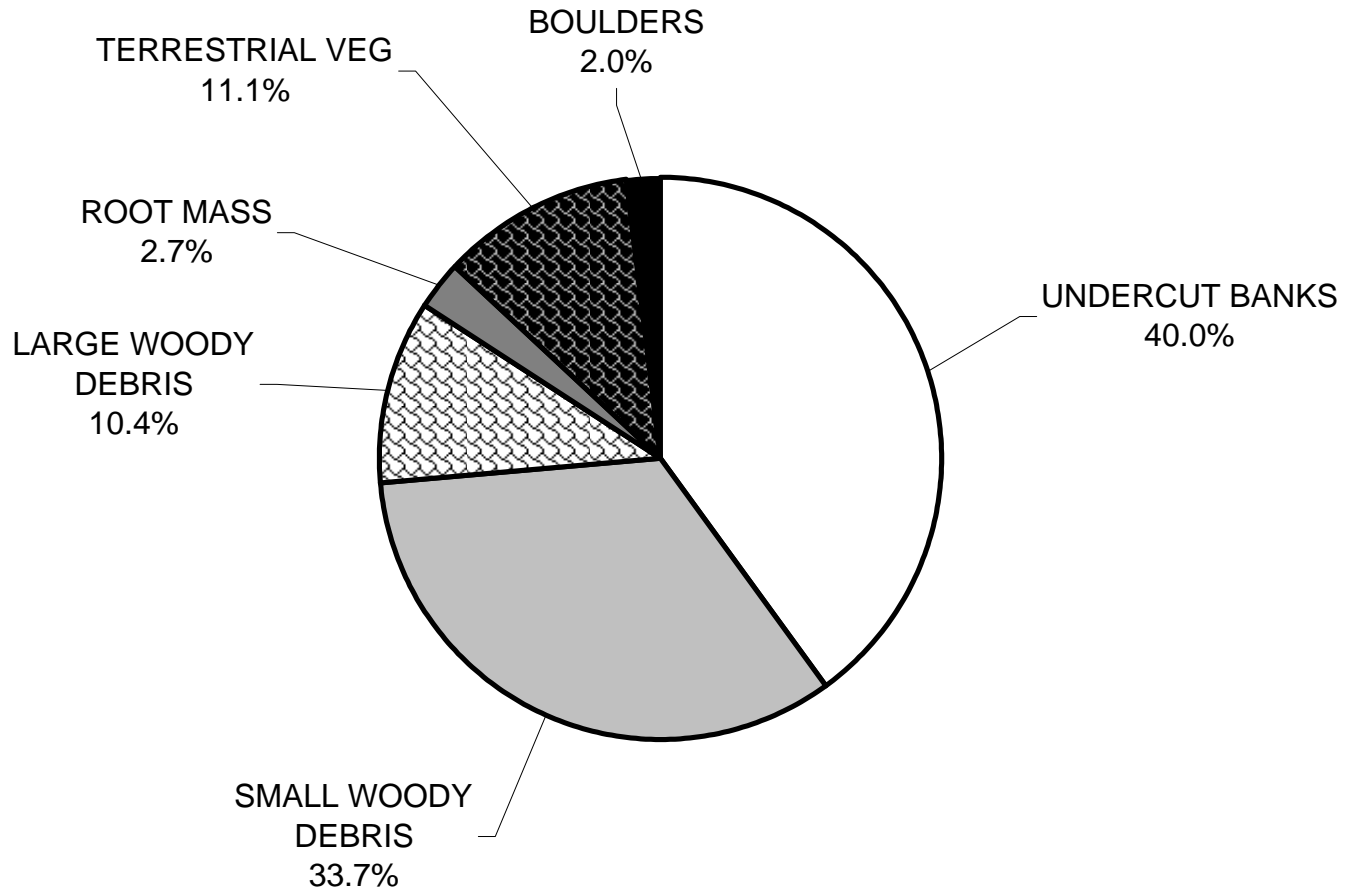
GRAPH 7

Table 5 summarizes mean percent cover by habitat type. Undercut banks are the dominant cover type in Barber Creek. Graph 7 describes the pool cover in Barber Creek. Undercut banks are the dominant pool cover type followed by small woody debris.

- 5) Increase woody cover in the pools and flatwater habitat units. Most of the existing cover in the pools is from undercut banks. Adding high quality complexity with woody cover in the pools is desirable.

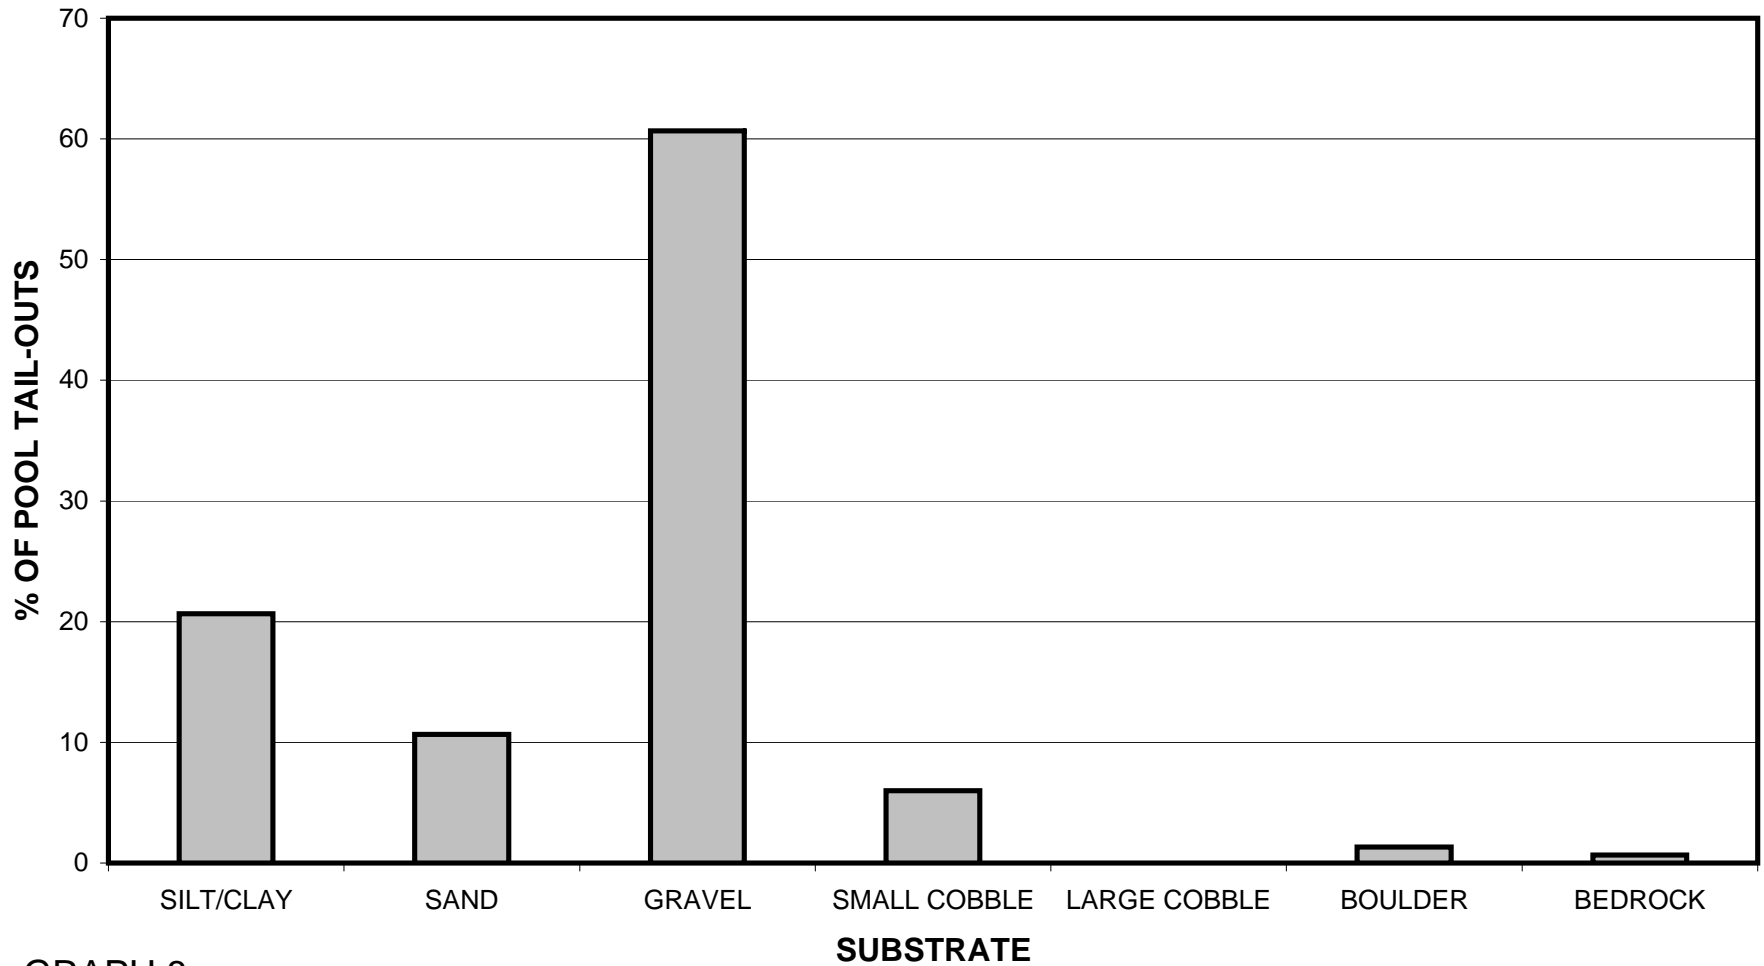
GRAPH 8

Table 6 summarizes the dominant substrate by habitat type. Graph 8 depicts the dominant substrate observed in pool tail-outs. Gravel was the dominant substrate observed in 61% of the pool tail-outs. Silt/clay was the next most frequently observed dominant substrate type and occurred in 21% of the pool tail-outs.

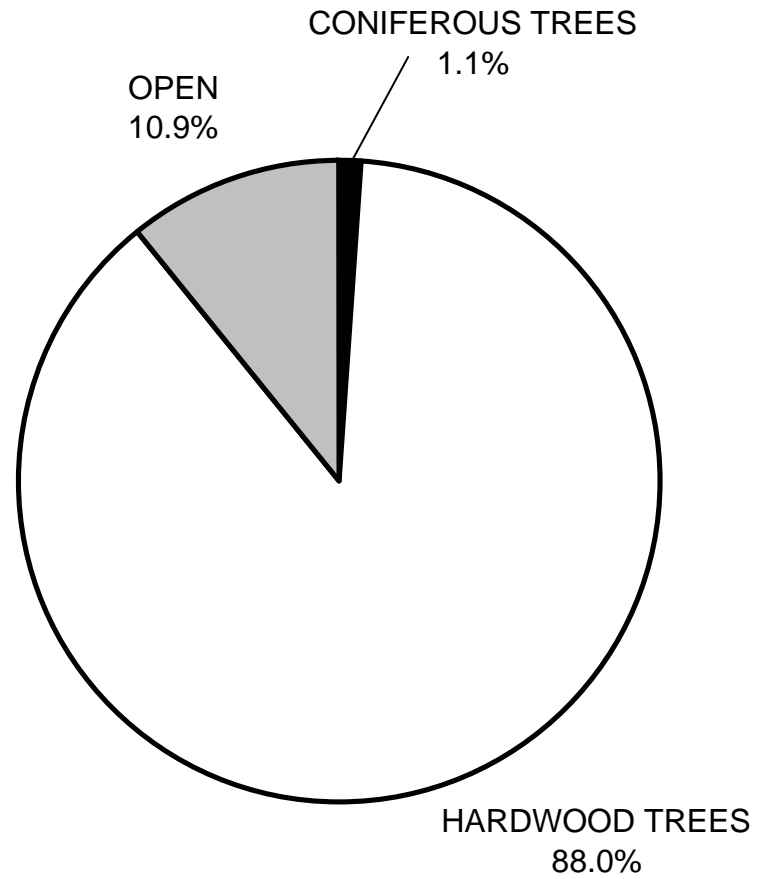
GRAPH 9

The mean percent canopy density for the surveyed length of Barber Creek was 89%. Eleven percent of the canopy was open. Of the canopy present, the mean percentages of hardwood and coniferous trees were 99% and 1%, respectively. Graph 9 describes the mean percent canopy in Barber Creek.

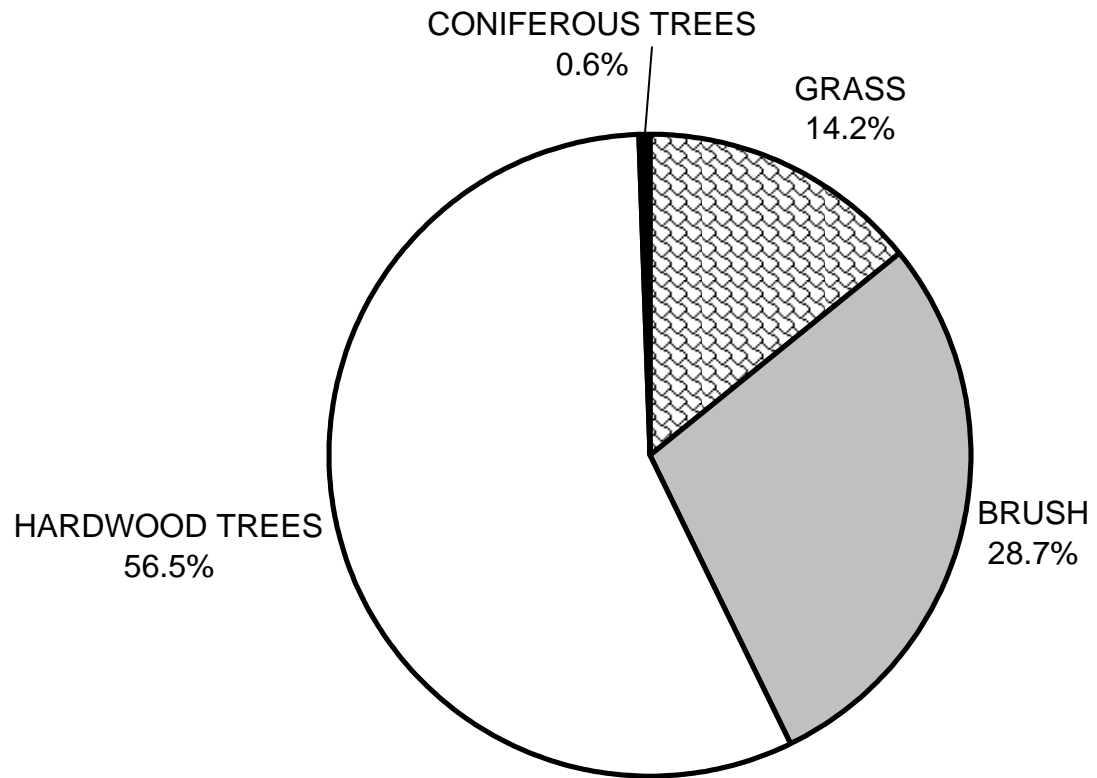
GRAPH 11

For the stream reach surveyed, the mean percent right bank vegetated was 95%. The mean percent left bank vegetated was 94%. The dominant elements composing the structure of the stream banks consisted of 97% sand/silt/clay, 1% bedrock, 1% boulder, and 1% cobble/gravel (Graph 10). Deciduous trees were the dominant vegetation type observed in 57% of the units surveyed. Additionally, 29% of the units surveyed had brush as the dominant vegetation type, and 14% had grass as the dominant vegetation type (Graph 11).

The percentage of right and left bank covered with vegetation was 95% and 94%, respectively. In areas of stream bank erosion or where bank vegetation is sparse, planting endemic species of coniferous and hardwood trees, in conjunction with bank stabilization, is recommended.
