STREAM INVENTORY REPORT

Cahto Creek

A stream inventory was conducted from July 14, 2009 to July 27, 2009 on Cahto Creek. The survey began at the confluence with Tenmile Creek and extended upstream 3.1 miles.

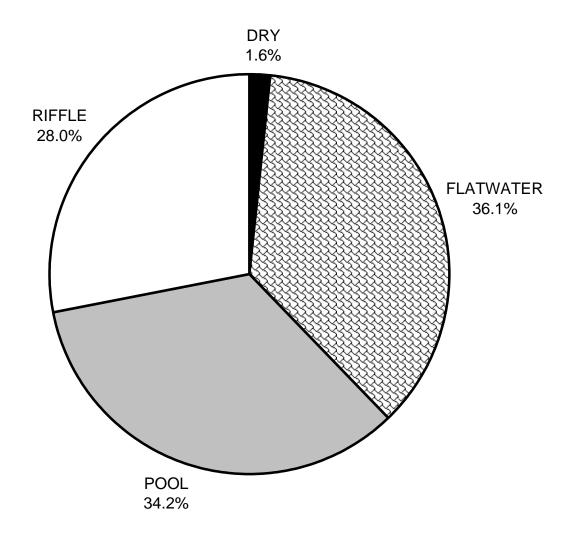
CAHTO CREEK 2009 HABITAT TYPES BY PERCENT OCCURRENCE

Table 1 summarizes the Level II riffle, flatwater, and pool habitat types. Based on frequency of occurrence there were 36% flatwater units, 34% pool units, and 28% riffle units (Graph 1). Based on total length of Level II habitat types there were 40% pool units, and 37% flatwater units, 21% riffle units (Graph 2).

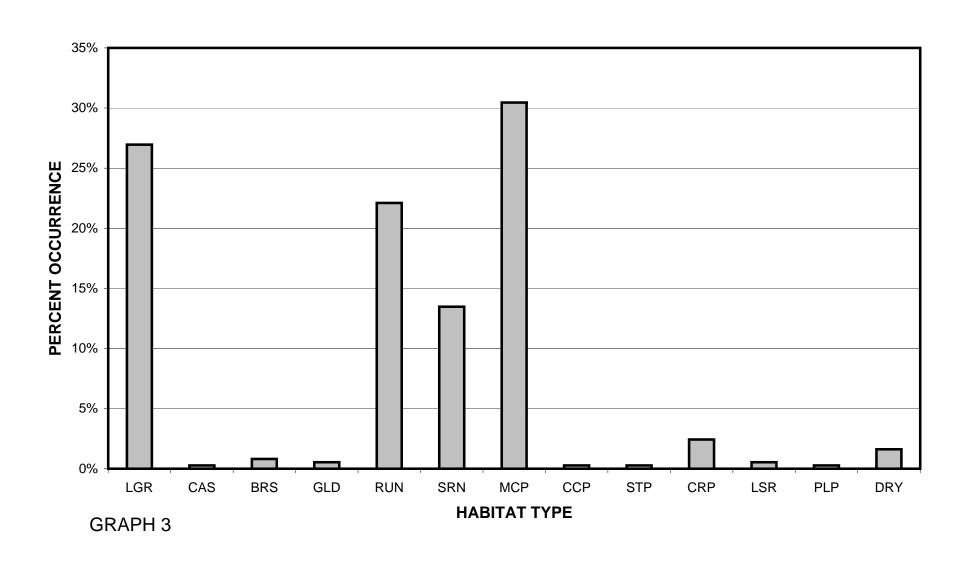
CAHTO CREEK 2009 HABITAT TYPES BY PERCENT OCCURRENCE

Thirteen Level IV habitat types were identified (Table 2). The most frequent habitat types by percent occurrence were mid-channel pool units, 30%; low gradient riffle units, 27%; and run units, 22% (Graph 3). Based on percent total length, mid-channel pool units made up 34%, low gradient riffle units 21%, and run units 20%.

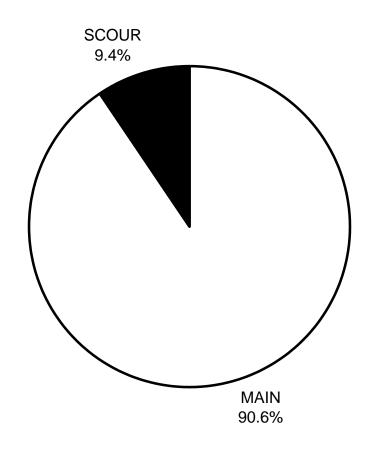
CAHTO CREEK 2009 POOL TYPES BY PERCENT OCCURRENCE

A total of 127 pools were identified (Table 3). Main channel pools were the most frequently encountered at 91% (Graph 4), and comprised 87% of the total length of all pools (Table 3).

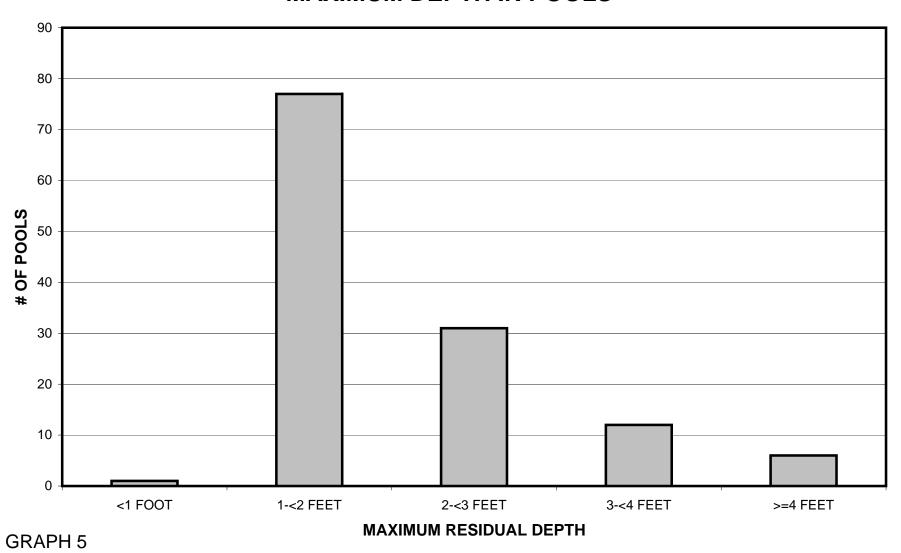
CAHTO CREEK 2009 MAXIMUM DEPTH IN POOLS

Table 4 is a summary of maximum residual pool depths by pool habitat types. Pool quality for salmonids increases with depth. Forty-nine of the 127 pools (39%) had a residual depth of two feet or greater (Graph 5).

Flatwater habitat types comprised 36.7% of the total length of this survey, riffles 21.4%, and pools 40.1%. Forty-nine of the 127 (39%) pools had a maximum residual depth greater than 2 feet. In general, pool enhancement projects are considered when primary pools comprise less than 40% of the length of total stream habitat. In first and second order streams, a primary pool is defined to have a maximum residual depth of at least two feet, occupy at least half the width of the low flow channel, and be as long as the low flow channel width. Installing large wood structures that will increase or deepen pool habitat is recommended.

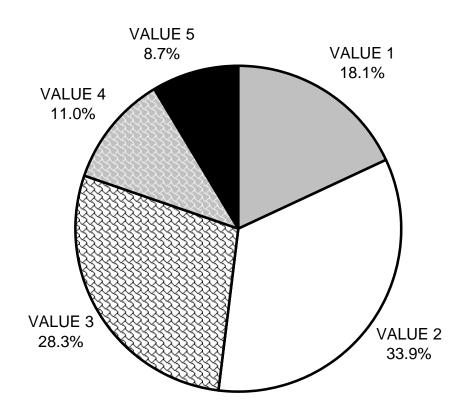
CAHTO CREEK 2009 PERCENT EMBEDDEDNESS

The depth of cobble embeddedness was estimated at pool tail-outs. Of the 127 pool tail-outs measured, 23 had a value of 1 (18.1%); 43 had a value of 2 (33.9%); 36 had a value of 3 (28.3%); 14 had a value of 4 (11%); 11 had a value of 5 (8.7%) (Graph 6). On this scale, a value of 1 indicates the best spawning conditions and a value of 4 the worst. Additionally, a value of 5 was assigned to tail-outs deemed unsuited for spawning due to inappropriate substrate such as bedrock, log sills, boulders, or other considerations.

Sixty-six of the 127 pool tail-outs measured had embeddedness ratings of 1 or 2. Fifty of the pool tail-outs had embeddedness ratings of 3 or 4. Eleven of the pool tail-outs had a rating of 5, which is considered unsuitable for spawning. Cobble embeddedness measured to be 25% or less, a rating of 1, is considered to indicate good quality spawning substrate for salmon and steelhead. Sediment sources in Cahto Creek should be mapped and rated according to their potential sediment yields, and control measures should be taken.

- 4) Inventory and map sources of stream bank erosion and prioritize them according to present and potential sediment yield. Identified sites should then be treated to reduce the amount of fine sediments entering the stream.

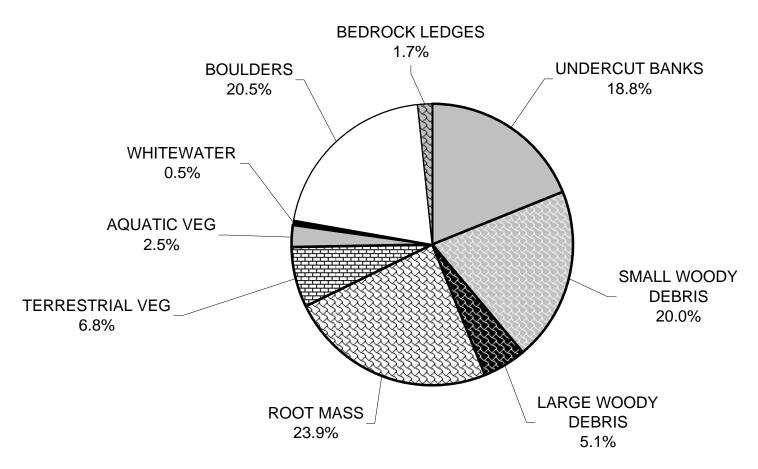
CAHTO CREEK 2009 MEAN PERCENT COVER TYPES IN POOLS

Table 5 summarizes mean percent cover by habitat type. Root mass is the dominant cover type in Cahto Creek. Graph 7 describes the pool cover in Cahto Creek. Root mass is the dominant pool cover type followed by boulders.

The mean shelter rating for pools is 29. The shelter rating in the flatwater habitats is 16. A pool shelter rating of approximately 100 is desirable. The amount of cover that now exists is being provided primarily by root mass in Cahto Creek. Root mass is the dominant cover type in pools followed by boulders. Log and root wad cover structures in the pool and flatwater habitats would enhance both summer and winter salmonid habitat. Log cover structure provides rearing fry with protection from predation, rest from water velocity, and also divides territorial units to reduce density related competition.

- 3) Increase woody cover in the pools and flatwater habitat units. Most of the existing cover in the pools is from root mass. Adding high quality complexity with woody cover in the pools is desirable.

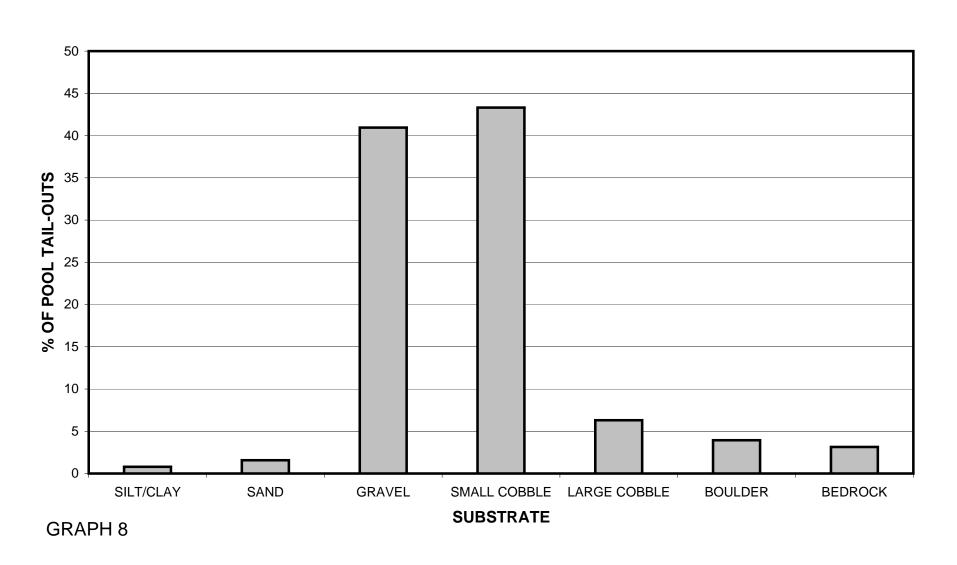
CAHTO CREEK 2009 SUBSTRATE COMPOSITION IN POOL TAIL-OUTS

Table 6 summarizes the dominant substrate by habitat type. Graph 8 depicts the dominant substrate observed in pool tail-outs. Small cobble was the dominant substrate observed in 43% of the pool tail-outs. Gravel was the next most frequently observed dominant substrate type and occurred in 41% of the pool tail-outs.

One hundred seven of the 127 pool tail-outs measured had gravel or small cobble as the dominant substrate. This is generally considered good for spawning salmonids.

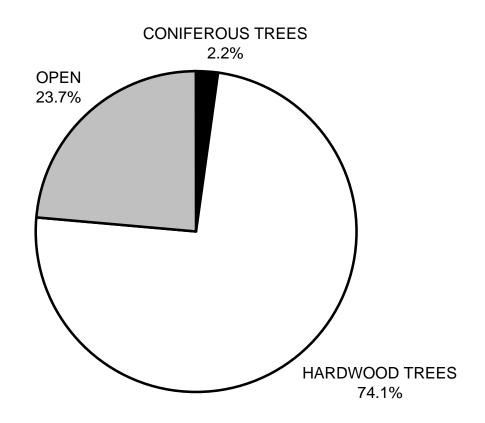
CAHTO CREEK 2009 MEAN PERCENT CANOPY

The mean percent canopy density for the surveyed length of Cahto Creek was 76%. Twenty-four percent of the canopy was open. Of the canopy present, the mean percentages of hardwood and coniferous trees were 97% and 3%, respectively. Graph 9 describes the mean percent canopy in Cahto Creek.

The mean percent canopy density for the stream was 76%. Reach 1 had a canopy density of 70%, Reach 2 had a canopy density of 91%. In general, revegetation projects are considered when canopy density is less than 80%.

- Increase the canopy in Reach 1 on Cahto Creek by planting appropriate native vegetation like willow, alder, redwood, and Douglas fir along the stream where shade canopy is not at acceptable levels. The reaches above this survey section should be inventoried and treated as well, since the water flowing here is affected from upstream. In many cases, planting will need to be coordinated to follow bank stabilization or upslope erosion control projects.

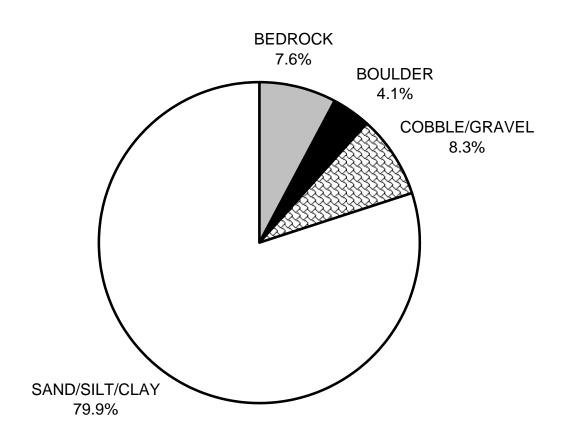
CAHTO CREEK 2009 DOMINANT BANK COMPOSITION IN SURVEY REACH

For the stream reach surveyed, the mean percent right bank vegetated was 84%. The mean percent left bank vegetated was 86%. The dominant elements composing the structure of the stream banks consisted of 80% sand/silt/clay, 8% bedrock, 8% cobble/gravel, and 4% boulder (Graph 10). Hardwood trees were the dominant vegetation type observed in 87.9% of the units surveyed. Additionally, 9.2% of the units surveyed had brush as the dominant vegetation type, and 2.2% had grass as the dominant vegetation type (Graph 11).

The percentage of right and left bank covered with vegetation was 84% and 86%, respectively. In areas of stream bank erosion or where bank vegetation is sparse, planting endemic species of coniferous and hardwood trees, in conjunction with bank stabilization, is recommended.
