#### STREAM INVENTORY REPORT

#### China Creek

A stream inventory was conducted from June 15 to June 23, 2009 on China Creek. The survey began at the confluence with Redwood Creek and extended upstream 2.2 miles.

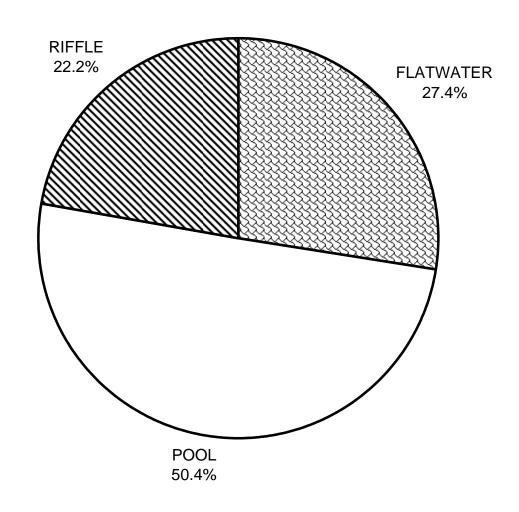
# CHINA CREEK 2009 HABITAT TYPES BY PERCENT OCCURRENCE

Table 1 summarizes the Level II riffle, flatwater, and pool habitat types. Based on frequency of occurrence there were 50% pool units, 27% flatwater units, and 22% riffle units (Graph 1). Based on total length of Level II habitat types there were 52% pool units, 34% flatwater units, and 15% riffle units (Graph 2).

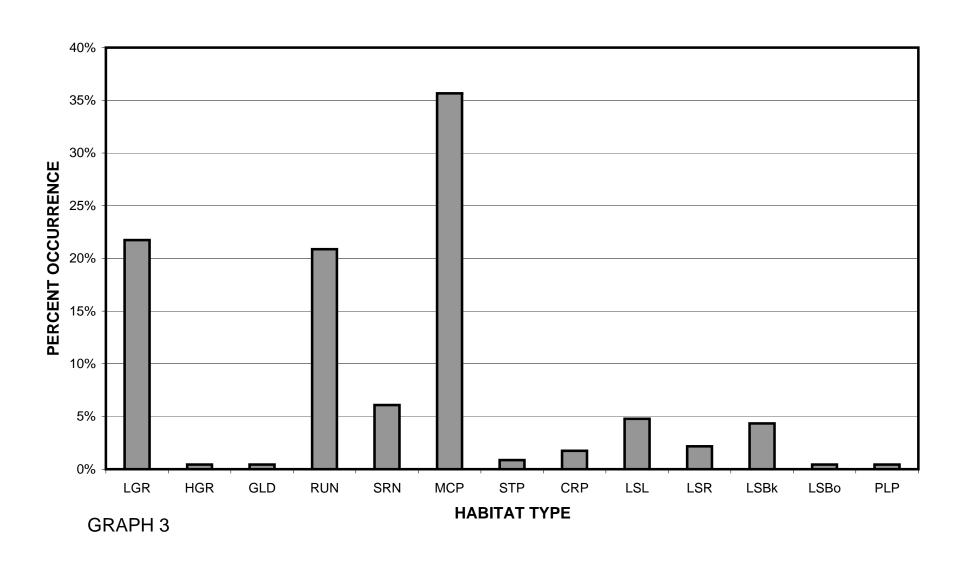
# CHINA CREEK 2009 HABITAT TYPES BY PERCENT OCCURRENCE

Thirteen Level IV habitat types were identified (Table 2). The most frequent habitat types by percent occurrence were mid-channel pool units, 36%; low gradient riffle units, 22%; and run units, 21% (Graph 3). Based on percent total length, mid-channel pool units made up 37%, run units 21%, and low gradient riffle units 14%.

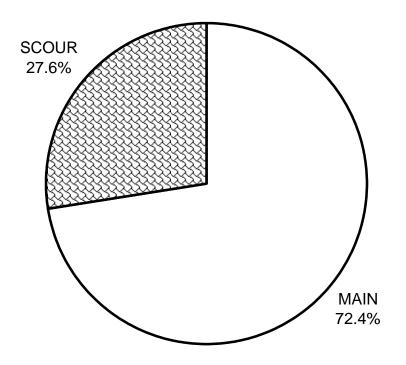
# CHINA CREEK 2009 POOL TYPES BY PERCENT OCCURRENCE

A total of 116 pools were identified (Table 3). Main channel pools were the most frequently encountered at 72% (Graph 4), and comprised 73% of the total length of all pools (Table 3).

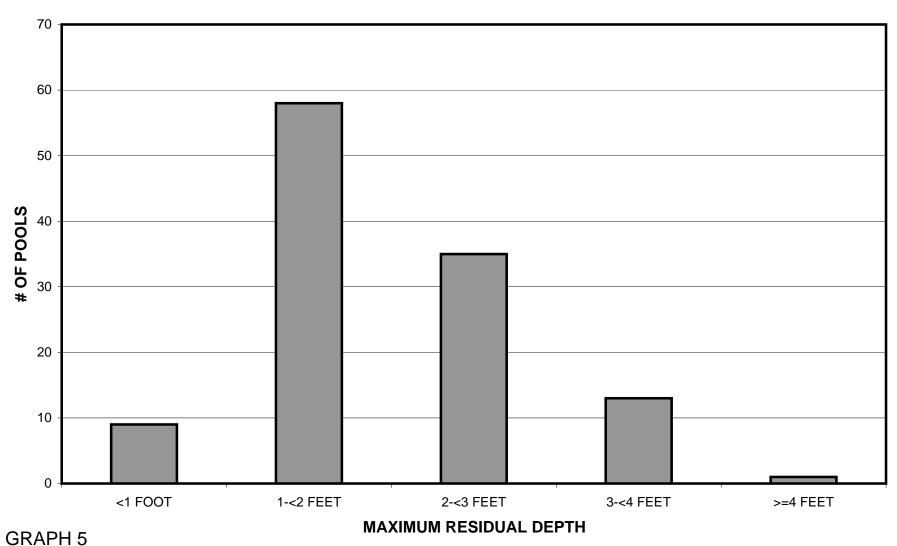
# CHINA CREEK 2009 MAXIMUM DEPTH IN POOLS

Table 4 is a summary of maximum residual pool depths by pool habitat types. Pool quality for salmonids increases with depth. Forty-nine of the 116 pools (42%) had a residual depth of two feet or greater (Graph 5).

Flatwater habitat types comprised 34% of the total length of this survey, riffles 15%, and pools 52%. Forty-nine of the 116 (42%) pools had a maximum residual depth greater than 2 feet. In general, pool enhancement projects are considered when primary pools comprise less than 40% of the length of total stream habitat. In first and second order streams, a primary pool is defined to have a maximum residual depth of at least two feet, occupy at least half the width of the low flow channel, and be as long as the low flow channel width. Installing large wood structures that will increase or deepen pool habitat is recommended.

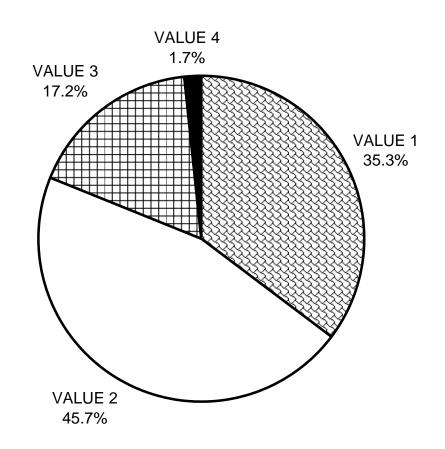
# CHINA CREEK 2009 PERCENT EMBEDDEDNESS

The depth of cobble embeddedness was estimated at pool tail-outs. Of the 116 pool tail-outs measured, 41 had a value of 1 (35.3%); 53 had a value of 2 (45.7%); 20 had a value of 3 (17.2%); 2 had a value of 4 (1.7%); (Graph 6). On this scale, a value of 1 indicates the best spawning conditions and a value of 4 the worst. Additionally, a value of 5 was assigned to tail-outs deemed unsuited for spawning due to inappropriate substrate such as bedrock, log sills, boulders, or other considerations.

Ninety-four of the 116 pool tail-outs measured had embeddedness ratings of 1 or 2. Twenty-two of the pool tail-outs had embeddedness ratings of 3 or 4. None of the pool tail-outs had a rating of 5, which is considered unsuitable for spawning. Cobble embeddedness measured to be 25% or less, a rating of 1, is considered to indicate good quality spawning substrate for salmon and steelhead.

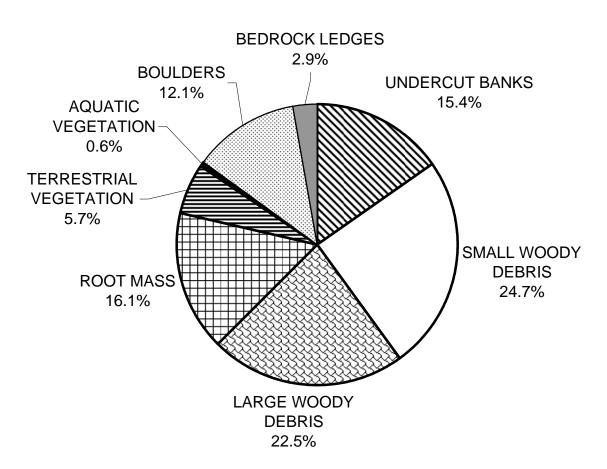
# CHINA CREEK 2009 MEAN PERCENT COVER TYPES IN POOLS

Table 5 summarizes mean percent cover by habitat type. Small woody debris is the dominant cover type in China Creek. Graph 7 describes the pool cover in China Creek. Small woody debris is the dominant pool cover type followed by large woody debris.

The mean shelter rating for pools is 30. The shelter rating in the flatwater habitats is 5. A pool shelter rating of approximately 100 is desirable. The amount of cover that now exists is being provided primarily by small woody debris in China Creek. Small woody debris is the dominant cover type in pools followed by large woody debris. Log and root wad cover structures in the pool and flatwater habitats would enhance both summer and winter salmonid habitat. Log cover structure provides rearing fry with protection from predation, rest from water velocity, and also divides territorial units to reduce density related competition.

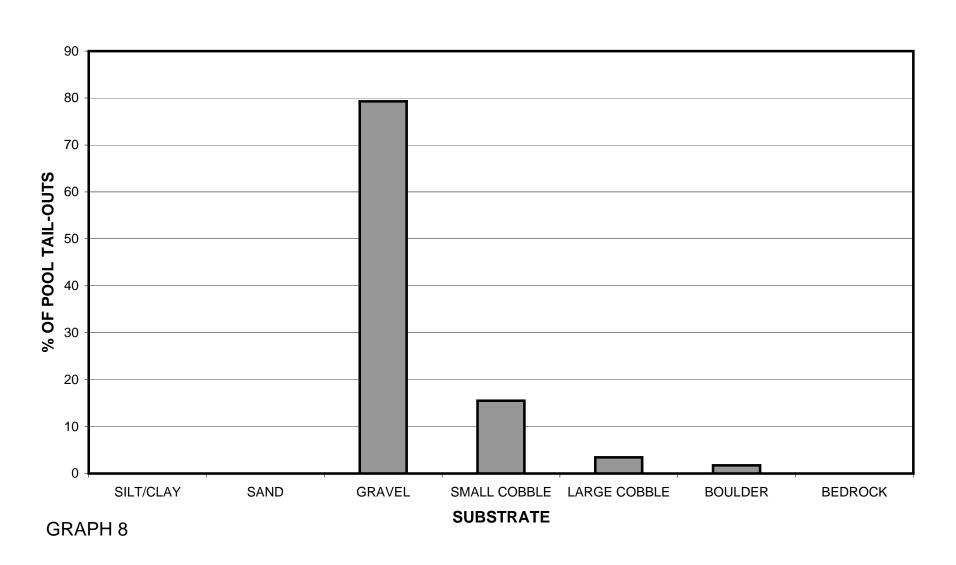
# CHINA CREEK 2009 SUBSTRATE COMPOSITION IN POOL TAIL-OUTS

Table 6 summarizes the dominant substrate by habitat type. Graph 8 depicts the dominant substrate observed in pool tail-outs. Gravel was the dominant substrate observed in 79% of the pool tail-outs. Small cobble was the next most frequently observed dominant substrate type and occurred in 16% of the pool tail-outs.

One hundred ten of the 116 pool tail-outs measured had gravel or small cobble as the dominant substrate. This is generally considered good for spawning salmonids.

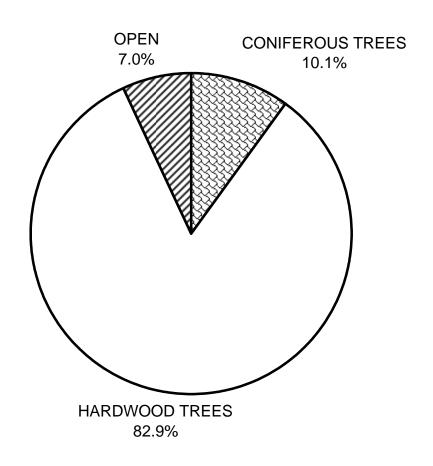
# CHINA CREEK 2009 MEAN PERCENT CANOPY

The mean percent canopy density for the surveyed length of China Creek was 93%. Seven percent of the canopy was open. Of the canopy present, the mean percentages of hardwood and coniferous trees were 89% and 11%, respectively. Graph 9 describes the mean percent canopy in China Creek.

The mean percent canopy density for the stream was 93%. In general, revegetation projects are considered when canopy density is less than 80%.

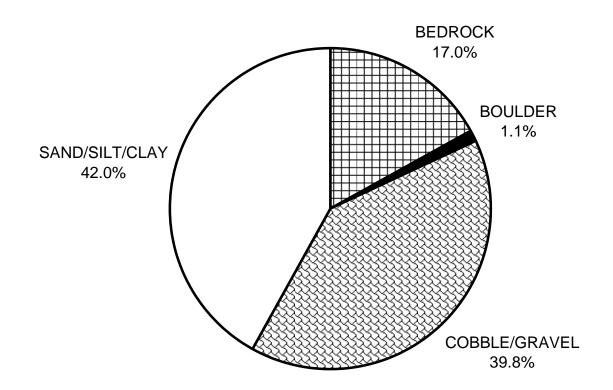
# CHINA CREEK 2009 DOMINANT BANK COMPOSITION IN SURVEY REACH

For the stream reach surveyed, the mean percent right bank vegetated was 89%. The mean percent left bank vegetated was 89%. The dominant elements composing the structure of the stream banks consisted of 42% sand/silt/clay, 40% cobble/gravel, 17% bedrock, and 1% boulder (Graph 10). Deciduous trees were the dominant vegetation type observed in 88% of the units surveyed. Additionally, 5% of the units surveyed had brush as the dominant vegetation type, and 4% had coniferous trees as the dominant vegetation type (Graph 11).

The percentage of right and left bank covered with vegetation was 89% and 89%, respectively. In areas of stream bank erosion or where bank vegetation is sparse, planting endemic species of coniferous and hardwood trees, in conjunction with bank stabilization, is recommended.
