# **STREAM INVENTORY REPORT**

## **Coon Creek**

A stream inventory was conducted on August 22, 2007 on Coon Creek. The survey began at the confluence with Butte Creek and extended upstream 0.5 miles.

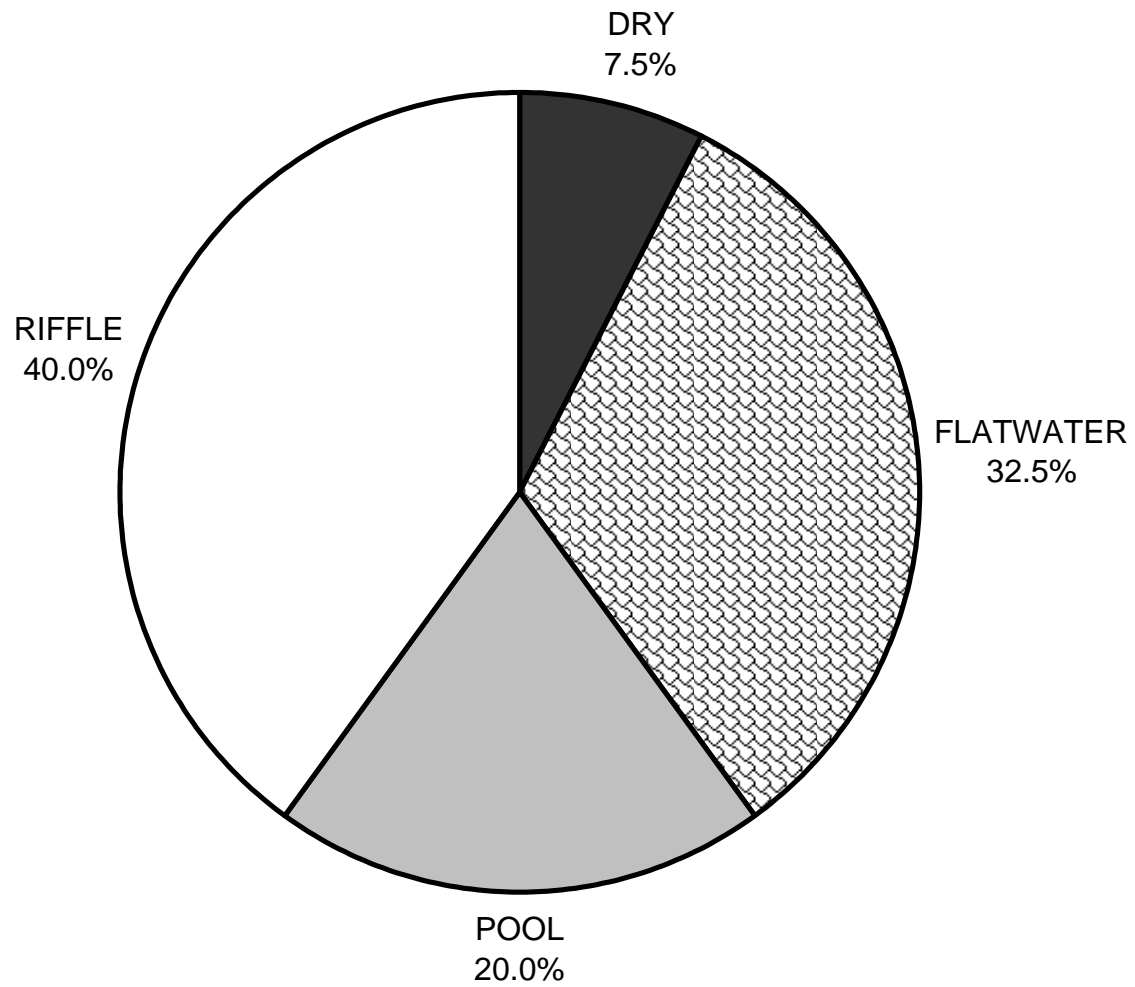
GRAPH 1

Table 1 summarizes the Level II riffle, flatwater, and pool habitat types. Based on frequency of occurrence there were 40% riffle units, 32% flatwater units, 20% pool units, and 8% dry units (Graph 1). Based on total length of Level II habitat types there were 55% riffle units, 29% flatwater units, 12% dry units, and 4% pool units (Graph 2).

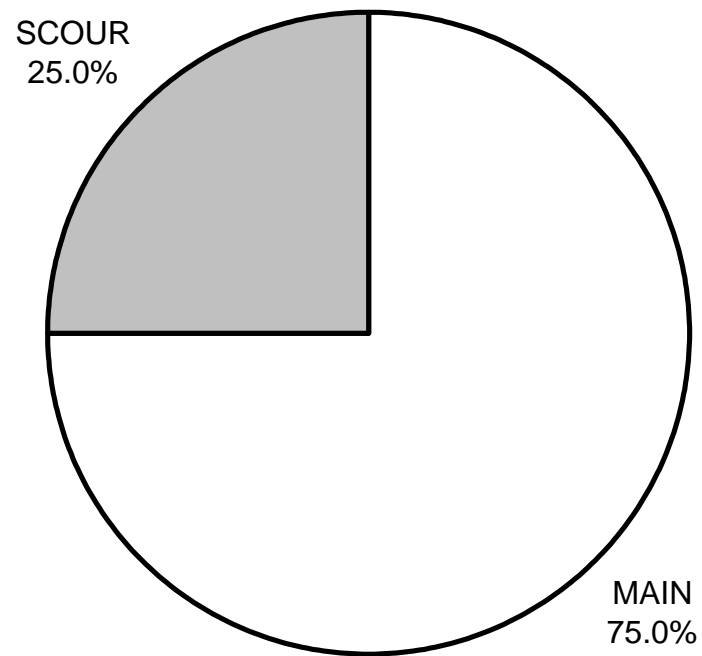
GRAPH 4

A total of 8 pools were identified (Table 3). Main Channel pools were the most frequently encountered, at 75% (Graph 4), and comprised 79% of the total length of all pools (Table 3).

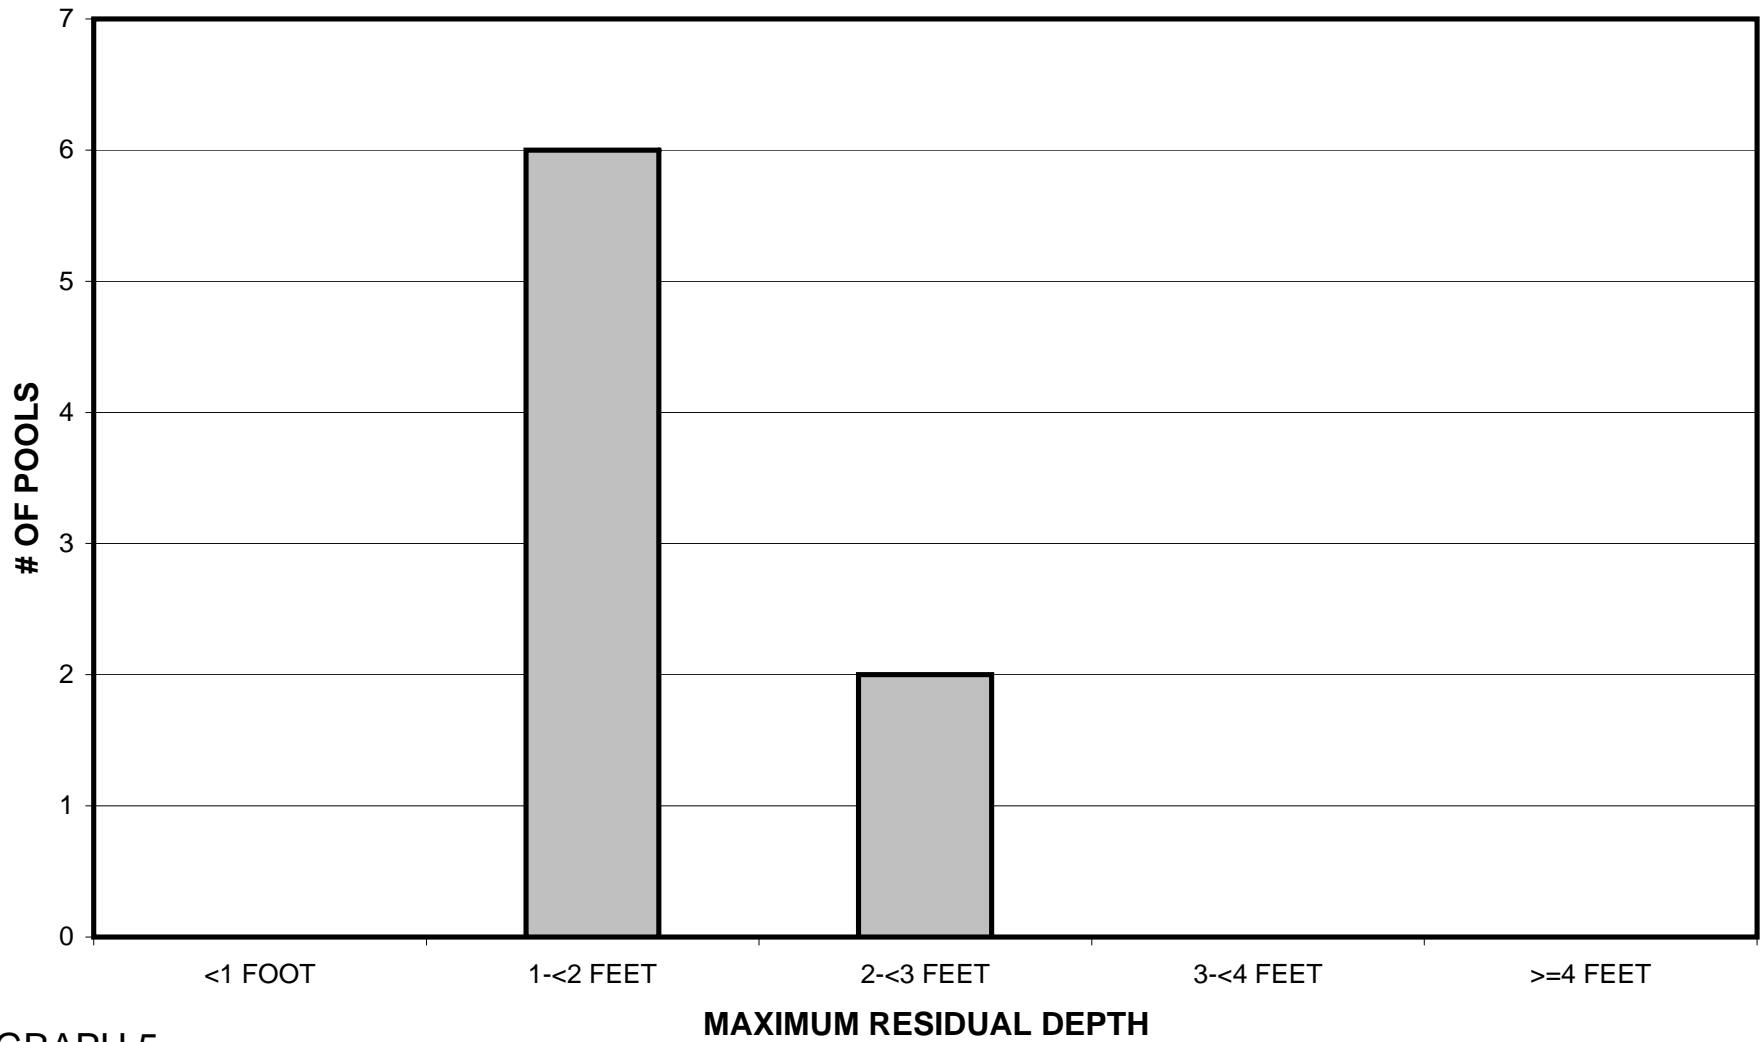
GRAPH 5

Table 4 is a summary of maximum residual pool depths by pool habitat types. Pool quality for salmonids increases with depth. Two of the 8 pools (25%) had a residual depth of two feet or greater (Graph 5).

Flatwater habitat types comprised 4% of the total length of this survey, riffles 55%, and pools 4%. The pools are relatively shallow, with only 2 of the 8 (25%) pools having a maximum residual depth greater than 2 feet. In general, pool enhancement projects are considered when primary pools comprise less than 40% of the length of total stream habitat. In first and second order streams, a primary pool is defined to have a maximum residual depth of at least two feet, occupy at least half the width of the low flow channel, and be as long as the low flow channel width. Installing structures that will increase or deepen pool habitat is recommended.

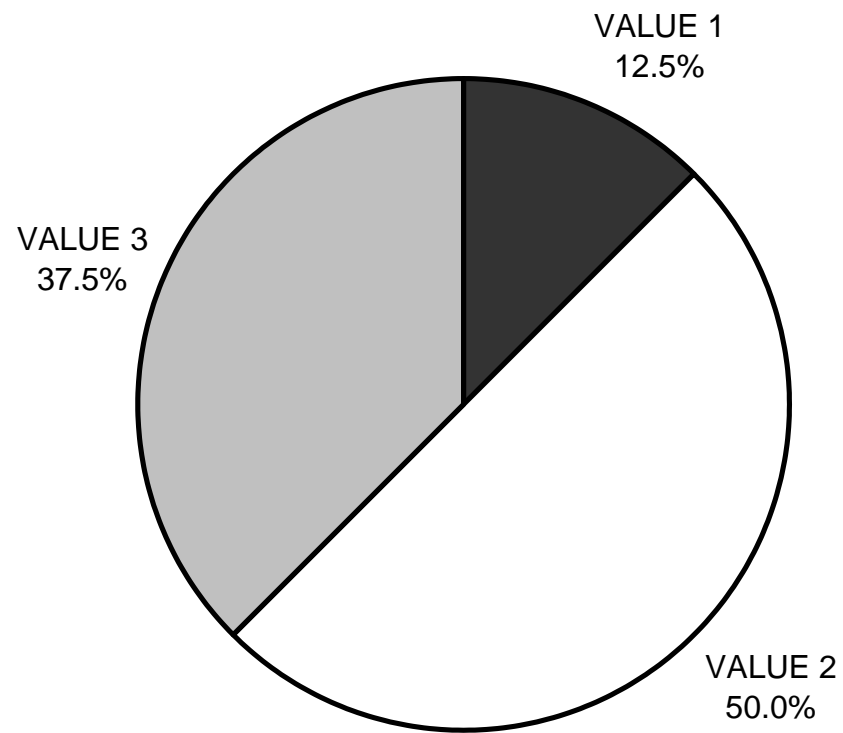
GRAPH 6

The depth of cobble embeddedness was estimated at pool tail-outs. Of the 8 pool tail-outs measured, 1 had a value of 1 (12.5%); 4 had a value of 2 (50%); 3 had a value of 3 (37.5%) (Graph 6). On this scale, a value of 1 indicates the best spawning conditions and a value of 4 the worst.

Five of the 8 pool tail-outs measured had embeddedness ratings of 1 or 2. Three of the pool tail-

outs had embeddedness ratings of 3 or 4. None of the pool tail-outs had a rating of 5, which is considered unsuitable for spawning. Cobble embeddedness measured to be 25% or less, a rating of 1, is considered to indicate good quality spawning substrate for salmon and steelhead.

- 4) Inventory and map sources of stream bank erosion and prioritize them according to present and potential sediment yield. Identified sites should then be treated to reduce the amount of fine sediments entering the stream.

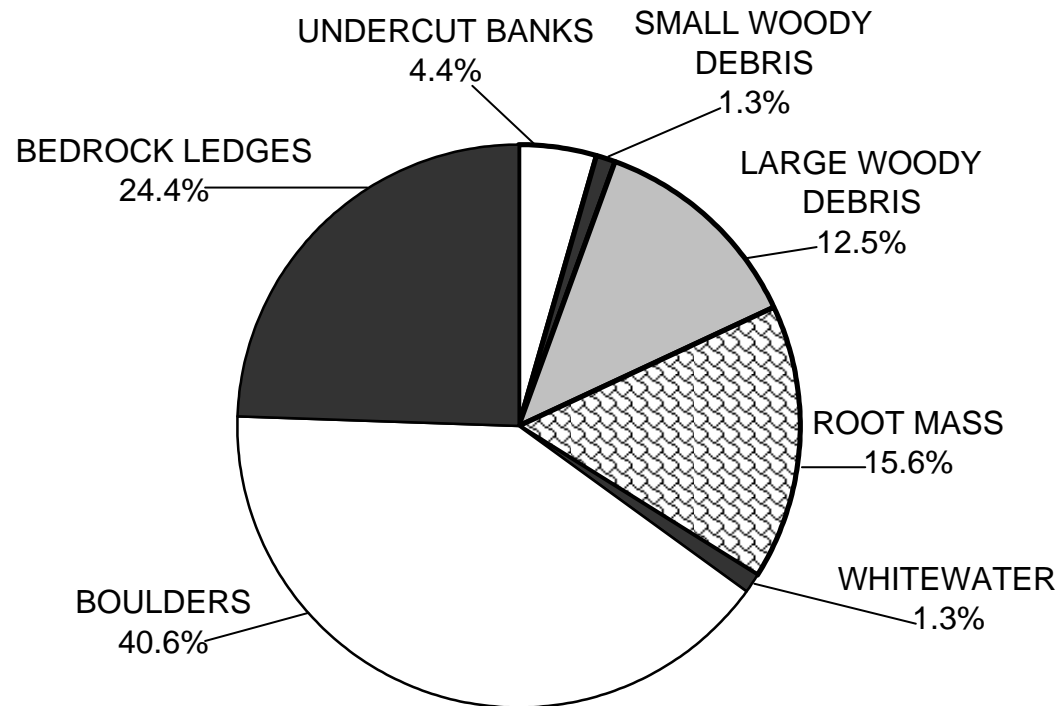
GRAPH 7

Table 5 summarizes mean percent cover by habitat type. Boulders are the dominant cover types in Coon Creek. Graph 7 describes the pool cover in Coon Creek. Boulders are the dominant pool cover type followed by bedrock ledges.

The mean shelter rating for pools was 45. The shelter rating in the flatwater habitats was 67. A pool shelter rating of approximately 100 is desirable. The amount of cover that now exists is being provided primarily by boulders in Coon Creek. Boulders are the dominant cover type in pools followed by bedrock ledges. Log and root wad cover structures in the pool and flatwater habitats would enhance both summer and winter salmonid habitat. Log cover structure provides rearing fry with protection from predation, rest from water velocity, and also divides territorial units to reduce density related competition.

- 1) Coon Creek should be managed as an anadromous, natural production stream.
- 2) Increase woody cover in the pools and flatwater habitat units. Most of the existing cover in the pools is from boulders. Adding high quality complexity with woody cover in the pools is desirable.

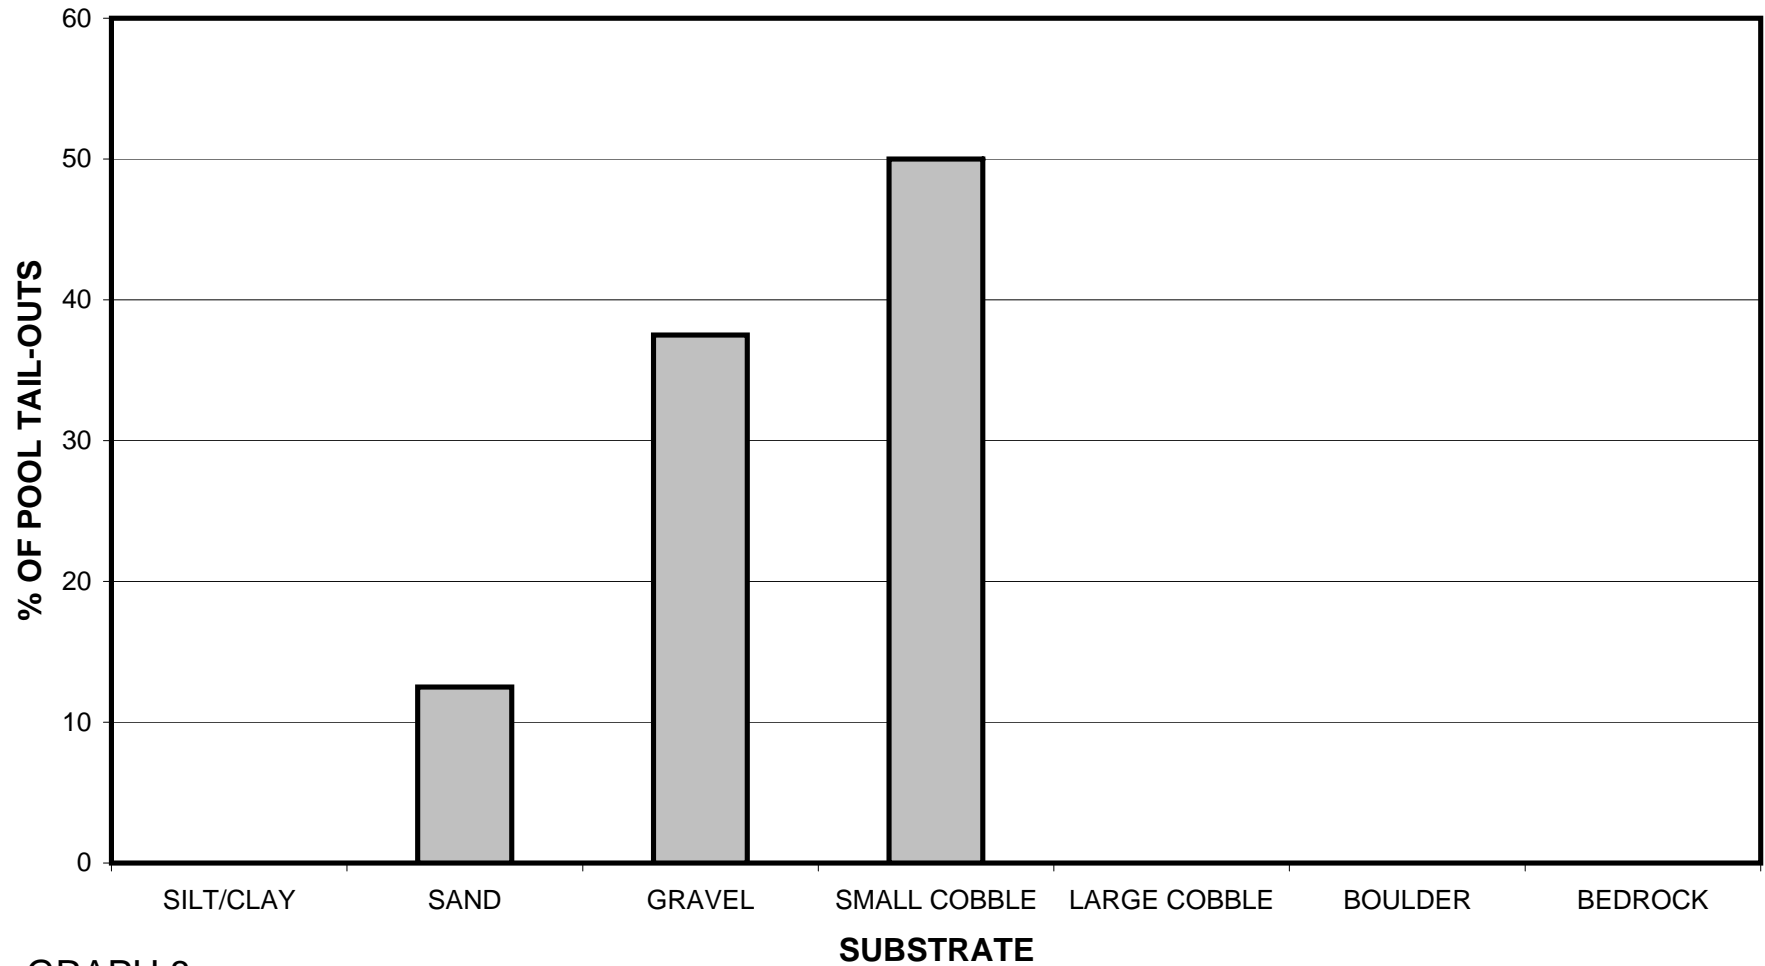
GRAPH 8

Table 6 summarizes the dominant substrate by habitat type. Graph 8 depicts the dominant substrate observed in pool tail-outs. Small cobble was observed in 50% of pool tail-outs, and gravel was observed 38% of pool tail-outs.

Seven of the 8 pool tail-outs measured had gravel or small cobble as the dominant substrate. This is generally considered good for spawning salmonids.

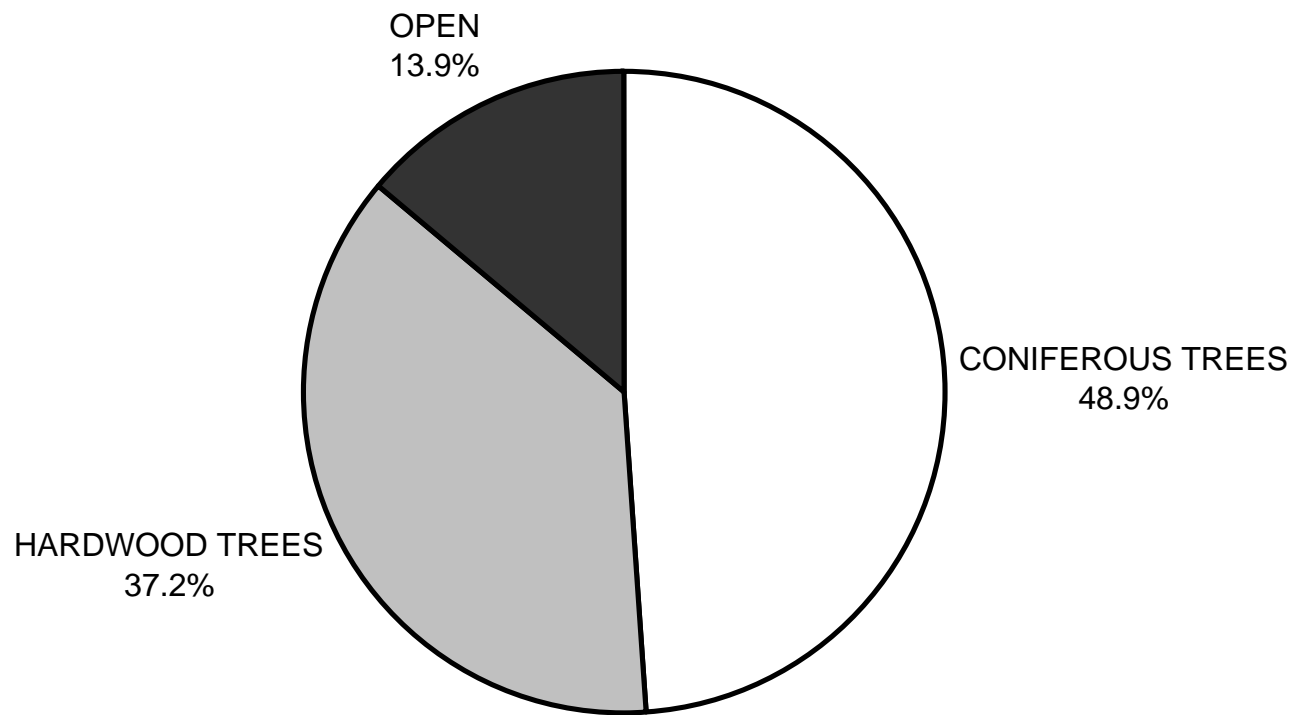
GRAPH 9

The mean percent canopy density for the surveyed length of Coon Creek was 86%. Fourteen percent of the canopy was open. Of the canopy present, the mean percentages of hardwood and coniferous trees were 43% and 57%, respectively. Graph 9 describes the mean percent canopy in Coon Creek.

The mean percent canopy density for the stream was 86%. In general, revegetation projects are considered when canopy density is less than 80%.

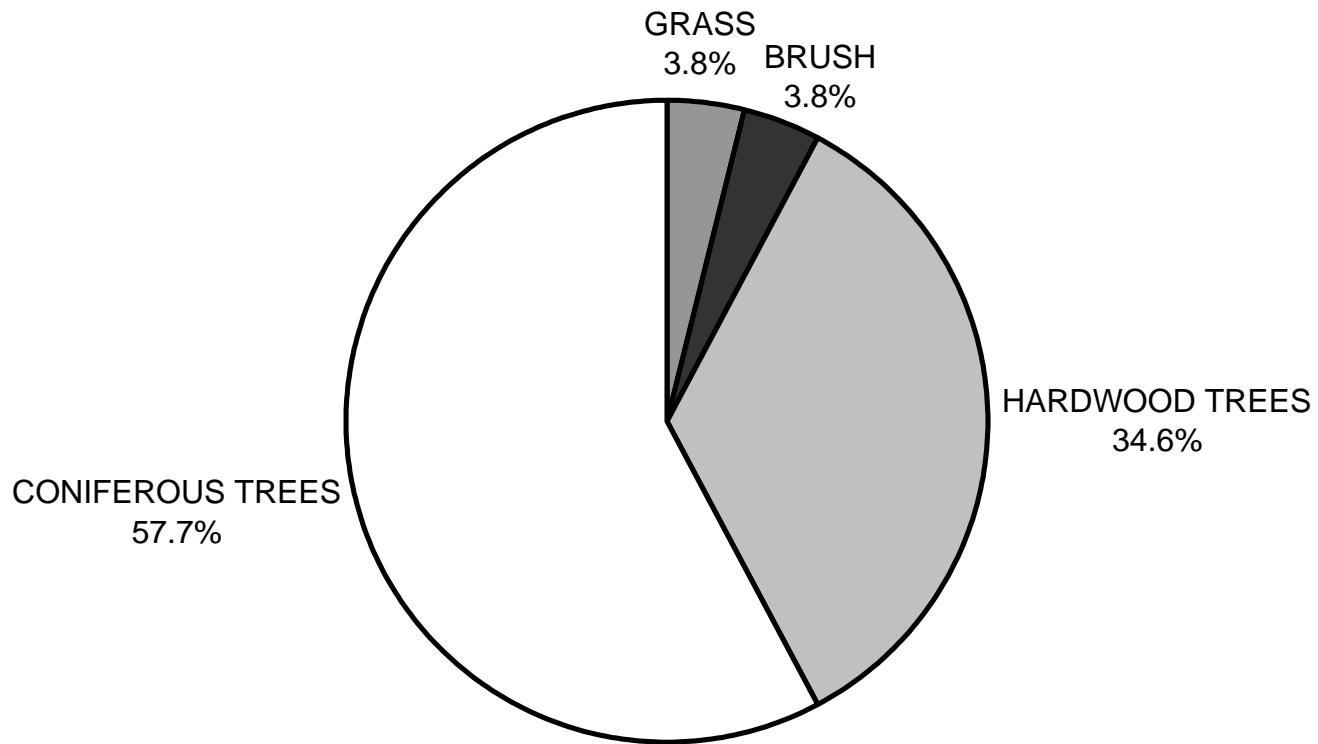
GRAPH 11

For the stream reach surveyed, the mean percent right bank vegetated was 85%. The mean percent left bank vegetated was 86%. The dominant elements composing the structure of the stream banks consisted of 58% cobble/gravel, 27% bedrock, 12% sand/silt/clay, and 4% boulder (Graph 10). Coniferous trees were the dominant vegetation type observed in 58% of the units surveyed. Additionally, 35% of the units surveyed had deciduous trees as the dominant vegetation type, 4% had grass as the dominant vegetation, and 4% had brush as the dominant vegetation (Graph 11).

The percentage of right and left bank covered with vegetation was 85% and 86%, respectively. In areas of stream bank erosion or where bank vegetation is sparse, planting endemic species of coniferous and hardwood trees, in conjunction with bank stabilization, is recommended.
