STREAM INVENTORY REPORT

Dutch Charlie Creek

A stream inventory was conducted during July 31, 2007 to August 6, 2007 on Dutch Charlie Creek. The survey began at the confluence with Thompson Creek and extended upstream 2.9 miles.

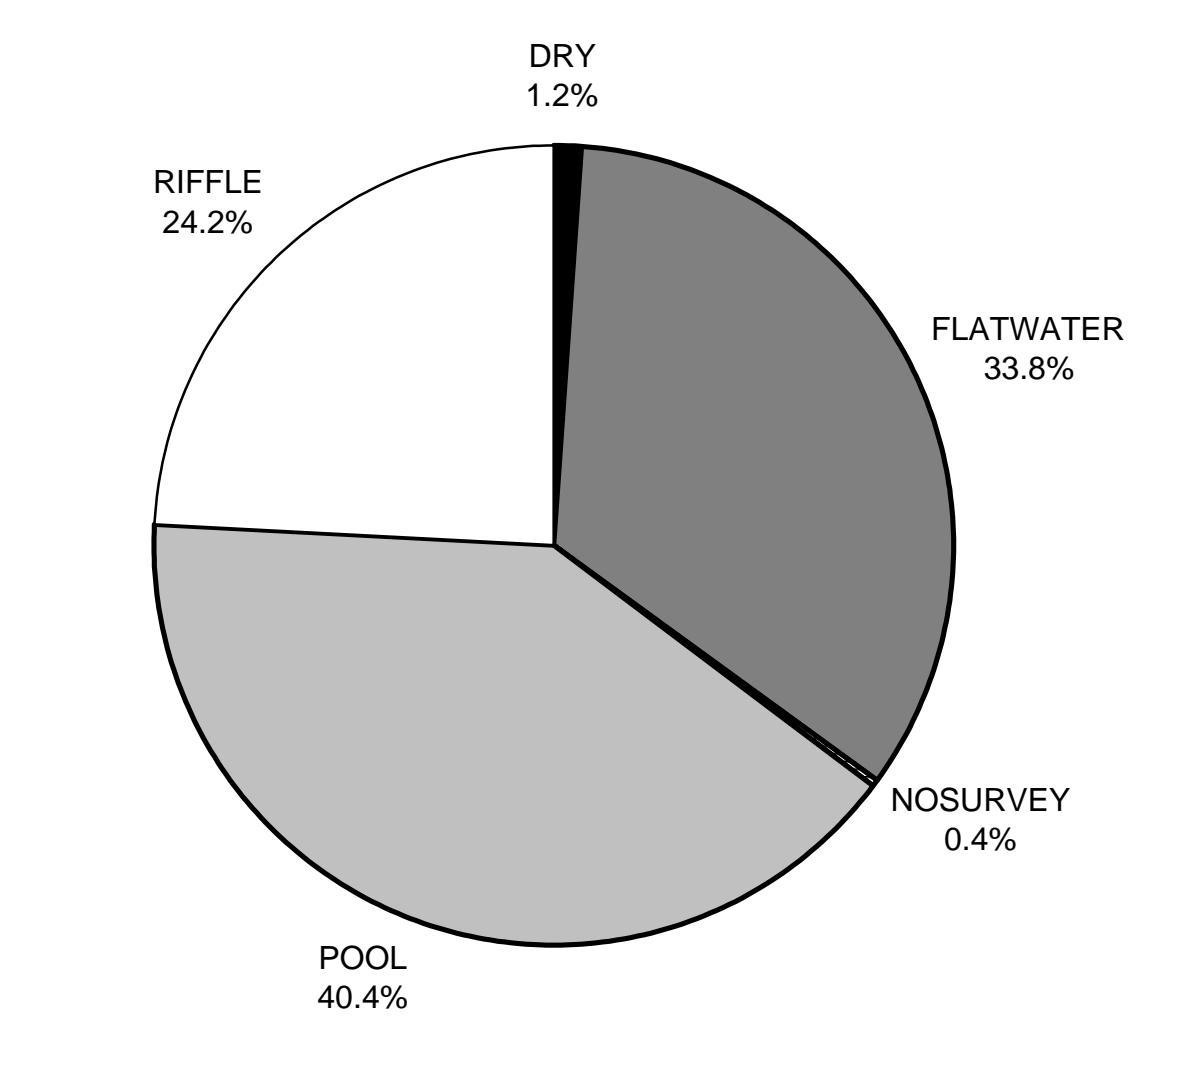
DUTCH CHARLIE CREEK 2007 HABITAT TYPES BY PERCENT OCCURRENCE

Table 1 summarizes the Level II riffle, flatwater, and pool habitat types. Based on frequency of occurrence there were 40.4% pool units, 33.8% flatwater units, 24.2% riffle units, 1.2% dry units and 0.4% no survey units (Graph 1). Based on total length of Level II habitat types there were 47.9% flatwater units, 33.6% pool units, 17.6% riffle units and 0.2% no survey units (Graph 2).

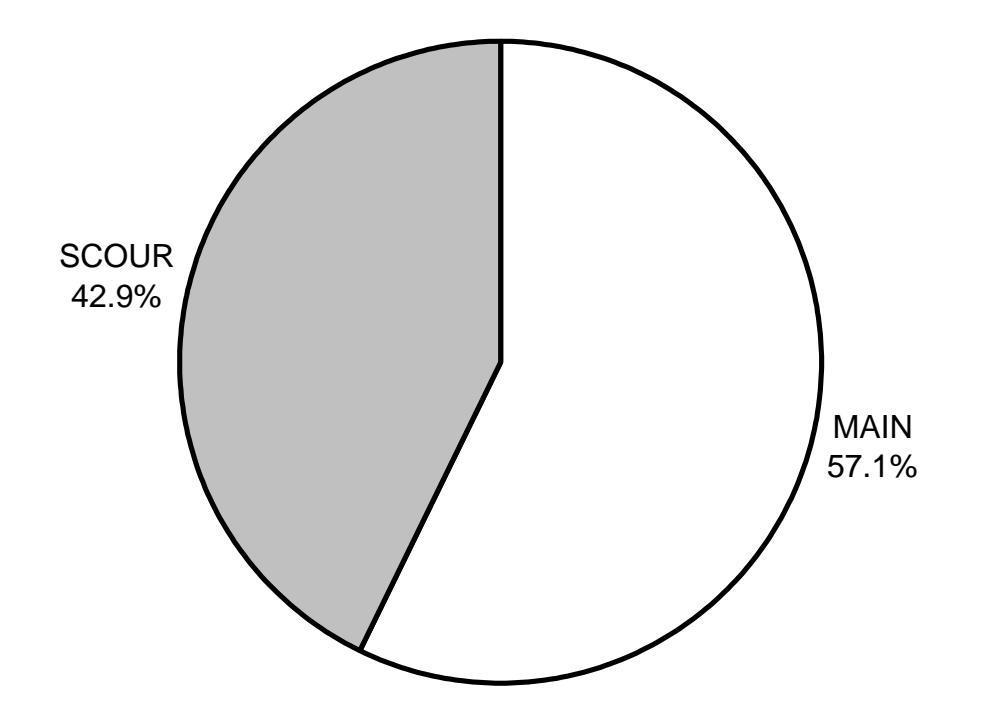
DUTCH CHARLIE CREEK 2007 POOL TYPES BY PERCENT OCCURRENCE

A total of 105 pools were identified (Table 3). Main channel pools were the most frequently encountered, at 57% (Graph 4), and comprised 58% of the total length of all pools (Table 3).

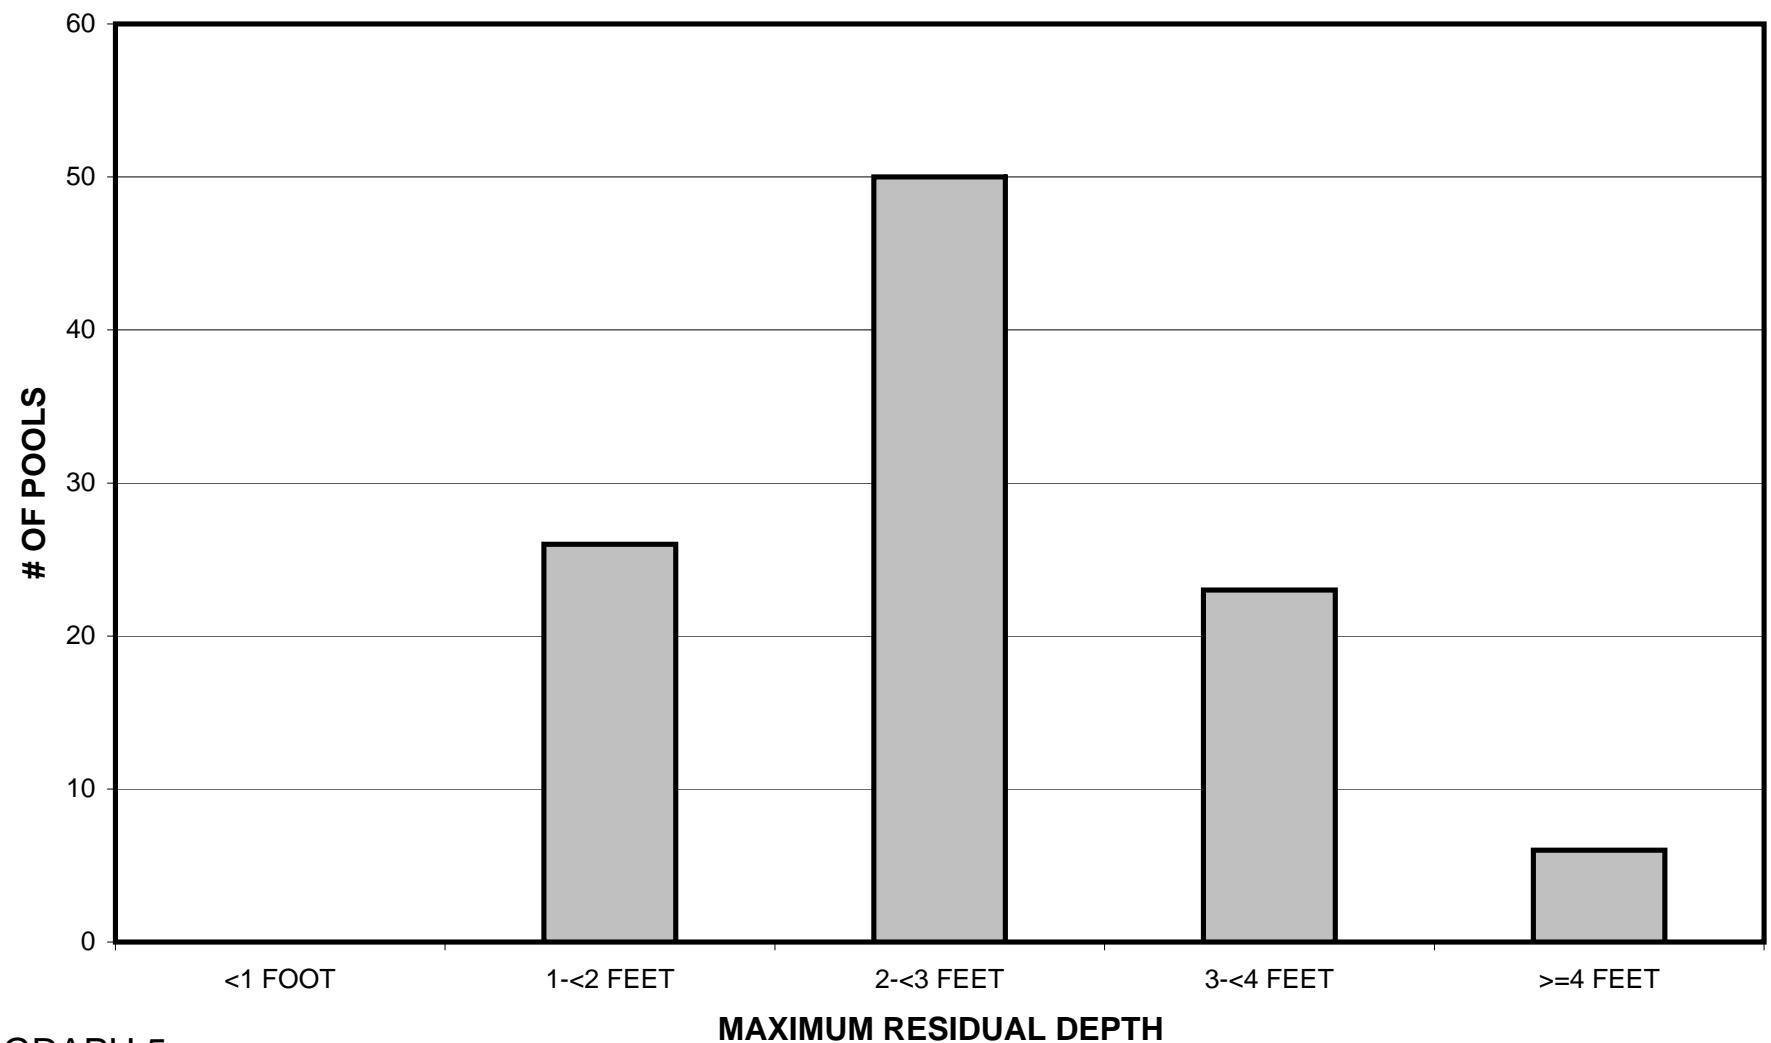
DUTCH CHARLIE CREEK 2007 MAXIMUM DEPTH IN POOLS

Table 4 is a summary of maximum residual pool depths by pool habitat types. Pool quality for salmonids increases with depth. Seventy-nine of the 105 pools (75%) had a residual depth of two feet or greater (Graph 5).

Flatwater habitat types comprised 48% of the total length of this survey, riffles 18%, and pools 34%. The pools are relatively deep, with 79 of the 105 (75%) pools having a maximum residual depth greater than 2 feet. In general, pool enhancement projects are considered when primary pools comprise less than 40% of the length of total stream habitat. In first and second order streams, a primary pool is defined to have a maximum residual depth of at least two feet, occupy at least half the width of the low flow channel, and be as long as the low flow channel width.

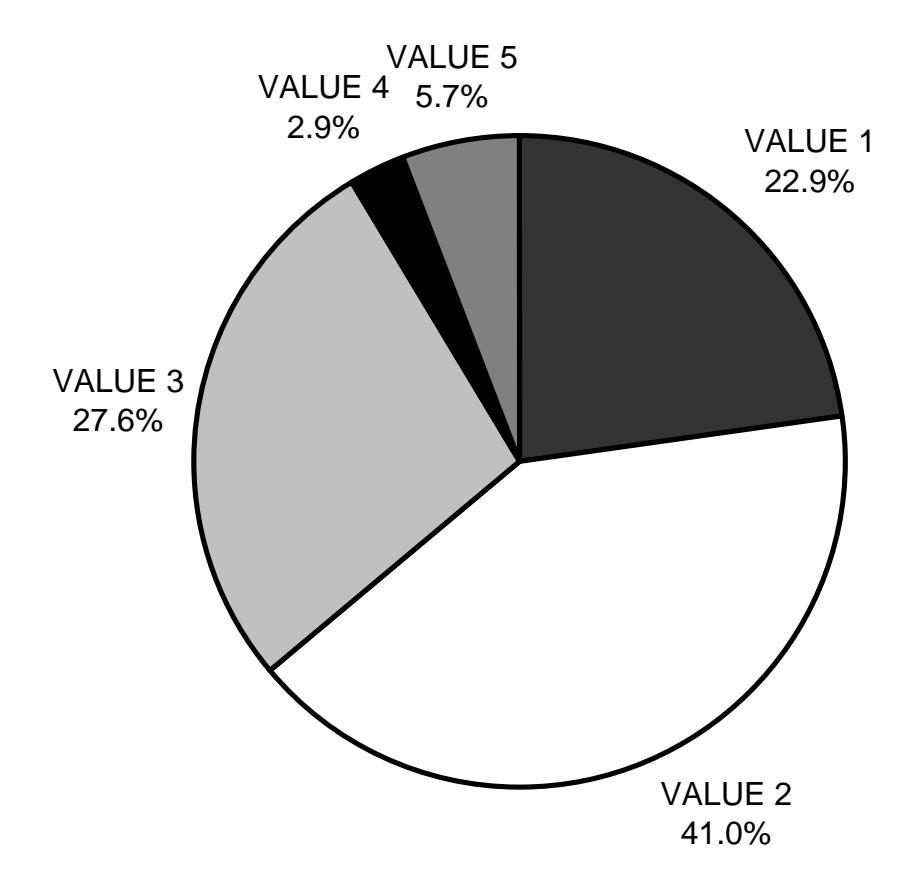
DUTCH CHARLIE CREEK 2007 PERCENT EMBEDDEDNESS

The depth of cobble embeddedness was estimated at pool tail-outs. Of the 105 pool tail-outs measured, 24 had a value of 1 (22.9%); 43 had a value of 2 (41%); 29 had a value of 3 (27.6%); 3 had a value of 4 (2.9%) and 6 had a value of 5 (5.7%) (Graph 6). On this scale, a value of 1 indicates the best spawning conditions and a value of 4 the worst. Additionally, a value of 5 was assigned to tail-outs deemed unsuited for spawning due to inappropriate substrate such as bedrock, log sills, boulders, or other considerations.

Sixty-seven of the 105 pool tail-outs measured had embeddedness ratings of 1 or 2. Thirty-two of the pool tail-outs had embeddedness ratings of 3 or 4. Six of the pool tail-outs had a rating of 5, which is considered unsuitable for spawning. Cobble embeddedness measured to be 25% or less, a rating of 1, is considered to indicate good quality spawning substrate for salmon and steelhead.

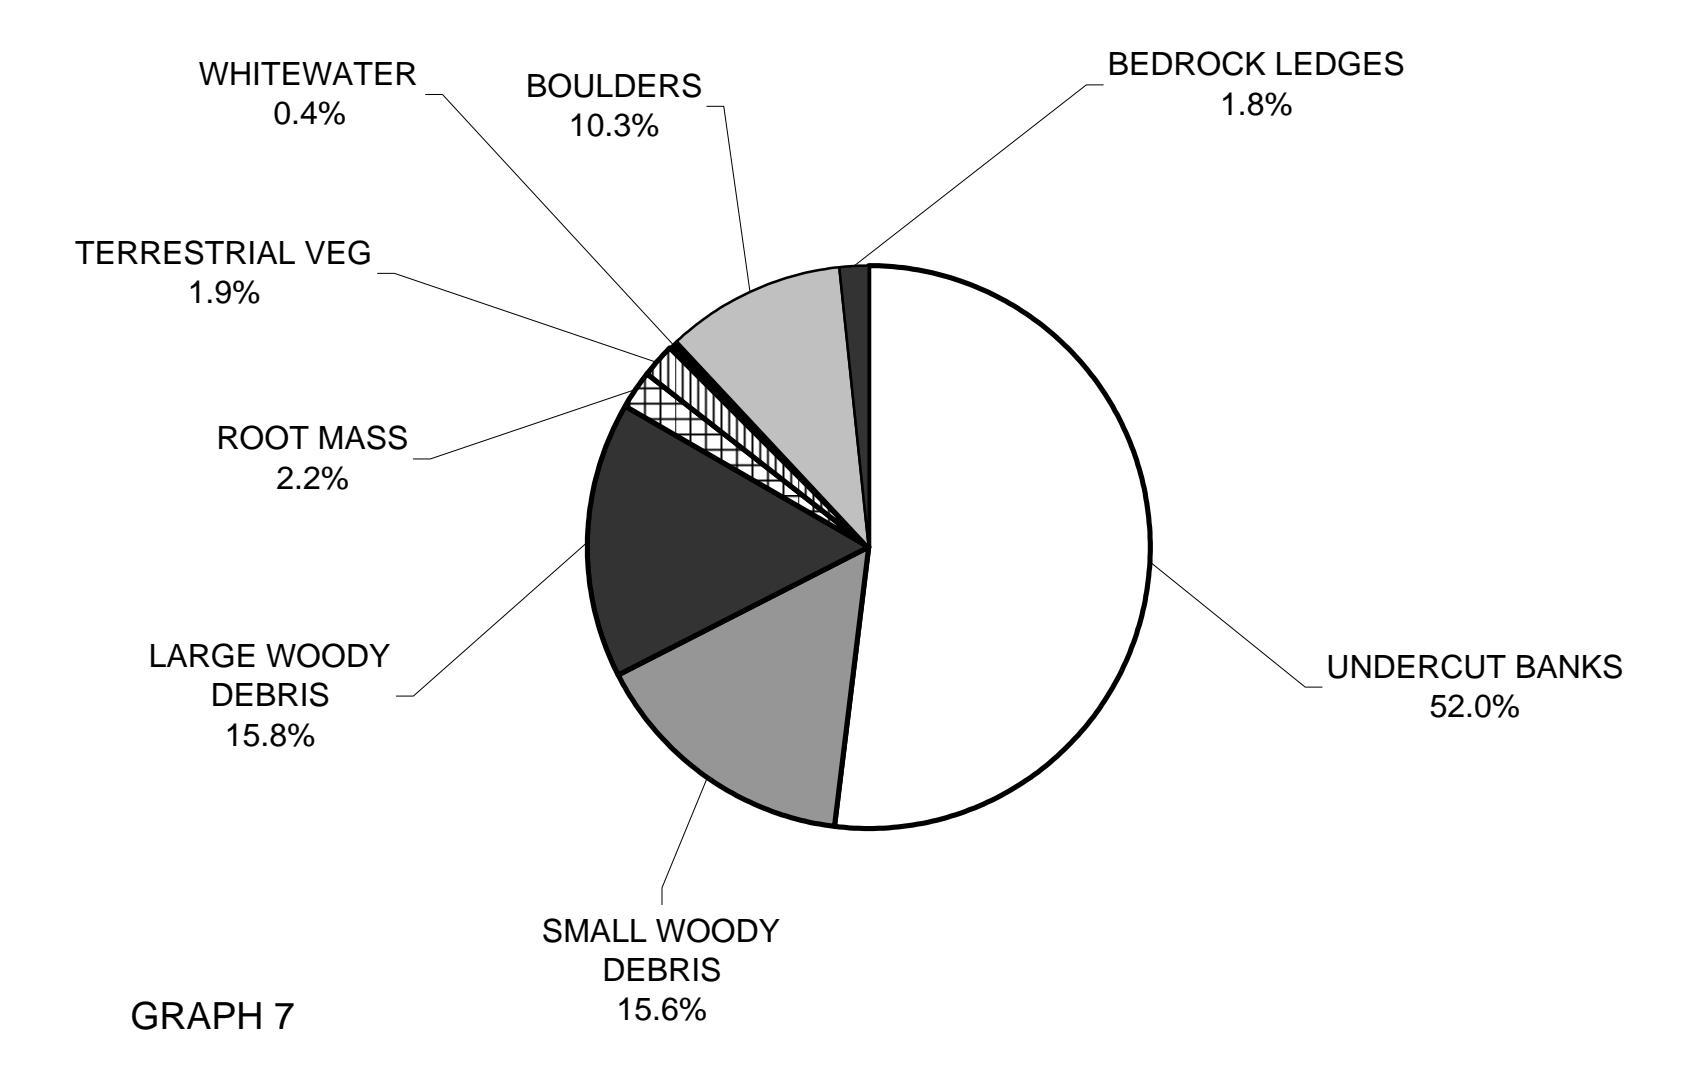
DUTCH CHARLIE CREEK 2007 MEAN PERCENT COVER TYPES IN POOLS

Table 5 summarizes mean percent cover by habitat type. Undercut banks are the dominant cover types in Dutch Charlie Creek. Graph 7 describes the pool cover in Dutch Charlie Creek. Undercut banks are the dominant pool cover type followed equally by large woody debris and small woody debris.

The mean shelter rating for pools was 59. The shelter rating in the flatwater habitats was 27. A pool shelter rating of approximately 100 is desirable. The amount of cover that now exists is being provided primarily by undercut banks in Dutch Charlie Creek. Undercut banks are the dominant cover type in pools followed equally by large woody debris and small woody debris. Log and root wad cover structures in the pool and flatwater habitats would enhance both summer and winter salmonid habitat. Log cover structure provides rearing fry with protection from predation, rest from water velocity, and also divides territorial units to reduce density related competition.

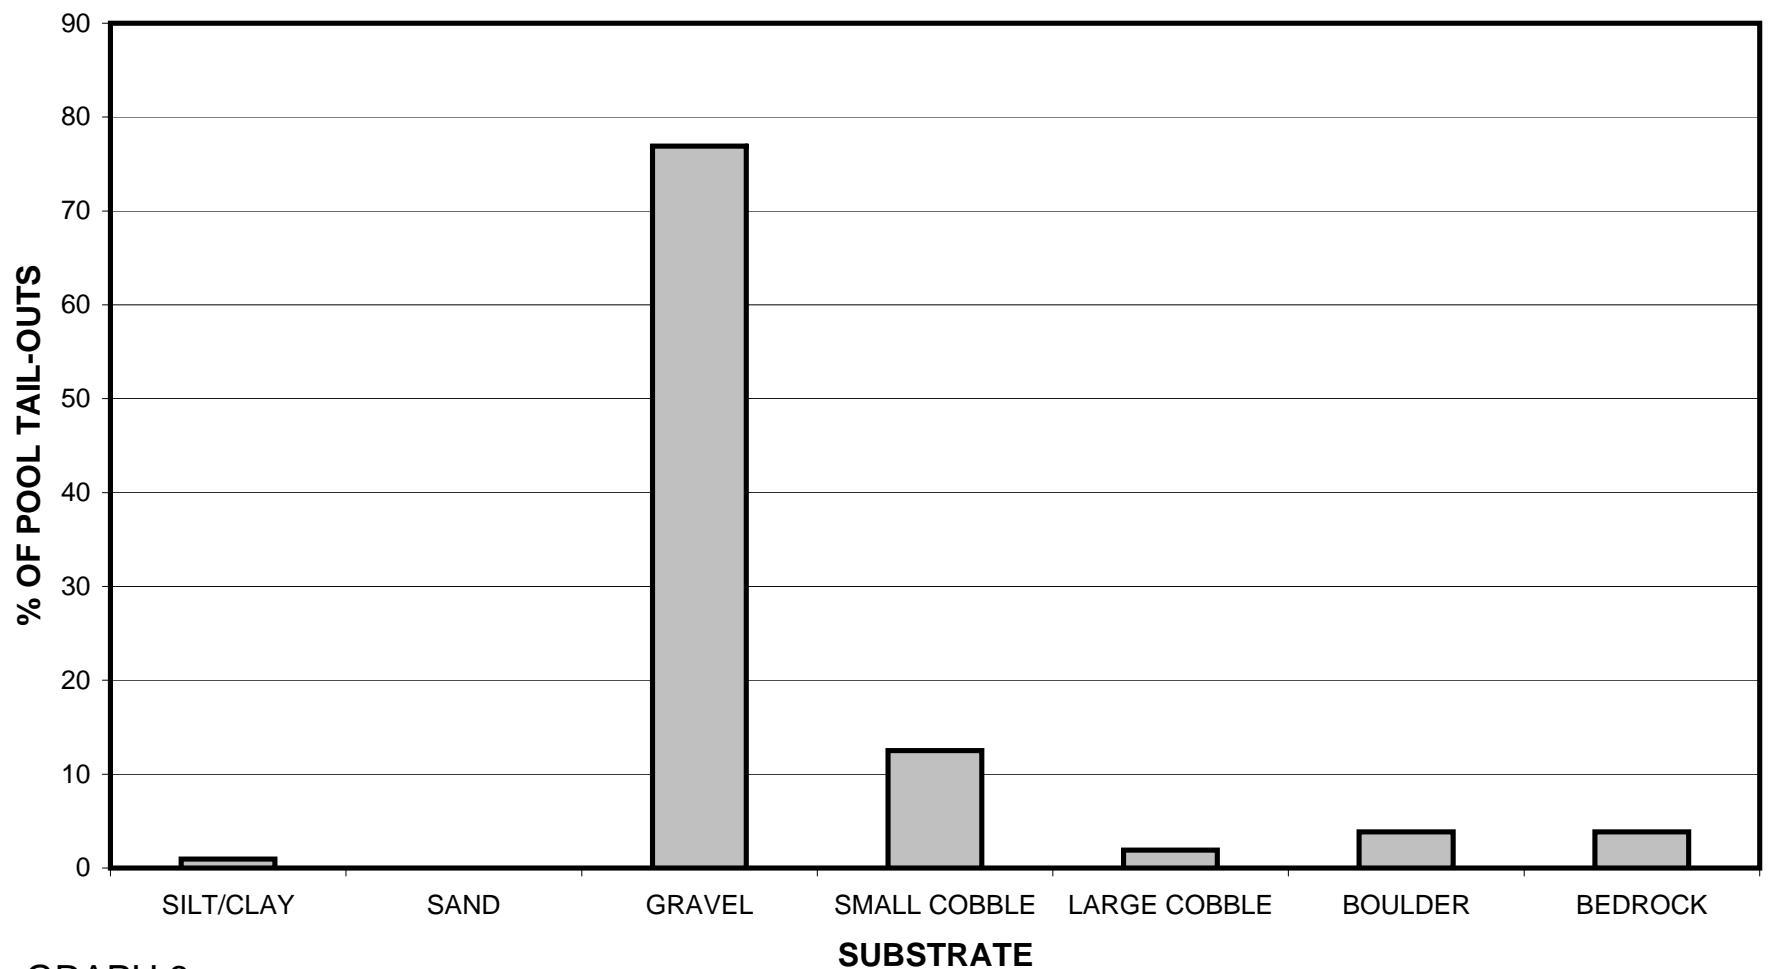
DUTCH CHARLIE CREEK 2007 SUBSTRATE COMPOSITION IN POOL TAIL-OUTS

Table 6 summarizes the dominant substrate by habitat type. Graph 8 depicts the dominant substrate observed in pool tail-outs. Gravel was the dominant substrate observed in 77% of pool tail-outs while small cobble was observed in 12% of pool tail-outs.

Ninety-three of the 104 pool tail-outs measured had gravel or small cobble as the dominant substrate. This is generally considered good for spawning salmonids.

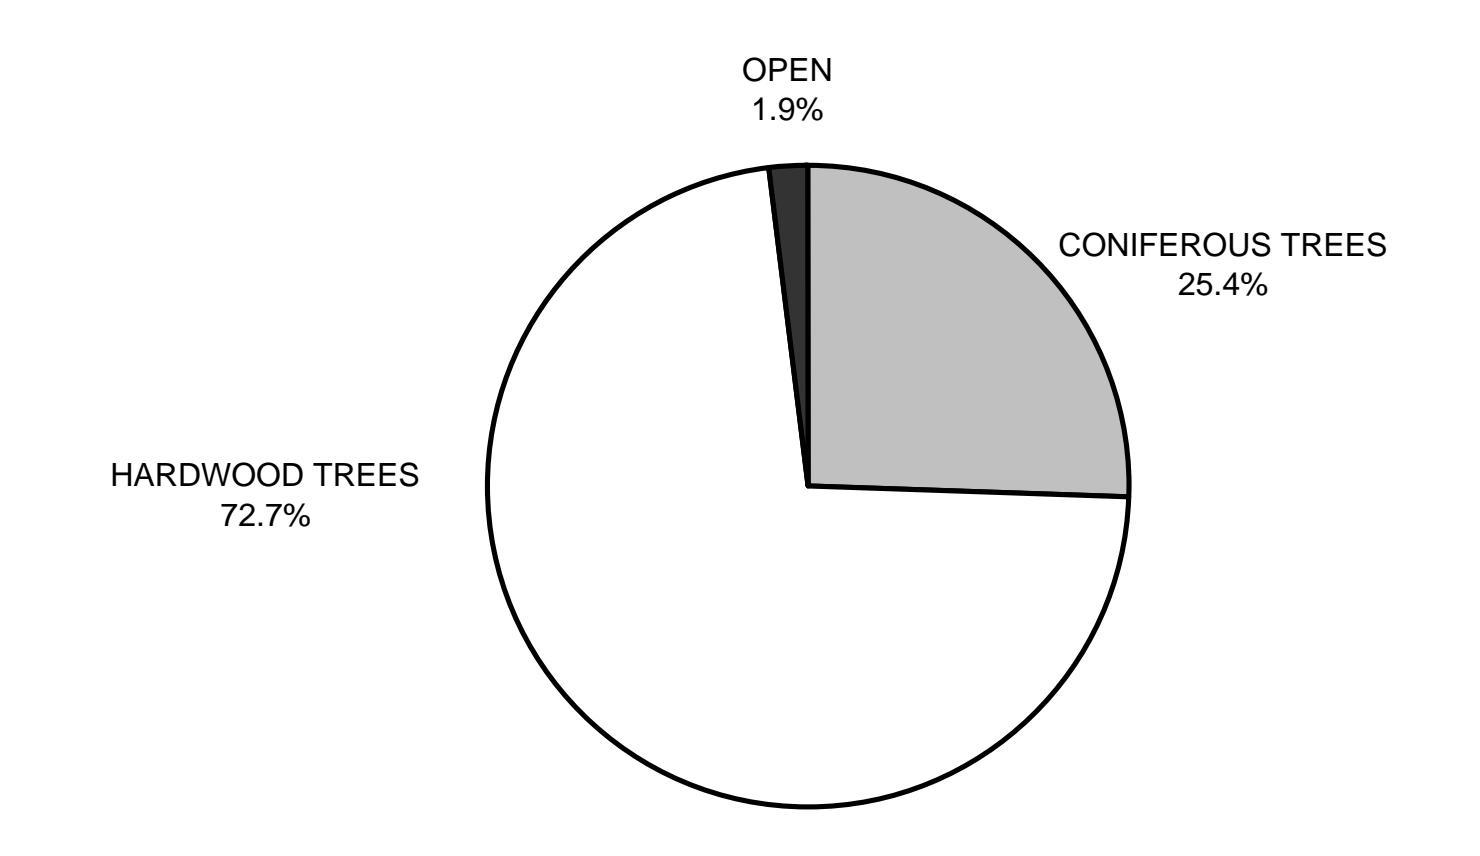
DUTCH CHARLIE CREEK 2007 MEAN PERCENT CANOPY

The mean percent canopy density for the surveyed length of Dutch Charlie Creek was 98%. Two percent of the canopy was open. Of the canopy present, the mean percentages of hardwood and coniferous trees were 73% and 25%, respectively. Graph 9 describes the mean percent total canopy in Dutch Charlie Creek.

The mean percent canopy density for the stream was 98%. Reach 1 had a canopy density of 98.9%, Reach 2 had a canopy density of 99.6% and Reach 3 had a canopy density of 97.9%. In general, revegetation projects are considered when canopy density is less than 80%.

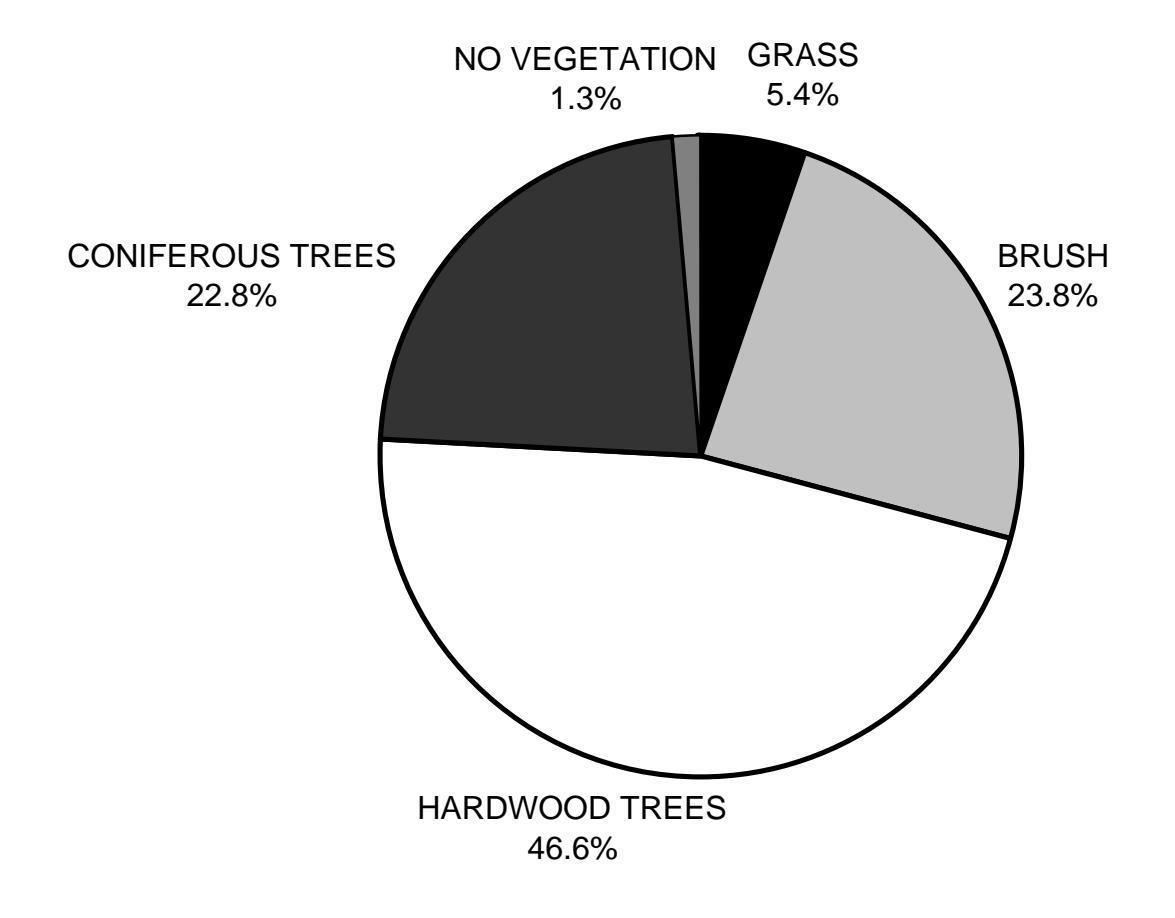
DUTCH CHARLIE CREEK 2007 DOMINANT BANK VEGETATION IN SURVEY REACH

For the stream reach surveyed, the mean percent right bank vegetated was 94%. The mean percent left bank vegetated was 94%. The dominant elements composing the structure of the stream banks consisted of 92% sand/silt/clay, 7% bedrock and 1% boulder (Graph 10). Deciduous trees were the dominant vegetation type observed in 47% of the units surveyed. Additionally, 23% of the units surveyed had coniferous trees as the dominant vegetation type and 24% had brush as the dominant vegetation (Graph 11).

The percentage of right and left bank covered with vegetation was 94% and 94%, respectively. In areas of stream bank erosion or where bank vegetation is sparse, planting endemic species of coniferous and hardwood trees, in conjunction with bank stabilization, is recommended.
