STREAM INVENTORY REPORT

Elk Creek

A stream inventory was conducted during July 3, 2007 to August 2, 2007 on Elk Creek. The survey began at the confluence with South Fork Eel River and extended upstream 4.1 miles. Stream inventories and reports to this report were also completed for two tributaries to Elk Creek.

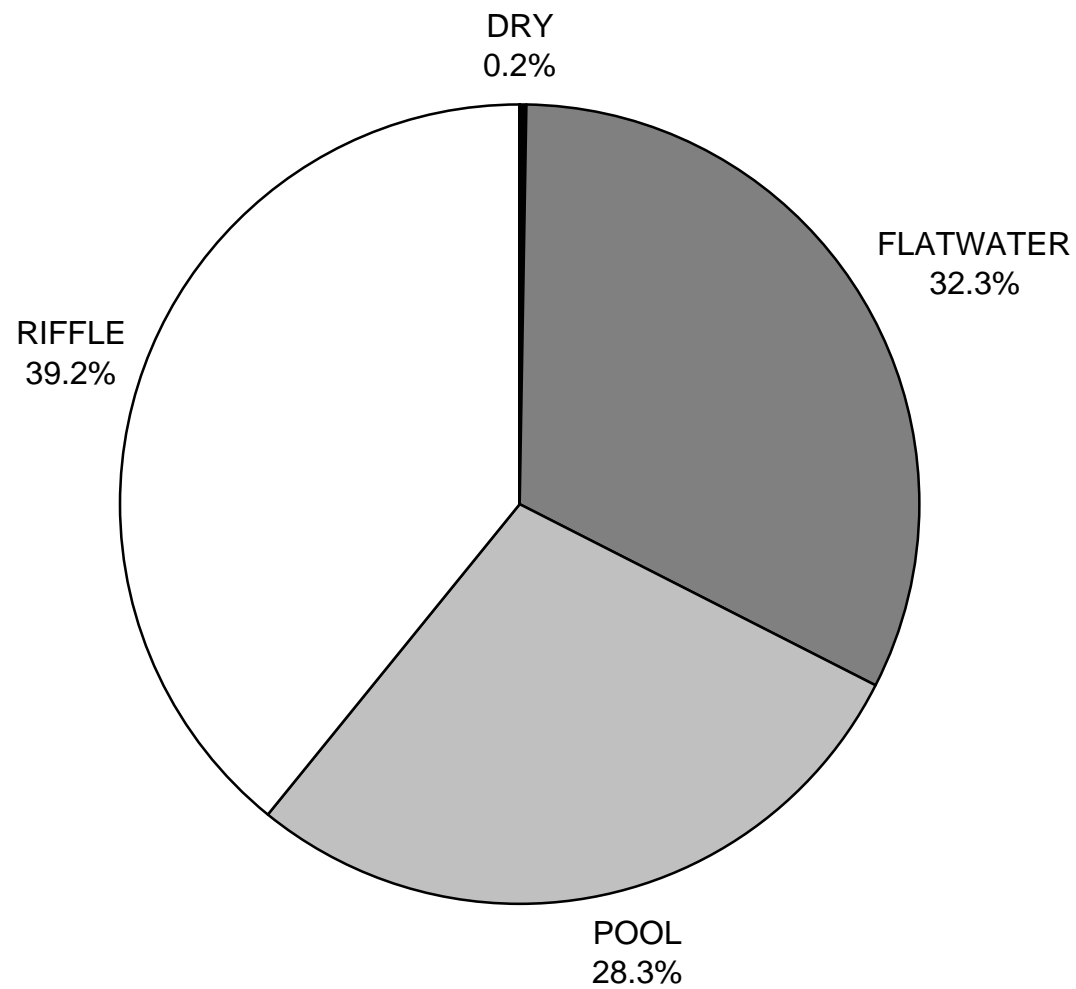
GRAPH 1

Table 1 summarizes the Level II riffle, flatwater, and pool habitat types. Based on frequency of occurrence there were 39% riffle units, 32% flatwater units, and 28% pool units (Graph 1). Based on total length of Level II habitat types there were 45% riffle units, 34% flatwater units, and 21% pool units (Graph 2).

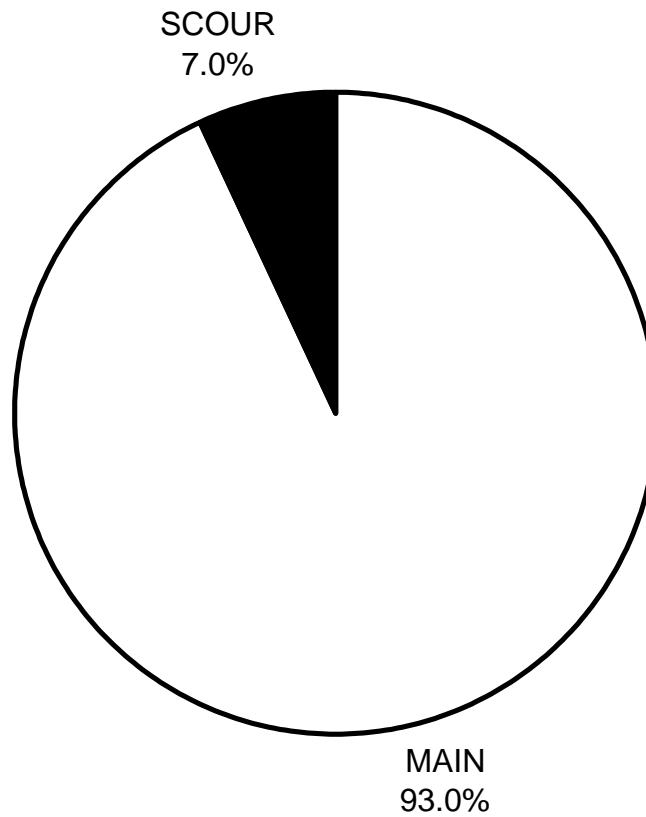
GRAPH 4

A total of 158 pools were identified, 157 were fully sampled (Table 3). Main channel pools were the most frequently encountered, at 93% (Graph 4), and comprised 94% of the total length of all pools (Table 3).

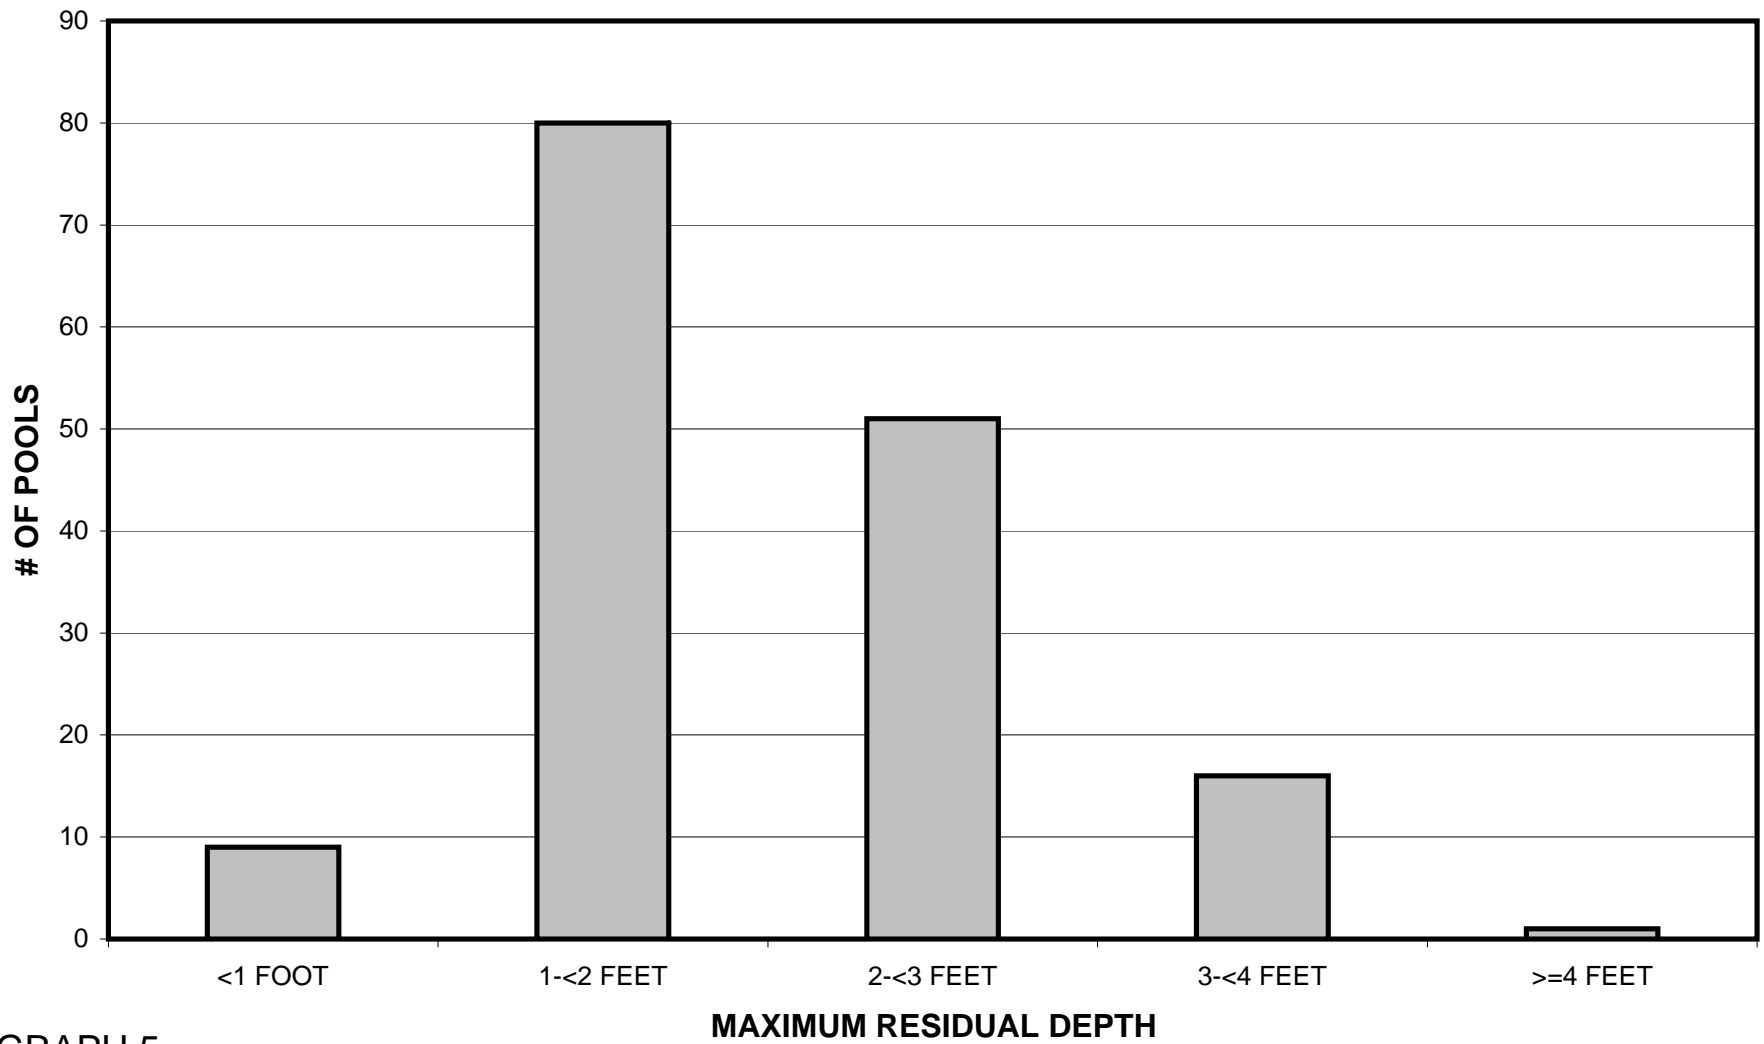
GRAPH 5

Table 4 is a summary of maximum residual pool depths by pool habitat types. Pool quality for salmonids increases with depth. Sixty-eight of the 157 pools (43%) had a residual depth of two feet or greater (Graph 5).

Flatwater habitat types comprised 34% of the total length of this survey, riffles 45%, and pools 21%. The pools are relatively shallow, with 68 of the 157 (43%) pools having a maximum residual depth greater than 2 feet. In general, pool enhancement projects are considered when primary pools comprise less than 40% of the length of total stream habitat. In first and second order streams, a primary pool is defined to have a maximum residual depth of at least two feet, occupy at least half the width of the low flow channel, and be as long as the low flow channel width. Installing structures that will increase or deepen pool habitat is recommended.

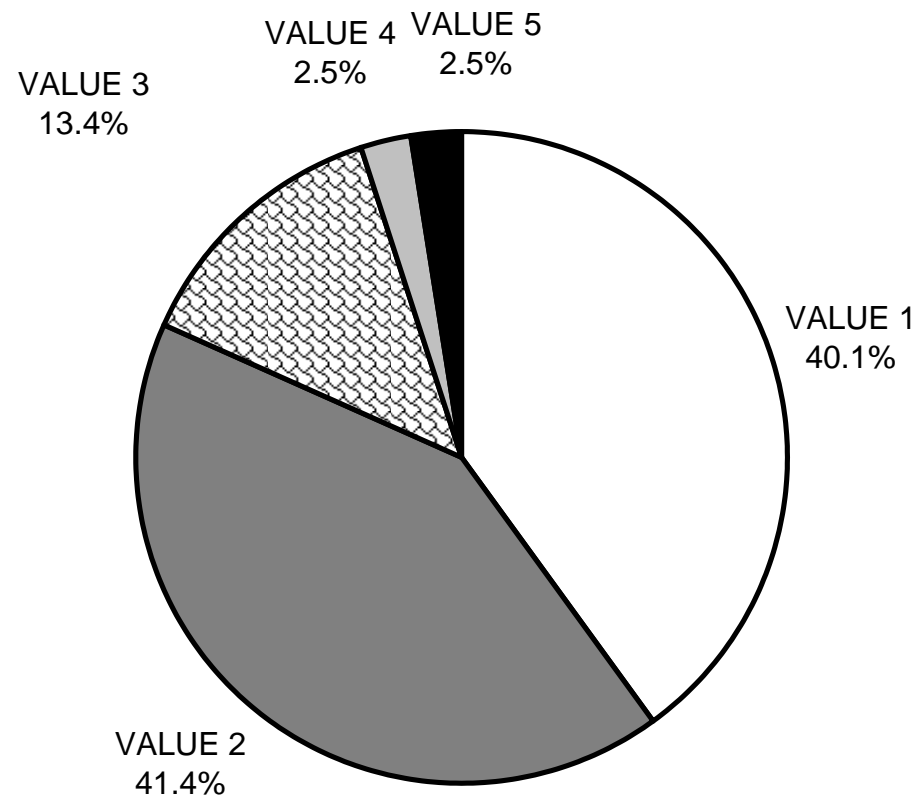
GRAPH 6

The depth of cobble embeddedness was estimated at pool tail-outs. Of the 157 pool tail-outs measured, 63 had a value of 1 (40.1%); 65 had a value of 2 (41.4%); 21 had a value of 3 (13.4%); 4 had a value of 4 (2.5%); 4 had a value of 5 (2.5%) (Graph 6). On this scale, a value of 1 indicates the best spawning conditions and a value of 4 the worst. Additionally, a value of 5 was assigned to tail-outs deemed unsuited for spawning due to inappropriate substrate such as bedrock, log sills, boulders, or other considerations.

One hundred and twenty-eight of the 157 pool tail-outs measured had embeddedness ratings of 1 or 2. Twenty-five of the pool tail-outs had embeddedness ratings of 3 or 4. Four of the pool tail-outs had a rating of 5, which is considered unsuitable for spawning. Cobble embeddedness measured to be 25% or less, a rating of 1, is considered to indicate good quality spawning substrate for salmon and steelhead.

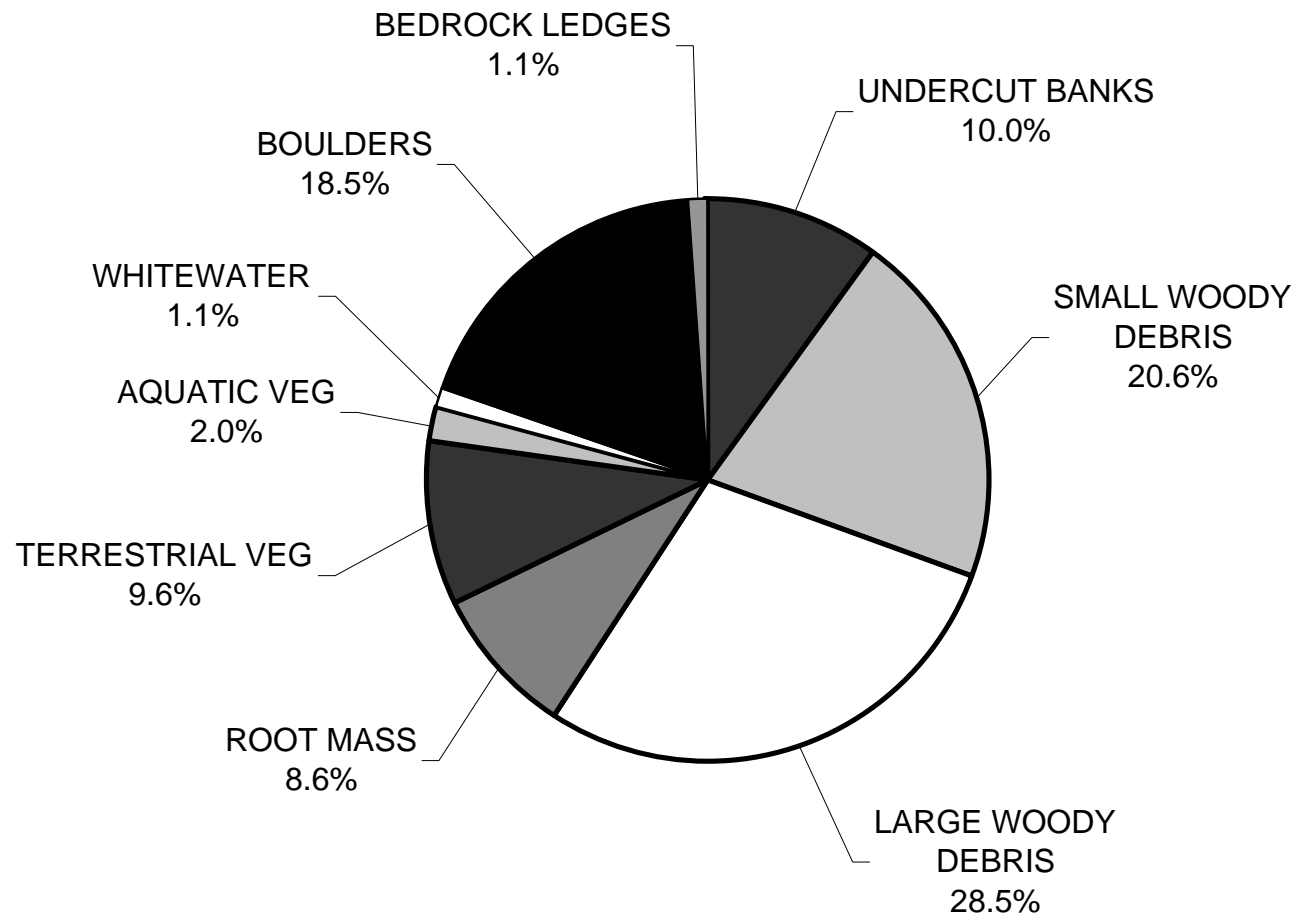
GRAPH 7

Table 5 summarizes mean percent cover by habitat type. Large woody debris is the dominant cover types in Elk Creek. Graph 7 describes the pool cover in Elk Creek. Large woody debris is the dominant pool cover type followed by small woody debris.

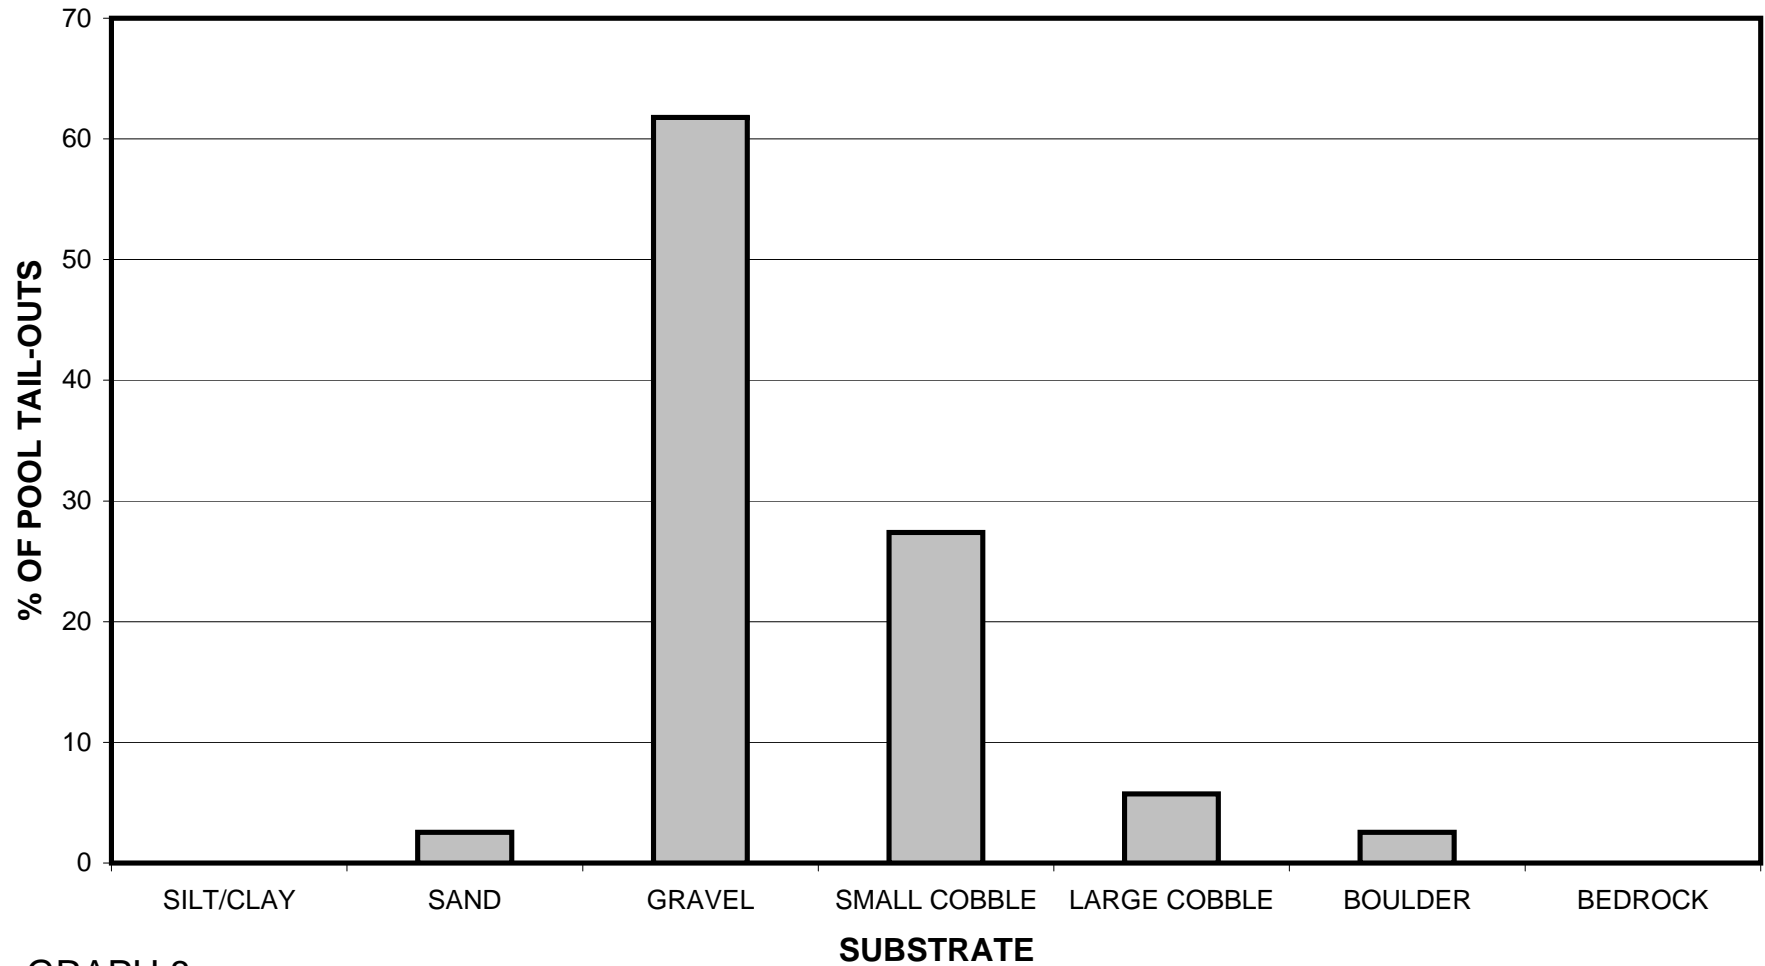
GRAPH 8

Table 6 summarizes the dominant substrate by habitat type. Graph 8 depicts the dominant substrate observed in pool tail-outs. Gravel was observed in 62% of pool tail-outs, and small cobble was observed in 27% of pool tail-outs.

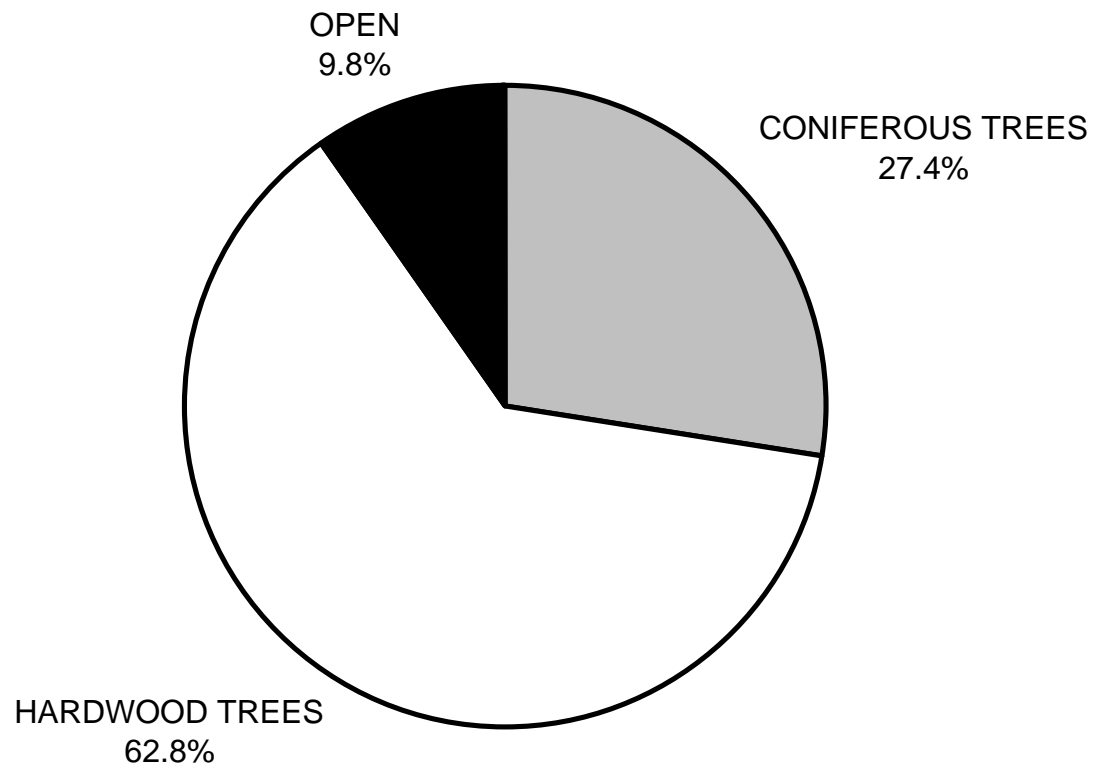
GRAPH 9

The mean percent canopy density for the surveyed length of Elk Creek was 90%. Ten percent of the canopy was open. Of the canopy present, the mean percentages of hardwood and coniferous trees were 70% and 30%, respectively. Graph 9 describes the mean percent canopy in Elk Creek.

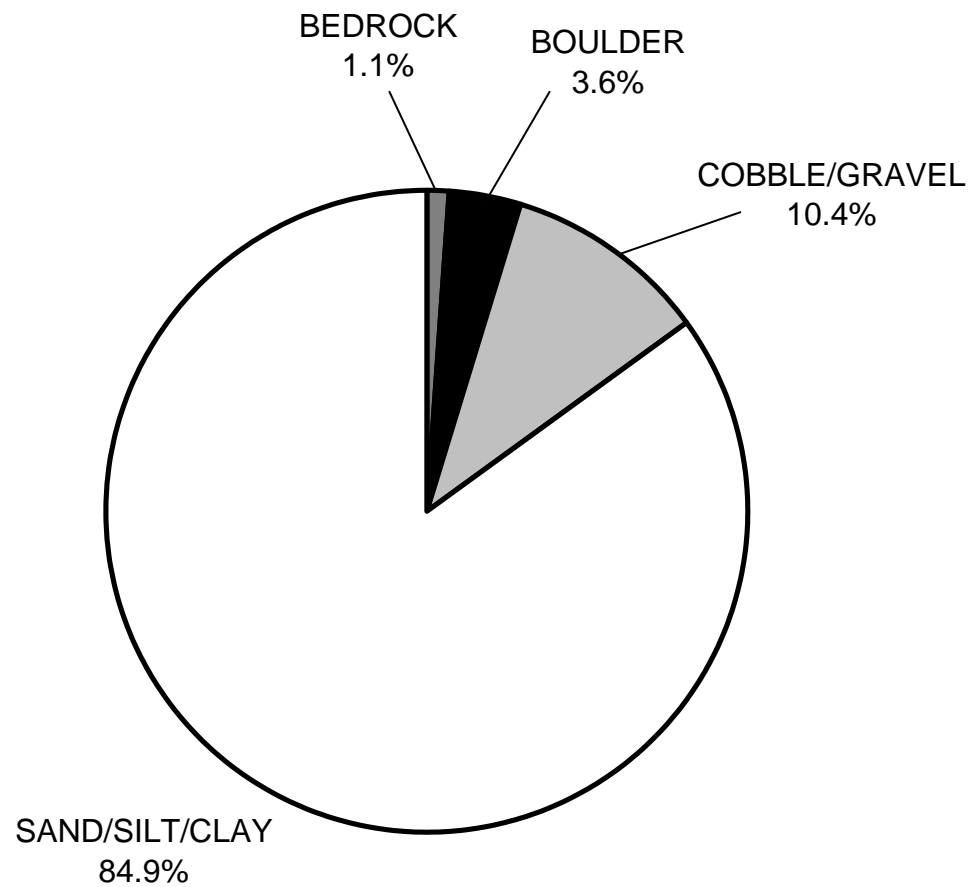
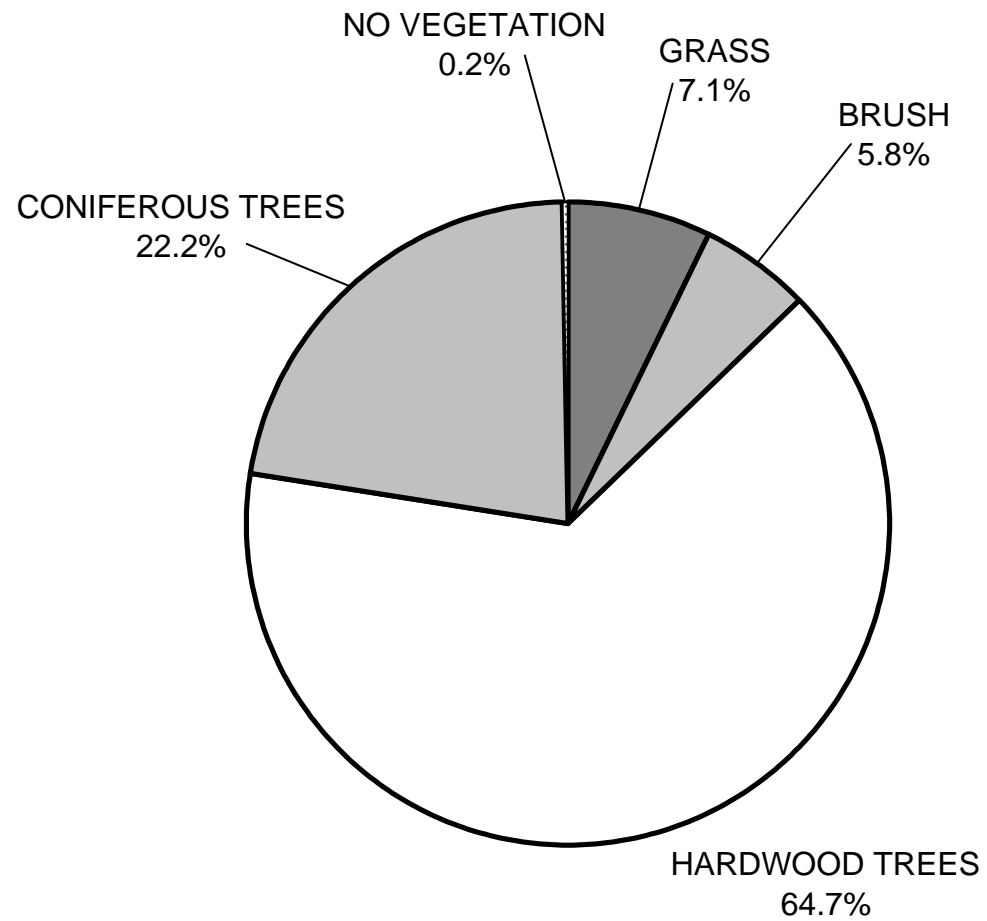
For the stream reach surveyed, the mean percent right bank vegetated was 78%. The mean percent left bank vegetated was 84%. The dominant elements composing the structure of the stream banks consisted of 85% sand/silt/clay, 10% cobble/gravel, 4% boulder, and 1% bedrock (Graph 10). Deciduous trees were the dominant vegetation type observed in 65% of the units surveyed. Additionally, 22% of the units surveyed had coniferous trees as the dominant vegetation type, and 7% had grass as the dominant vegetation (Graph 11).

The percentage of right and left bank covered with was high at 78% and 84%, respectively. In areas of stream bank erosion or where bank vegetation is sparse, planting endemic species of coniferous and hardwood trees, in conjunction with bank stabilization, is recommended.
