STREAM INVENTORY REPORT

Hartsook Creek

A stream inventory was conducted from June 1 to June 10, 2009 on Hartsook Creek. The survey began at the confluence with the South Fork Eel River and extended upstream 1.3 miles.

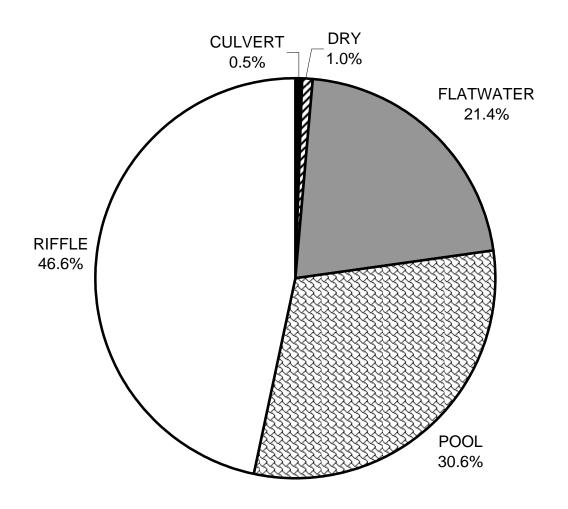
HARTSOOK CREEK 2009 HABITAT TYPES BY PERCENT OCCURRENCE

Table 1 summarizes the Level II riffle, flatwater, and pool habitat types. Based on frequency of occurrence there were 47% riffle units, 31% pool units, and 21% flatwater units (Graph 1). Based on total length of Level II habitat types there were 63% riffle units, 22% flatwater units, and 12% pool units (Graph 2).

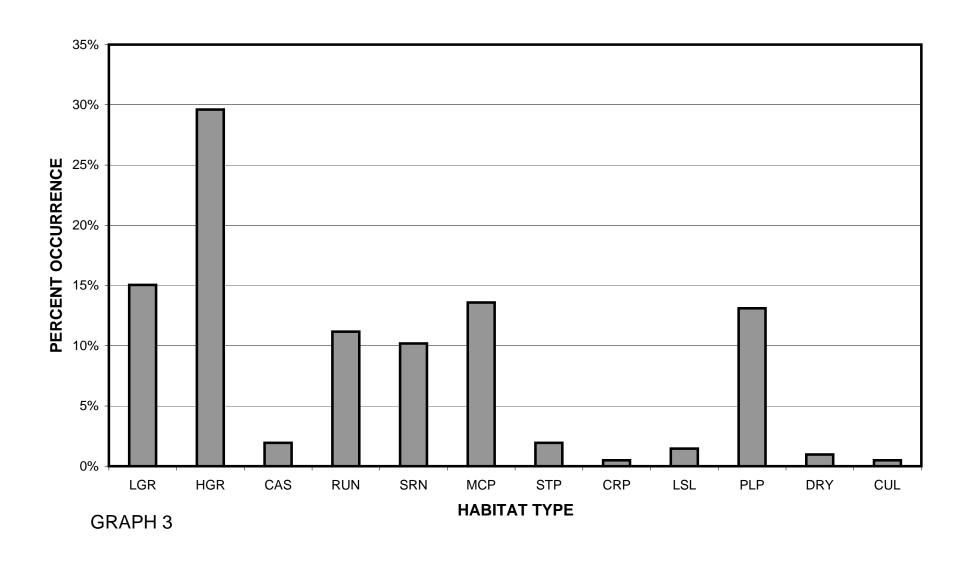
HARTSOOK CREEK 2009 HABITAT TYPES BY PERCENT OCCURRENCE

Eleven Level IV habitat types were identified (Table 2). The most frequent habitat types by percent occurrence were high gradient riffle units, 30%; low gradient riffle units, 15%; and midchannel pool units, 14% (Graph 3). Based on percent total length, high gradient riffle units made up 44%, step-run units 15%, and low gradient riffle units 14%.

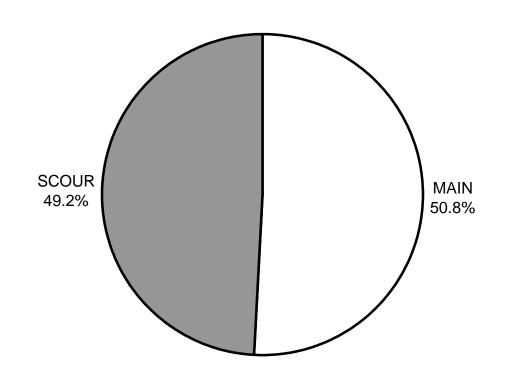
HARTSOOK CREEK 2009 POOL TYPES BY PERCENT OCCURRENCE

A total of 63 pools were identified (Table 3). Main channel pools were the most frequently encountered at 51% (Graph 4), and comprised 62% of the total length of all pools (Table 3).

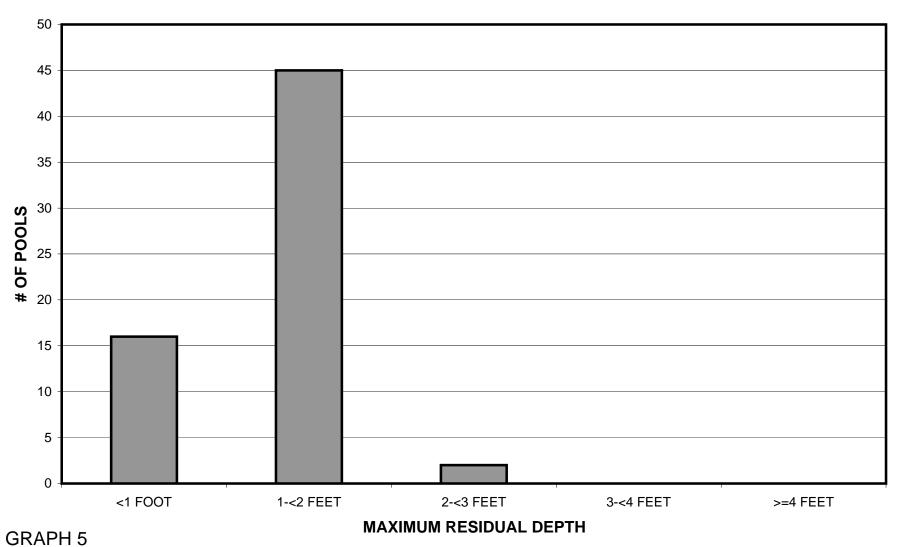
HARTSOOK CREEK 2009 MAXIMUM DEPTH IN POOLS

Table 4 is a summary of maximum residual pool depths by pool habitat types. Pool quality for salmonids increases with depth. Two of the 63 pools (3%) had a residual depth of two feet or greater (Graph 5).

Flatwater habitat types comprised 22% of the total length of this survey, riffles 63%, and pools 12%. Two of the 63 (3%) pools had a maximum residual depth greater than 2 feet. In general, pool enhancement projects are considered when primary pools comprise less than 40% of the length of total stream habitat. In first and second order streams, a primary pool is defined to have a maximum residual depth of at least two feet, occupy at least half the width of the low flow channel, and be as long as the low flow channel width. Installing structures in Reach 1 the B4 channel type that will increase or deepen pool habitat is recommended.

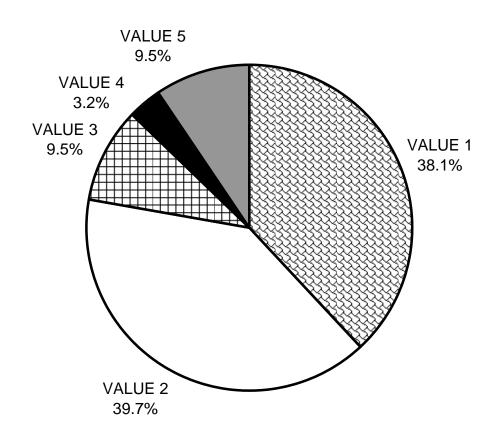
HARTSOOK CREEK 2009 PERCENT EMBEDDEDNESS

The depth of cobble embeddedness was estimated at pool tail-outs. Of the 63 pool tail-outs measured, 24 had a value of 1 (38.1%); 25 had a value of 2 (39.7%); 6 had a value of 3 (9.5%); 2 had a value of 4 (3.2%); 6 had a value of 5 (9.5%) (Graph 6). On this scale, a value of 1 indicates the best spawning conditions and a value of 4 the worst. Additionally, a value of 5 was assigned to tail-outs deemed unsuited for spawning due to inappropriate substrate such as bedrock, log sills, boulders, or other considerations.

Forty-nine of the 63 pool tail-outs measured had embeddedness ratings of 1 or 2. Eight of the pool tail-outs had embeddedness ratings of 3 or 4. Six of the pool tail-outs had a rating of 5, which is considered unsuitable for spawning. Cobble embeddedness measured to be 25% or less, a rating of 1, is considered to indicate good quality spawning substrate for salmon and steelhead.

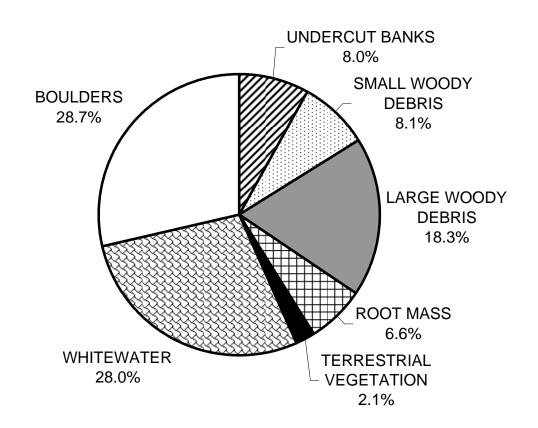
HARTSOOK CREEK 2009 MEAN PERCENT COVER TYPES IN POOLS

Table 5 summarizes mean percent cover by habitat type. Boulders are the dominant cover type in Hartsook Creek. Graph 7 describes the pool cover in Hartsook Creek. Boulders are the dominant pool cover type followed by whitewater.

The mean shelter rating for pools is 24. The shelter rating in the flatwater habitats is 2. A pool shelter rating of approximately 100 is desirable. The amount of cover that now exists is being provided primarily by boulders in Hartsook Creek. Boulders are the dominant cover type in pools followed by whitewater. Log and root wad cover structures in the pool and flatwater habitats would enhance both summer and winter salmonid habitat. Log cover structure provides rearing fry with protection from predation, rest from water velocity, and also divides territorial units to reduce density related competition.

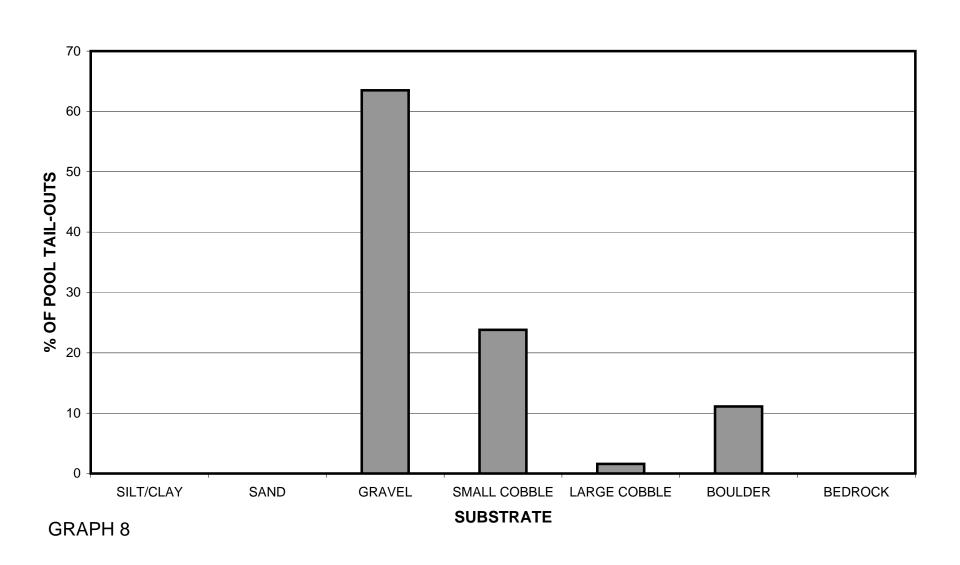
HARTSOOK CREEK 2009 SUBSTRATE COMPOSITION IN POOL TAIL-OUTS

Table 6 summarizes the dominant substrate by habitat type. Graph 8 depicts the dominant substrate observed in pool tail-outs. Gravel was the dominant substrate observed in 63% percent of the pool tail-outs. Small cobble was the next most frequently observed dominant substrate type and occurred in 24% of the pool tail-outs.

Fifty-five of the 63 pool tail-outs measured had gravel or small cobble as the dominant substrate. This is generally considered good for spawning salmonids.

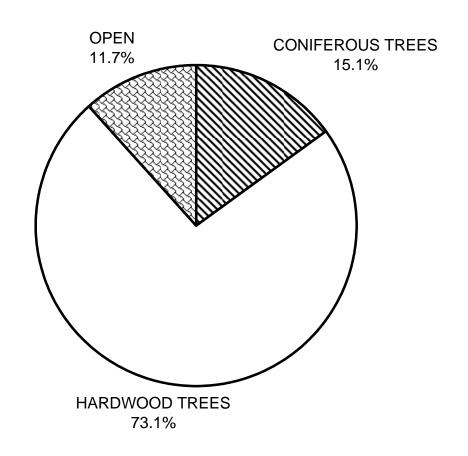
HARTSOOK CREEK 2009 MEAN PERCENT CANOPY

The mean percent canopy density for the surveyed length of Hartsook Creek was 88%. Twelve percent of the canopy was open. Of the canopy present, the mean percentages of hardwood and coniferous trees were 83% and 17%, respectively. Graph 9 describes the mean percent canopy in Hartsook Creek.

The mean percent canopy density for the stream was 88%. Reach 1 had a canopy density of 85%, reach 2 had a canopy density of 94%. In general, revegetation projects are considered when canopy density is less than 80%.

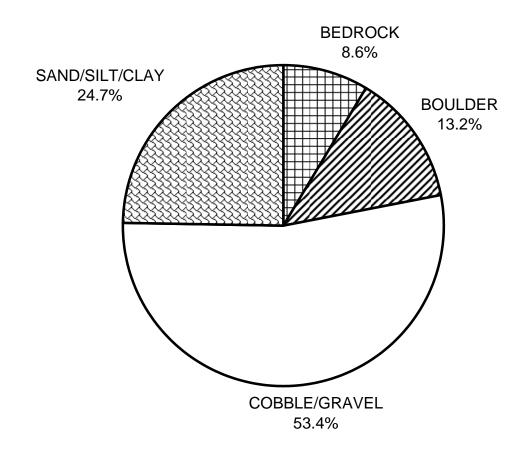
HARTSOOK CREEK 2009 DOMINANT BANK COMPOSITION IN SURVEY REACH

For the stream reach surveyed, the mean percent right bank vegetated was 92%. The mean percent left bank vegetated was 93%. The dominant elements composing the structure of the stream banks consisted of 53% cobble/gravel, 25% sand/silt/clay, 13% boulder, and 9% bedrock (Graph 10). Brush was the dominant vegetation type observed in 47% of the units surveyed. Additionally, 31% of the units surveyed had deciduous trees as the dominant vegetation type, and 14% had coniferous trees as the dominant vegetation type (Graph 11).

The percentage of right and left bank covered with vegetation was 92% and 93%, respectively. In areas of stream bank erosion or where bank vegetation is sparse, planting endemic species of coniferous and hardwood trees, in conjunction with bank stabilization, is recommended.
