# **STREAM INVENTORY REPORT**

## **Milk Ranch Creek**

A stream inventory was conducted during July 16, 2007 to July 25, 2007 on Milk Ranch Creek. The survey began at the confluence with South Fork Eel River and extended upstream 1.5 miles.

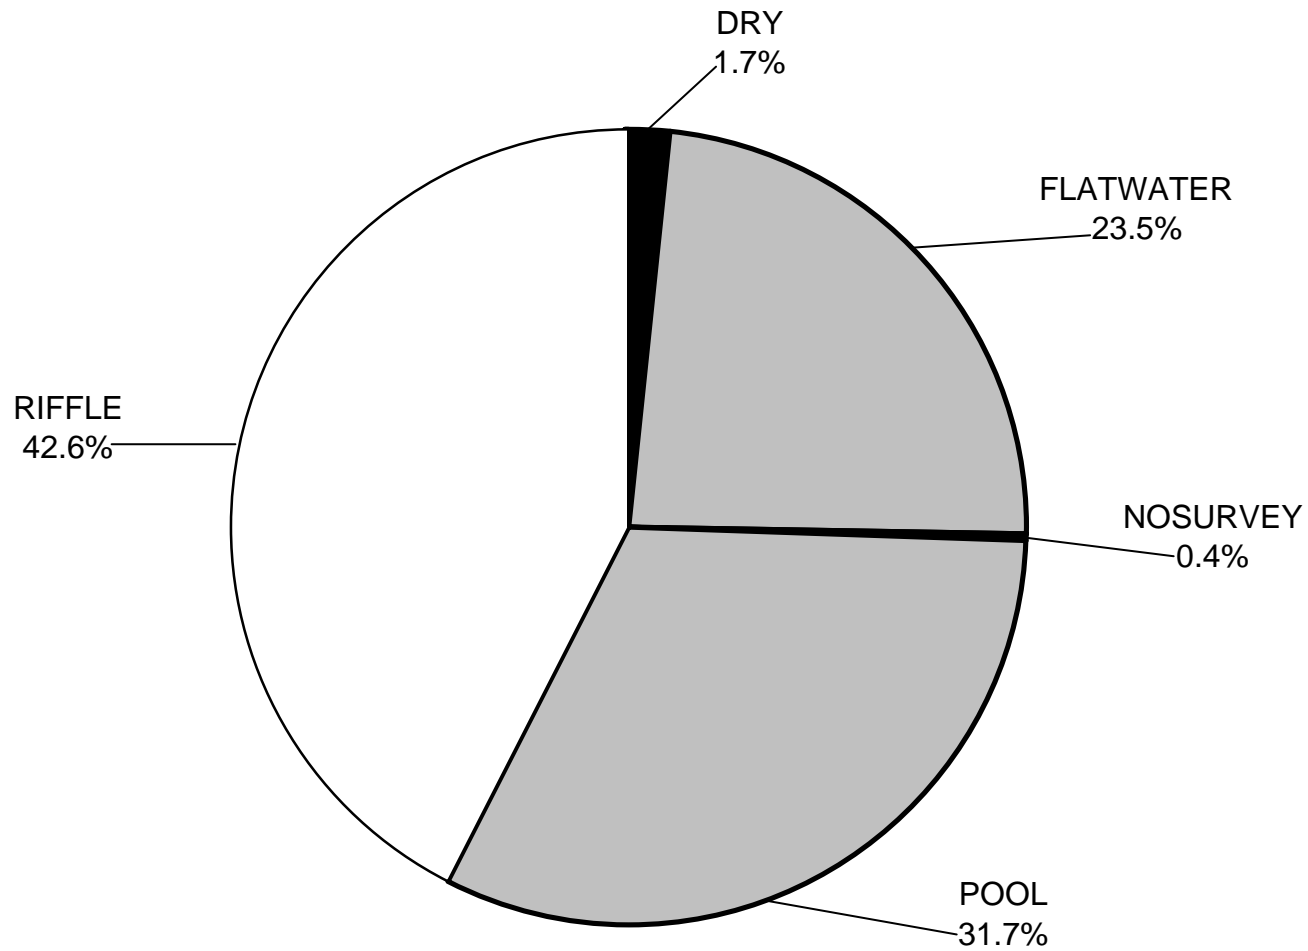
GRAPH 1

Table 1 summarizes the Level II riffle, flatwater, and pool habitat types. Based on frequency of occurrence there were 43% riffle units, 32% pool units, 23% flatwater units, 2% dry units, 0.4% no-survey units (Graph 1). Based on total length of Level II habitat types there were 53% riffle units, 25% flatwater units, 17% pool units, 4% dry units, and 0.1% no-survey units (Graph 2).

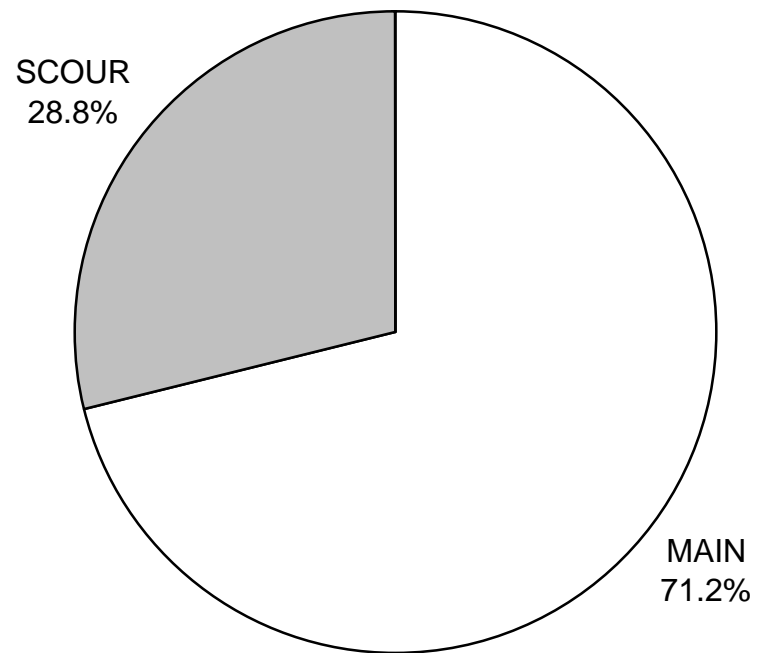
GRAPH 4

A total of 73 pools were identified (Table 3). Main channel pools were the most frequently encountered, at 71% (Graph 4), and comprised 75% of the total length of all pools (Table 3).

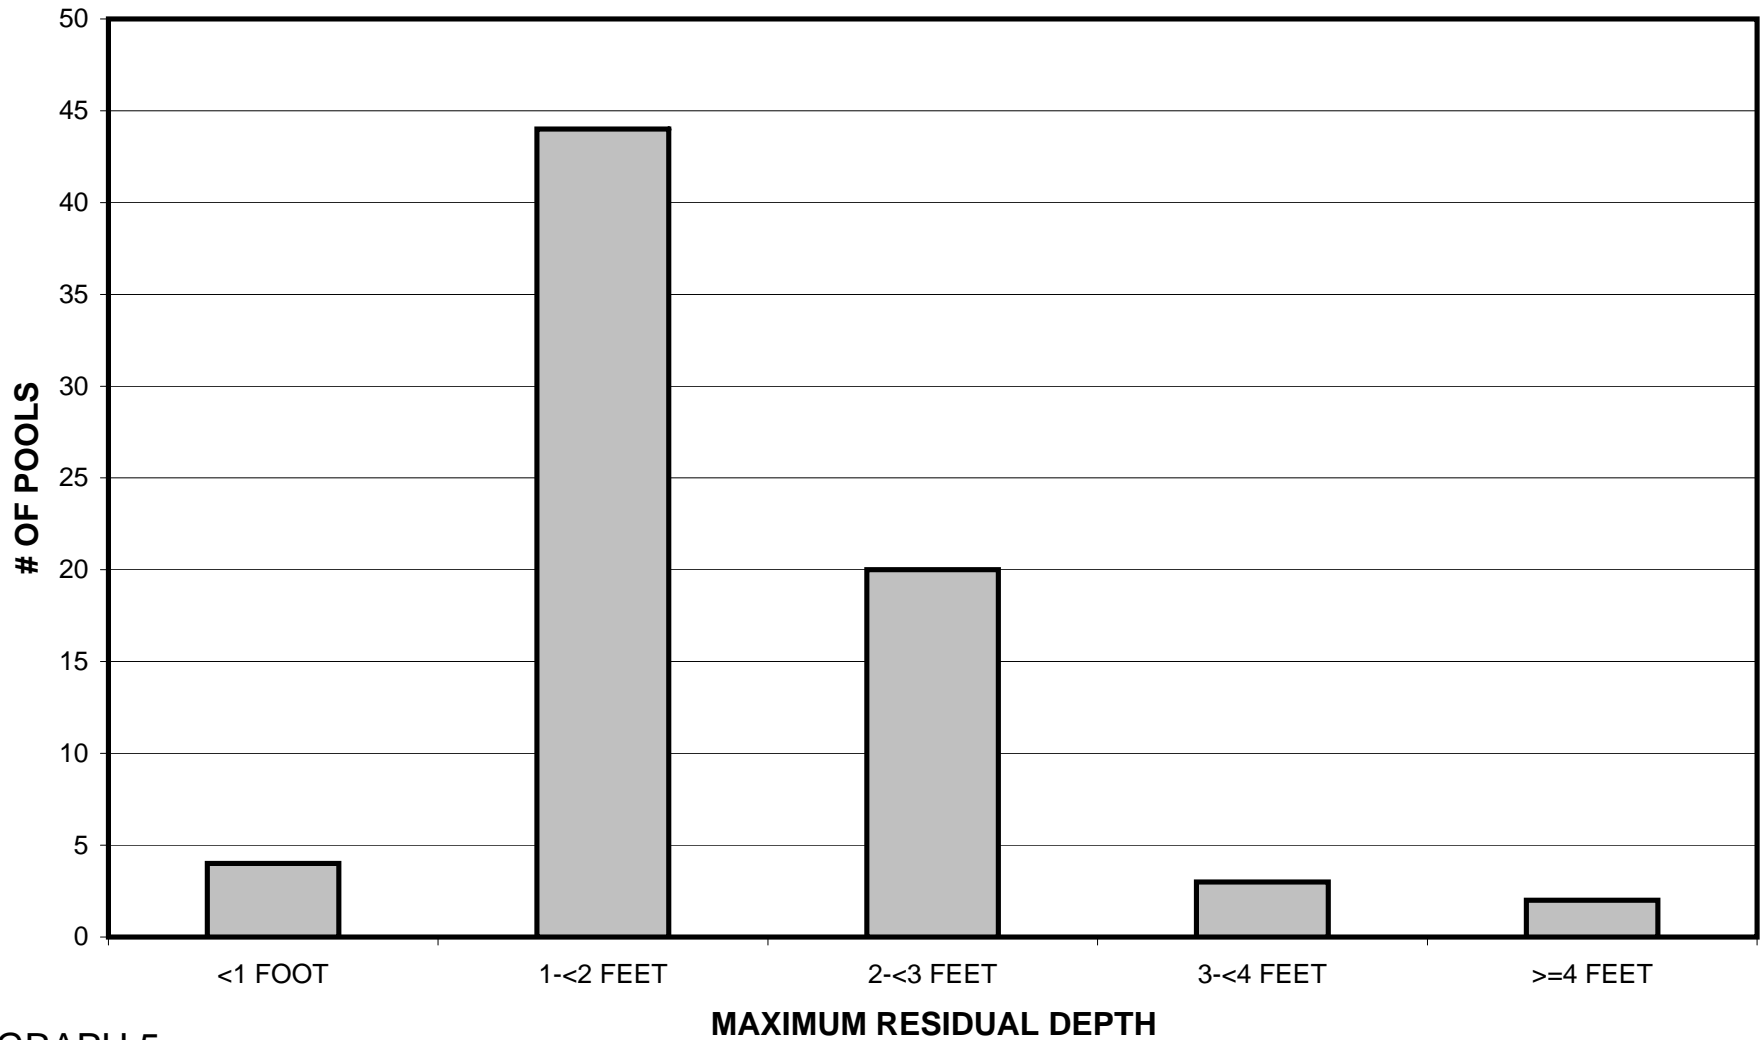
GRAPH 5

Table 4 is a summary of maximum residual pool depths by pool habitat types. Pool quality for salmonids increases with depth. Twenty-five of the 73 pools (34%) had a residual depth of two feet or greater (Graph 5).

Flatwater habitat types comprised 25% of the total length of this survey, riffles 53%, and pools 17%. The pools are relatively shallow, with only 25 of the 73 (34%) pools having a maximum residual depth greater than 2 feet. In general, pool enhancement projects are considered when primary pools comprise less than 40% of the length of total stream habitat. In first and second order streams, a primary pool is defined to have a maximum residual depth of at least two feet, occupy at least half the width of the low flow channel, and be as long as the low flow channel width. Installing structures that will increase or deepen pool habitat is recommended for Reach 1.

- 3) In Reach 1, design and engineer pool enhancement structures to increase the number of pools. This must be done where the banks are stable or in conjunction with stream bank armor to prevent erosion.

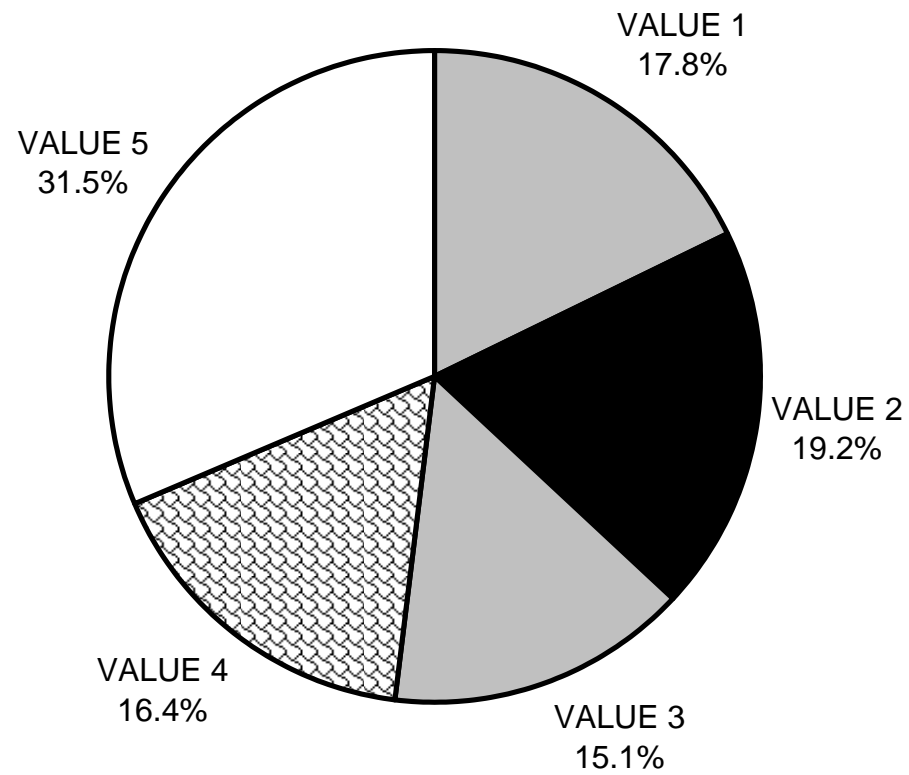
GRAPH 6

The depth of cobble embeddedness was estimated at pool tail-outs. Of the 73 pool tail-outs measured, 13 had a value of 1 (17.8%); 14 had a value of 2 (19.2%); 11 had a value of 3 (15.1%); 12 had a value of 4 (16.4%); 23 had a value of 5 (31.5%) (Graph 6). On this scale, a value of 1 indicates the best spawning conditions and a value of 4 the worst. Additionally, a value of 5 was assigned to tail-outs deemed unsuited for spawning due to inappropriate substrate such as bedrock, log sills, boulders, or other considerations.

Twenty-seven of the 73 pool tail-outs measured had embeddedness ratings of 1 or 2. Twenty-three of the pool tail-outs had embeddedness ratings of 3 or 4. Twenty-three of the pool tail-outs had a rating of 5, which is considered unsuitable for spawning. Cobble embeddedness measured to be 25% or less, a rating of 1, is considered to indicate good quality spawning substrate for

salmon and steelhead. Sediment sources in Milk Ranch Creek should be mapped and rated according to their potential sediment yields, and control measures should be taken.

- 5) Inventory and map sources of stream bank erosion and prioritize them according to present and potential sediment yield. Identified sites should then be treated to reduce the amount of fine sediments entering the stream.

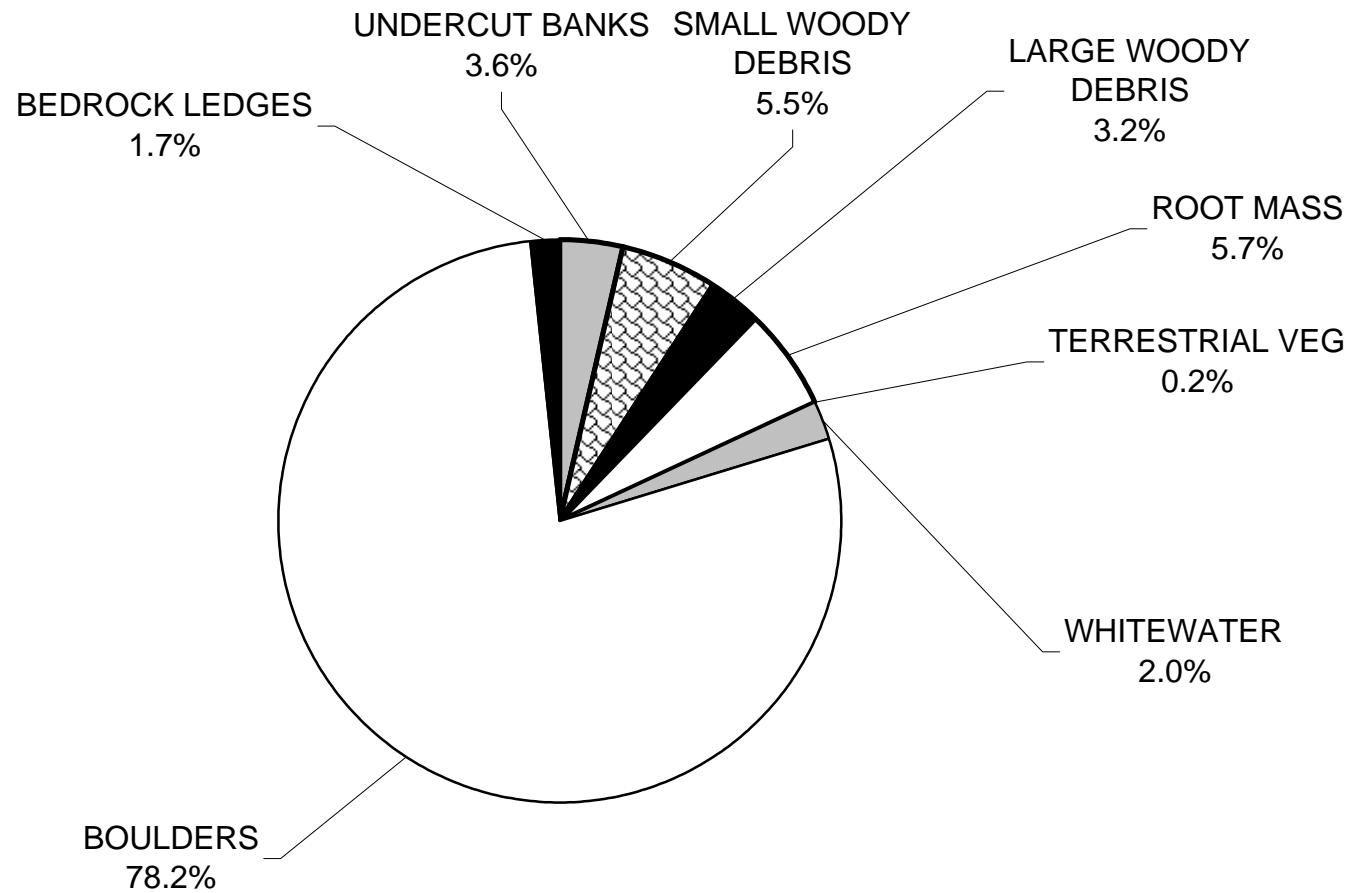
GRAPH 7

Table 5 summarizes mean percent cover by habitat type. Boulders are the dominant cover types in Milk Ranch Creek. Graph 7 describes the pool cover in Milk Ranch Creek. Boulders are the dominant pool cover type followed by root mass.

The mean shelter rating for pools was 18. The shelter rating in the flatwater habitats was 9. A pool shelter rating of approximately 100 is desirable. The amount of cover that now exists is being provided primarily by boulders in Milk Ranch Creek. Boulders are the dominant cover type in pools followed by root mass. Log and root wad cover structures in the pool and flatwater habitats would enhance both summer and winter salmonid habitat. Log cover structure provides rearing fry with protection from predation, rest from water velocity, and also divides territorial units to reduce density related competition.

- 4) Increase woody cover in the pools and flatwater habitat units. Most of the existing cover in the pools is from boulders. Adding high quality complexity with woody cover in the pools is desirable.

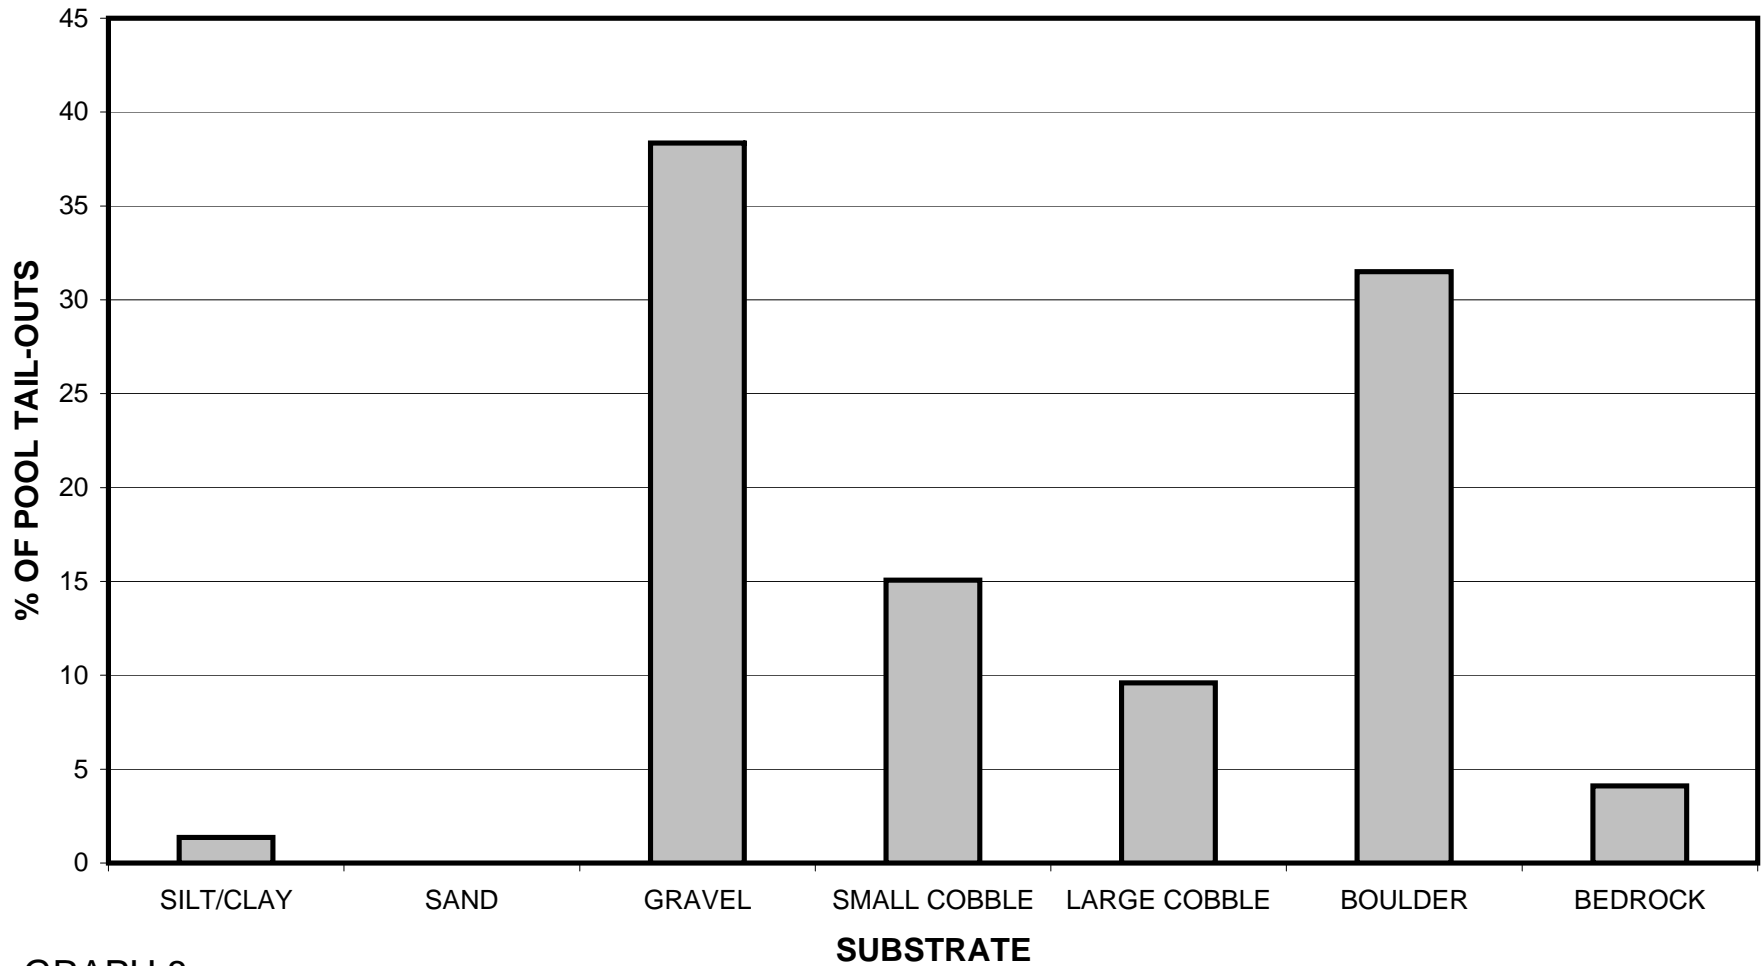
GRAPH 8

Table 6 summarizes the dominant substrate by habitat type. Graph 8 depicts the dominant substrate observed in pool tail-outs. Gravel was observed in 38% of pool tail-outs, and boulders were observed in 32% of pool tail-outs.

Thirty-four of the 73 pool tail-outs had silt, sand, large cobble, boulders or bedrock as the dominant substrate. This is generally considered unsuitable for spawning salmonids.

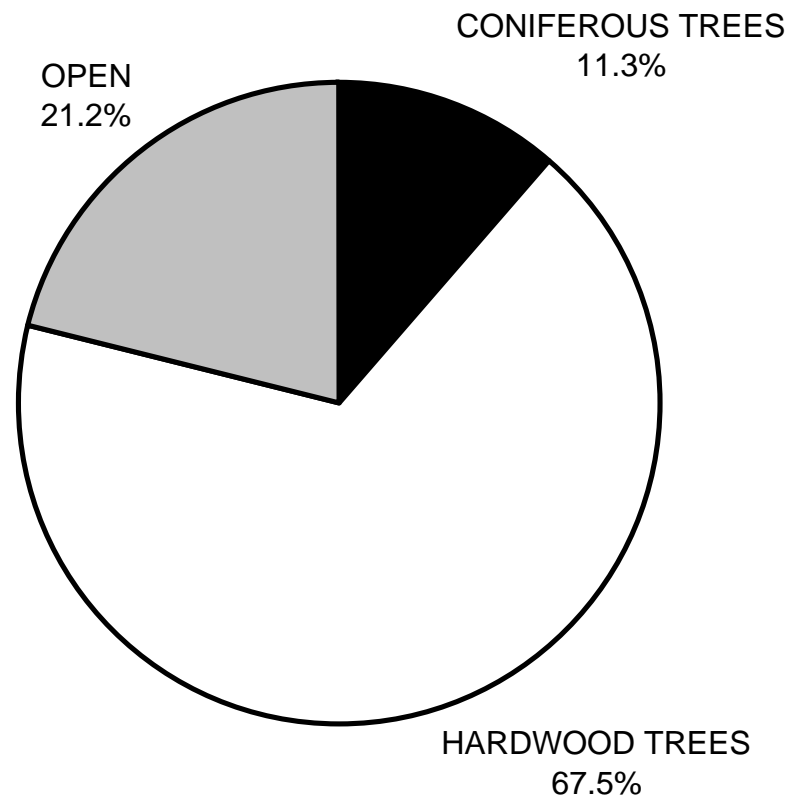
GRAPH 9

The mean percent canopy density for the surveyed length of Milk Ranch Creek was 79%. Twenty-one percent of the canopy was open. Of the canopy present, the mean percentages of hardwood and coniferous trees were 86% and 14%, respectively. Graph 9 describes the mean percent canopy in Milk Ranch Creek.

The mean percent canopy density for the stream was 79%. Reach 1 had a canopy density of 76.3%, Reach 2 had a canopy density of 80.7%. In general, revegetation projects are considered when canopy density is less than 80%.

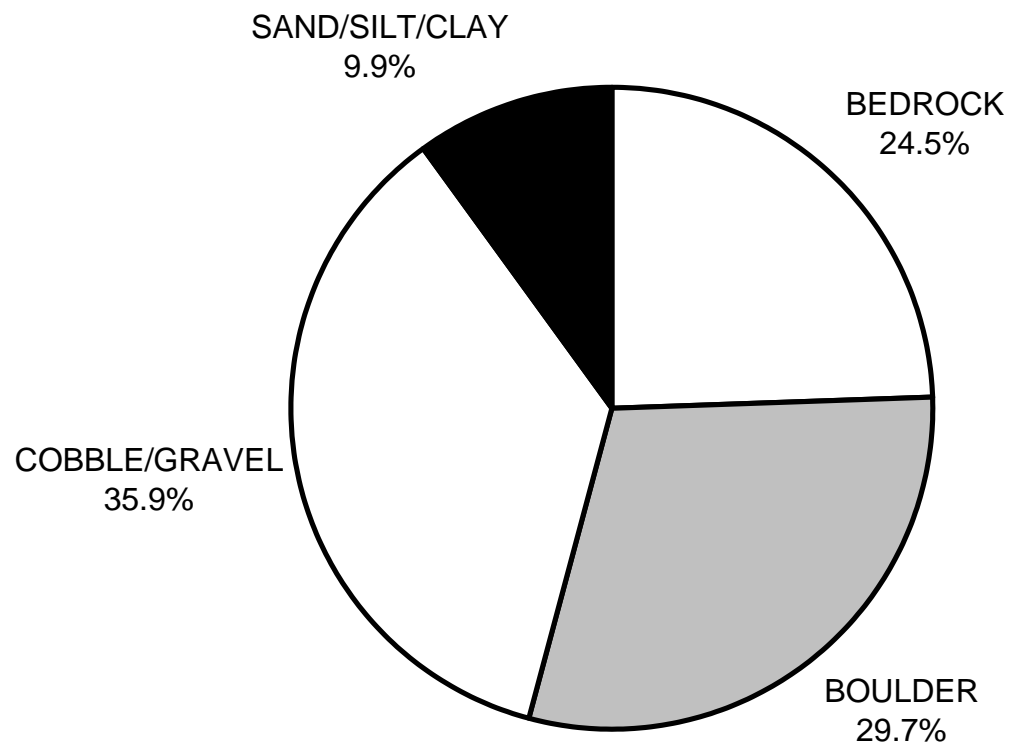
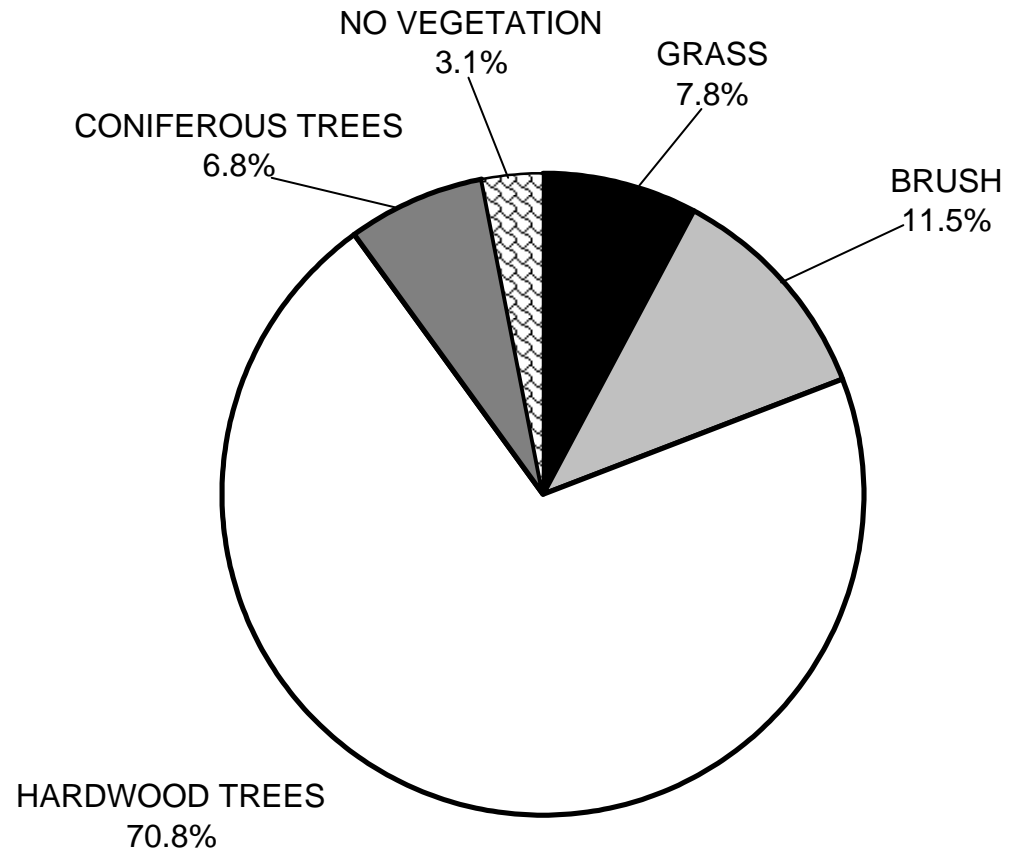
For the stream reach surveyed, the mean percent right bank vegetated was 90%. The mean percent left bank vegetated was 94%. The dominant elements composing the structure of the stream banks consisted of 36% cobble/gravel, 30% boulder, 24% bedrock, and 10% sand/silt/clay (Graph 10). Deciduous trees were the dominant vegetation type observed in 71% of the units surveyed. Additionally, 11% of the units surveyed had brush as the dominant vegetation type, 8% had grass as the dominant vegetation, and 7% had coniferous trees (Graph 11).

The percentage of right and left bank covered with vegetation was high at 90% and 94%, respectively. In areas of stream bank erosion or where bank vegetation is sparse, planting endemic species of coniferous and hardwood trees, in conjunction with bank stabilization, is recommended.
