STREAM INVENTORY REPORT

Mill Creek

A stream inventory was conducted during June 4, 2007 to June 13, 2007 on Mill Creek. The survey began at the confluence with Bull Creek and extended upstream 1.2 miles.

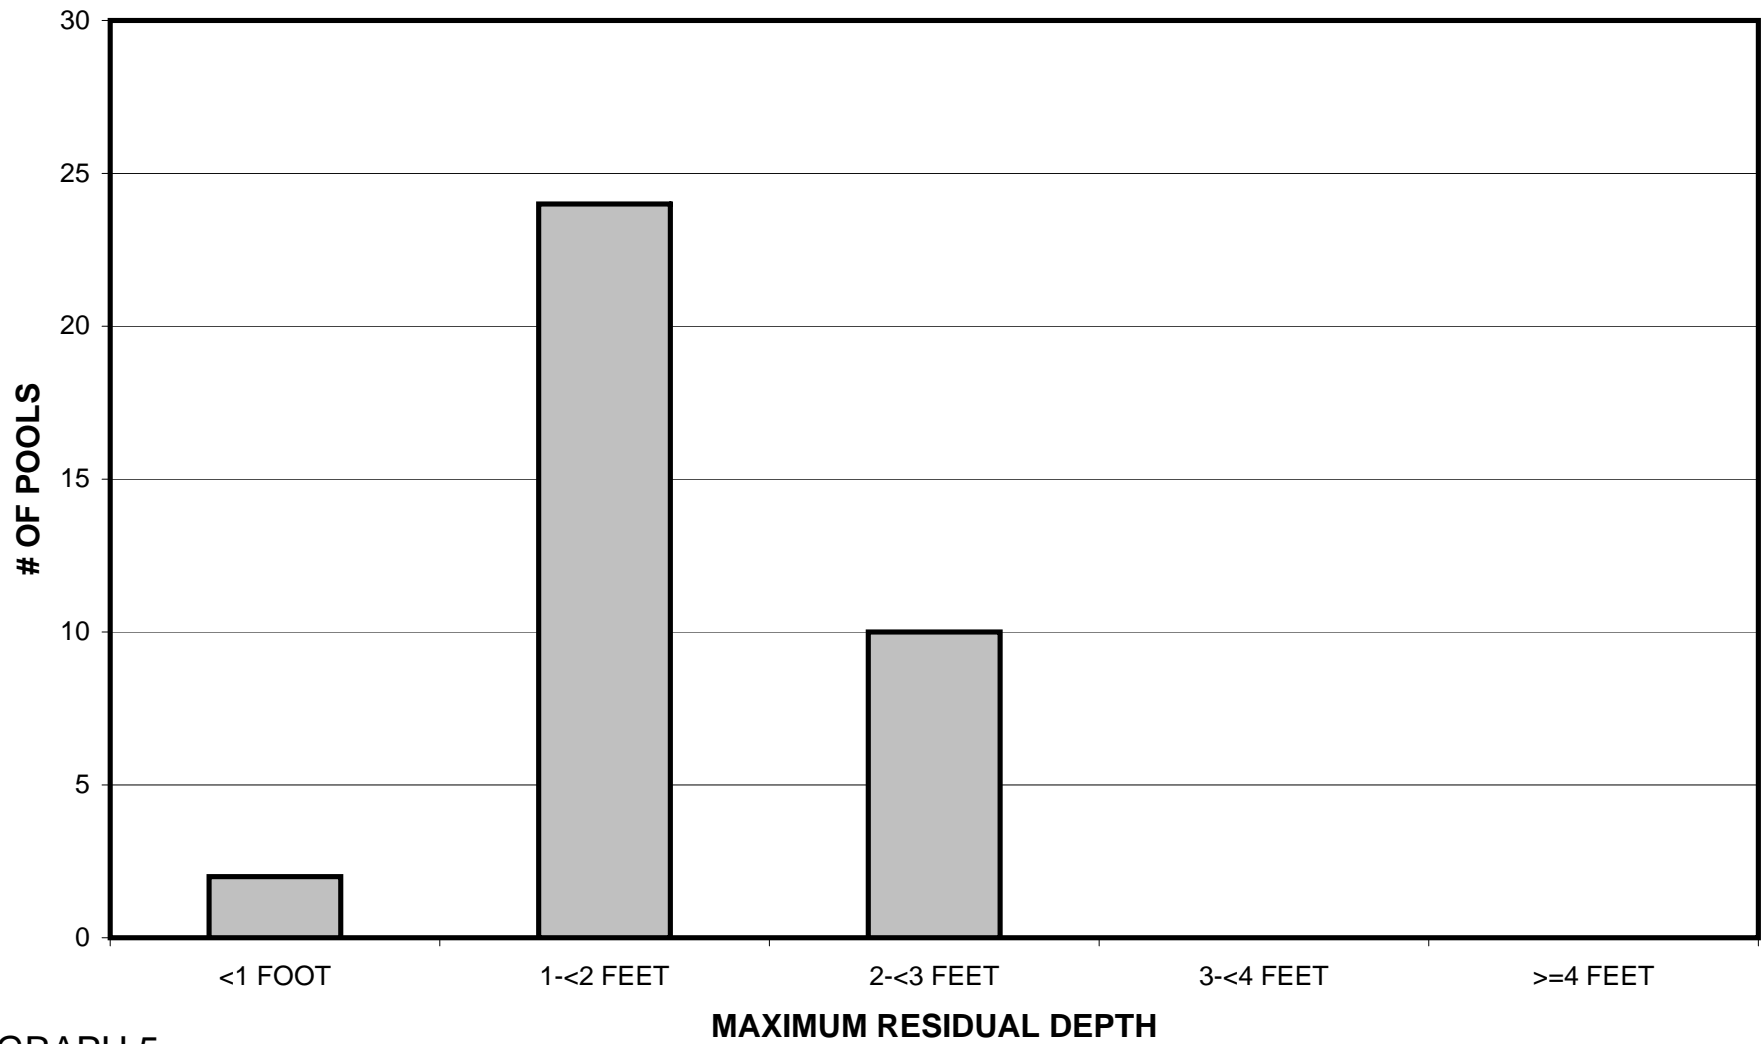
GRAPH 5

Table 4 is a summary of maximum residual pool depths by pool habitat types. Pool quality for salmonids increases with depth. Ten of the 36 pools (28%) had a residual depth of two feet or greater (Graph 5).

Flatwater habitat types comprised 9% of the total length of this survey, riffles 66%, and pools 24%. The pools are relatively shallow with only 10 of the 36 (28%) pools had a maximum residual depth greater than 2 feet. In general, pool enhancement projects are considered when primary pools comprise less than 40% of the length of total stream habitat. In first and second order streams, a primary pool is defined to have a maximum residual depth of at least two feet, occupy at least half the width of the low flow channel, and be as long as the low flow channel width. Installing structure that will increase or deepen pool habitat is recommended for Reaches 1 and 2.

- 1) Mill Creek should be managed as an anadromous, natural production stream.
- 2) In Reach 1 and 2, design and engineer pool enhancement structures to increase the number of pools. This must be done where the banks are stable or in conjunction with stream bank armor to prevent erosion.

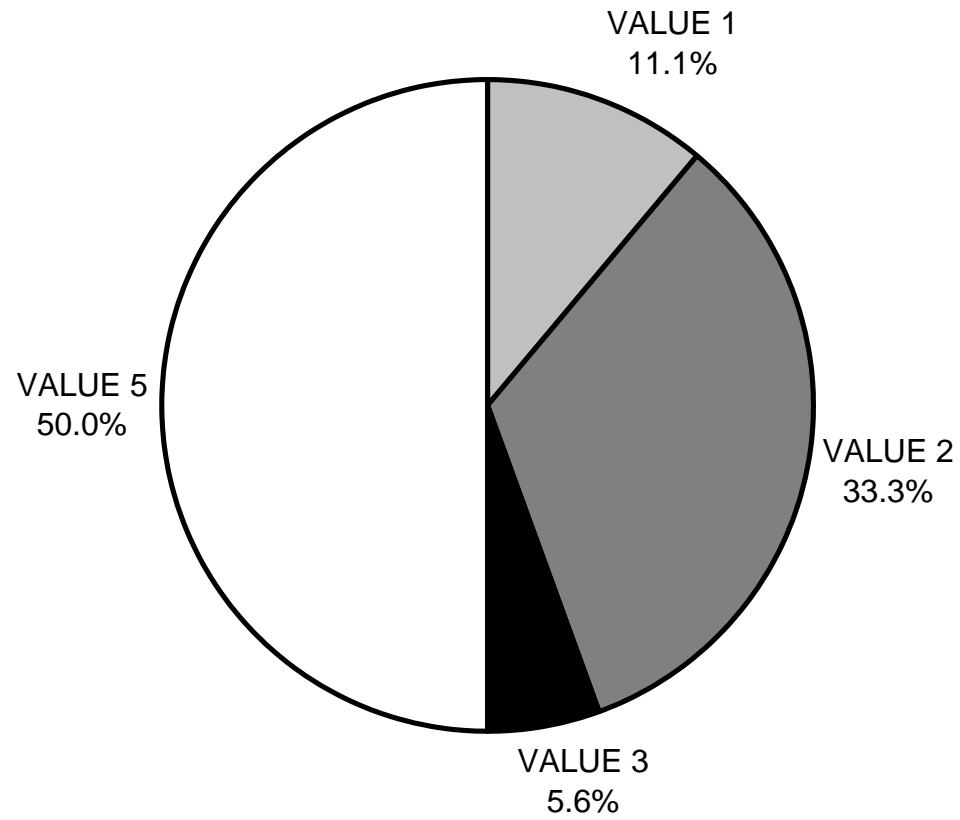
GRAPH 6

The depth of cobble embeddedness was estimated at pool tail-outs. Of the 36 pool tail-outs measured, 4 had a value of 1 (11.1%); 12 had a value of 2 (33.3%); 2 had a value of 3 (5.6%); 18 had a value of 5 (50%); (Graph 6). On this scale, a value of 1 indicates the best spawning conditions and a value of 4 the worst. Additionally, a value of 5 was assigned to tail-outs deemed unsuited for spawning due to inappropriate substrate such as bedrock, log sills, boulders, or other considerations.

Sixteen of the 36 pool tail-outs measured had embeddedness ratings of 1 or 2. Two of the pool tail-outs had embeddedness ratings of 3 or 4. Eighteen of the pool tail-outs had a rating of 5, which is considered unsuitable for spawning. Cobble embeddedness measured to be 25% or less,

a rating of 1, is considered to indicate good quality spawning substrate for salmon and steelhead. Sediment sources in Mill Creek should be mapped and rated according to their potential sediment yields, and control measures should be taken.

- 4) Inventory and map sources of stream bank erosion and prioritize them according to present and potential sediment yield. Identified sites should then be treated to reduce the amount of fine sediments entering the stream.

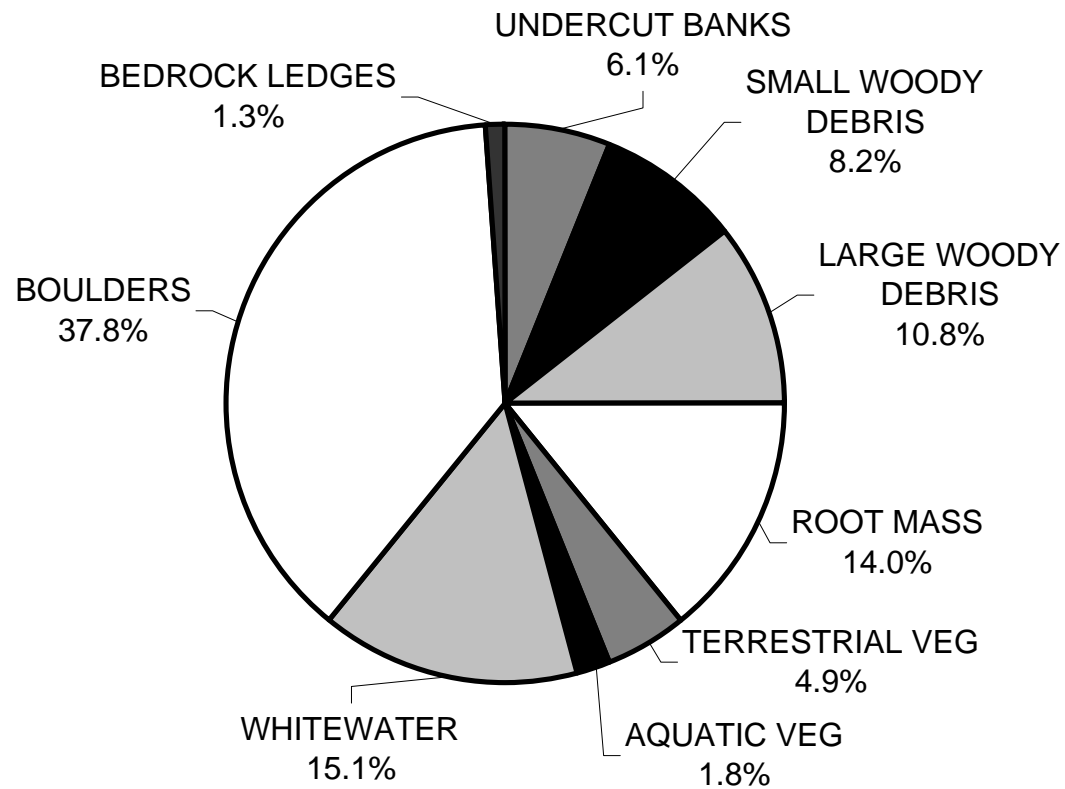
GRAPH 7

Table 5 summarizes mean percent cover by habitat type. Boulders are the dominant cover types in Mill Creek. Graph 7 describes the pool cover in Mill Creek. Boulders are the dominant pool cover type followed by whitewater.

The mean shelter rating for pools was 73. The shelter rating in the flatwater habitats was 57. A pool shelter rating of approximately 100 is desirable. The amount of cover that now exists is being provided primarily by boulders in Mill Creek. Boulders are the dominant cover type in pools followed by whitewater. Log and root wad cover structures in the pool and flatwater habitats would enhance both summer and winter salmonid habitat. Log cover structure provides rearing fry with protection from predation, rest from water velocity, and also divides territorial units to reduce density related competition.

- 3) Increase woody cover in the pools and flatwater habitat units. Most of the existing cover in the pools is from boulders. Adding high quality complexity with woody cover in the pools is desirable.

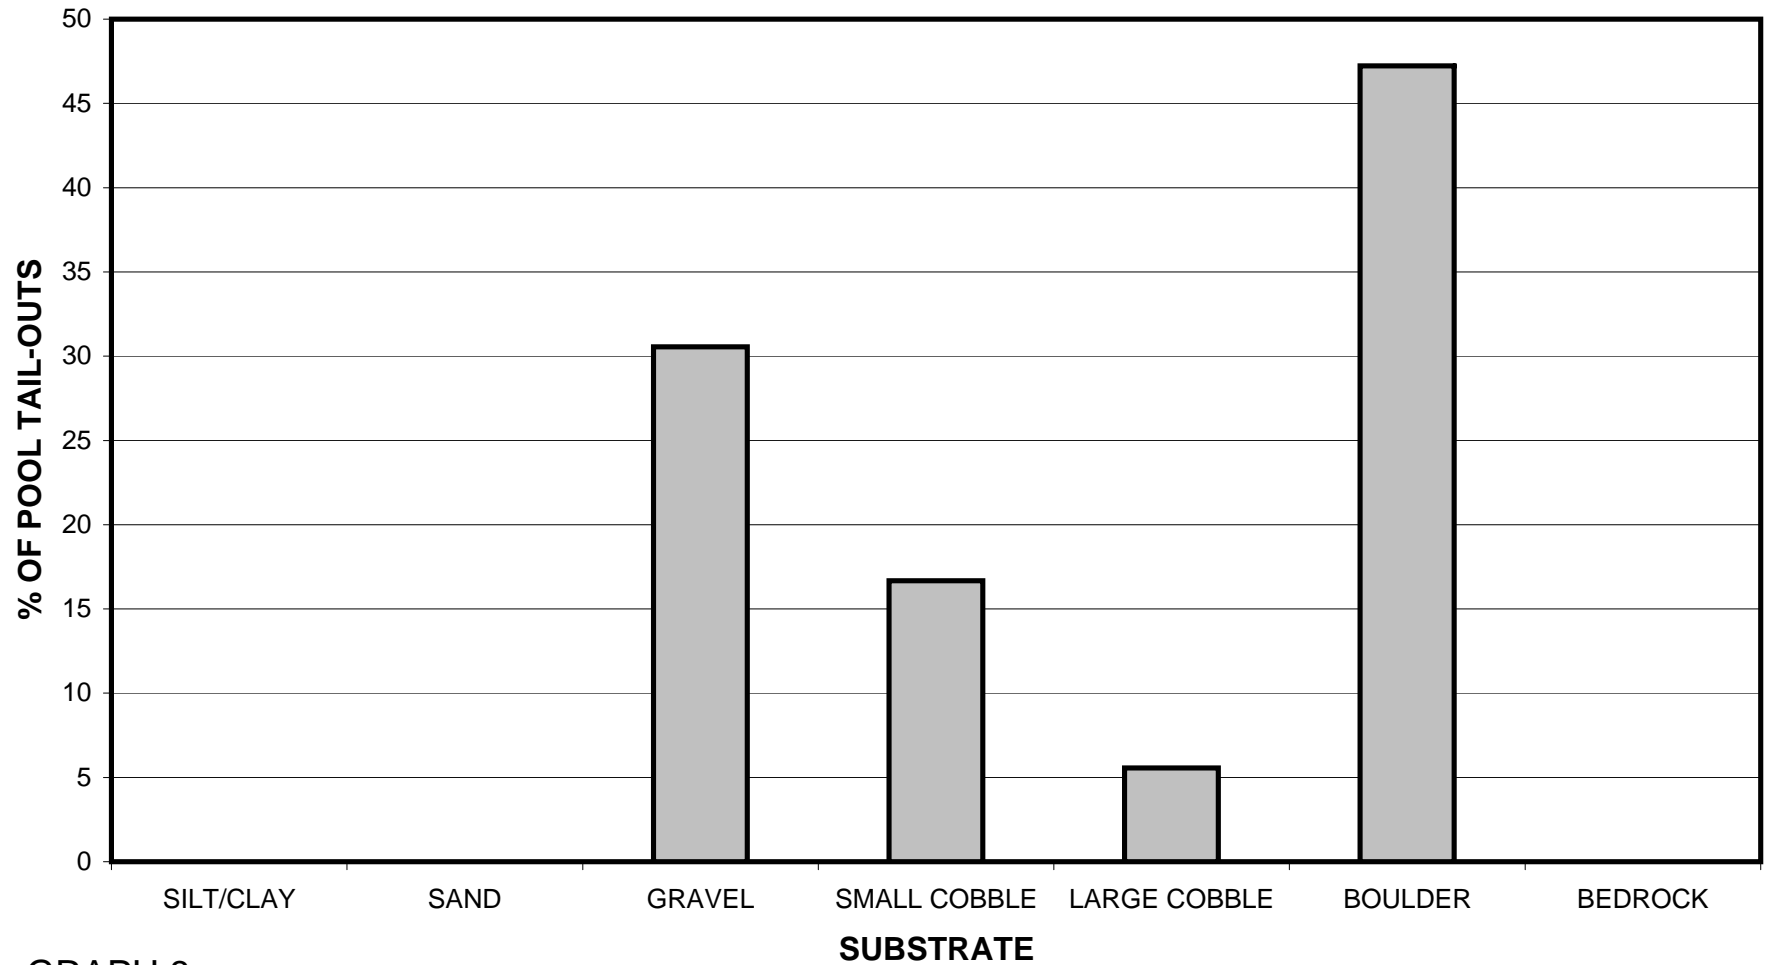
GRAPH 8

Table 6 summarizes the dominant substrate by habitat type. Boulders were the dominant substrate observed in 47% of pool tail-outs. Gravel was the next most frequently observed substrate type and occurred in 31% of pool tail-outs (Graph 8).

Nineteen of the 36 pool tail-outs had silt, sand, large cobble, boulders or bedrock as the dominant substrate. This is generally considered unsuitable for spawning salmonids.
