STREAM INVENTORY REPORT

Mill Creek

A stream inventory was conducted on July 20, 2009 on Mill Creek. The survey began at the confluence with Salmon Creek and extended upstream 0.5 miles.

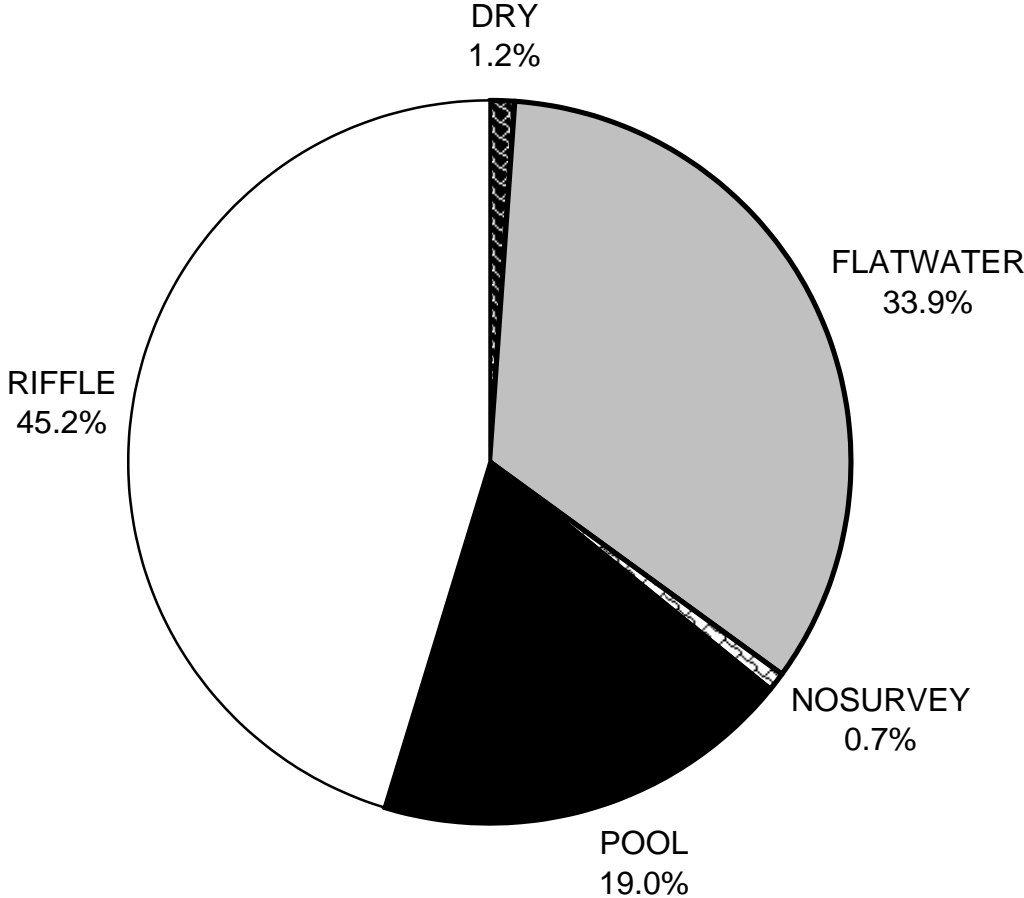
GRAPH 2

Table 1 summarizes the Level II riffle, flatwater, and pool habitat types. Based on frequency of occurrence there were 40% riffle units, 29% flatwater units, 28% pool units, 1% no-survey units and 1% dry units (Graph 1). Based on total length of Level II habitat types there were 45% riffle units, 34% flatwater units, 19% pool units, 1% no-survey units, and 1% dry units (Graph 2).

**MILL CREEK 2009
HABITAT TYPES BY PERCENT TOTAL LENGTH**

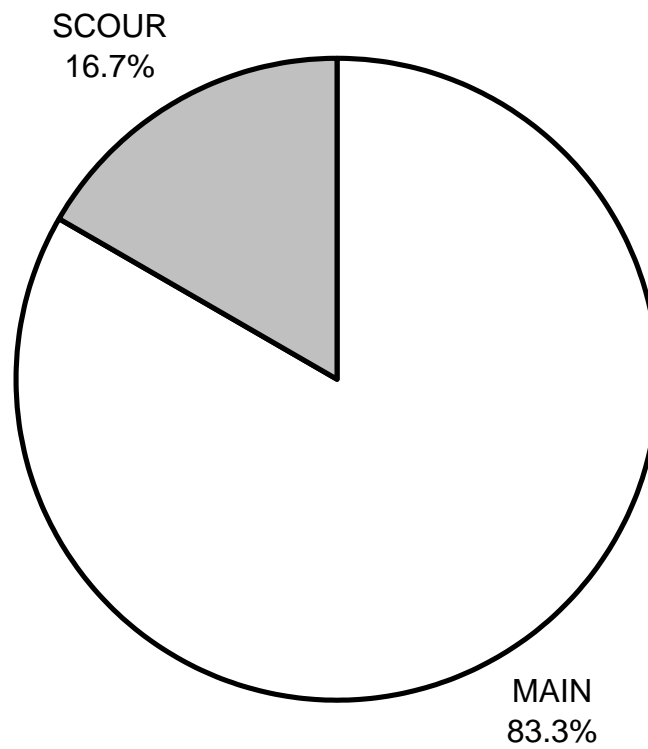
GRAPH 4

A total of 24 pools were identified (Table 3). Main channel pools were the most frequently encountered at 83% (Graph 4), and comprised 87% of the total length of all pools (Table 3).

**MILL CREEK 2009
POOL TYPES BY PERCENT OCCURRENCE**

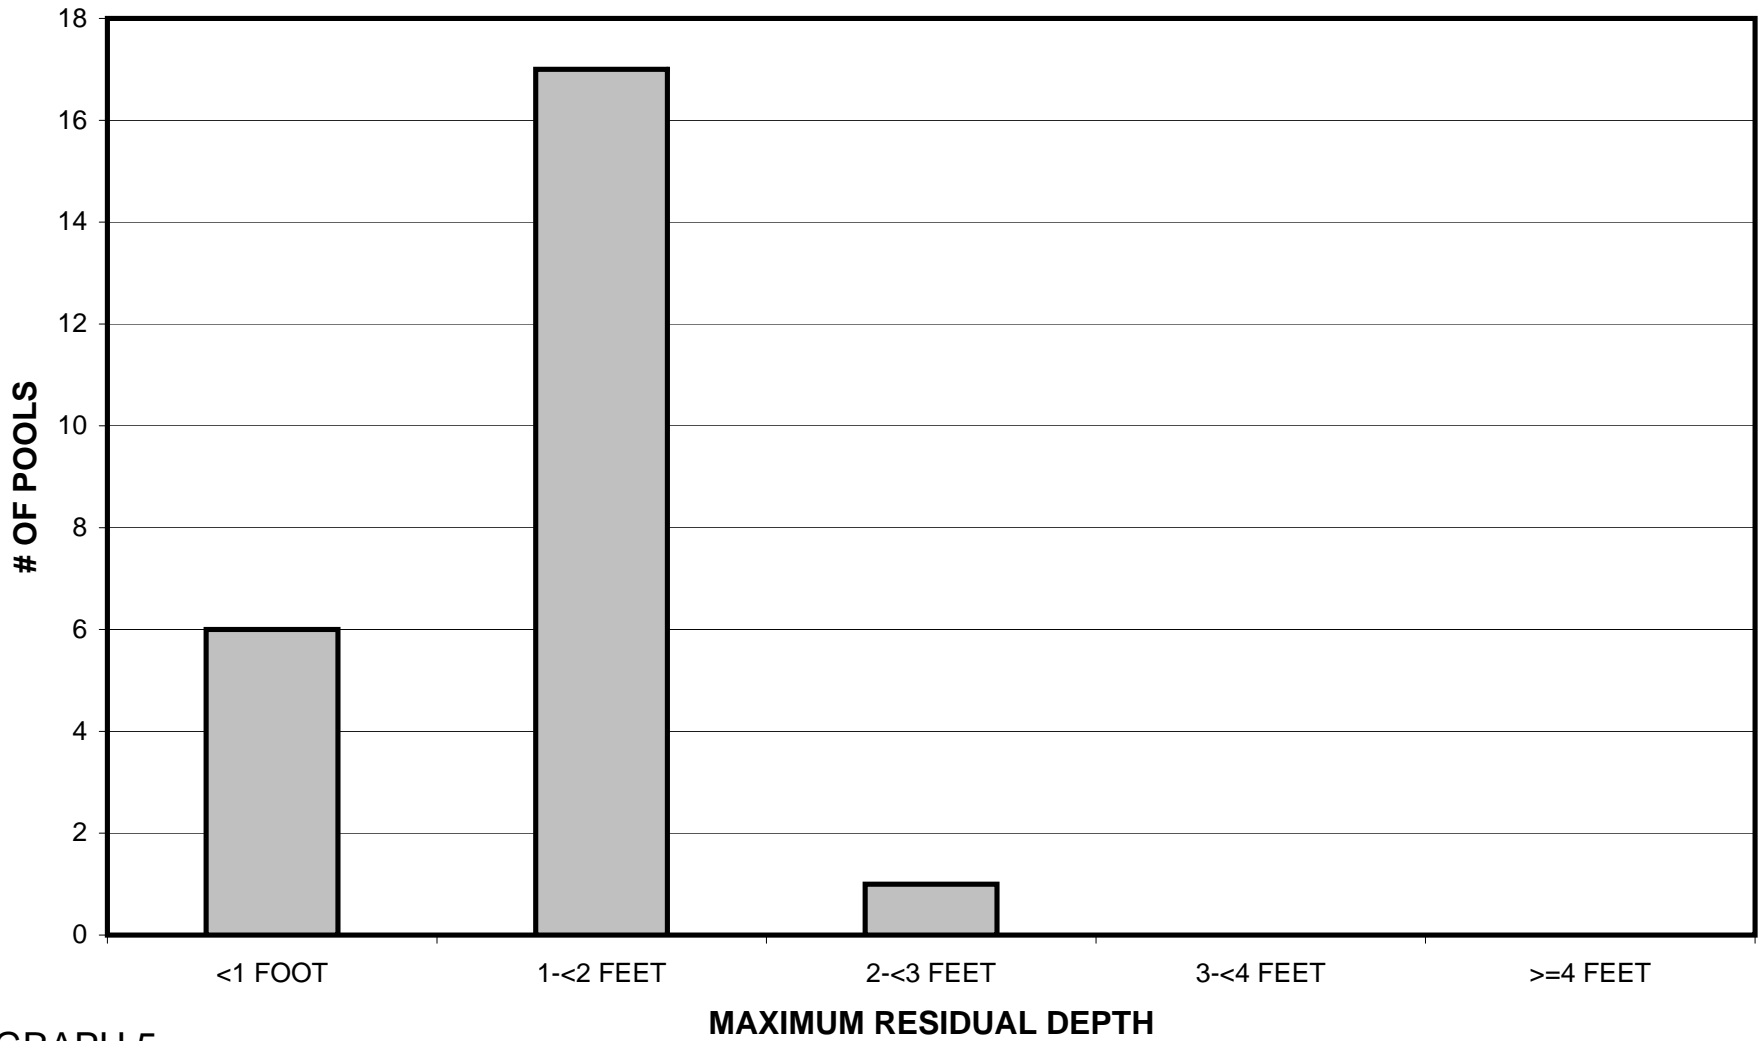
GRAPH 5

Table 4 is a summary of maximum residual pool depths by pool habitat types. Pool quality for salmonids increases with depth. One of the 24 pools (4%) had a residual depth of two feet or greater (Graph 5).

Flatwater habitat types comprised 34% of the total length of this survey, riffles 45%, and pools 19%. One of the 24 (4%) pools had a maximum residual depth greater than 2 feet. In general, pool enhancement projects are considered when primary pools comprise less than 40% of the length of total stream habitat. In first and second order streams, a primary pool is defined to have a maximum residual depth of at least two feet, occupy at least half the width of the low flow channel, and be as long as the low-flow channel width. Installing structures that will increase or deepen pool habitat is recommended.

MILL CREEK 2009 MAXIMUM DEPTH IN POOLS

- 3) Where feasible, design and engineer pool enhancement structures to increase the number of pools. This must be done where the banks are stable or in conjunction with stream bank armor to prevent erosion.

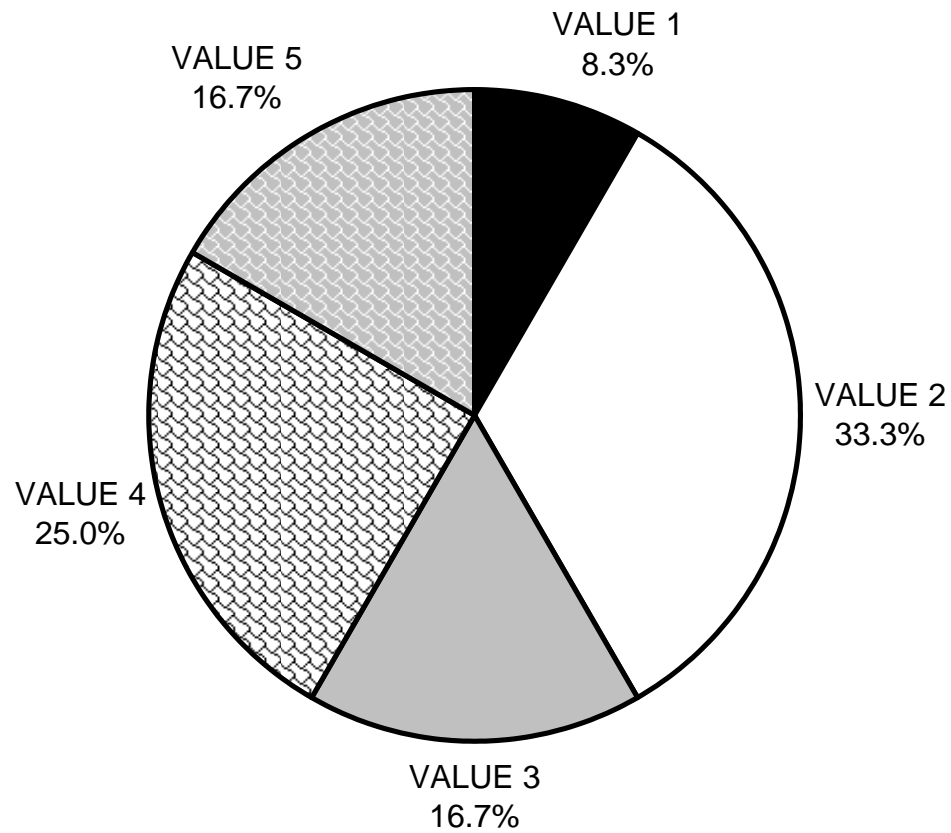
GRAPH 6

The depth of cobble embeddedness was estimated at pool tail-outs. Of the 24 pool tail-outs measured, 2 had a value of 1 (8.3%); 8 had a value of 2 (33.3%); 4 had a value of 3 (16.7%); 6 had a value of 4 (25%); 4 had a value of 5 (16.7%) (Graph 6). On this scale, a value of 1 indicates the best spawning conditions and a value of 4 the worst. Additionally, a value of 5 was assigned to tail-outs deemed unsuited for spawning due to inappropriate substrate such as bedrock, log sills, boulders, or other considerations.

Ten of the 24 pool tail-outs measured had embeddedness ratings of 1 or 2. Ten of the pool tail-outs had embeddedness ratings of 3 or 4. Four of the pool tail-outs had a rating of 5, which is considered unsuitable for spawning. Cobble embeddedness measured to be 25% or less, a rating of 1, is considered to indicate good quality spawning substrate for salmon and steelhead. Sediment sources in Mill Creek should be mapped and rated according to their potential sediment yields, and control measures should be taken.

MILL CREEK 2009 PERCENT EMBEDDEDNESS

- 5) Inventory and map sources of stream bank erosion and prioritize them according to present and potential sediment yield. Identified sites should then be treated to reduce the amount of fine sediments entering the stream.

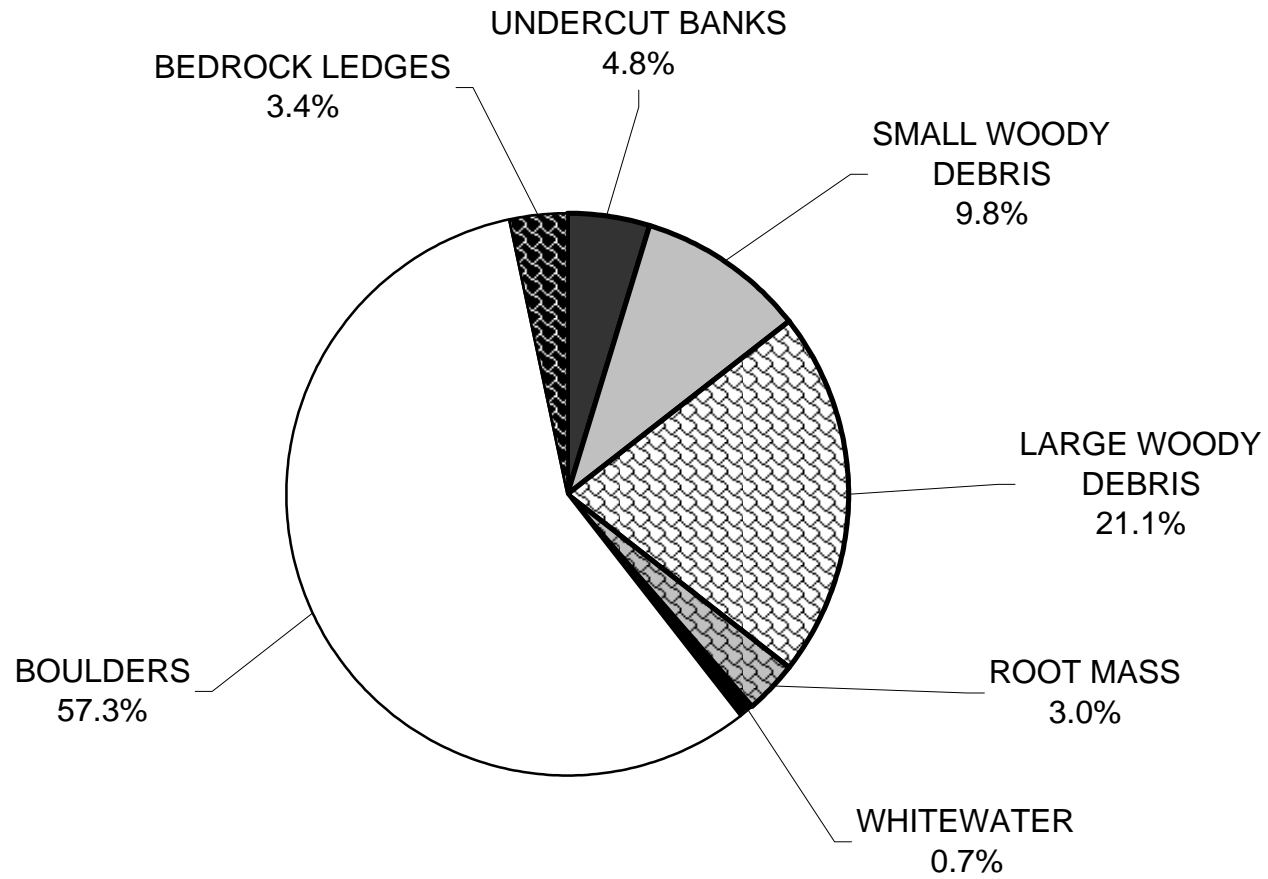
GRAPH 7

Table 5 summarizes mean percent cover by habitat type. Boulders are the dominant cover type in Mill Creek. Graph 7 describes the pool cover in Mill Creek. Boulders are the dominant pool cover type followed by large woody debris.

The mean shelter rating for pools is 21. The shelter rating in the flatwater habitats is 12. A pool shelter rating of approximately 100 is desirable. The amount of cover that now exists is being provided primarily by boulders in Mill Creek. Boulders are the dominant cover type in pools followed by large woody debris. Log and root wad cover structures in the pool and flatwater habitats would enhance both summer and winter salmonid habitat. Log cover structure provides rearing fry with protection from predation, rest from water velocity, and also divides territorial units to reduce density related competition.

MILL CREEK 2009 MEAN PERCENT COVER TYPES IN POOLS

- 4) Increase woody cover in the pools and flatwater habitat units. Most of the existing cover in the pools is from boulders. Adding high quality complexity with woody cover in the pools is desirable.

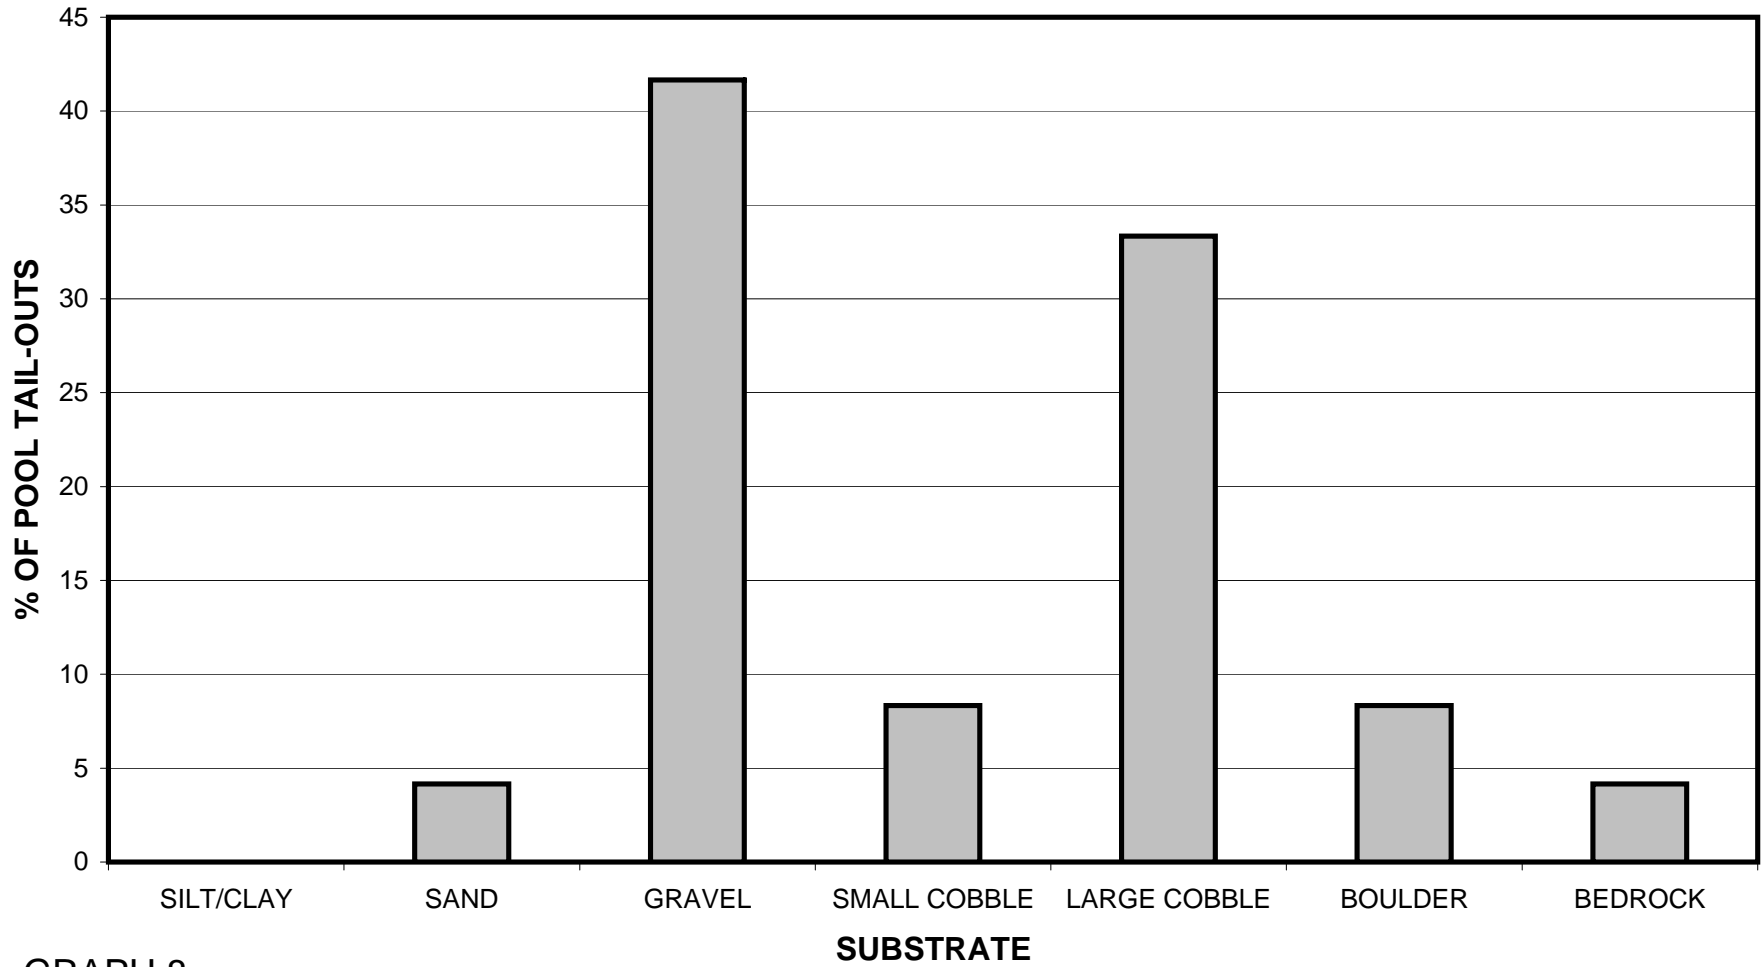
GRAPH 8

Table 6 summarizes the dominant substrate by habitat type. Graph 8 depicts the dominant substrate observed in pool tail-outs. Gravel was the dominant substrate observed in 42% of the pool tail-outs. Large cobble was the next most frequently observed dominant substrate type and occurred in 33% of the pool tail-outs.

Twelve of the 24 pool tail-outs had silt, sand, large cobble, boulders or bedrock as the dominant substrate. This is generally considered unsuitable for spawning salmonids.

MILL CREEK 2009 SUBSTRATE COMPOSITION IN POOL TAIL-OUTS

- 6) Suitable size spawning substrate on Mill Creek is limited to relatively few reaches. Projects should be designed at suitable sites to trap and sort spawning gravel.

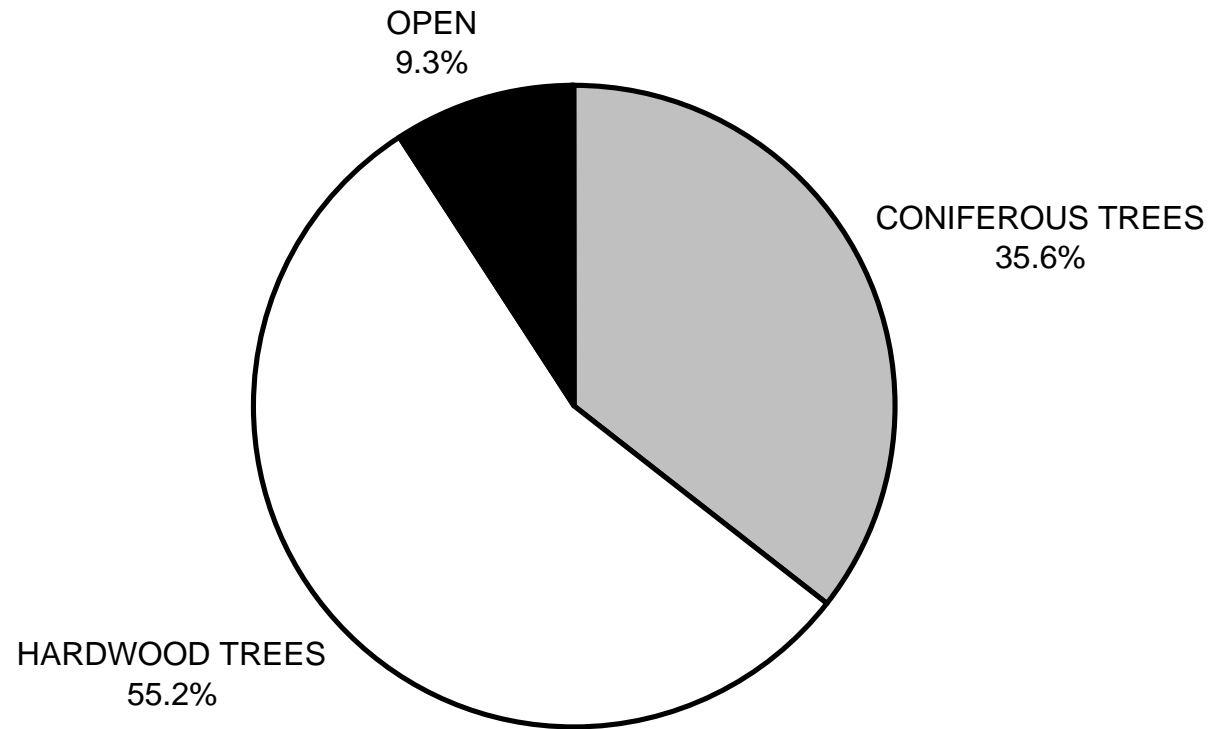
GRAPH 9

The mean percent canopy density for the surveyed length of Mill Creek was 91%. Nine percent of the canopy was open. Of the canopy present, the mean percentages of hardwood and coniferous trees were 61% and 39%, respectively. Graph 9 describes the mean percent canopy in Mill Creek.

The mean percent canopy density for the stream was 91%. In general, revegetation projects are considered when canopy density is less than 80%.

MILL CREEK 2009 MEAN PERCENT CANOPY

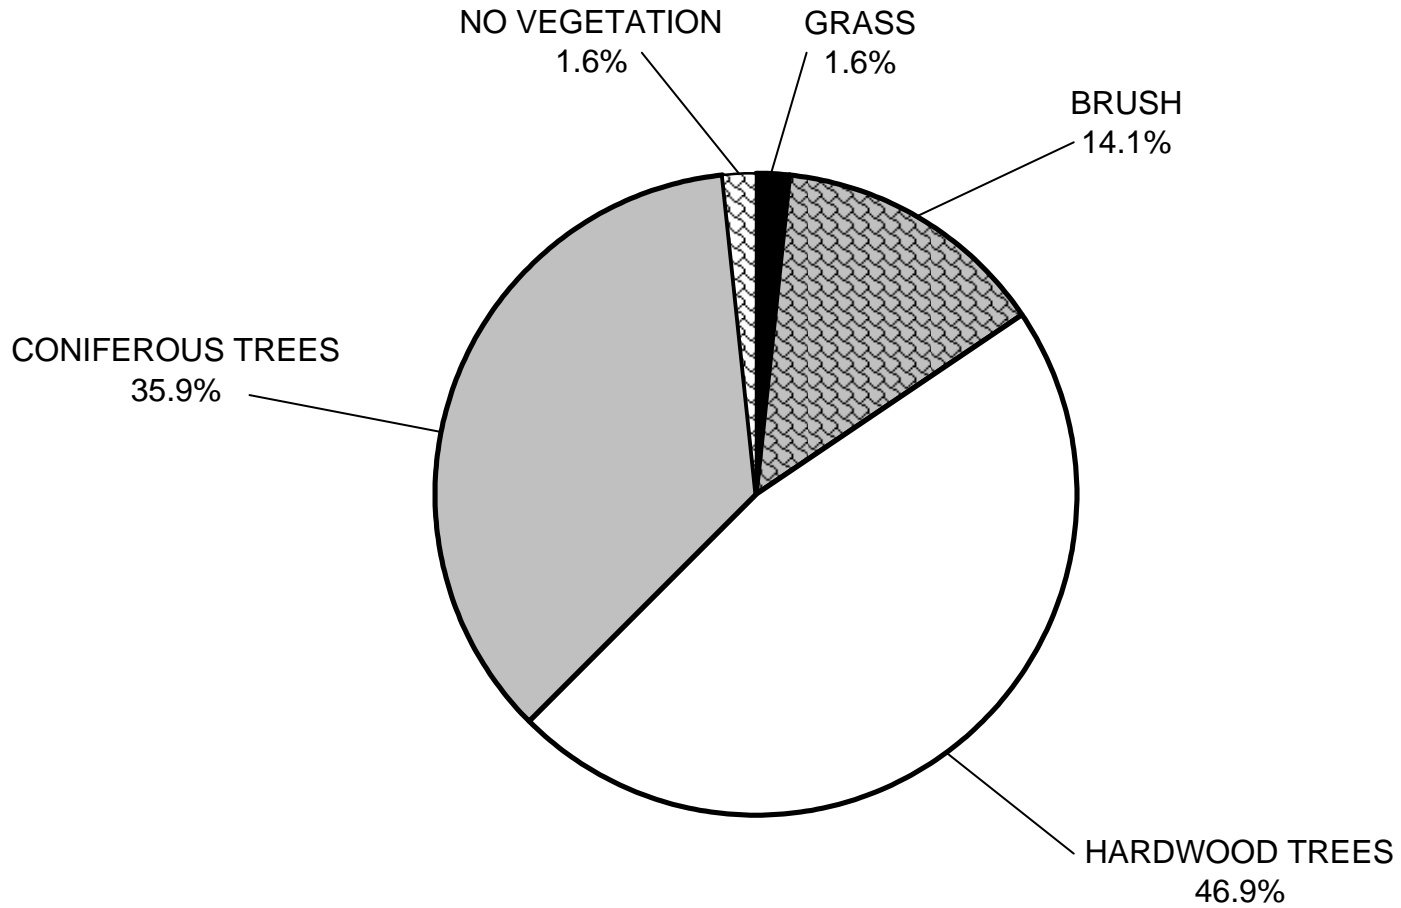
GRAPH 11

For the stream reach surveyed, the mean percent right bank vegetated was 93%. The mean percent left bank vegetated was 92%. The dominant elements composing the structure of the stream banks consisted of 56% cobble/gravel, 27% sand/silt/clay, 9% bedrock, and 8% boulder (Graph 10). Deciduous trees were the dominant vegetation type observed in 47% of the units surveyed. Additionally, 36% of the units surveyed had coniferous trees as the dominant vegetation type, 14% had brush, and 2% had grass as the dominant vegetation type (Graph 11).

MILL CREEK 2009 DOMINANT BANK VEGETATION IN SURVEY REACH

The percentage of right and left bank covered with vegetation was 93% and 92%, respectively. In areas of stream bank erosion or where bank vegetation is sparse, planting endemic species of coniferous and hardwood trees, in conjunction with bank stabilization, is recommended.
