SALMON AND STEELHEAD RESTORATION AND ENHANCEMENT PROGRAM

STREAM INVENTORY REPORT

**Panther Creek, South Fork Eel River, 1998**

CALIFORNIA DEPARTMENT OF FISH AND GAME

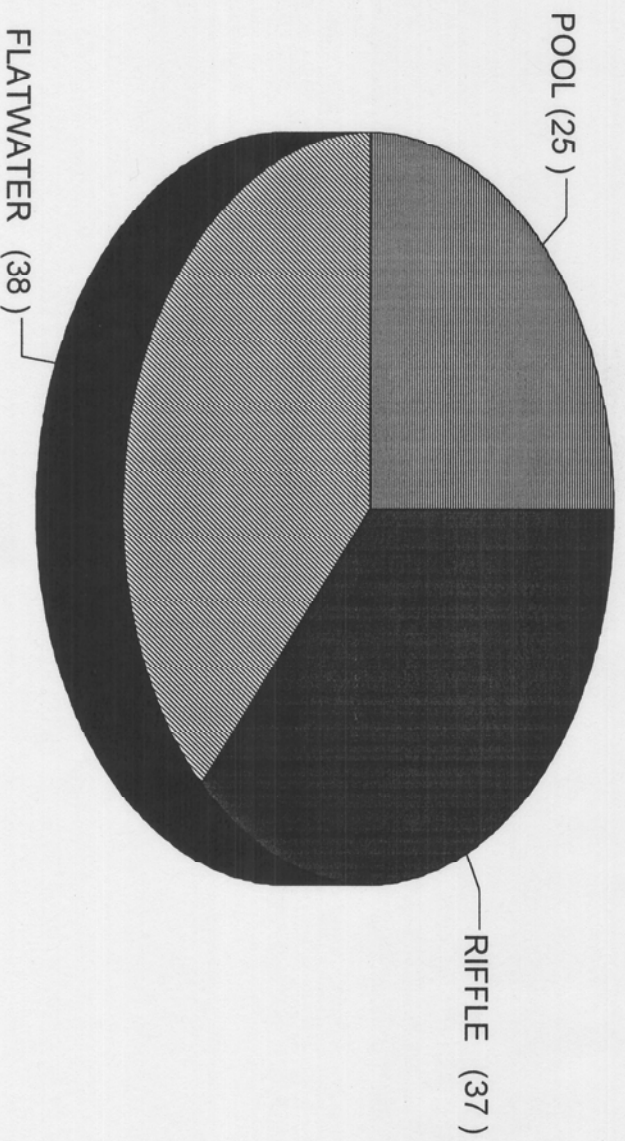
GRAPH 1

Table 1 summarizes the Level II riffle, flatwater, and pool habitat types. Based on frequency of occurrence there were 37% riffle units, 38% flatwater units, and 25% pool units (Graph 1). Based on total length of Level II habitat types there were 30% riffle units, 59% flatwater units, and 11% pool units (Graph 2).

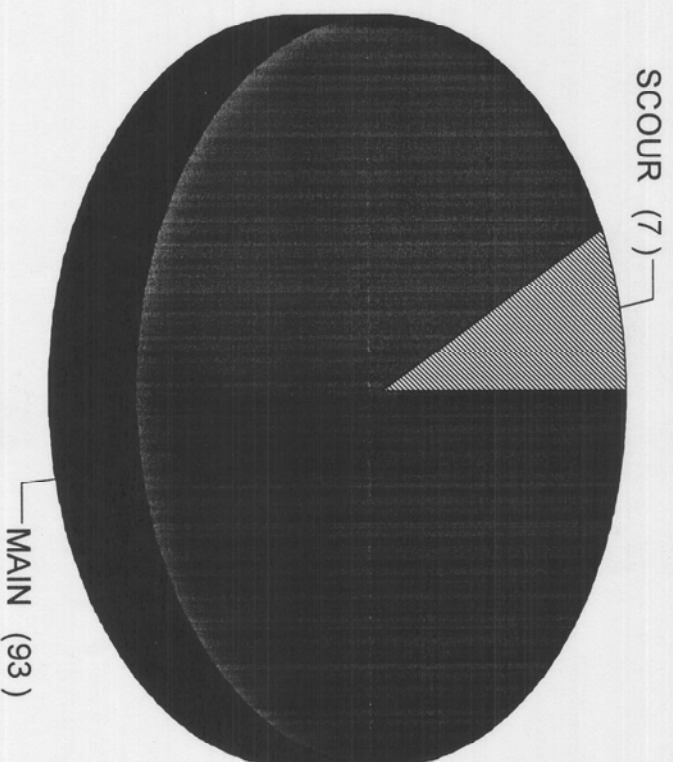
GRAPH 4

A total of fifteen pools were identified (Table 3). Main channel pools were most frequently encountered at 93% and comprised 95% of the total length of all pools (Graph 4).

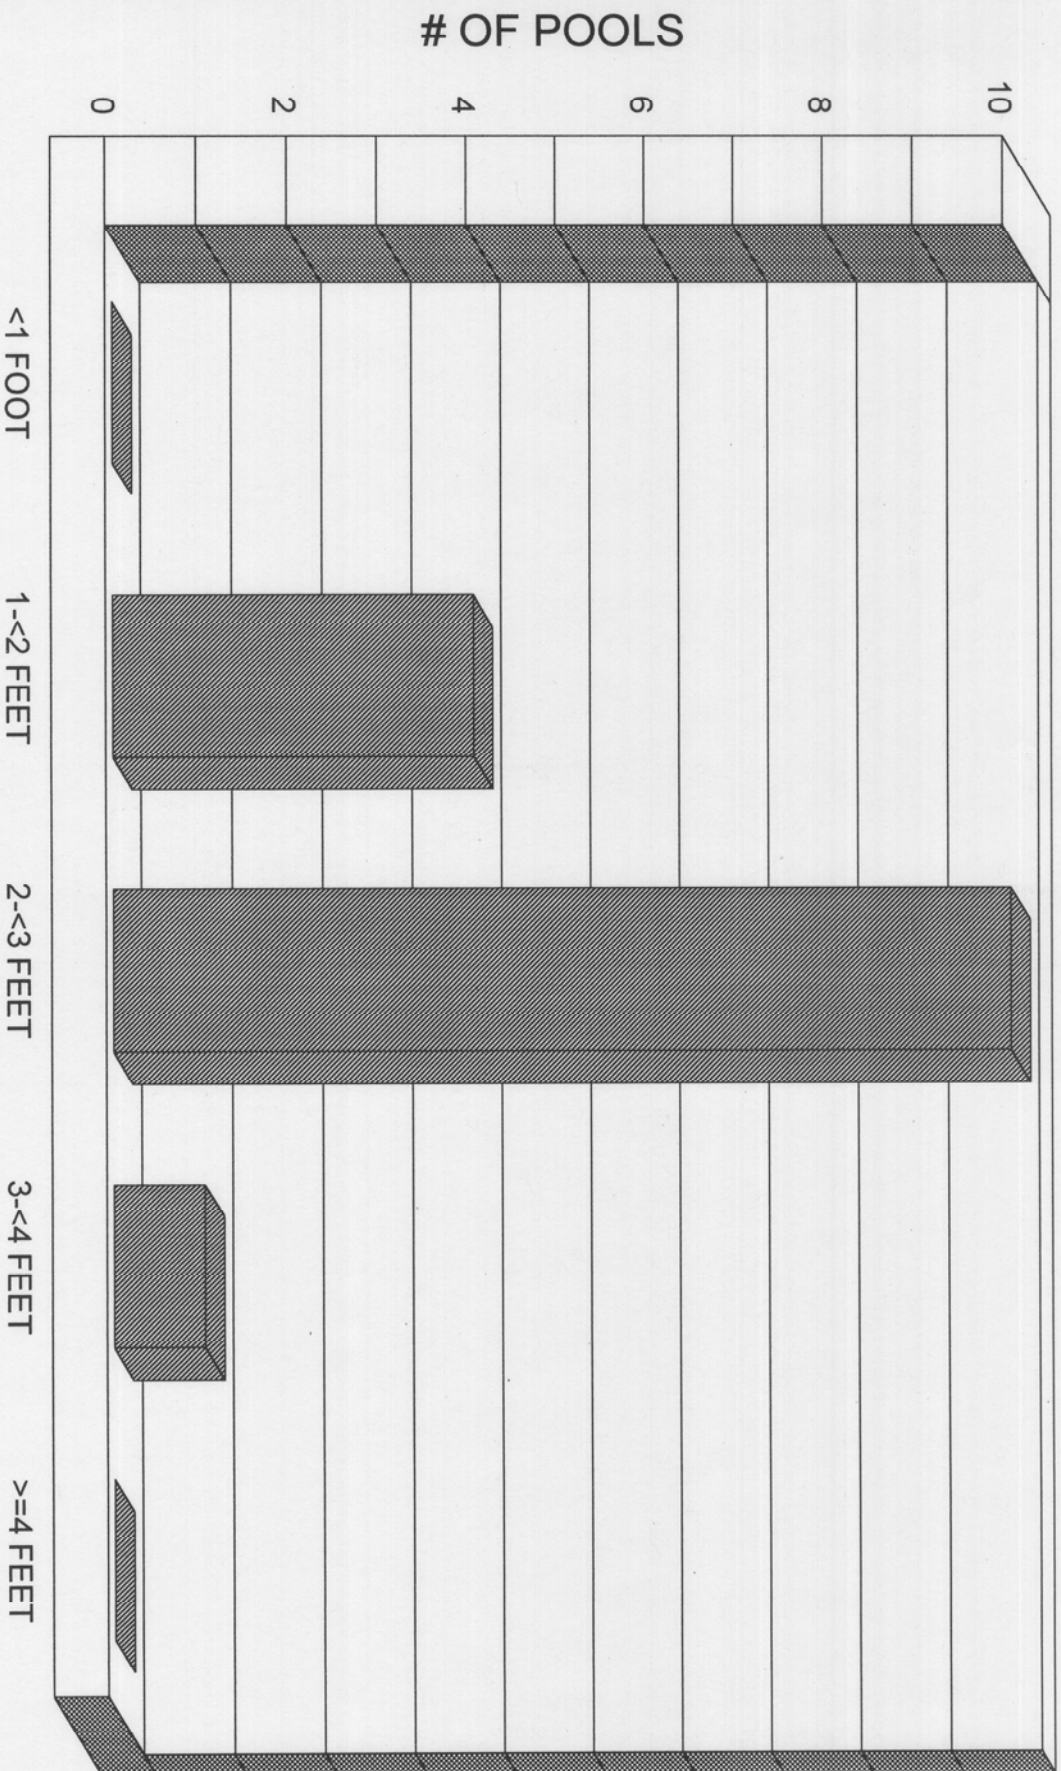
GRAPH 5

Table 4 is a summary of maximum pool depths by pool habitat types. Pool quality for salmonids increases with depth. Eleven of the fifteen pools (73%) had a depth of two feet or greater (Graph 5).

- 5) Primary pools comprise 8% of the total stream length surveyed. Within the B4 channel reach, design and engineer pool enhancement structures to increase the number of pools. This must be done where the banks are stable or in conjunction with stream bank armor to prevent erosion.
- 6) Increase woody cover in the pools and flatwater habitat units. Most of the existing cover is from boulders. Adding high quality complexity with woody cover is desirable.

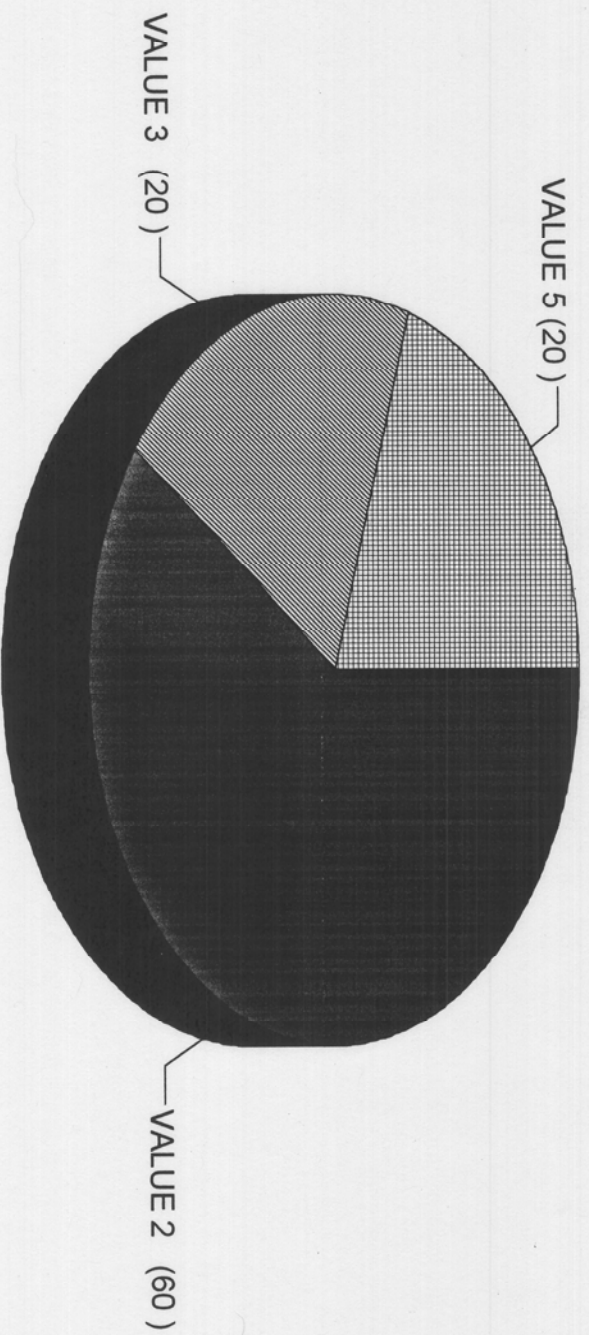
GRAPH 6

The depth of cobble embeddedness was estimated at pool tail-outs. Of the fifteen pool tail-outs measured, zero had a value of 1; nine had a value of 2 (60%); three had a value of 3 (20%); zero had a value of 4; and three had a value of 5 (20%) (Graph 6). On this scale, a value of 1 indicates the highest quality of spawning substrate and a value of 5 indicates the tail-out is not suitable for spawning.

None of the fifteen pool tail-outs measured had an embeddedness rating of 1, 60% had a rating of 2, 20% had ratings of 3 or 4, and 20% had a rating of 5 and were considered unsuitable for spawning. All of the three pool-tail outs with a rating of 5 were unsuitable for spawning due to the dominant substrate being bedrock or boulders. Cobble embeddedness measured to be 25% or less, a rating of 1, is considered to indicate good quality spawning substrate for salmon and steelhead.

- 4) Inventory and map sources of stream bank erosion and prioritize them according to present and potential sediment yield. Identified sites should then be treated to reduce the amount of fine sediments entering the stream.

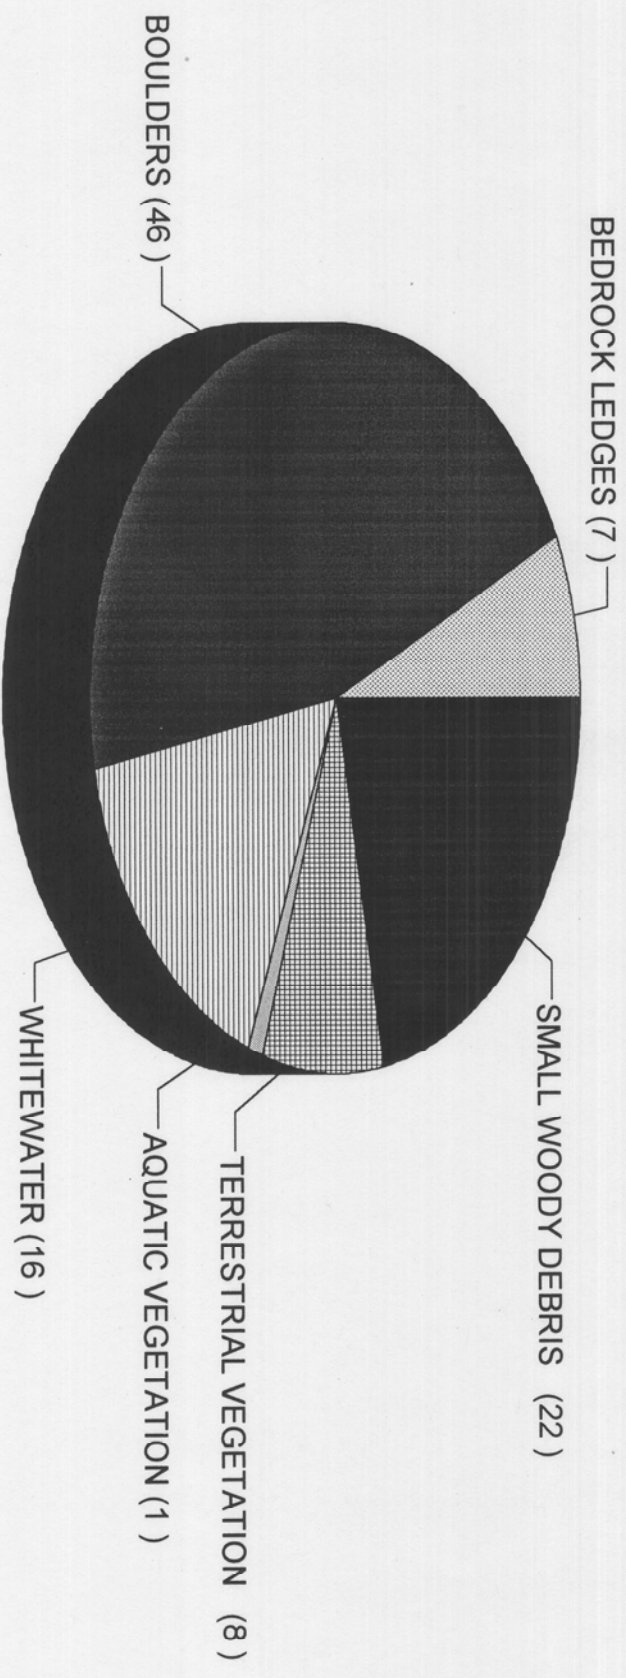
GRAPH 7

Table 5 summarizes mean percent cover by habitat type. Boulders are the dominant cover type in Panther Creek. Large woody debris are lacking in nearly all habitat types. Graph 7 describes the pool cover in Panther Creek.

The mean shelter rating for pools was 30. The shelter rating in the flatwater habitats was 18. A pool shelter rating of approximately 100 is desirable. The relatively small amount of cover that now exists is being provided primarily by boulders in all habitat types. Additionally, small woody debris contributes a small amount. Log and root wad cover structures in the pool and flatwater habitats are needed to improve both summer and winter salmonid habitat. Log cover structure provides rearing fry with protection from predation, rest from water velocity, and also divides territorial units to reduce density related competition.

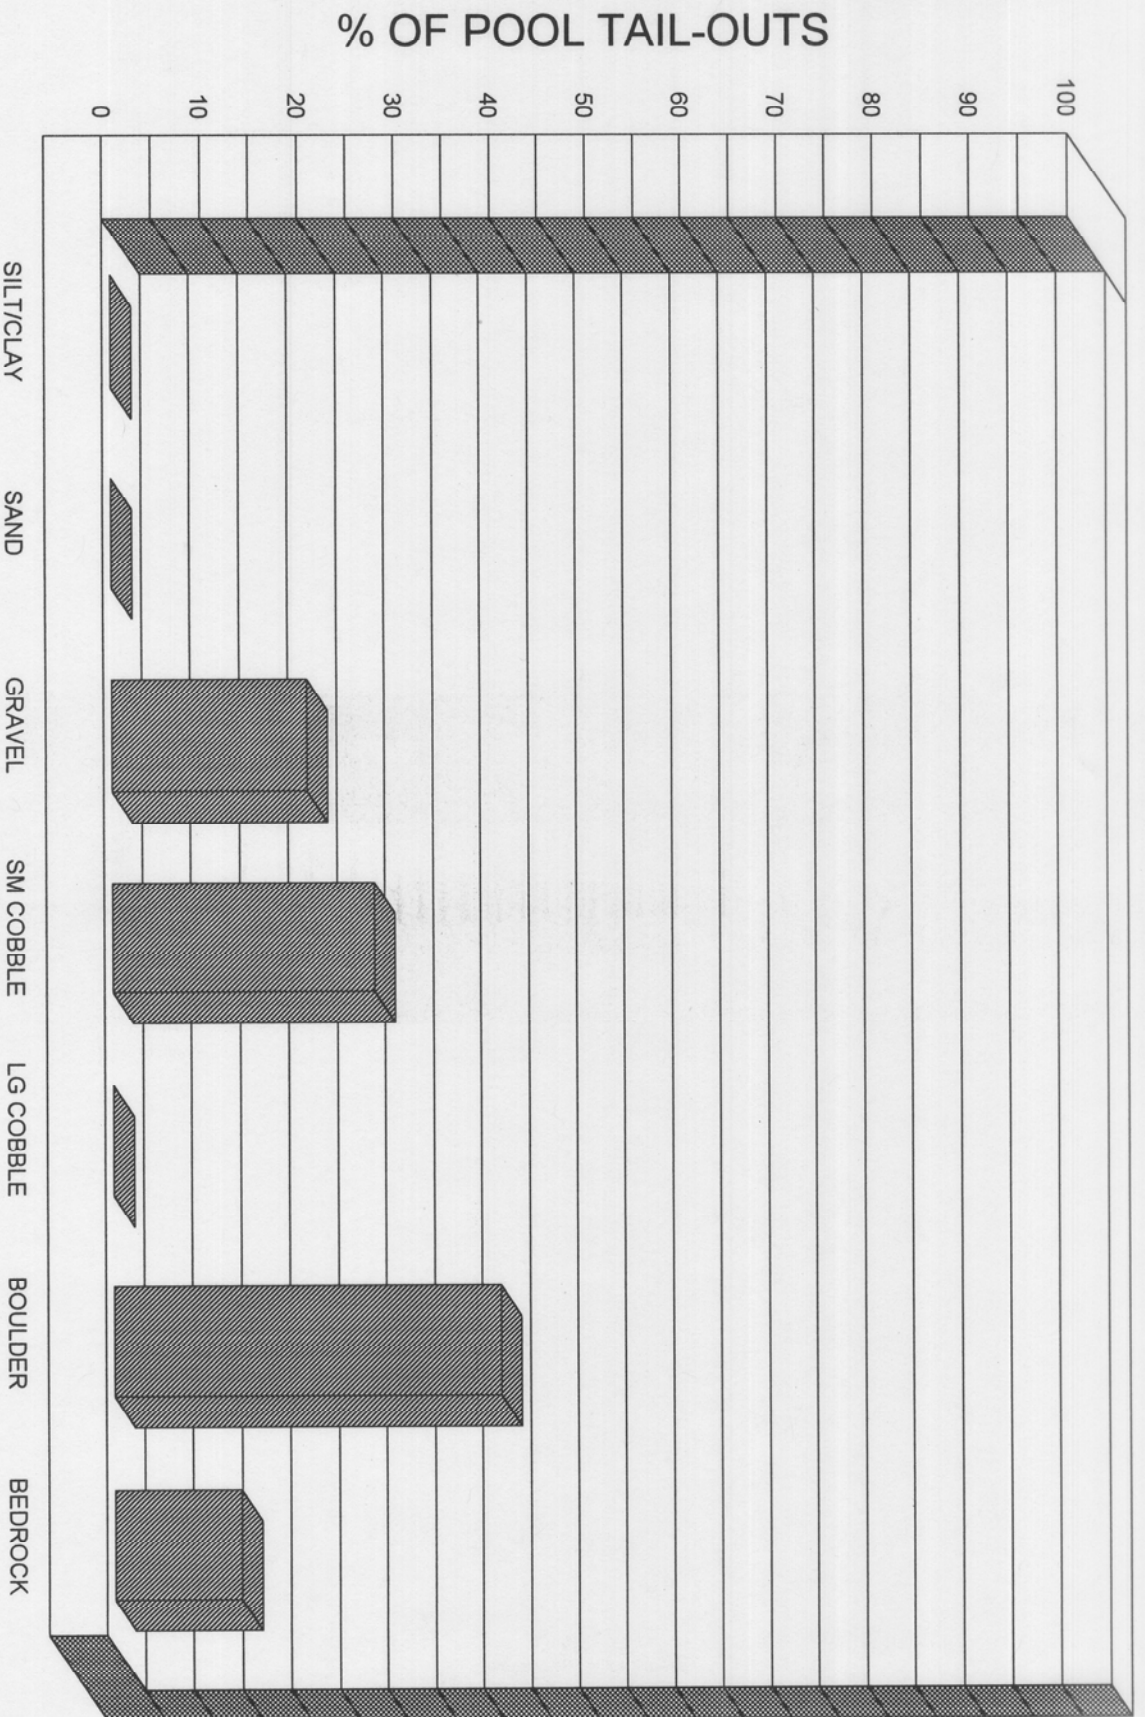
GRAPH 8

Table 6 summarizes the dominant substrate by habitat type. Boulders were the dominant substrate observed in 6 of the 15 (40%) pool tail-outs measured. Small cobble was the next most frequently observed dominant substrate type and occurred in 27% of the pool tail-outs (Graph 8).

Seven of the fifteen (46%) pool tail-outs measured had gravel or small cobble as the dominant substrate. Suitable size spawning substrate in the A4 channel reach is limited.

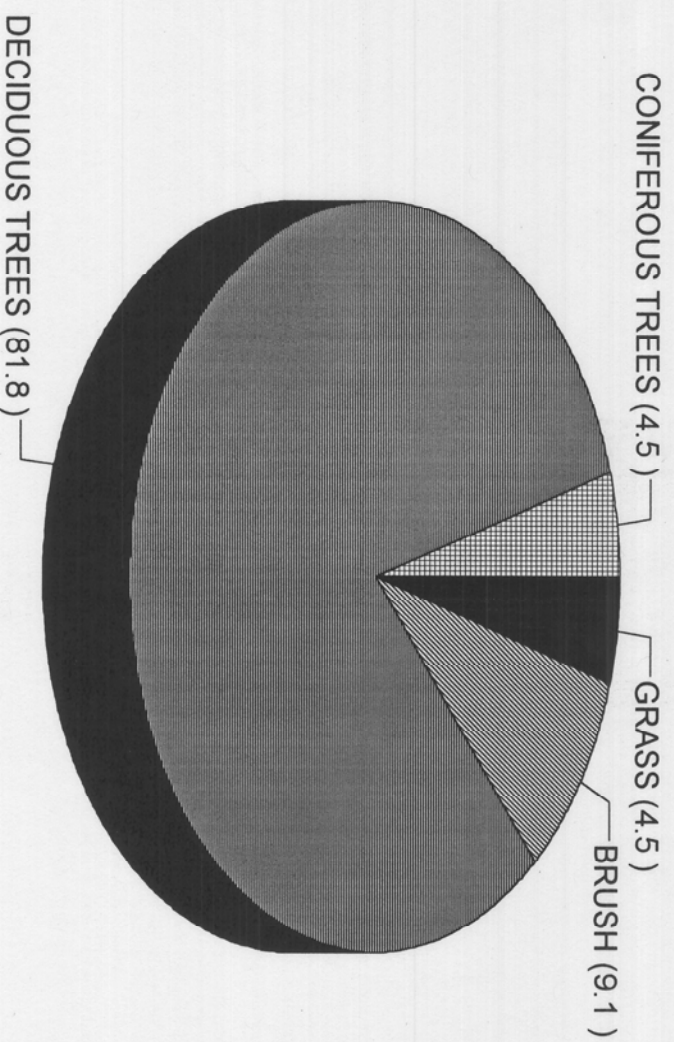
GRAPH 11

For the stream reach surveyed, the mean percent right bank vegetated was 59.1%. The mean percent left bank vegetated was 67.7%. The dominant elements composing the structure of the stream banks consisted of 9.1% bedrock, 40.9% boulder, and 50% cobble/gravel (Graph 10). Deciduous trees were the dominant vegetation type observed in 81.9% of the units surveyed. Additionally, 9.1% of the units surveyed had brush as the dominant vegetation type, and 4.5%

had coniferous trees as the dominant vegetation, including down trees, logs, and root wads (Graph 11).

The percentage of right and left bank covered with vegetation was 59.1% and 67.7%, respectively. In areas of stream bank erosion or where bank vegetation is not at acceptable levels, planting endemic species of coniferous and deciduous trees, in conjunction with bank stabilization, is recommended.

- 3) Increase the canopy and bank vegetation on Panther Creek by planting willow, alder, redwood, and Douglas fir along the stream where shade canopy or bank coverage is not at acceptable levels. The reaches above this survey section should be inventoried and treated as well, since the water flowing here is effected from upstream. In many cases, planting will need to be coordinated to follow bank stabilization or upslope erosion control projects.
