STREAM INVENTORY REPORT

Upper Redwood Creek aka "Pollock Creek"

A stream inventory was conducted from June 23 to July 9, 2009 on the upper reach of Redwood Creek commonly known as and hereinafter referred to as Pollock Creek. The survey began at the confluence with China Creek and extended upstream 2.7 miles.

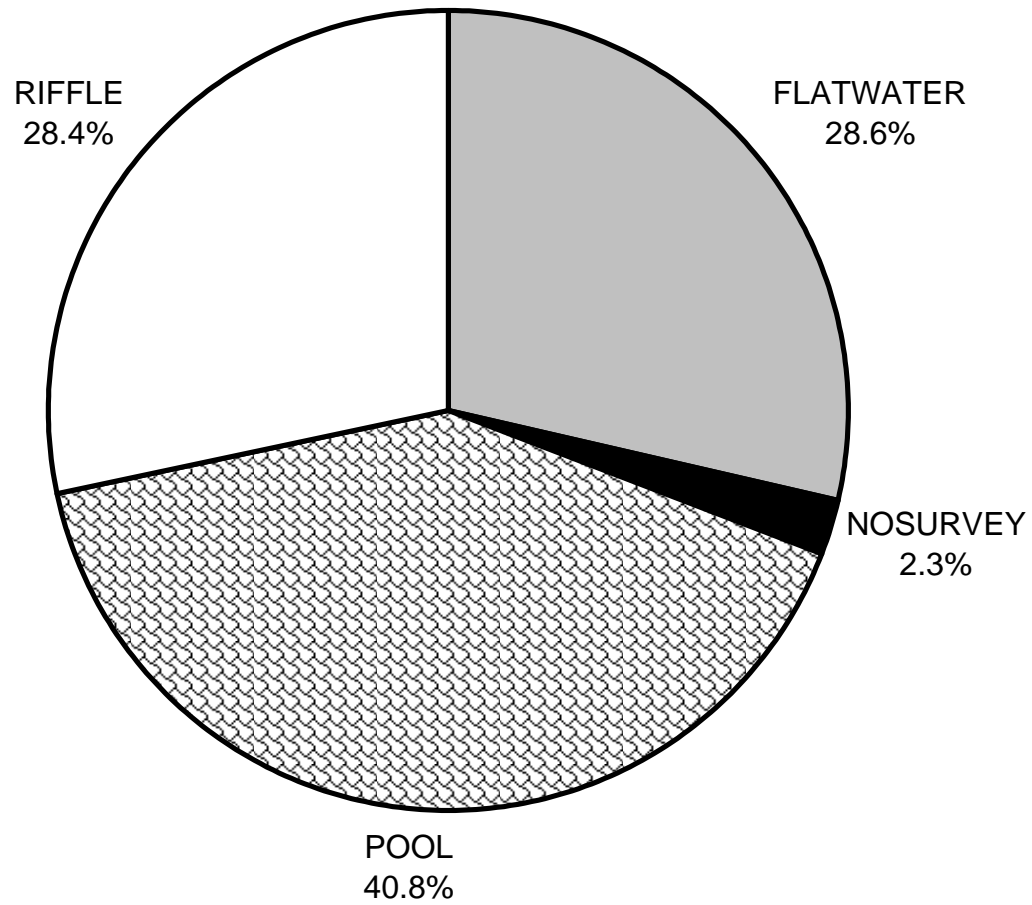
GRAPH 1

Table 1 summarizes the Level II riffle, flatwater, and pool habitat types. Based on frequency of occurrence there were 41% pool units, 29% flatwater units, and 28% riffle units (Graph 1). Based on total length of Level II habitat types there were 44% pool units, 37% flatwater units, and 16% riffle units (Graph 2).

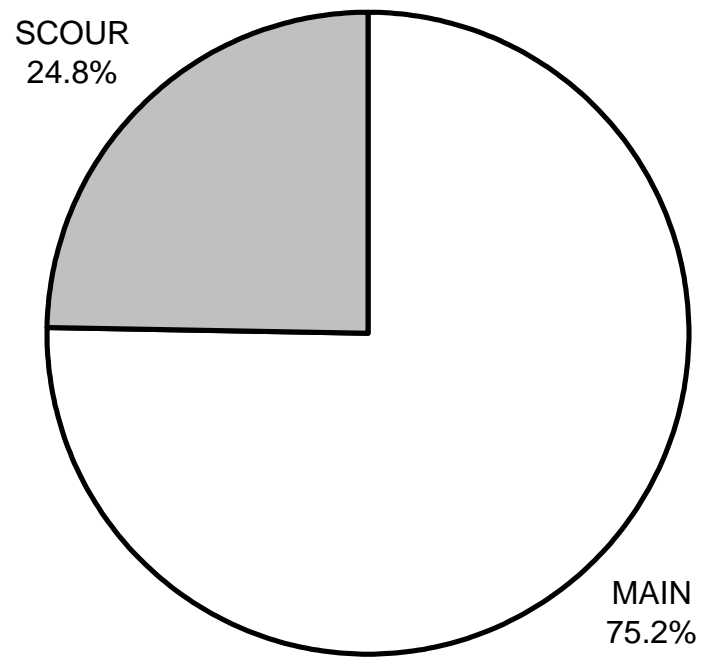
GRAPH 4

A total of 161 pools were identified (Table 3). Main channel pools were the most frequently encountered at 75% (Graph 4), and comprised 81% of the total length of all pools (Table 3).

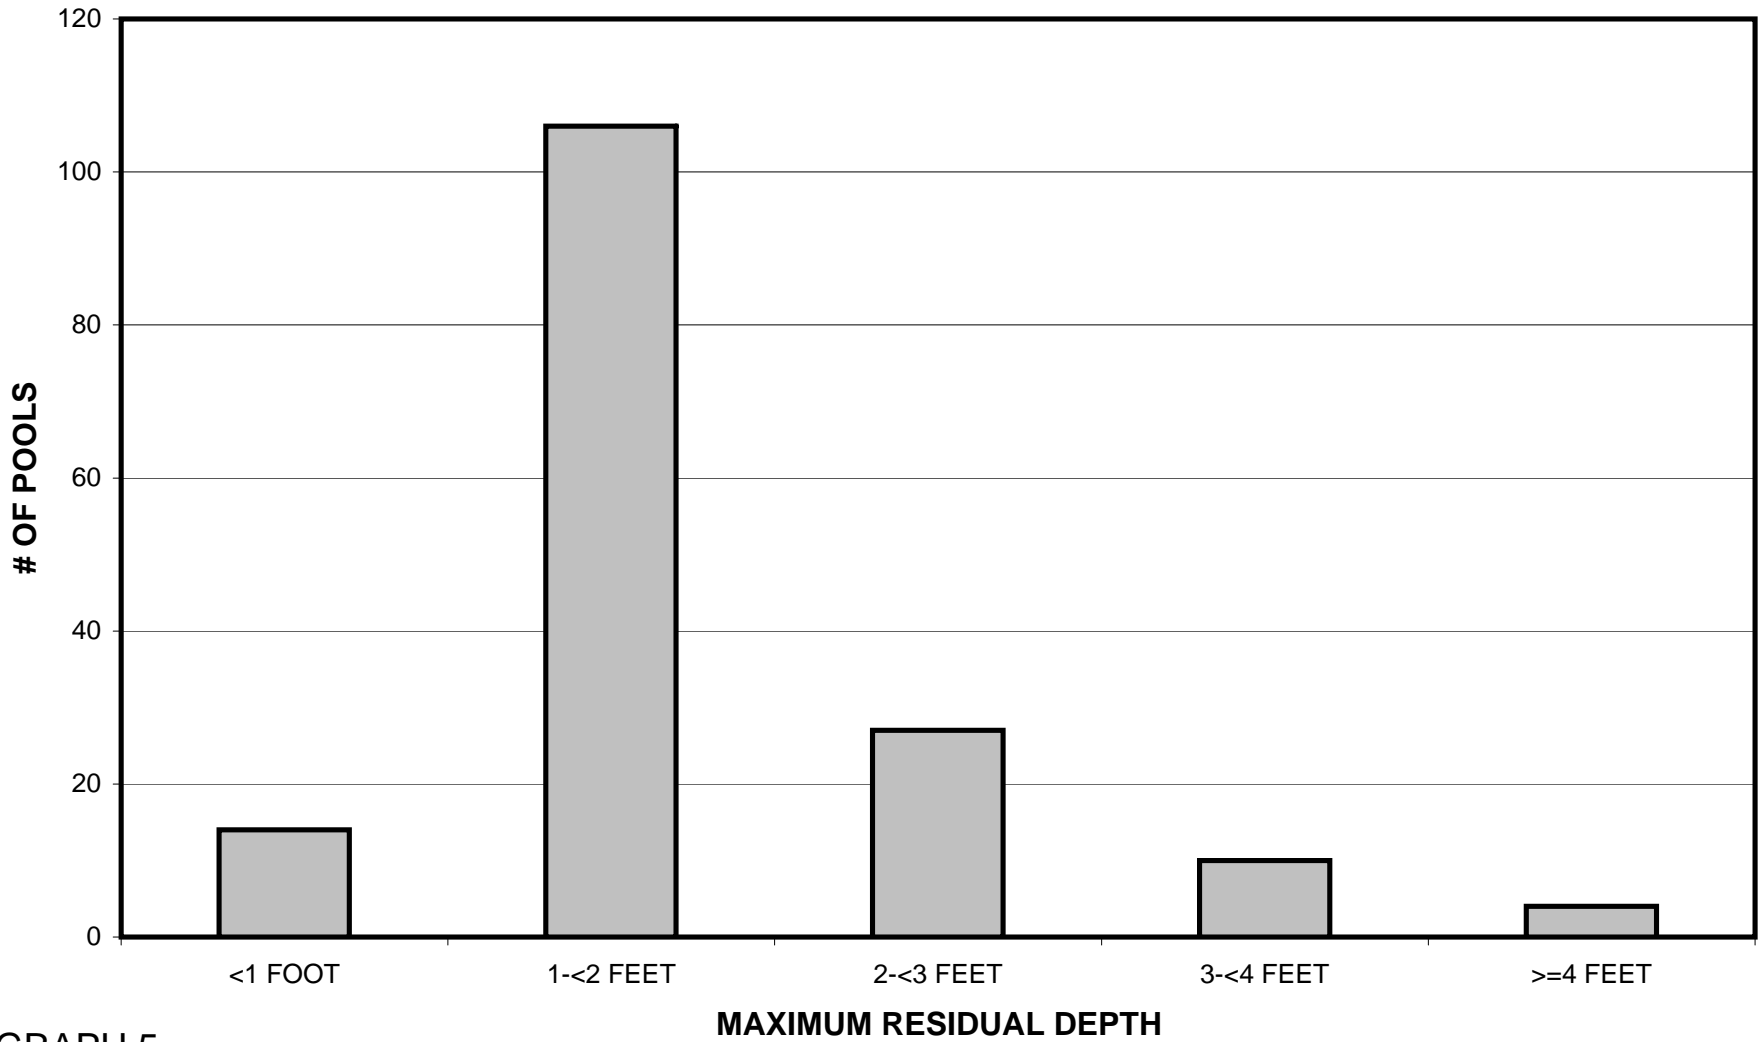
GRAPH 5

Table 4 is a summary of maximum residual pool depths by pool habitat types. Pool quality for salmonids increases with depth. Forty-one of the 161 pools (25%) had a residual depth of two feet or greater (Graph 5).

Flatwater habitat types comprised 37% of the total length of this survey, riffles 16%, and pools 44%. Forty-one of the 161 (25%) pools had a maximum residual depth greater than 2 feet. In general, pool enhancement projects are considered when primary pools comprise less than 40% of the length of total stream habitat. In first and second order streams, a primary pool is defined to have a maximum residual depth of at least two feet, occupy at least half the width of the low flow channel, and be as long as the low flow channel width. Installing large wood structures that will increase or deepen pool habitat is recommended.

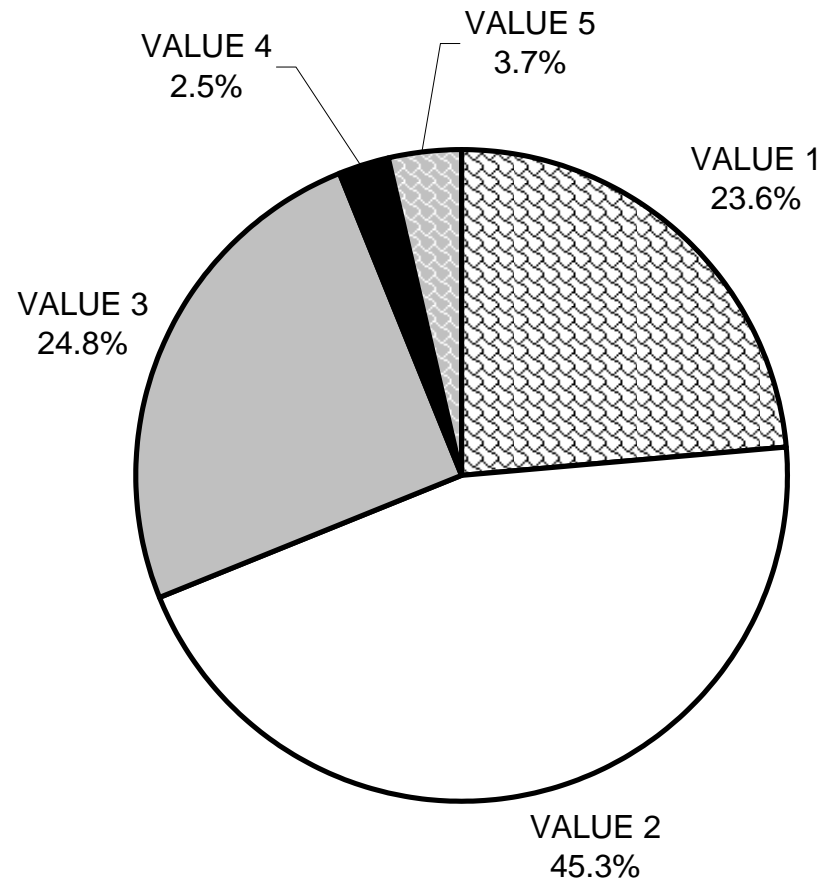
GRAPH 6

The depth of cobble embeddedness was estimated at pool tail-outs. Of the 161 pool tail-outs measured, 38 had a value of 1 (23.6%); 73 had a value of 2 (45.3%); 40 had a value of 3 (24.8%); 4 had a value of 4 (2.5%); 6 had a value of 5 (3.7%) (Graph 6). On this scale, a value of 1 indicates the best spawning conditions and a value of 4 the worst. Additionally, a value of 5 was assigned to tail-outs deemed unsuited for spawning due to inappropriate substrate such as bedrock, log sills, boulders, or other considerations.

One hundred eleven of the 161 pool tail-outs measured had embeddedness ratings of 1 or 2. Forty-four of the pool tail-outs had embeddedness ratings of 3 or 4. Six of the pool tail-outs had a rating of 5, which is considered unsuitable for spawning. Cobble embeddedness measured to be 25% or less, a rating of 1, is considered to indicate good quality spawning substrate for salmon and steelhead.

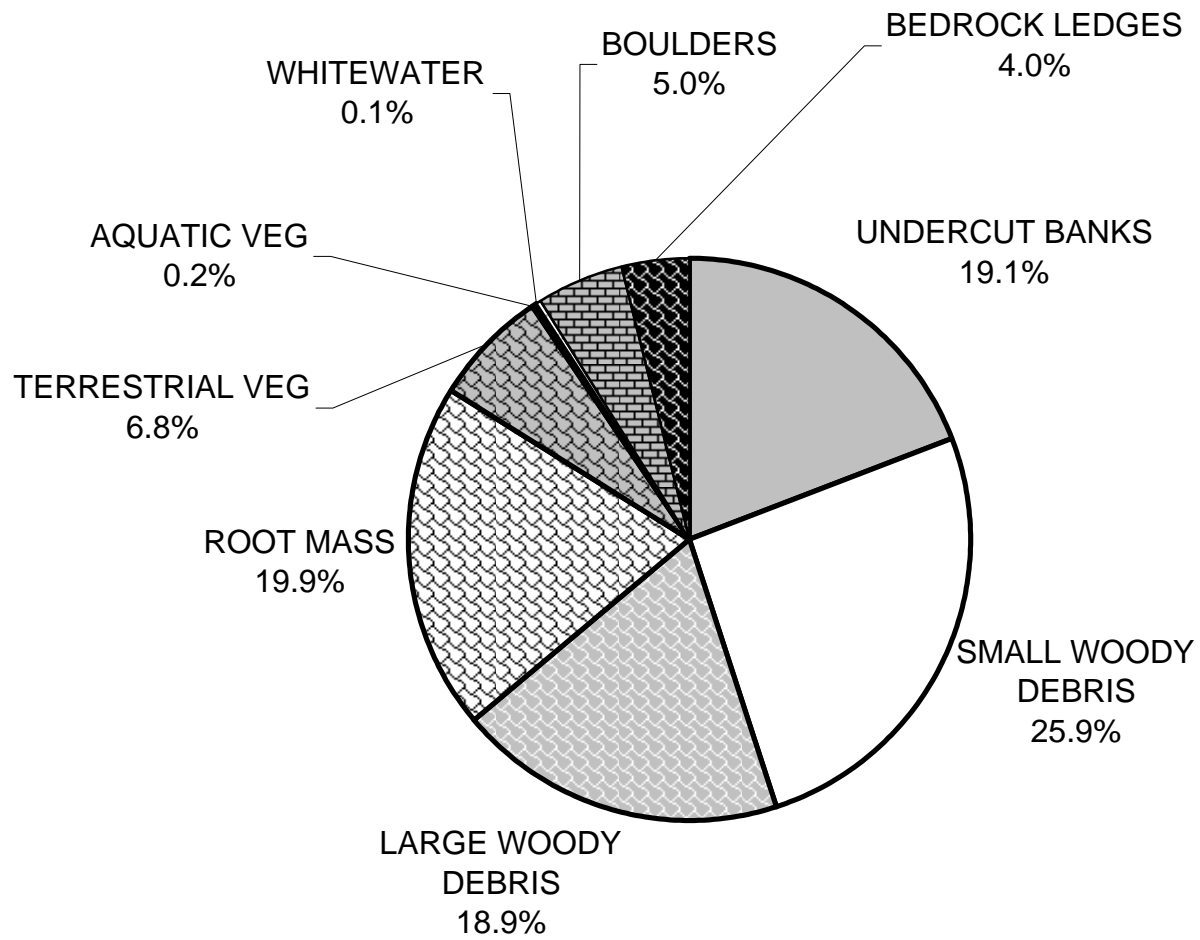
GRAPH 7

Table 5 summarizes mean percent cover by habitat type. Small woody debris is the dominant cover type in Pollock Creek. Graph 7 describes the pool cover in Pollock Creek. Small woody debris is the dominant pool cover type followed by root mass.

The mean shelter rating for pools is 36. The shelter rating in the flatwater habitats is 1. A pool shelter rating of approximately 100 is desirable. The amount of cover that now exists is being provided primarily by small woody debris in Pollock Creek. Small woody debris is the dominant cover type in pools followed by root mass. Log and root wad cover structures in the pool and flatwater habitats would enhance both summer and winter salmonid habitat. Log cover structure provides rearing fry with protection from predation, rest from water velocity, and also divides territorial units to reduce density related competition.

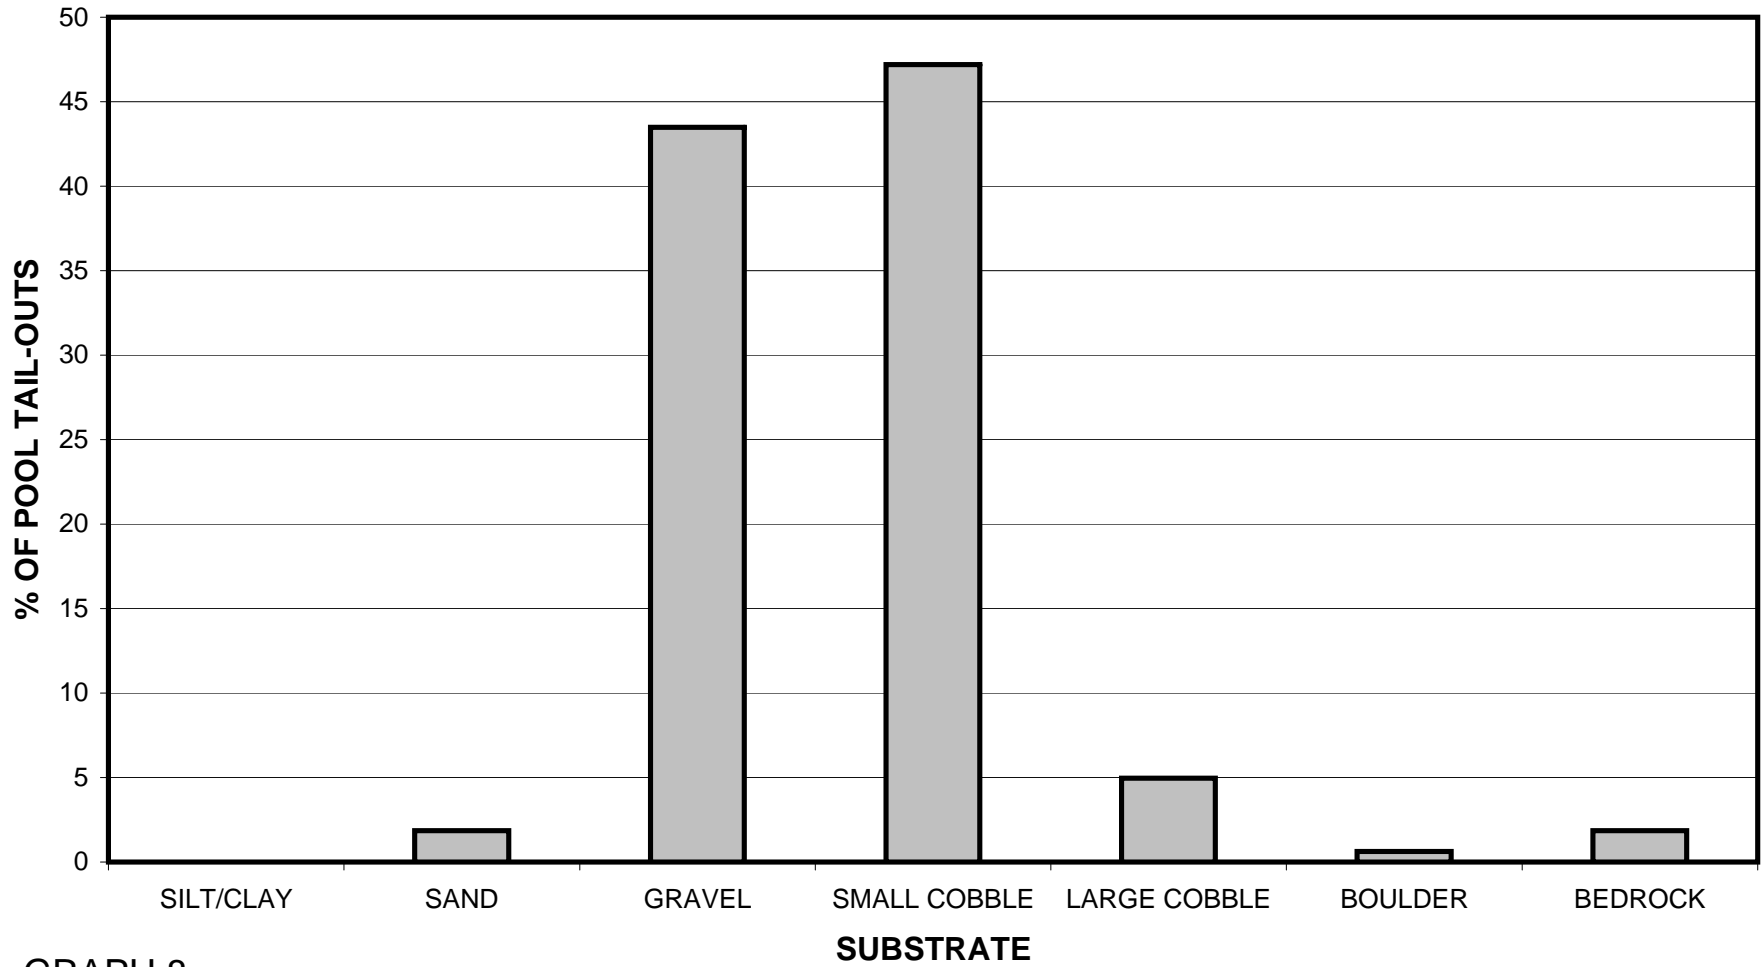
GRAPH 8

Table 6 summarizes the dominant substrate by habitat type. Graph 8 depicts the dominant substrate observed in pool tail-outs. Small cobble was the dominant substrate observed in 47% of the pool tail-outs. Gravel was the next most frequently observed dominant substrate type and occurred in 43% of the pool tail-outs.

One hundred forty-six of the 161 pool tail-outs measured had gravel or small cobble as the dominant substrate. This is generally considered good for spawning salmonids.

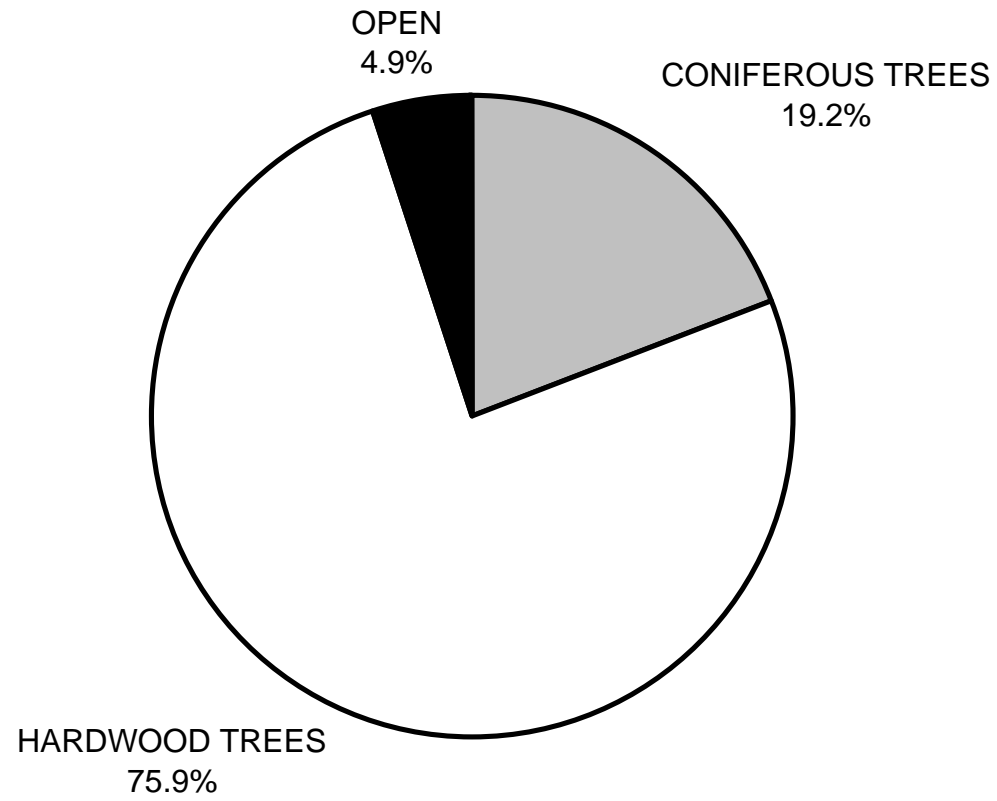
GRAPH 9

The mean percent canopy density for the surveyed length of Pollock Creek was 95%. Five percent of the canopy was open. Of the canopy present, the mean percentages of hardwood and coniferous trees were 80% and 20%, respectively. Graph 9 describes the mean percent canopy in Pollock Creek.

The mean percent canopy density for the stream was 95%. Reach 1 had a canopy density of 95.2%, reach 2 had a canopy density of 94.7%, and reach 3 had a canopy density of 94.5%. In general, revegetation projects are considered when canopy density is less than 80%.

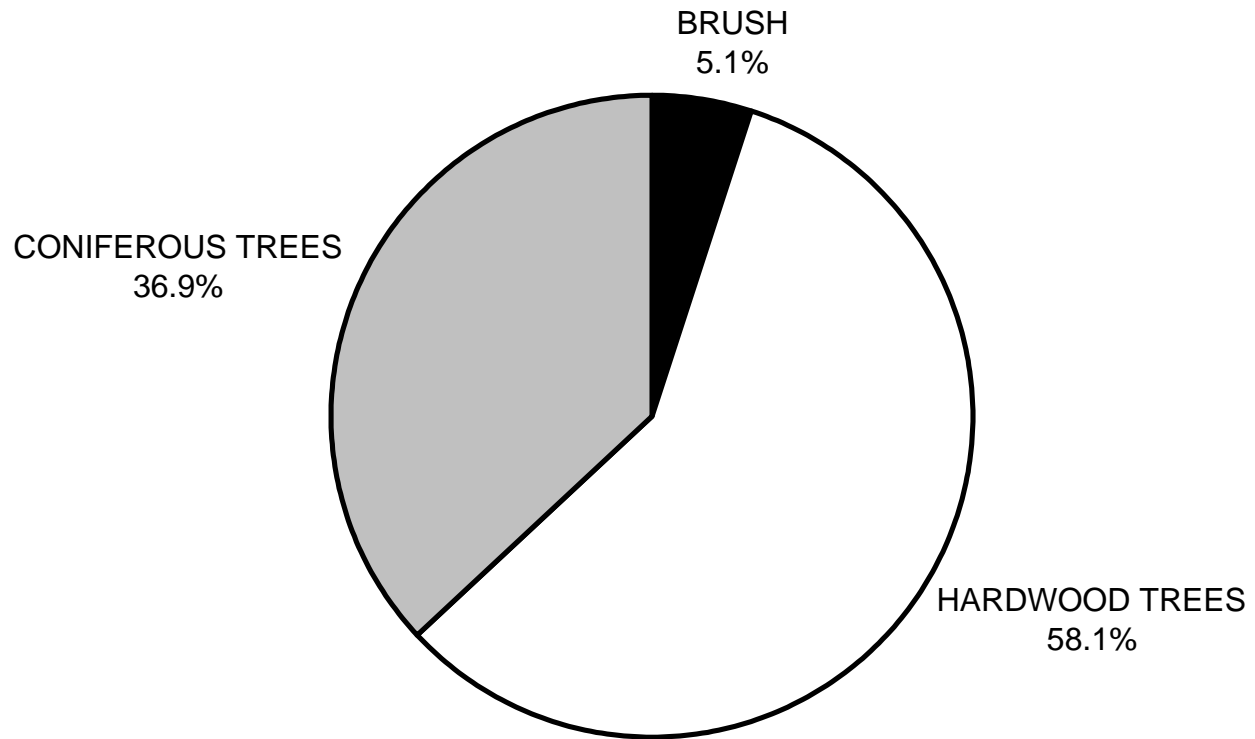
GRAPH 11

For the stream reach surveyed, the mean percent right bank vegetated was 91%. The mean percent left bank vegetated was 92%. The dominant elements composing the structure of the stream banks consisted of 68% sand/silt/clay, 22% cobble/gravel, 9% bedrock, and 1% boulder (Graph 10). Hardwood trees were the dominant vegetation type observed in 58% of the units surveyed. Additionally, 37% of the units surveyed had coniferous trees as the dominant vegetation type, and 5% had brush as the dominant vegetation type (Graph 11).

The percentage of right and left bank covered with vegetation was 91% and 92%, respectively. In areas of stream bank erosion or where bank vegetation is sparse, planting endemic species of coniferous and hardwood trees, in conjunction with bank stabilization, is recommended.
