STREAM INVENTORY REPORT

Redwood Creek

A stream inventory was conducted from June 15 to July 6, 2009 on Redwood Creek. The survey began at the confluence with South Fork Eel River and extended upstream 7.4 miles. Stream inventories and reports were also completed for three tributaries to Redwood Creek.

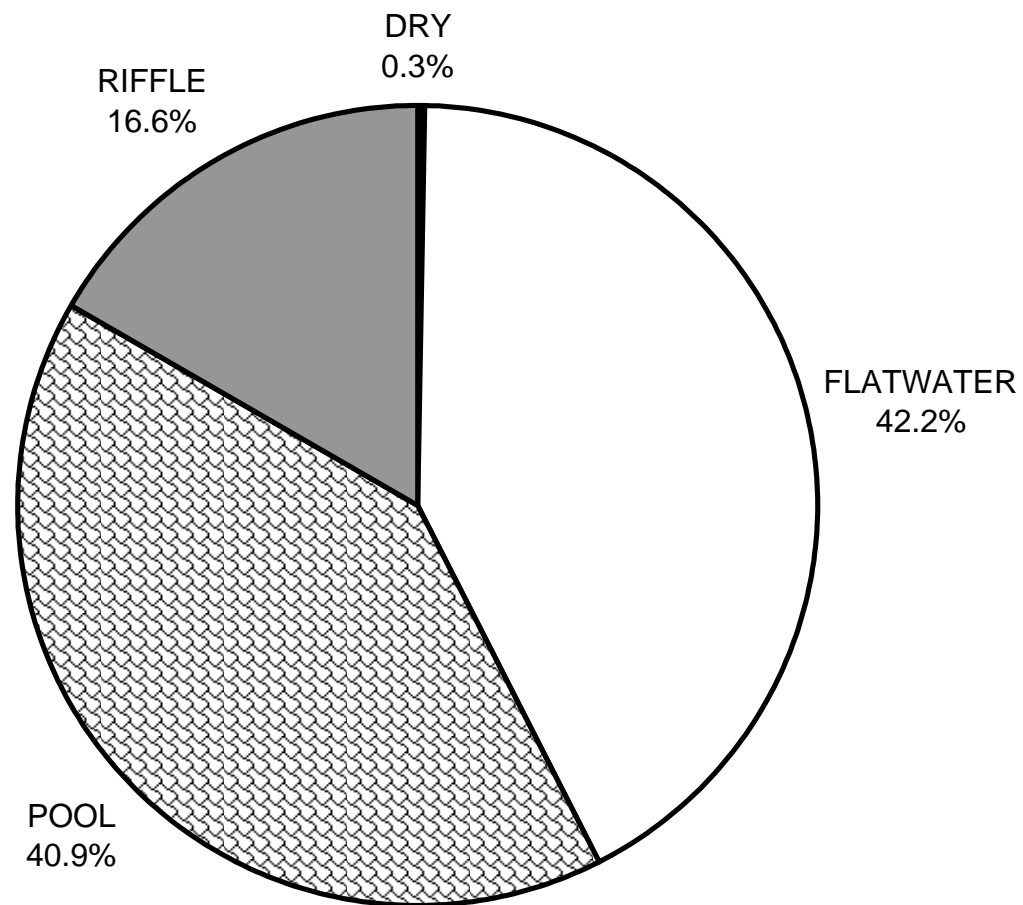
GRAPH 1

Table 1 summarizes the Level II riffle, flatwater, and pool habitat types. Based on frequency of occurrence there were 42% flatwater units, 41% pool units, and 16% riffle units (Graph 1). Based on total length of Level II habitat types there were 47% flatwater units, 44% pool units, and 8% riffle units (Graph 2).

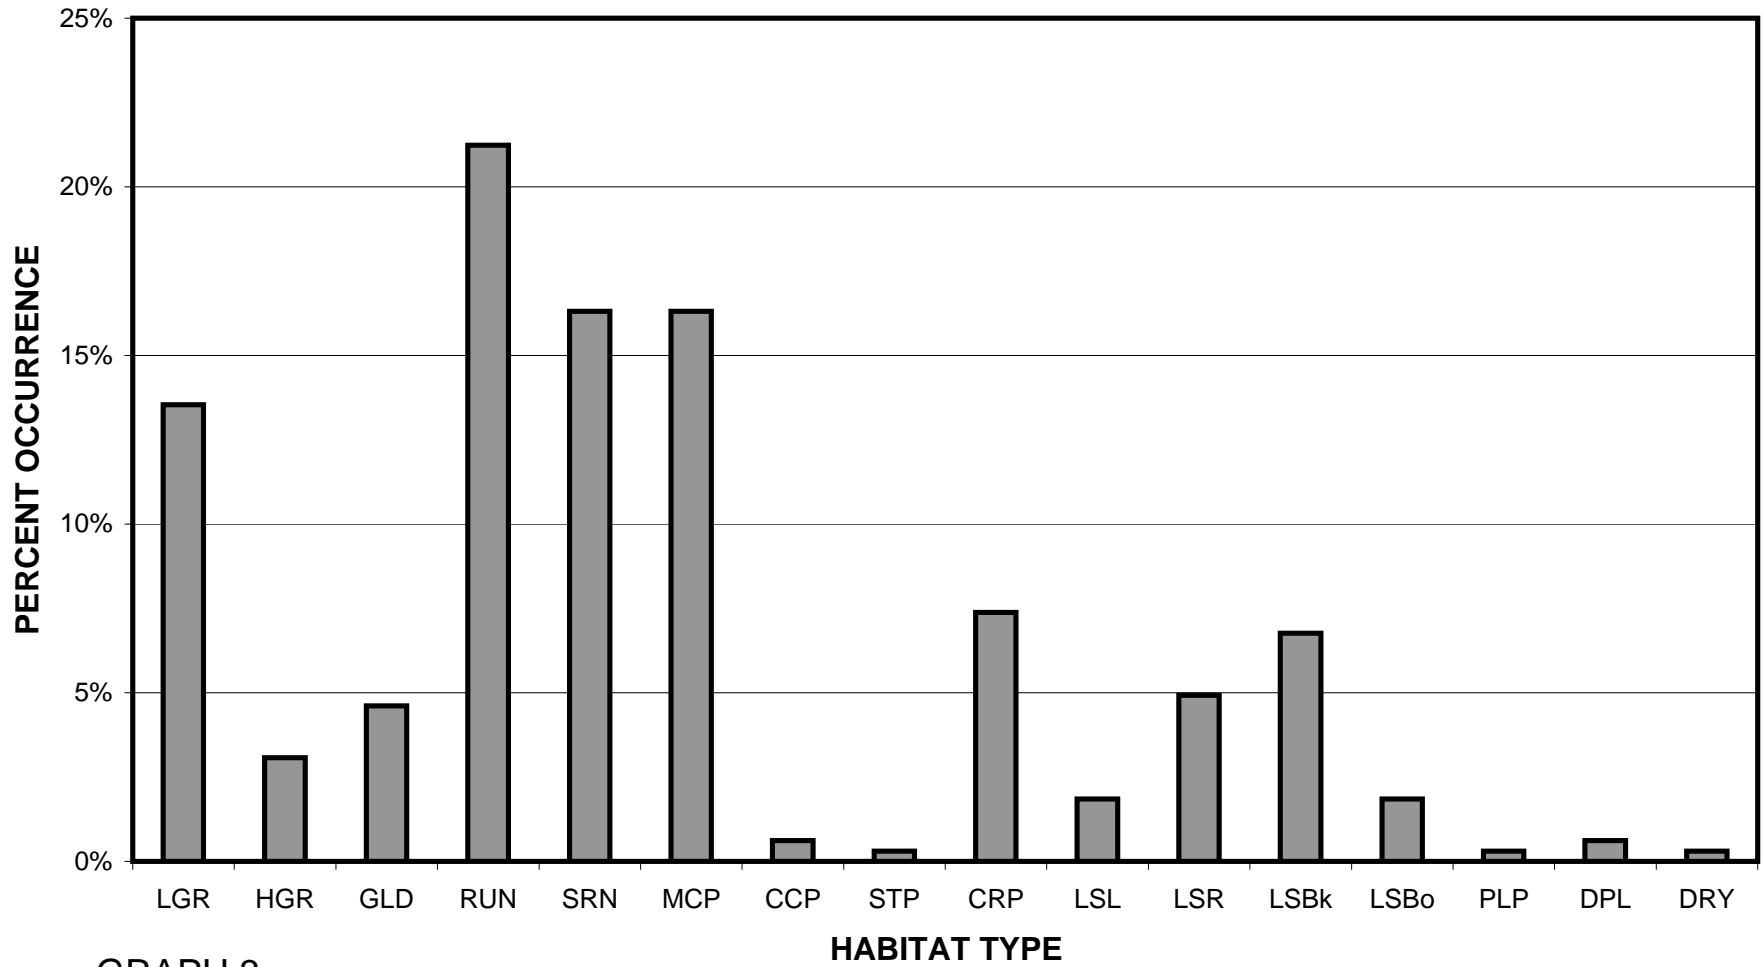
GRAPH 3

Sixteen Level IV habitat types were identified (Table 2). The most frequent habitat types by percent occurrence were run units, 21%; step run units, 16%; mid-channel pool units, 16%; and

low gradient riffle units, 13% (Graph 3). Based on percent total length step run units made up 23%, mid-channel pool units 20%, and run units 18%.

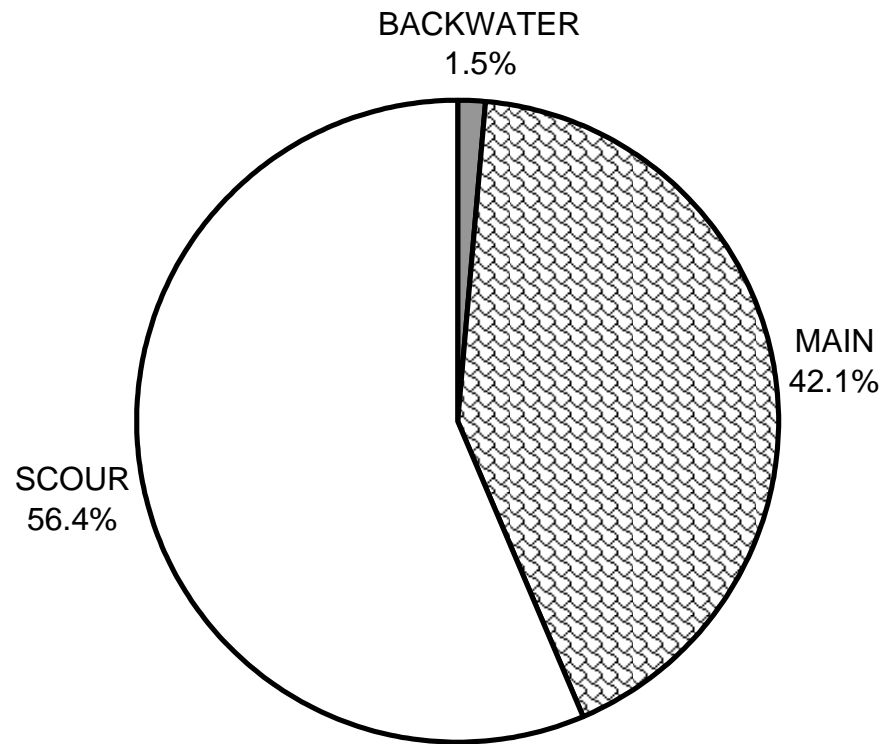
GRAPH 4

A total of 133 pools were identified (Table 3). Scour pools were the most frequently encountered at 56% (Graph 4), and comprised 52% of the total length of all pools (Table 3).

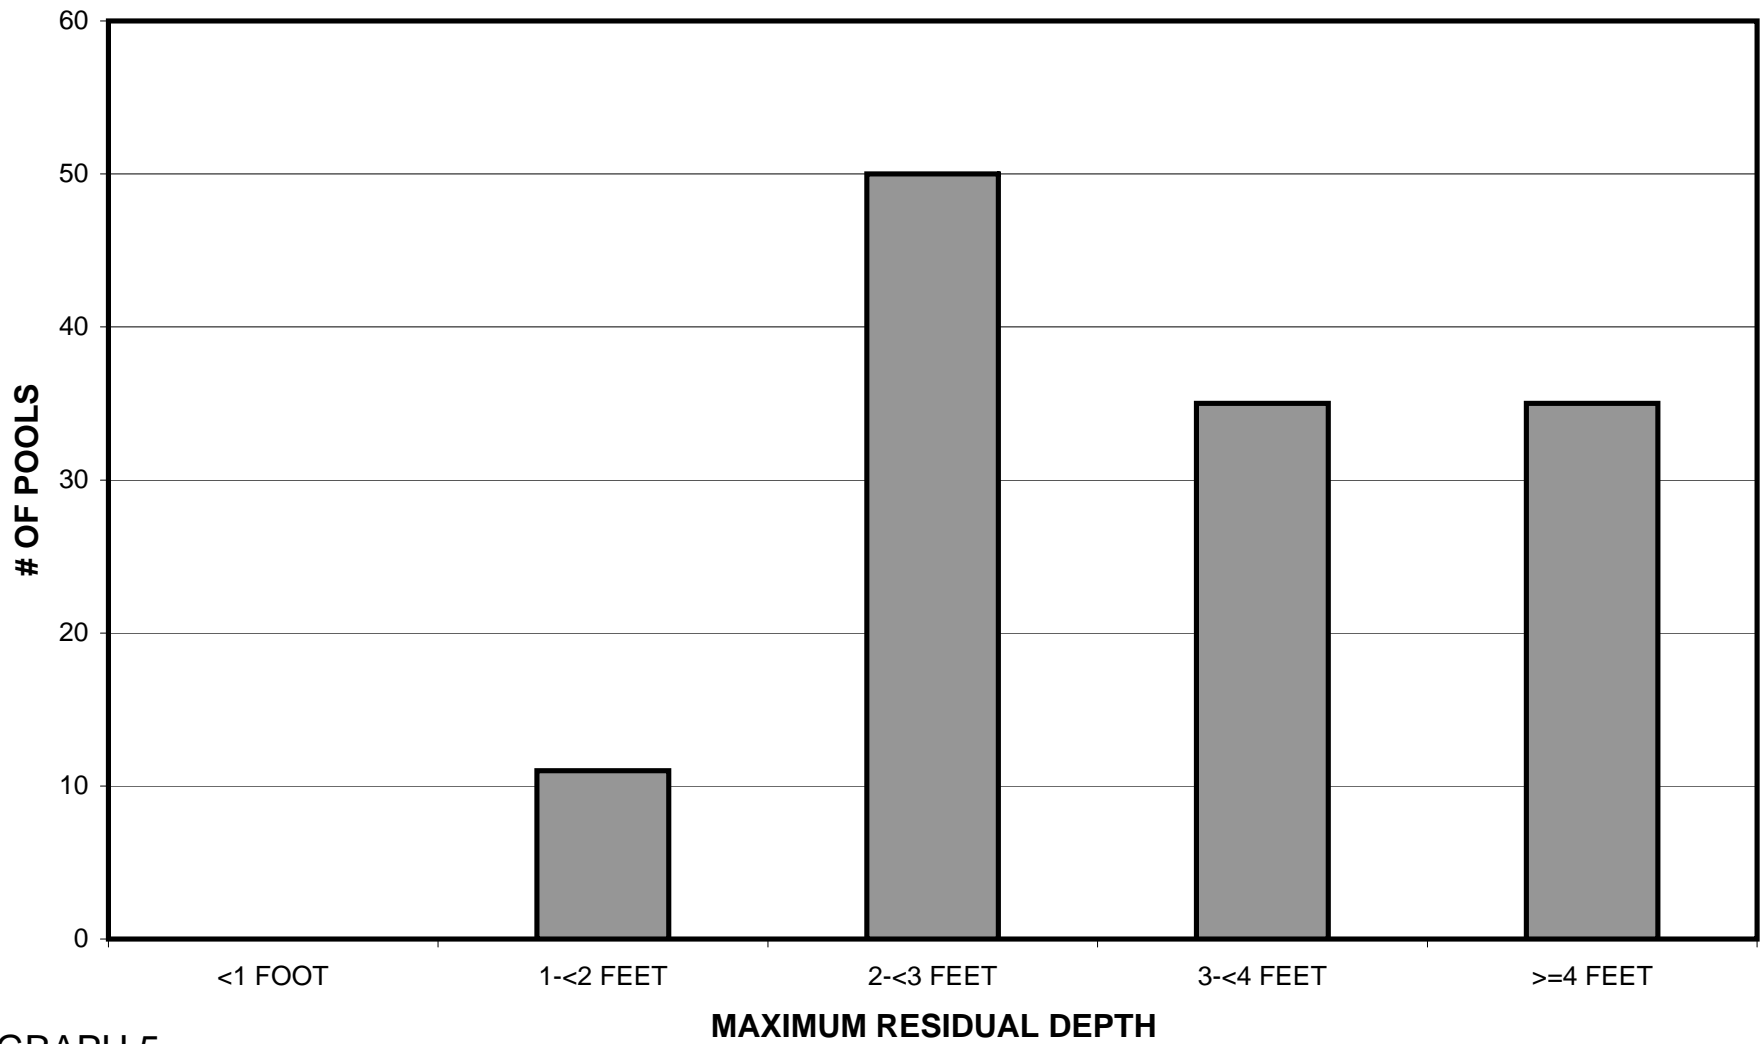
GRAPH 5

Table 4 is a summary of maximum residual pool depths by pool habitat types. Pool quality for salmonids increases with depth. Seventy of the 131 pools (53%) had a residual depth of three feet or greater (Graph 5).

Flatwater habitat types comprised 47% of the total length of this survey, riffles 9%, and pools 44%. Seventy of the 131 pools (53%) pools had a maximum residual depth greater than 3 feet. In general, pool enhancement projects are considered when primary pools comprise less than 40% of the length of total stream habitat. In third and fourth order streams, a primary pool is defined to have a maximum residual depth of at least three feet, occupy at least half the width of

the low flow channel, and be as long as the low flow channel width. Installing large wood structures that will increase or deepen pool habitat is recommended.

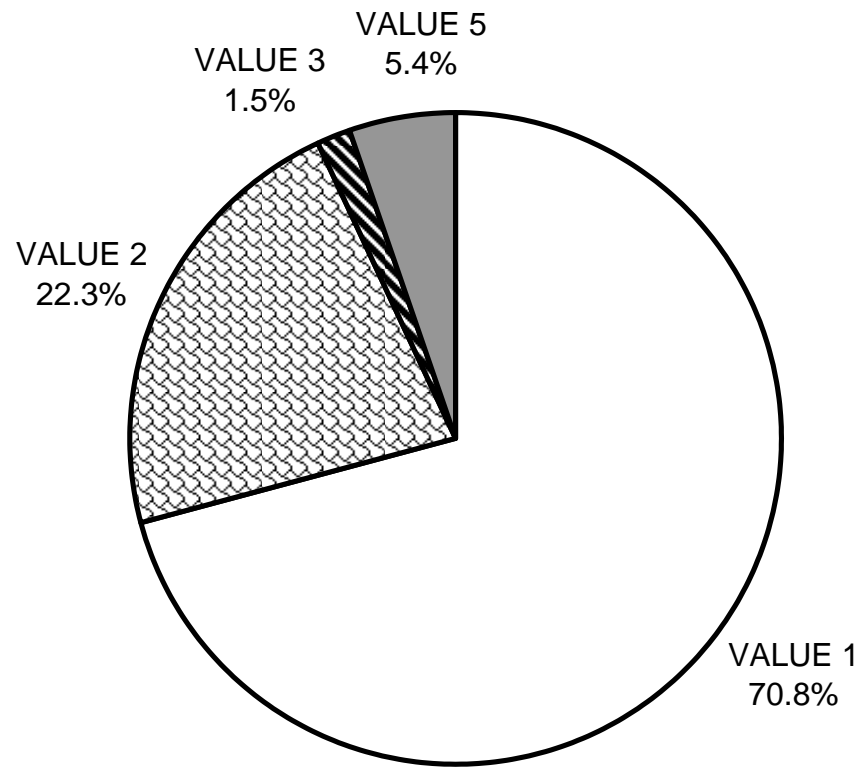
GRAPH 6

The depth of cobble embeddedness was estimated at pool tail-outs. Of the 130 pool tail-outs measured, 92 had a value of 1 (70.8%); 29 had a value of 2 (22.3%); 2 had a value of 3 (1.5%); 7 had a value of 5 (5.4%) (Graph 6). On this scale, a value of 1 indicates the best spawning conditions and a value of 4 the worst. Additionally, a value of 5 was assigned to tail-outs deemed unsuited for spawning due to inappropriate substrate such as bedrock, log sills, boulders, or other considerations.

One hundred twenty-one of the 130 pool tail-outs measured had embeddedness ratings of 1 or 2. Two of the pool tail-outs had embeddedness ratings of 3 or 4. Seven of the pool tail-outs had a rating of 5, which is considered unsuitable for spawning. Cobble embeddedness measured to be 25% or less, a rating of 1, is considered to indicate good quality spawning substrate for salmon and steelhead.

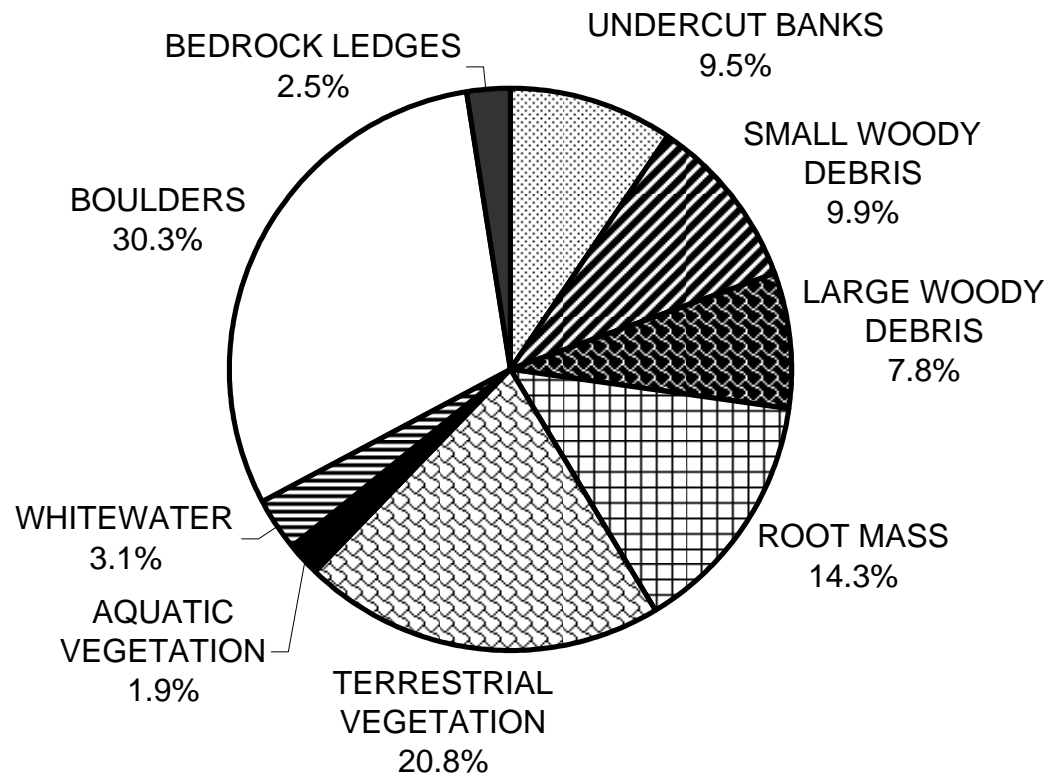
GRAPH 7

Table 5 summarizes mean percent cover by habitat type. Boulders are the dominant cover type in Redwood Creek. Graph 7 describes the pool cover in Redwood Creek. Boulders are the dominant pool cover type followed by terrestrial vegetation.

The mean shelter rating for pools is 21. The shelter rating in the flatwater habitats is 9. A pool shelter rating of approximately 100 is desirable. The amount of cover that now exists is being provided primarily by boulders in Redwood Creek. Boulders are the dominant cover type in pools followed by terrestrial vegetation. Log and root wad cover structures in the pool and flatwater habitats would enhance both summer and winter salmonid habitat. Log cover structure provides rearing fry with protection from predation, rest from water velocity, and also divides territorial units to reduce density related competition.

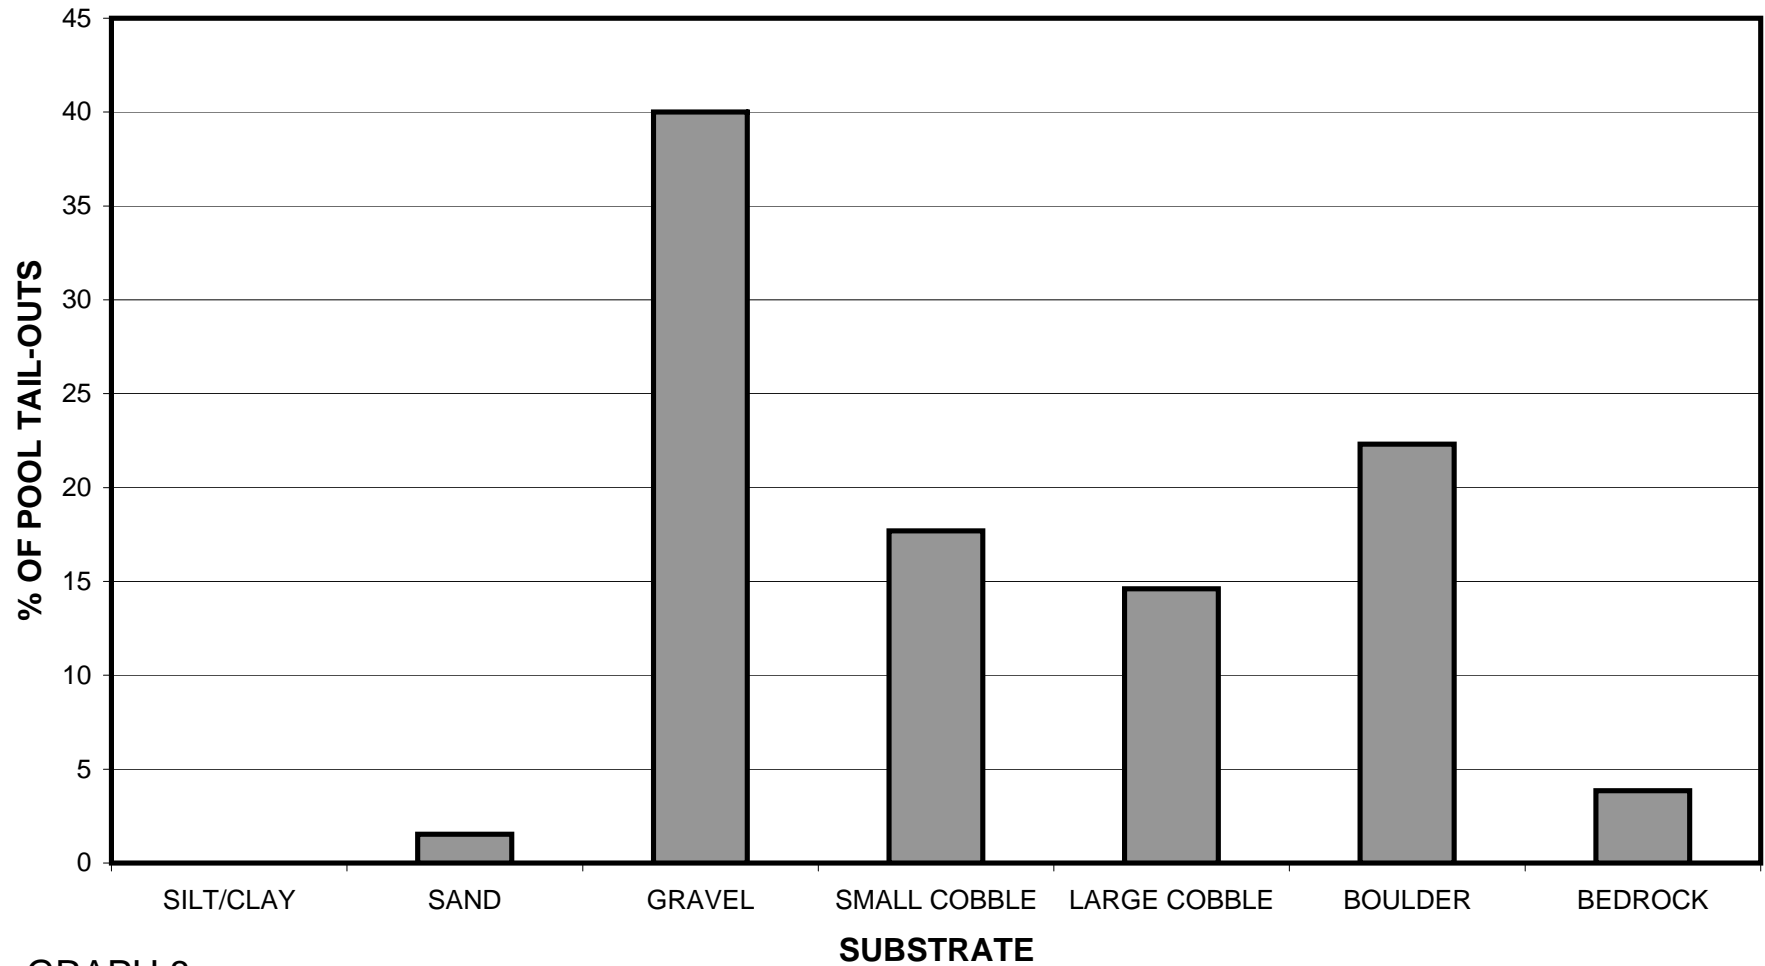
GRAPH 8

Table 6 summarizes the dominant substrate by habitat type. Graph 8 depicts the dominant substrate observed in pool tail-outs. Gravel was the dominant substrate observed in 40% of the pool tail-outs. Boulders were the next most frequently observed dominant substrate type and occurred in 22% of the pool tail-outs.

Seventy-five of the 130 pool tail-outs measured had gravel or small cobble as the dominant substrate. This is generally considered good for spawning salmonids.

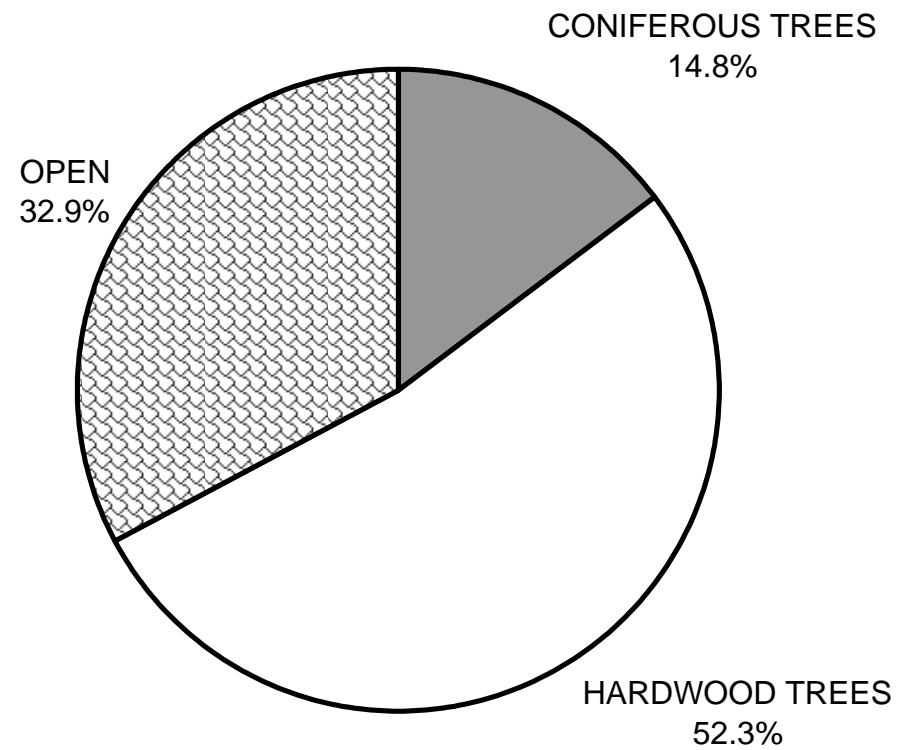
GRAPH 9

The mean percent canopy density for the surveyed length of Redwood Creek was 67%. Thirty-three percent of the canopy was open. Of the canopy present, the mean percentages of hardwood and coniferous trees were 78% and 22%, respectively. Graph 9 describes the mean percent canopy in Redwood Creek.

The mean percent canopy density for the stream was 67%. Reach 1 had a canopy density of 57%, and Reach 3 had a canopy density of 77%. In general, revegetation projects are considered when canopy density is less than 80%.

- 5) Increase the canopy on Redwood Creek by planting appropriate native vegetation like willow, alder, redwood, and Douglas fir along the stream where shade canopy is not at acceptable levels. The reaches above this survey section should be inventoried and treated as well, since the water flowing here is affected from upstream. In many cases, planting will need to be coordinated to follow bank stabilization or upslope erosion control projects.

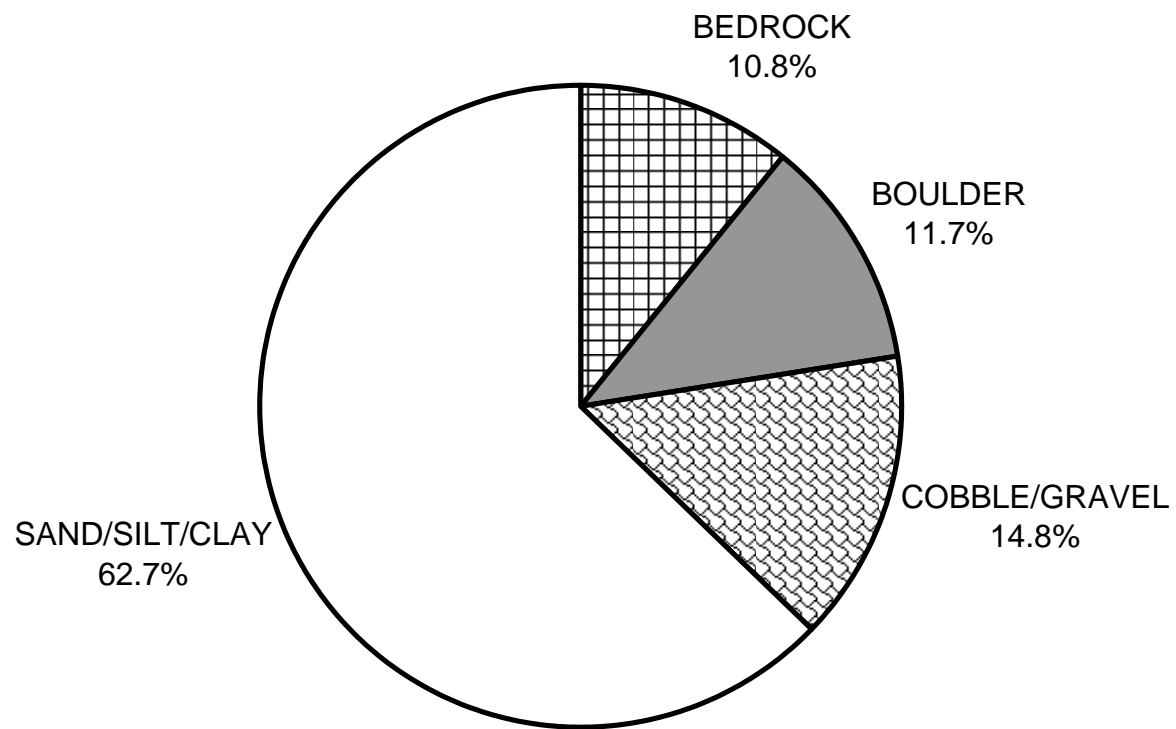
GRAPH 10

For the stream reach surveyed, the mean percent right bank vegetated was 90%. The mean percent left bank vegetated was 91%. The dominant elements composing the structure of the stream banks consisted of 63% sand/silt/clay, 15% cobble/gravel, 12% boulder, and 11% bedrock (Graph 10). Deciduous trees were the dominant vegetation type observed in 69% of the units surveyed. Additionally, 19% of the units surveyed had coniferous trees as the dominant vegetation type, and 11% had brush as the dominant vegetation type (Graph 11).

The percentage of right and left bank covered with vegetation was 90% and 91%, respectively. In areas of stream bank erosion or where bank vegetation is sparse, planting endemic species of coniferous and hardwood trees, in conjunction with bank stabilization, is recommended.
