STREAM INVENTORY REPORT

Rohner Creek

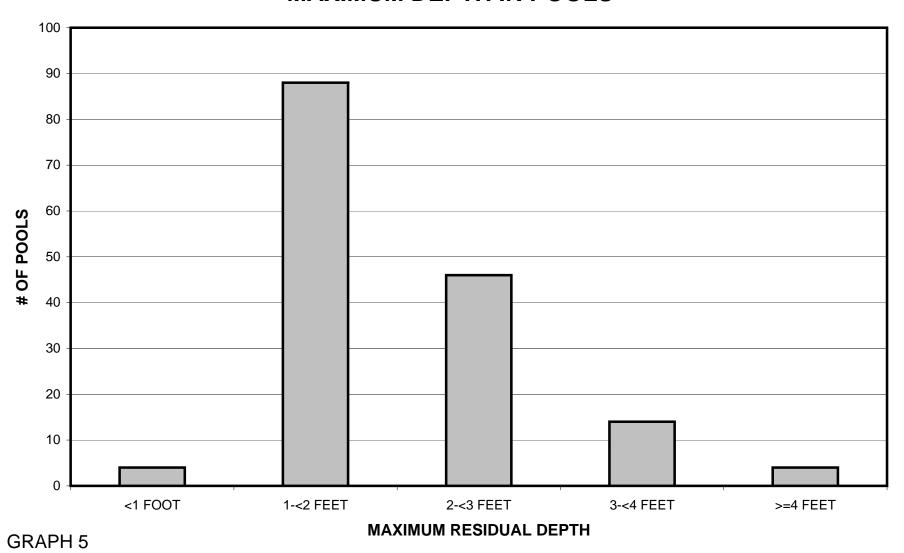
ROHNER CREEK 2009 MAXIMUM DEPTH IN POOLS

Table 4 is a summary of maximum residual pool depths by pool habitat types. Pool quality for salmonids increases with depth. Sixty-four of the 156 pools (41%) had a residual depth of two feet or greater (Graph 5).

Flatwater habitat types comprised 25% of the total length of this survey, riffles 8%, and pools 31%. Sixty-four of the 156 (41%) pools had a maximum residual depth greater than 2 feet. In general, pool enhancement projects are considered when primary pools comprise less than 40% of the length of total stream habitat. In first and second order streams, a primary pool is defined to have a maximum residual depth of at least two feet, occupy at least half the width of the low flow channel, and be as long as the low flow channel width. Installing large wood structures that will increase or deepen pool habitat is recommended.

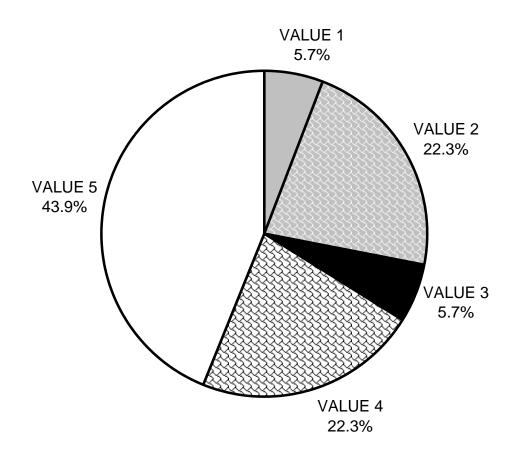
ROHNER CREEK 2009 PERCENT EMBEDDEDNESS

The depth of cobble embeddedness was estimated at pool tail-outs. Of the 156 pool tail-outs measured, 9 had a value of 1 (5.7%); 35 had a value of 2 (22.3%); 9 had a value of 3 (5.7%); 34 had a value of 4 (22.3%); 69 had a value of 5 (43.9%) (Graph 6). On this scale, a value of 1 indicates the best spawning conditions and a value of 4 the worst. Additionally, a value of 5 was assigned to tail-outs deemed unsuited for spawning due to inappropriate substrate such as bedrock, log sills, boulders, or other considerations.

Forty-four of the 156 pool tail-outs measured had embeddedness ratings of 1 or 2. Forty-three of the pool tail-outs had embeddedness ratings of 3 or 4. Sixty-nine of the pool tail-outs had a rating of 5, which is considered unsuitable for spawning. Cobble embeddedness measured to be 25% or less, a rating of 1, is considered to indicate good quality spawning substrate for salmon and steelhead. Sediment sources in Rohner Creek should be mapped and rated according to their potential sediment yields, and control measures should be taken.

- 4) Active and potential sediment sources related to the road system need to be identified, mapped, and treated according to their potential for sediment yield to the stream and its tributaries.

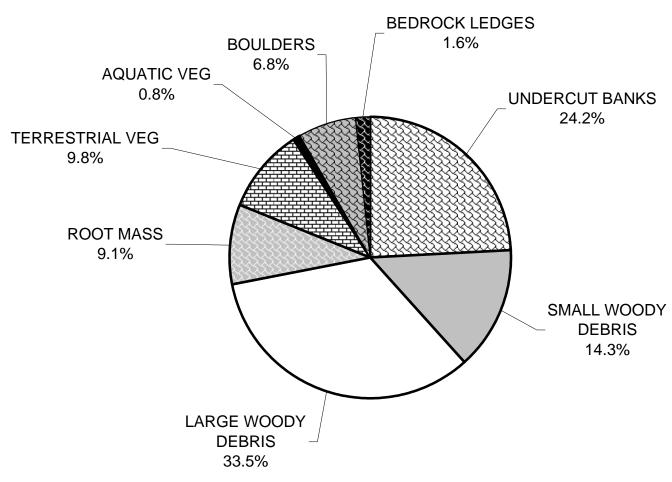
ROHNER CREEK 2009 MEAN PERCENT COVER TYPES IN POOLS

Table 5 summarizes mean percent cover by habitat type. Large woody debris is the dominant cover type in Rohner Creek. Graph 7 describes the pool cover in Rohner Creek. Large woody debris is the dominant pool cover type followed by undercut banks.

The mean shelter rating for pools is 18. The shelter rating in the flatwater habitats is 18. A pool shelter rating of approximately 100 is desirable. The amount of cover that now exists is being provided primarily by large woody debris in Rohner Creek. Large woody debris is the dominant cover type in pools followed by undercut banks. Log and root wad cover structures in the pool and flatwater habitats would enhance both summer and winter salmonid habitat. Log cover

- 3) Increase woody cover in the pools and flatwater habitat units. Most of the existing cover in the pools is from large woody debris. Adding high quality complexity with woody cover in the pools is desirable.

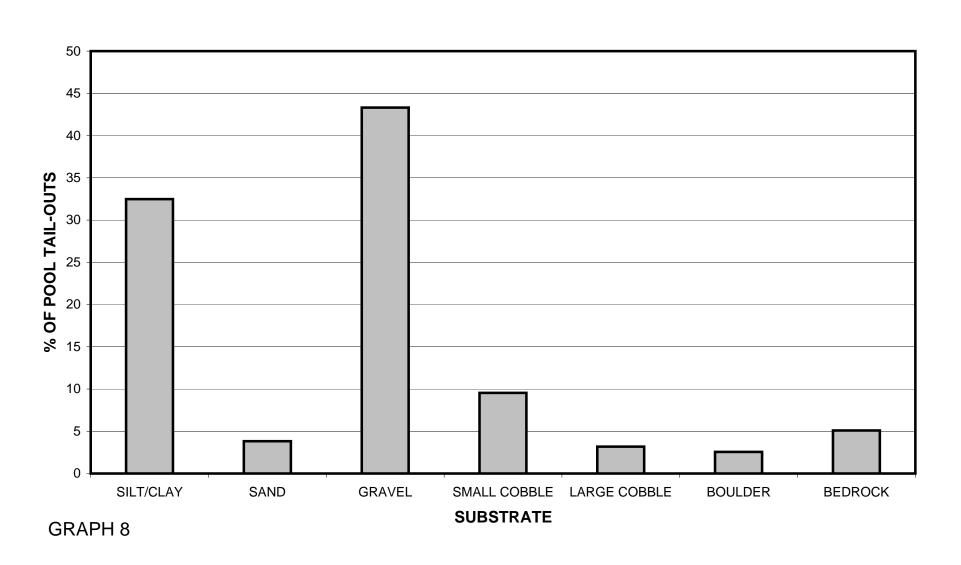
ROHNER CREEK 2009 SUBSTRATE COMPOSITION IN POOL TAIL-OUTS

Table 6 summarizes the dominant substrate by habitat type. Graph 8 depicts the dominant substrate observed in pool tail-outs. Gravel was the dominant substrate observed in 43% of the pool tail-outs. Silt/clay was the next most frequently observed dominant substrate type and occurred in 32% of the pool tail-outs.

Eighty-three of the 156 pool tail-outs measured had gravel or small cobble as the dominant substrate. Seventy-three of the 156 pool tail-outs had silt, sand, large cobble, boulders or bedrock as the dominant substrate. Suitable size spawning and quality substrate on Rohner Creek is limited to relatively few reaches. Projects should be designed at suitable sites to trap and sort spawning gravel.

- 5) Suitable size spawning substrate on Rohner Creek is limited to relatively few reaches. Projects should be designed at suitable sites to trap and sort spawning gravel.
