# **STREAM INVENTORY REPORT**

## **Salmon Creek**

A stream inventory was conducted during October 3, 2007 to October 29, 2007 on Salmon Creek. The survey began at the confluence with the South Fork Eel River and extended upstream 7.3 miles.

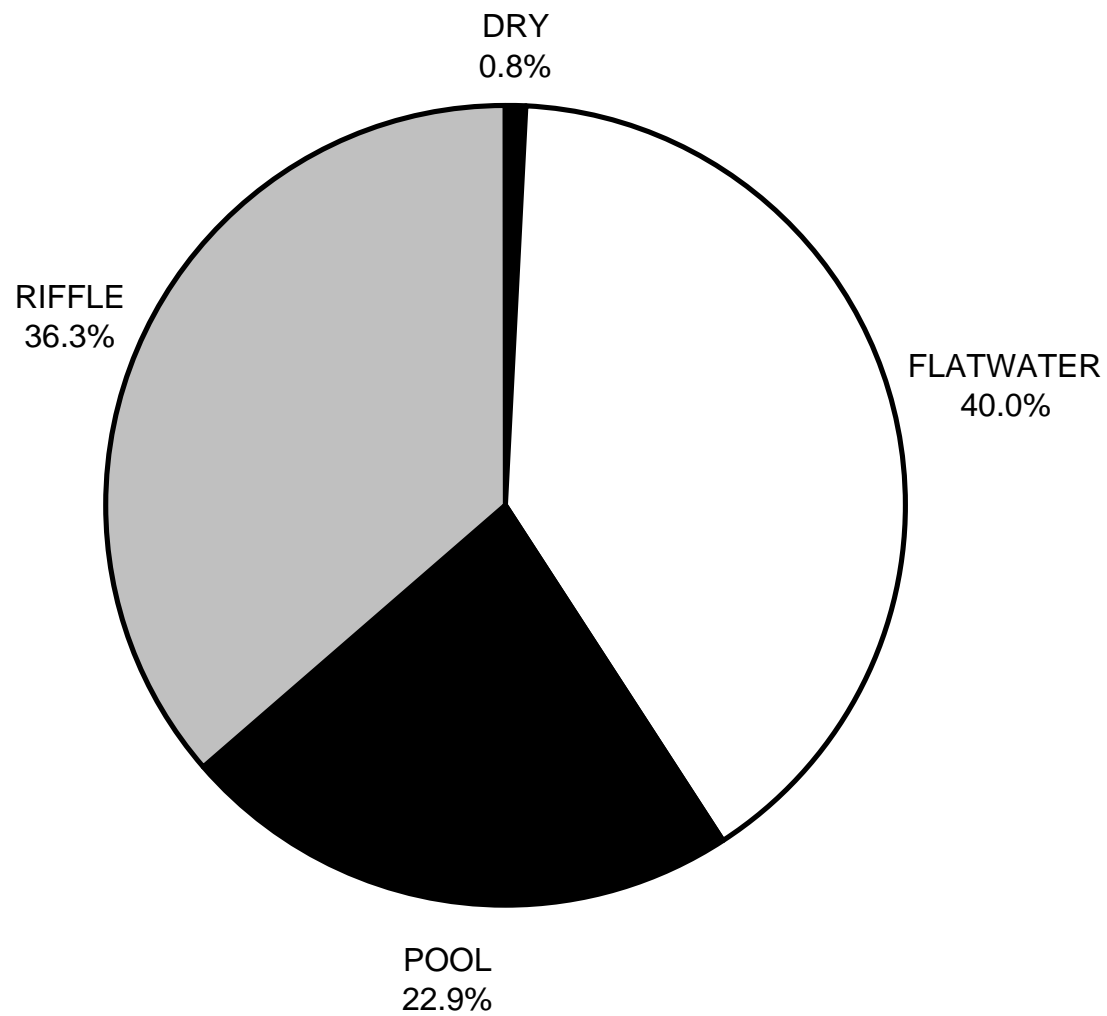
GRAPH 1

Table 1 summarizes the Level II riffle, flatwater, and pool habitat types. Based on frequency of occurrence there were 40% flatwater units, 36% riffle units, 23% pool units, and 1% dry units (Graph 1). Based on total length of Level II habitat types there were 45% flatwater units, 28% riffle units, 24% pool units, and 2% dry units (Graph 2).

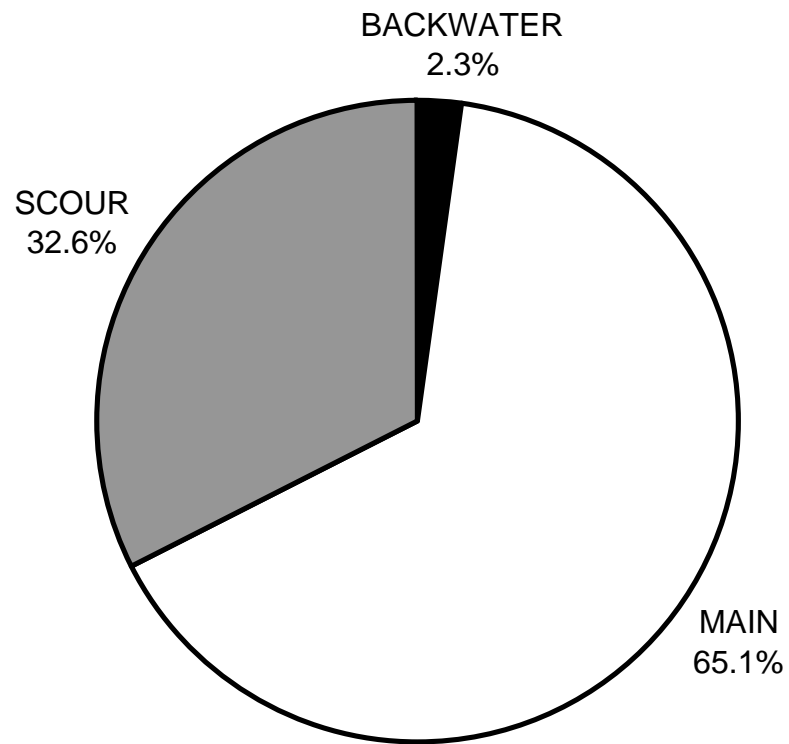
GRAPH 4

A total of 86 pools were identified (Table 3). Main channel pools were the most frequently encountered, at 65% (Graph 4), and comprised 70% of the total length of all pools (Table 3).

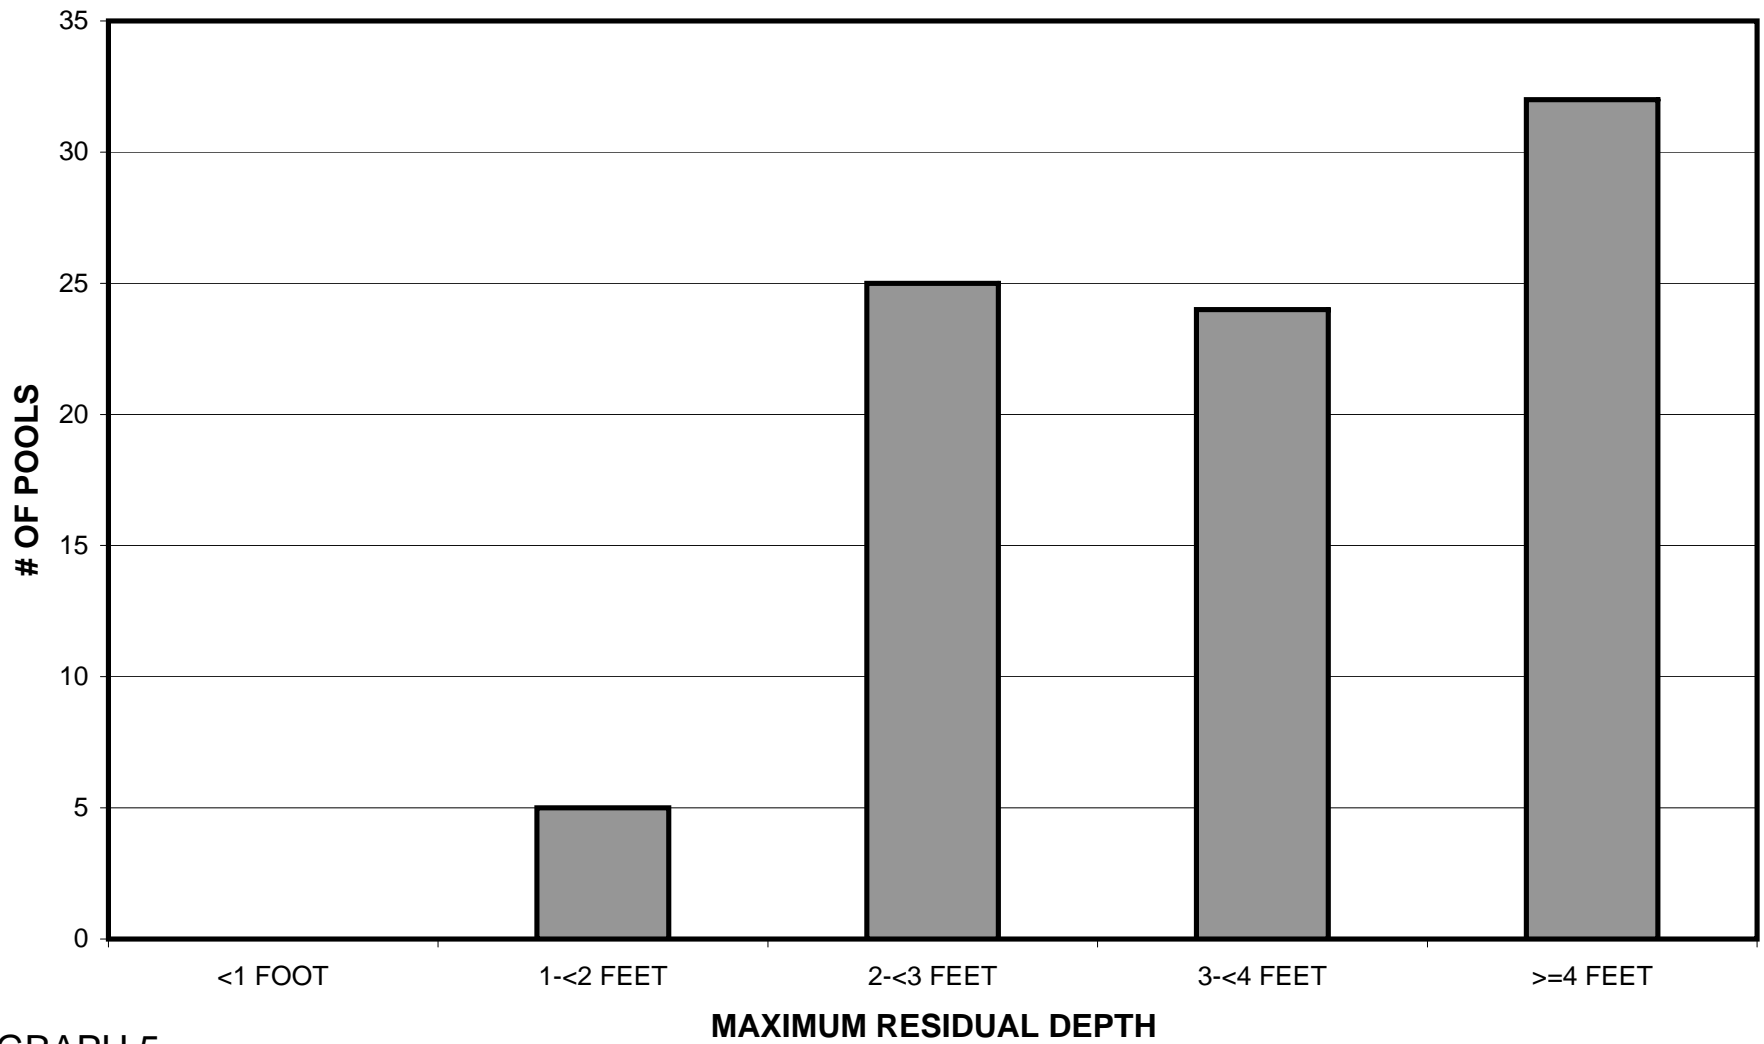
GRAPH 5

Table 4 is a summary of maximum residual pool depths by pool habitat types. Pool quality for salmonids increases with depth. Fifty-six of the 86 pools (65%) had a residual depth of three feet or greater (Graph 5).

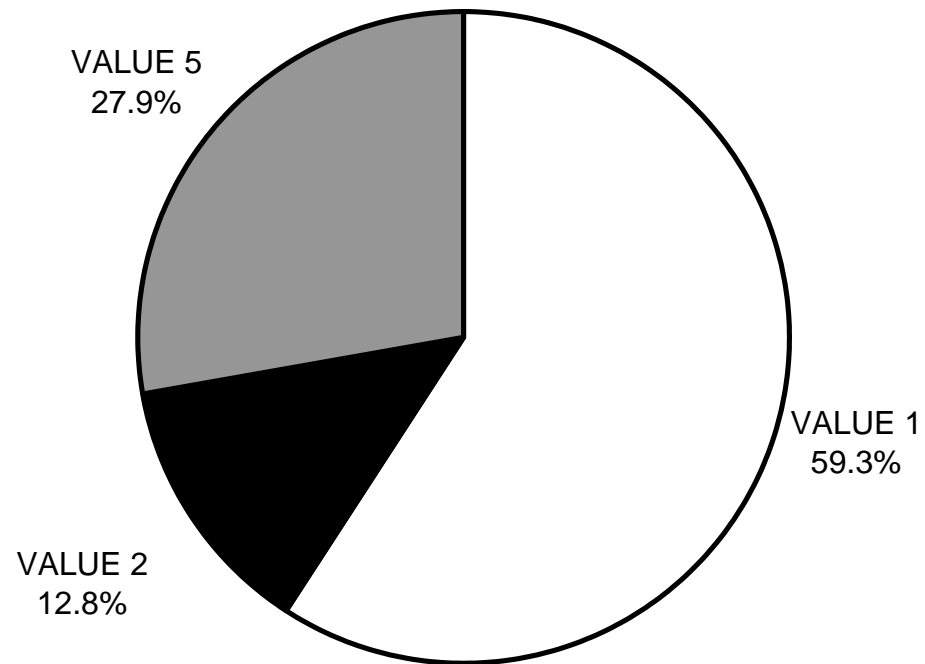
GRAPH 6

The depth of cobble embeddedness was estimated at pool tail-outs. Of the 86 pool tail-outs measured, 51 had a value of 1 (59.3%); 11 had a value of 2 (12.8%); and 24 had a value of 5 (27.9%) (Graph 6). On this scale, a value of 1 indicates the best spawning conditions and a value of 4 the worst. Additionally, a value of 5 was assigned to tail-outs deemed unsuited for spawning due to inappropriate substrate such as bedrock, log sills, boulders, or other considerations.

Sixty-two of the 85 pool tail-outs measured had embeddedness ratings of 1 or 2. None of the pool tail-outs had embeddedness ratings of 3 or 4. Twenty-four of the pool tail-outs had a rating of 5, which is considered unsuitable for spawning. Cobble embeddedness measured to be 25% or less, a rating of 1, is considered to indicate good quality spawning substrate for salmon and steelhead.

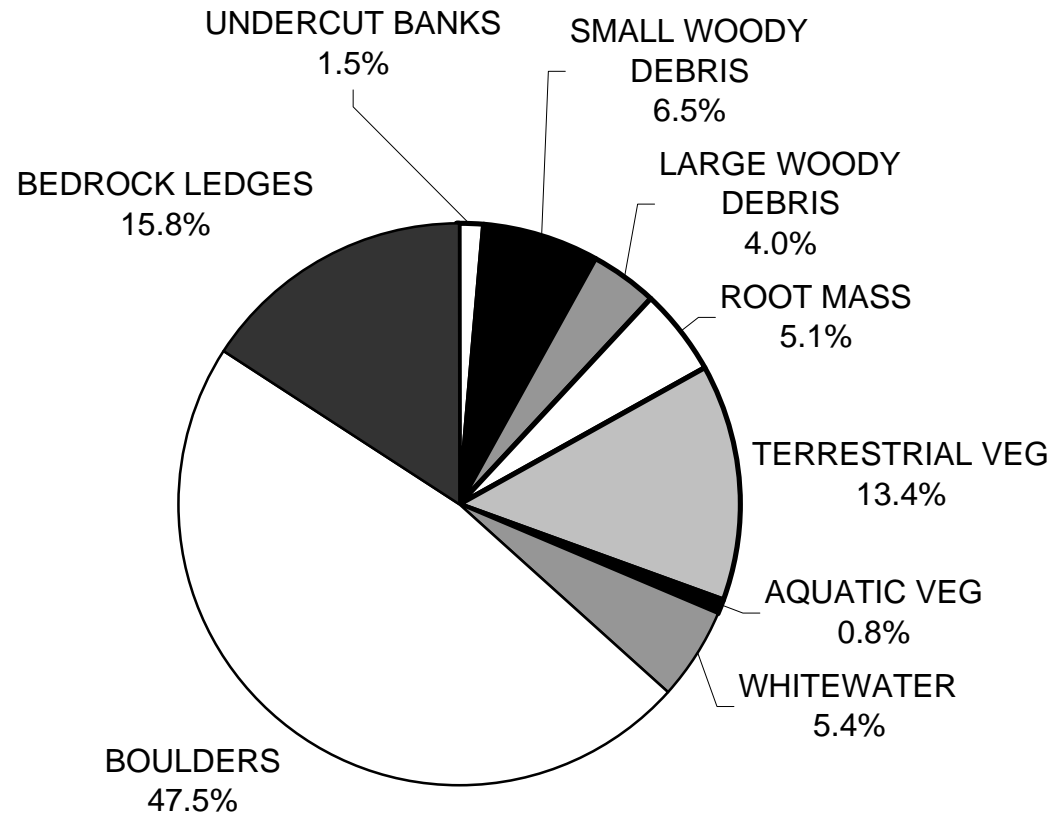
GRAPH 7

Table 5 summarizes mean percent cover by habitat type. Boulders are the dominant cover types in Salmon Creek. Graph 7 describes the pool cover in Salmon Creek. Boulders are the dominant pool cover type followed by bedrock ledges.

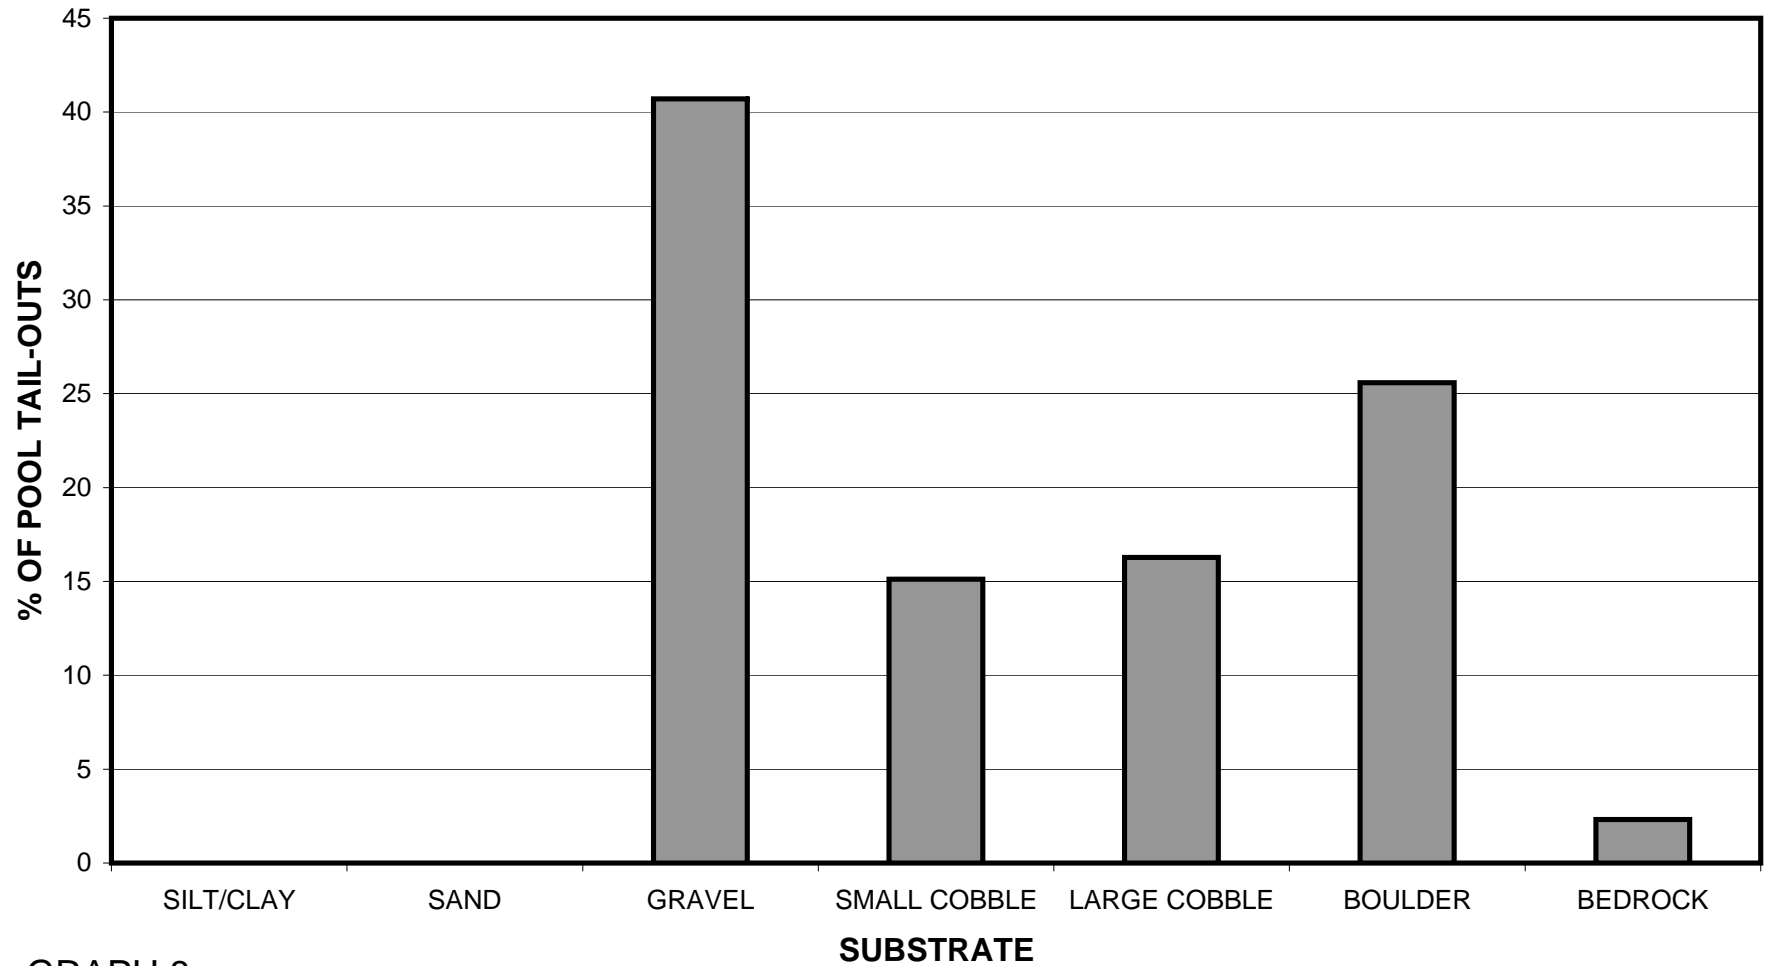
GRAPH 8

Table 6 summarizes the dominant substrate by habitat type. Graph 8 depicts the dominant substrate observed in pool tail-outs. Gravel was observed in 41% of pool tail-outs, and boulders were observed in 26% of pool tail-outs.

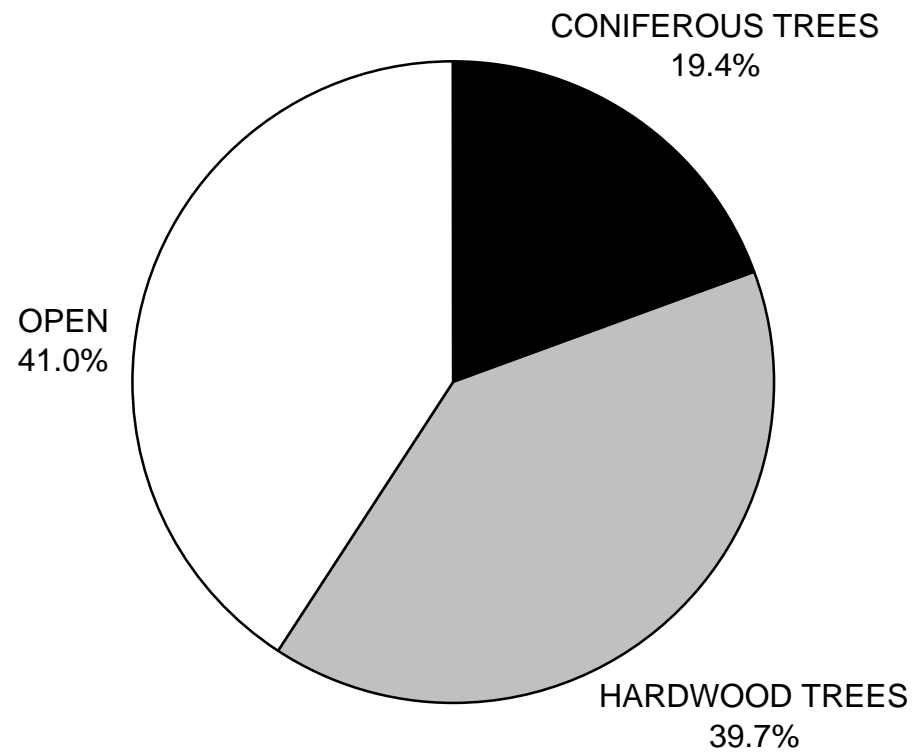
GRAPH 9

The mean percent canopy density for the surveyed length of Salmon Creek was 59%. Forty-one percent of the canopy was open. Of the canopy present, the mean percentages of hardwood and coniferous trees were 67% and 33%, respectively. Graph 9 describes the mean percent canopy in Salmon Creek.

The mean percent canopy density for the stream was 59%. Reach 1 had a canopy density of 72.9%, reach 2 had a canopy density of 45.7%, reach 3 had a canopy density of 46.3%, and reach 4 had a canopy density of 60.3%. In general, revegetation projects are considered when canopy density is less than 80%.

- 4) Increase the canopy on Salmon Creek by planting appropriate native vegetation like willow, alder, redwood, and Douglas fir along the stream where shade canopy is not at acceptable levels. The reaches above this survey section should be inventoried and treated as well, since the water flowing here is affected from upstream. In many cases, planting will need to be coordinated to follow bank stabilization or upslope erosion control projects.

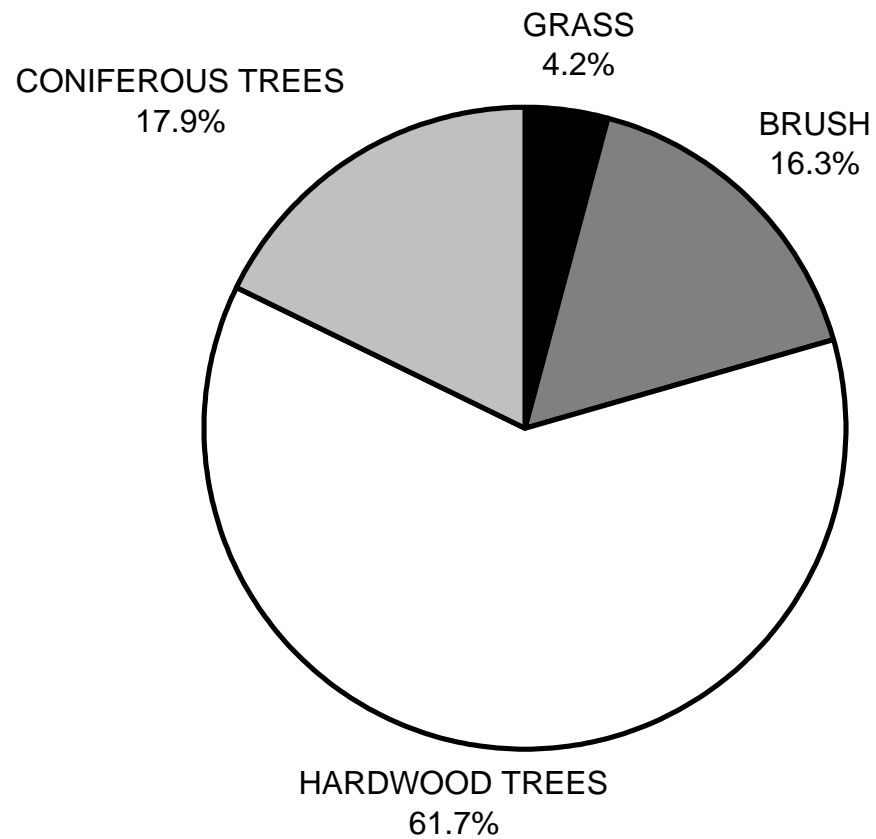
GRAPH 11

For the stream reach surveyed, the mean percent right bank vegetated was 68%. The mean percent left bank vegetated was 66%. The dominant elements composing the structure of the stream banks consisted of 35% cobble/gravel, 27% boulder, 20% bedrock, and 17% sand/silt/clay (Graph 10). Hardwood trees were the dominant vegetation type observed in 62% of the units surveyed. Additionally, 18% of the units surveyed had coniferous trees as the dominant vegetation type, and 16% had brush as the dominant vegetation (Graph 11).
