STREAM INVENTORY SUB-SECTION REPORT

Salmon Creek, 2003

Salmon Creek

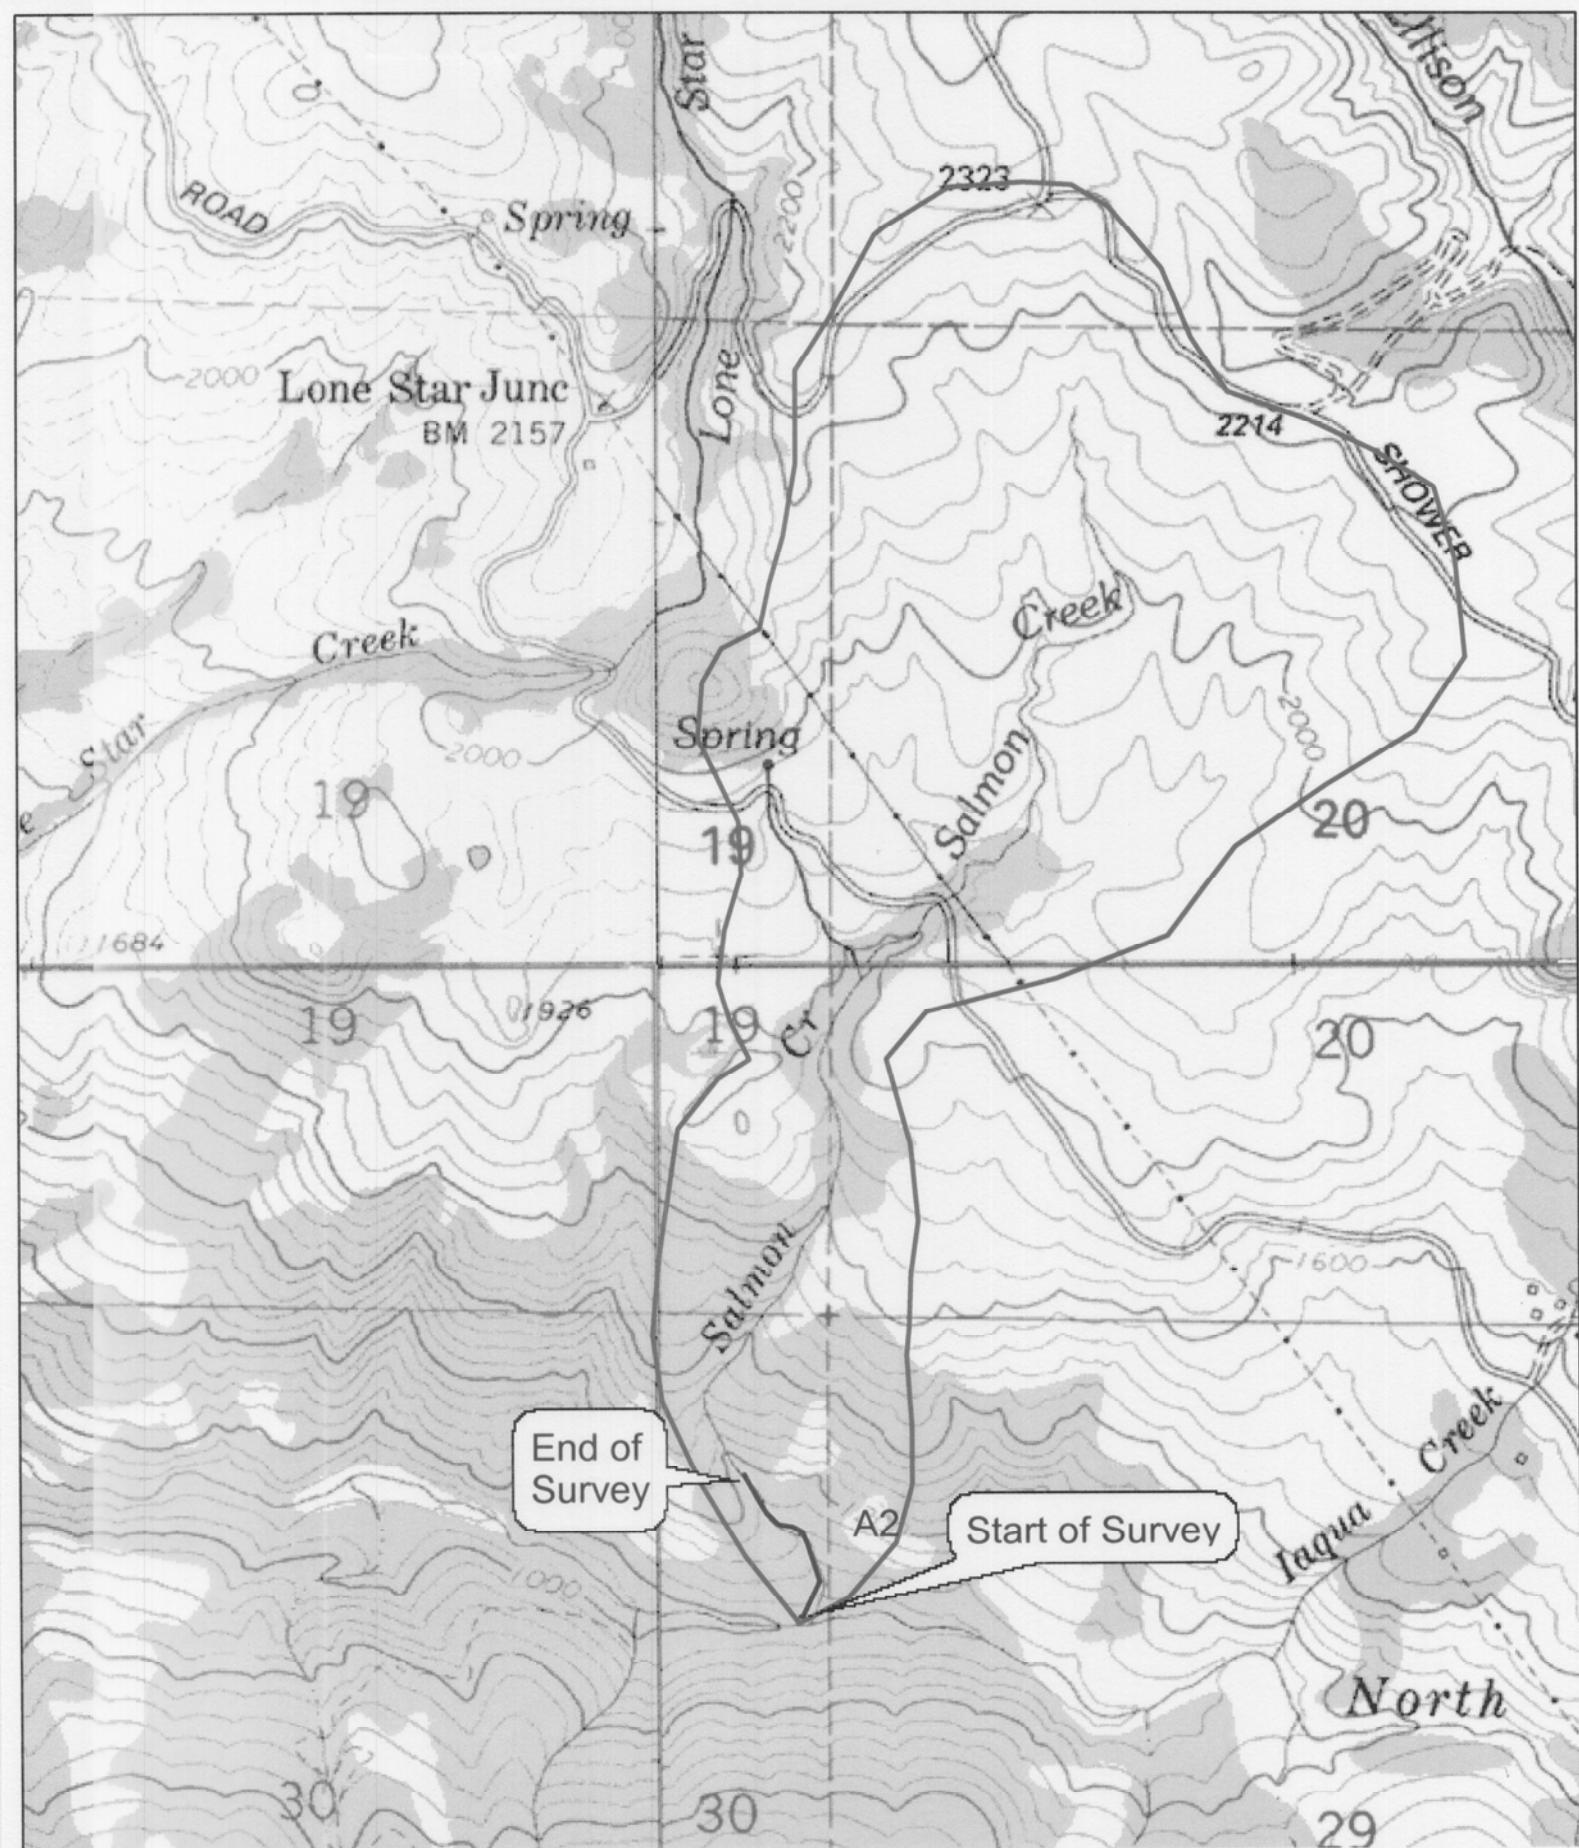
Location: 040° 37' 31.43" N 123° 52' 20.34" W
Caption: Salmon Creek 2003 Habitat Survey

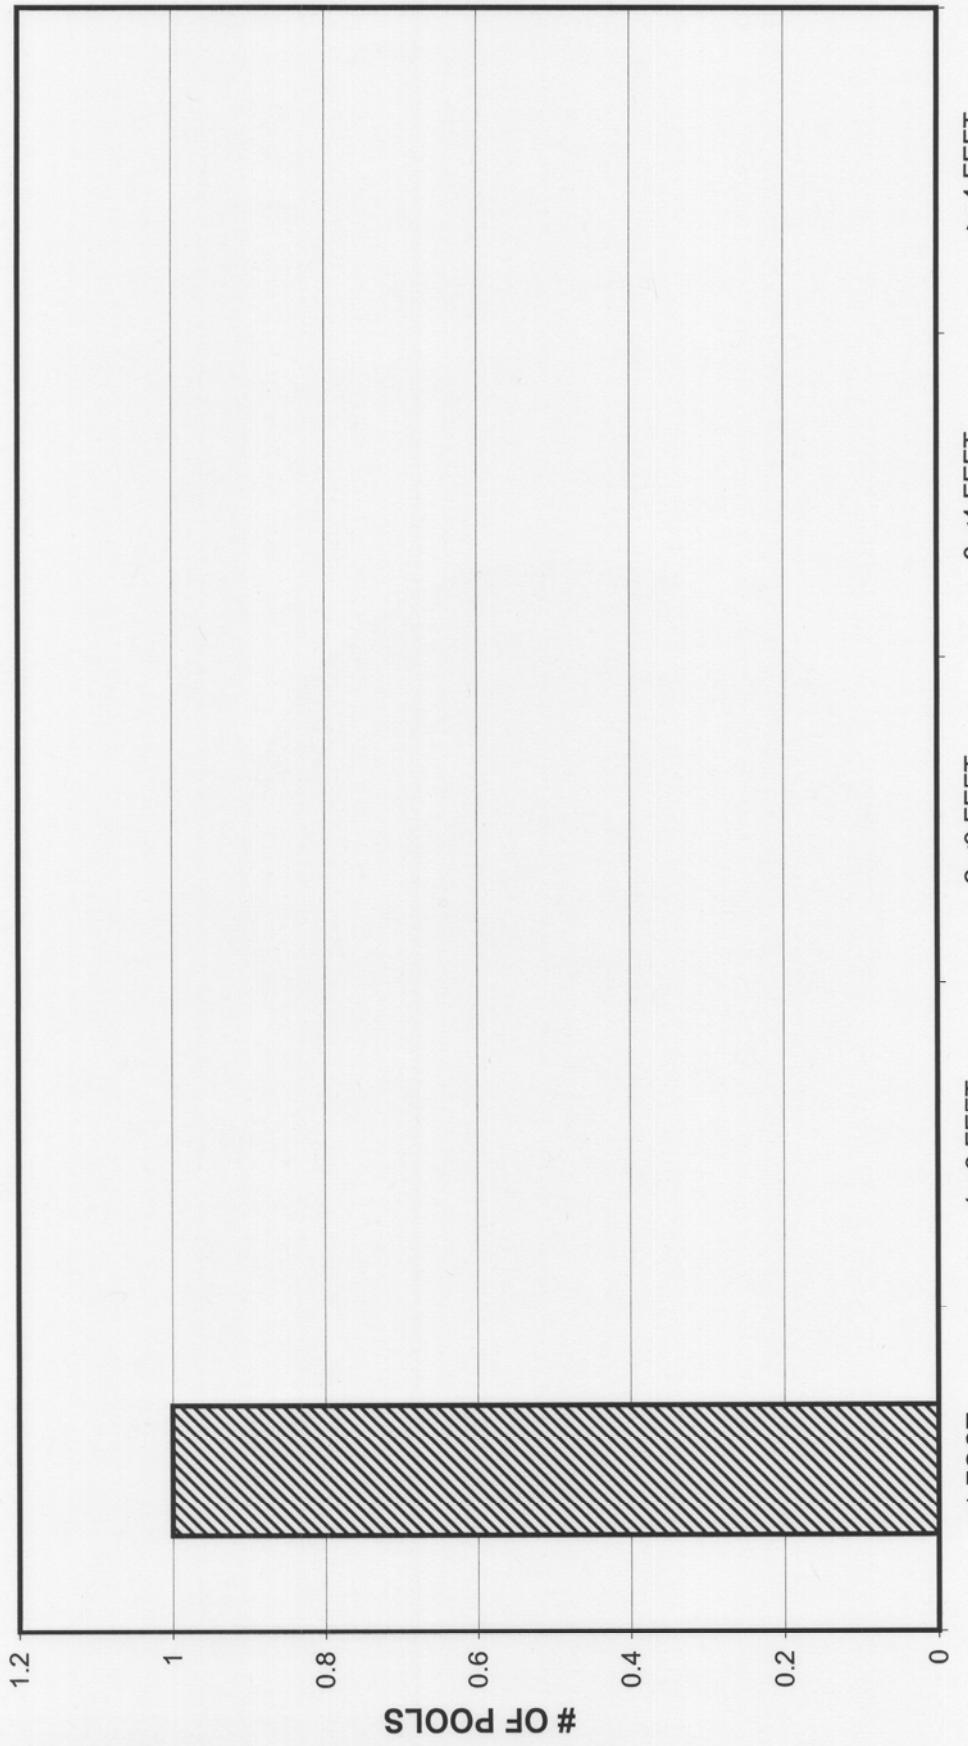
GRAPH 5

Based on the total length of this survey, Level II habitat units consisted of 46% flatwater units, 31% riffle units, 15% dry units, and 8% pool units. The one pool unit within the surveyed reach is relatively shallow, having a maximum depth of less than 2 feet.

Salmon Creek 2003
MAXIMUM DEPTH IN POOLS

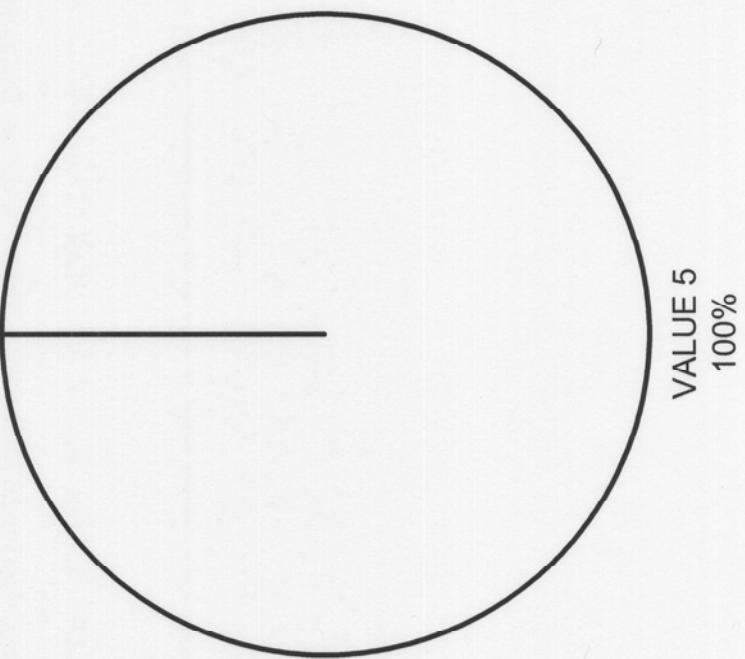
GRAPH 6

The one pool tail-out measured had an embeddedness rating of 5. Cobble embeddedness of 25% or less, a rating of 1, is considered best for the needs of salmon and steelhead. In Salmon Creek, sediment sources should be mapped and rated according to their potential sediment yields, and control measures should be taken.

Salmon Creek 2003
PERCENT EMBEDDEDNESS

VALUE 5
100%

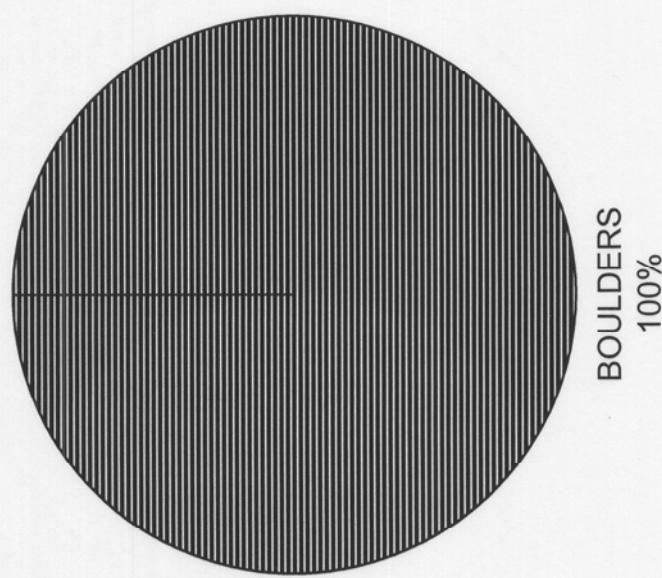
GRAPH 7

The mean shelter rating for pools was 30. The shelter rating in the flatwater habitats was 70. A pool shelter rating of approximately 100 is desirable.

Salmon Creek 2003
MEAN PERCENT COVER TYPES IN POOLS

- 4) Increase woody cover in the pools and flatwater habitat units. All of the existing cover is from boulders. Adding high quality complexity with woody cover is desirable and in some areas the material is at hand.

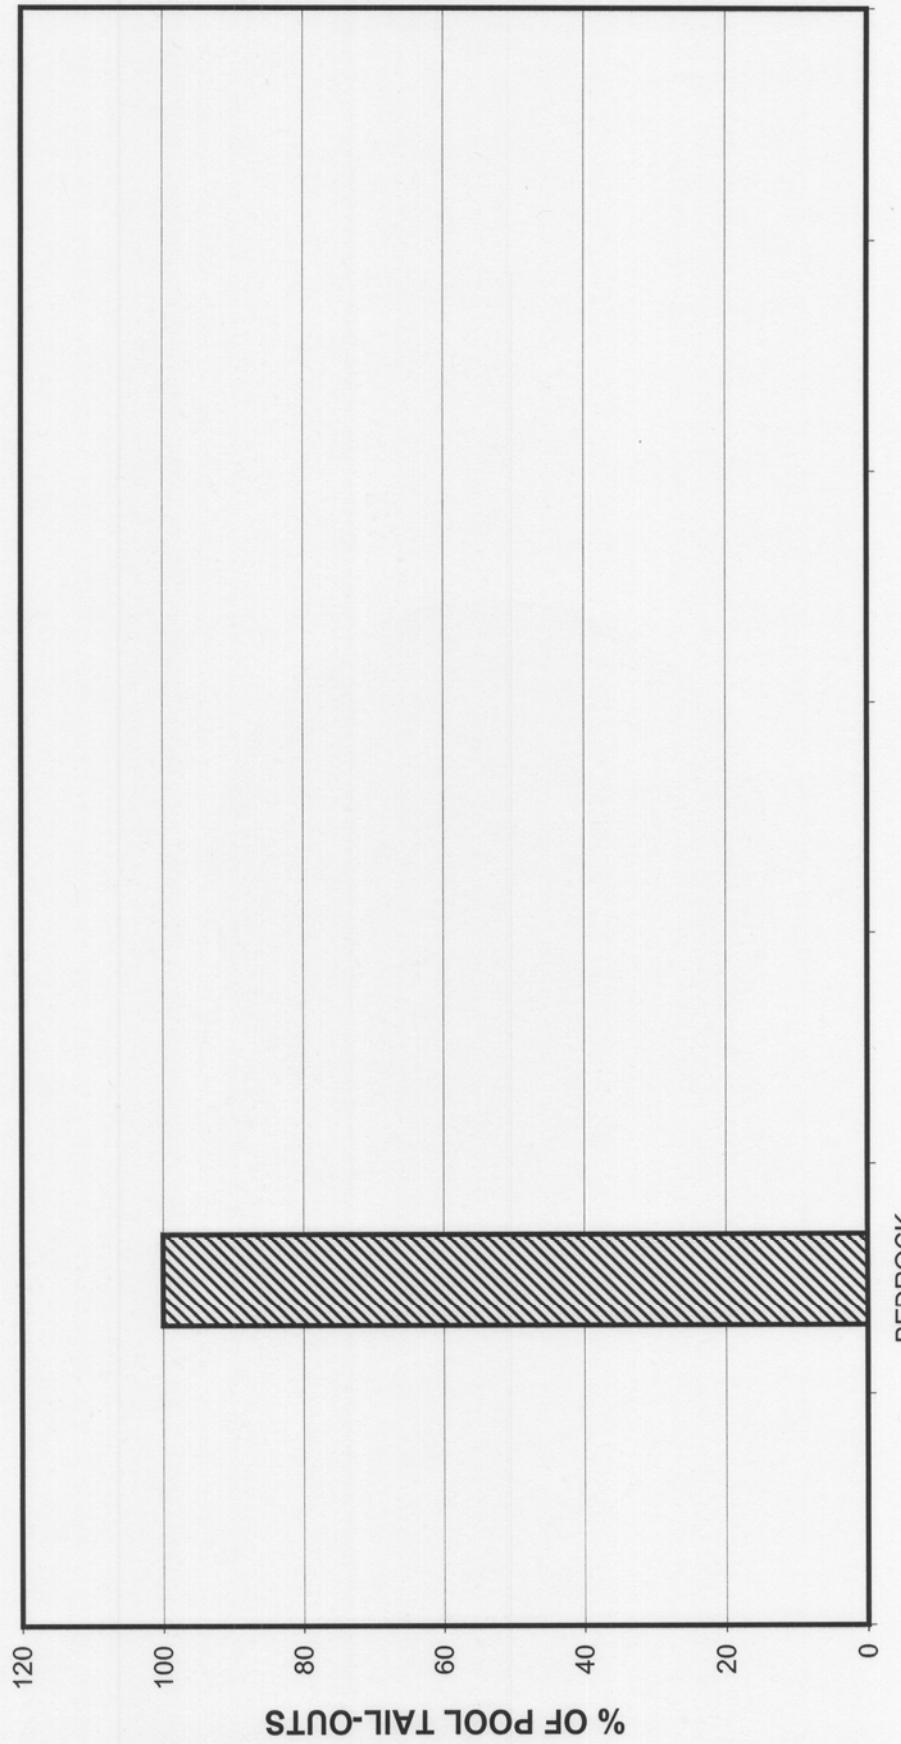
GRAPH 8

The one pool tail-out measured had bedrock as the dominant substrate. This is considered unsuitable for spawning salmonids.

Salmon Creek 2003
SUBSTRATE COMPOSITION IN POOL TAIL-OUTS
