## STREAM INVENTORY REPORT

### STANDLEY CREEK

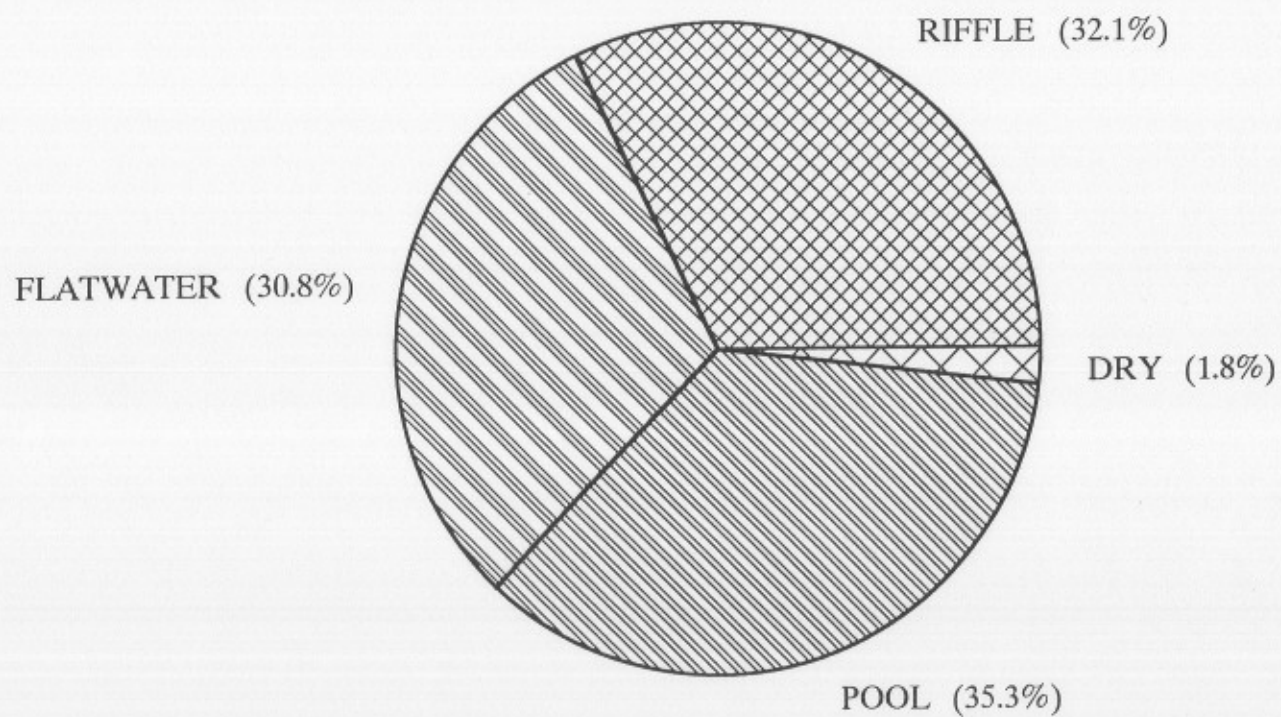
GRAPH 1

Table 1 summarizes the Level II riffle, flatwater, and pool habitat types. By percent **occurrence**, pools made up 35.3%, riffles 32.1%, and flatwater 30.8% (Graph 1). Riffle habitat types made up 38.3% of the total survey **length**, flatwater 37.3%, and pools 23.1% (Graph 2).

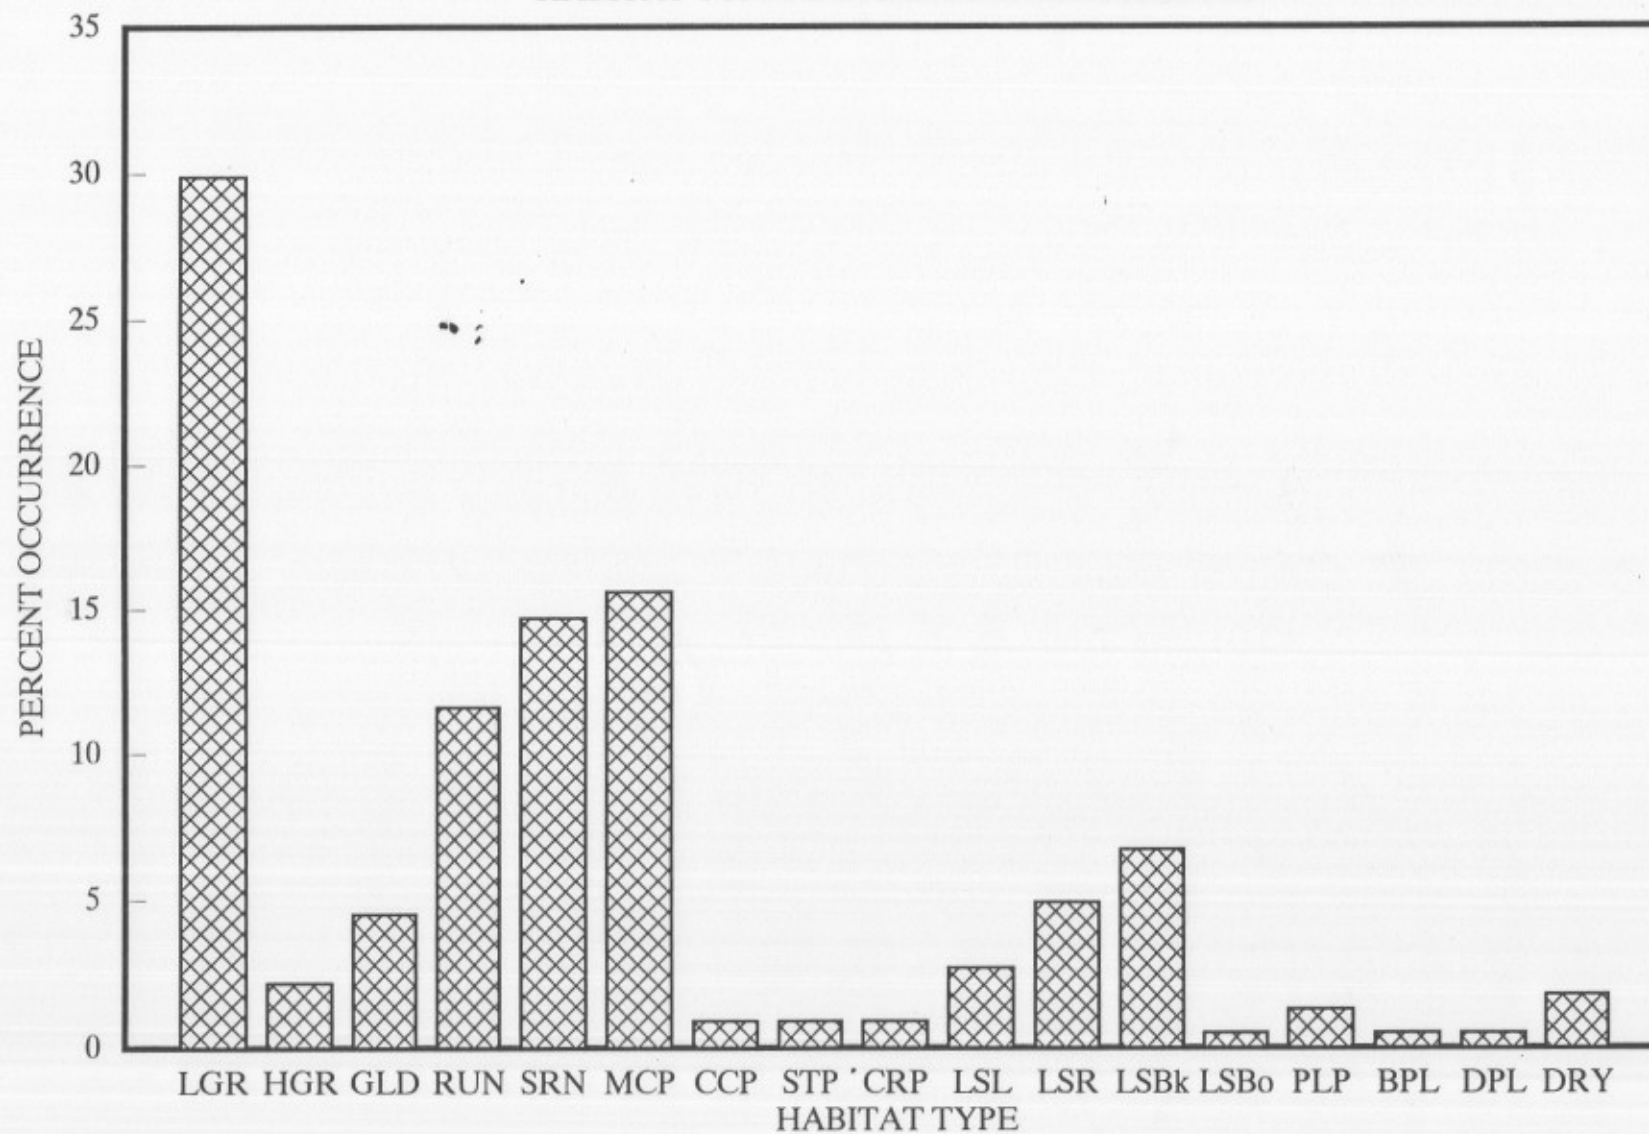
GRAPH 3

Sixteen Level IV habitat types were identified. The data are summarized in Table 2. The most frequent habitat types by percent **occurrence** were low gradient riffles, 29.9%; mid-channel pools, 15.6%; and step runs, 14.7% (Graph 3). By percent total **length**, low gradient riffles made up 36.3%, step runs 24.4%, and mid-channel pools 10.0%.

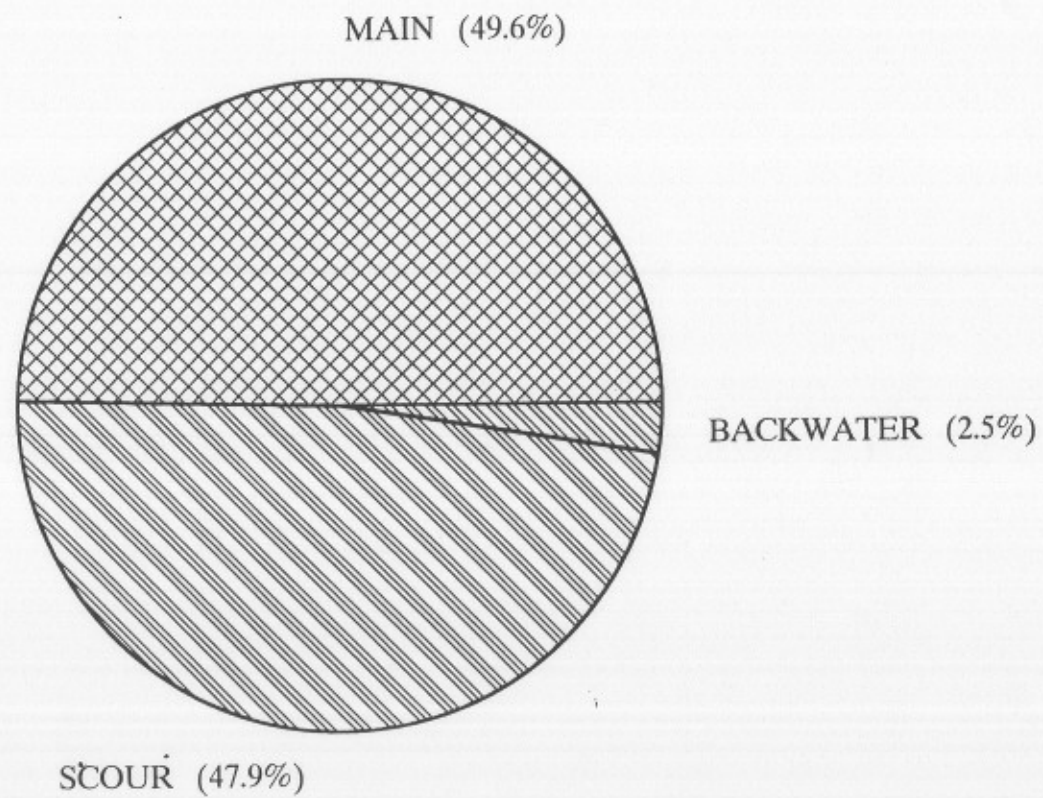
GRAPH 4

Seventy-nine pools were identified (Table 3). Scour pools were most often encountered at 52.2%, and comprised 50.1% of the total length of pools (Graph 4).

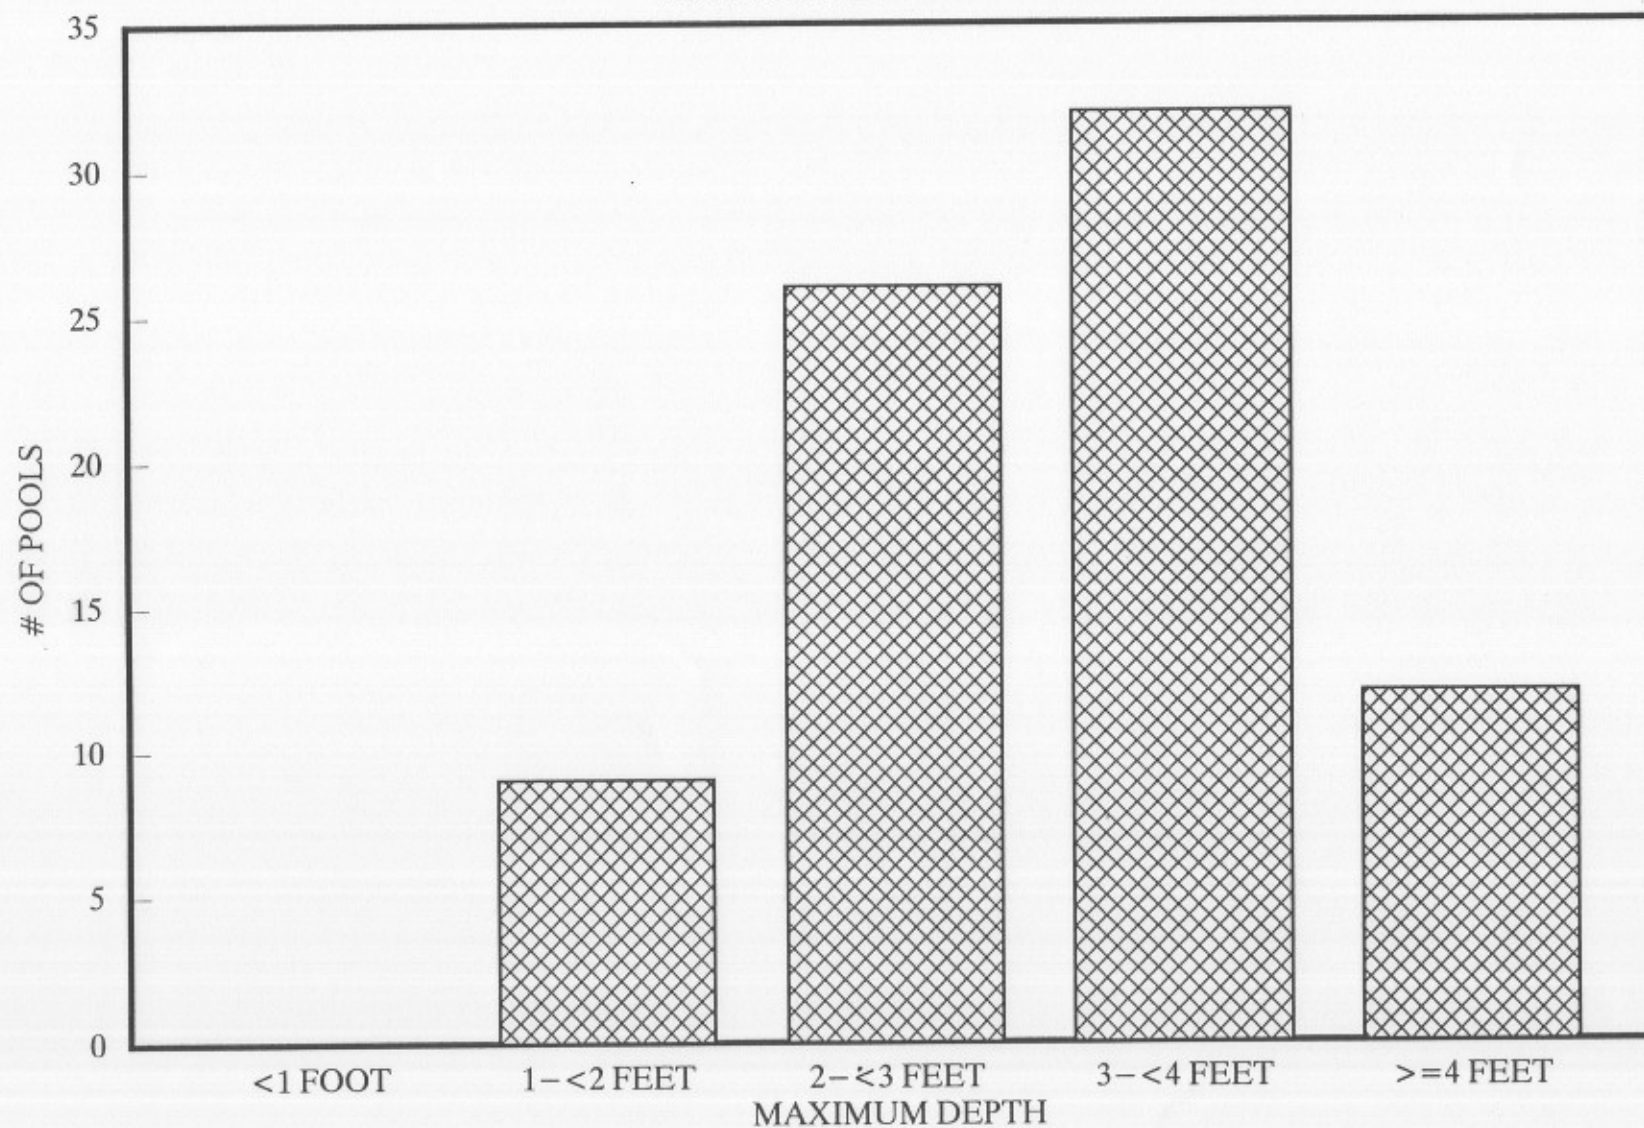
GRAPH 5

Table 4 is a summary of maximum pool depths by pool habitat types. Depth is an indicator of pool quality. Seventy of the 79 pools (89%) had a depth of two feet or greater (Graph 5).

Riffle habitat types comprised 38.3% of the total **length** of this survey, flatwater 37.3%, and pools 23.1%. The pools are relatively deep with 70 of the 79 pools having a maximum depth greater than 2 feet. However, in coastal coho and steelhead streams, it is generally desirable to have primary pools comprise approximately 50% of total habitat. Therefore, installing structures that will increase or deepen pool habitat is

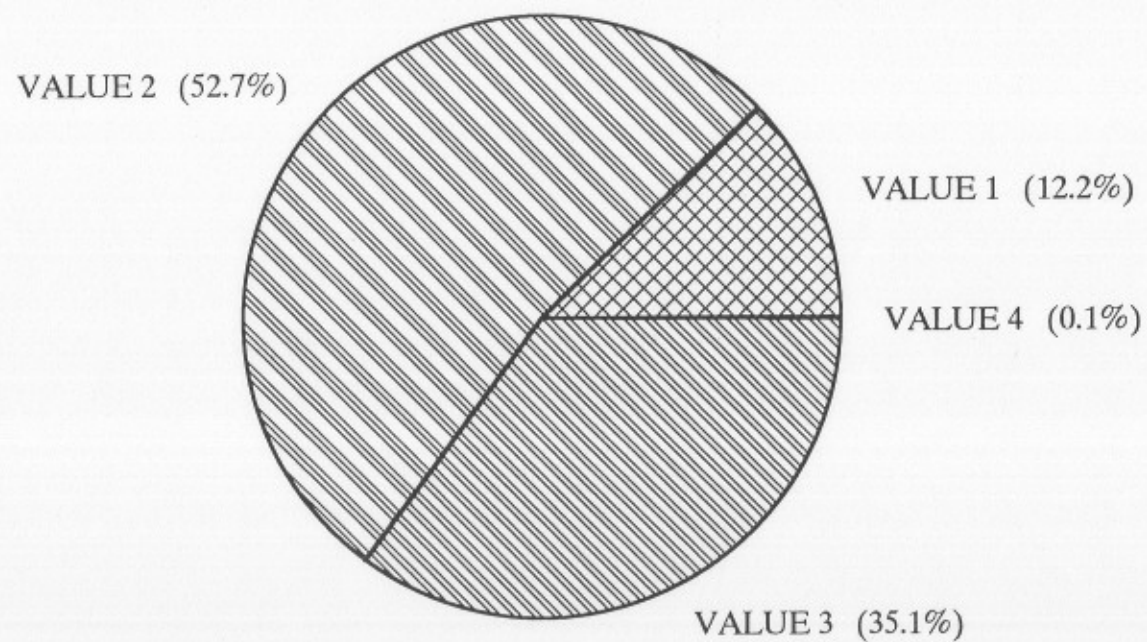
GRAPH 6

The depth of cobble embeddedness was estimated at pool tail-outs. Of the 74 pool tail-outs measured, 9 had a value of 1 (12.2%); 39 had a value of 2 (52.7%); 26 had a value of 3 (35.1%); and zero had a value of 4 (0.0%). On this scale, a value of one is the best for fisheries (Graph 6).

Twenty-six of the 74 pool tail-outs measured had embeddedness ratings of 3 or 4. Nine had a 1 rating. Embeddedness in excess of 26%, a rating of 2 or more, is considered poor quality for fish habitat. In Standley Creek, sediment sources should be mapped and rated according to their potential sediment yields, and control measures taken.

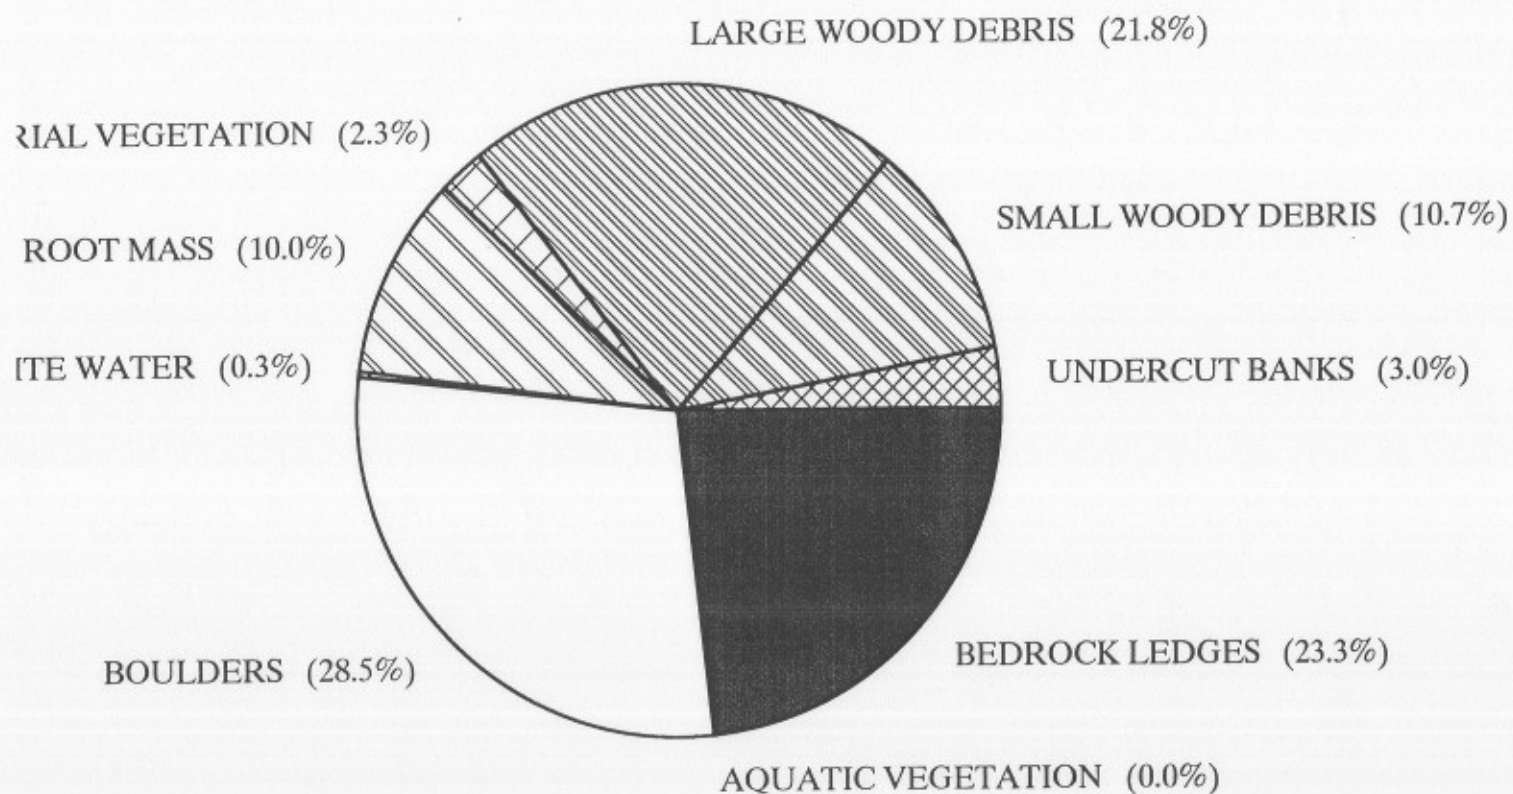
Table 5 summarizes mean percent cover by habitat type. Boulders are the dominant cover type in Standley Creek and are extensive. Large woody debris is the next most common cover type. Graph 7 describes the pool cover in Standley Creek.

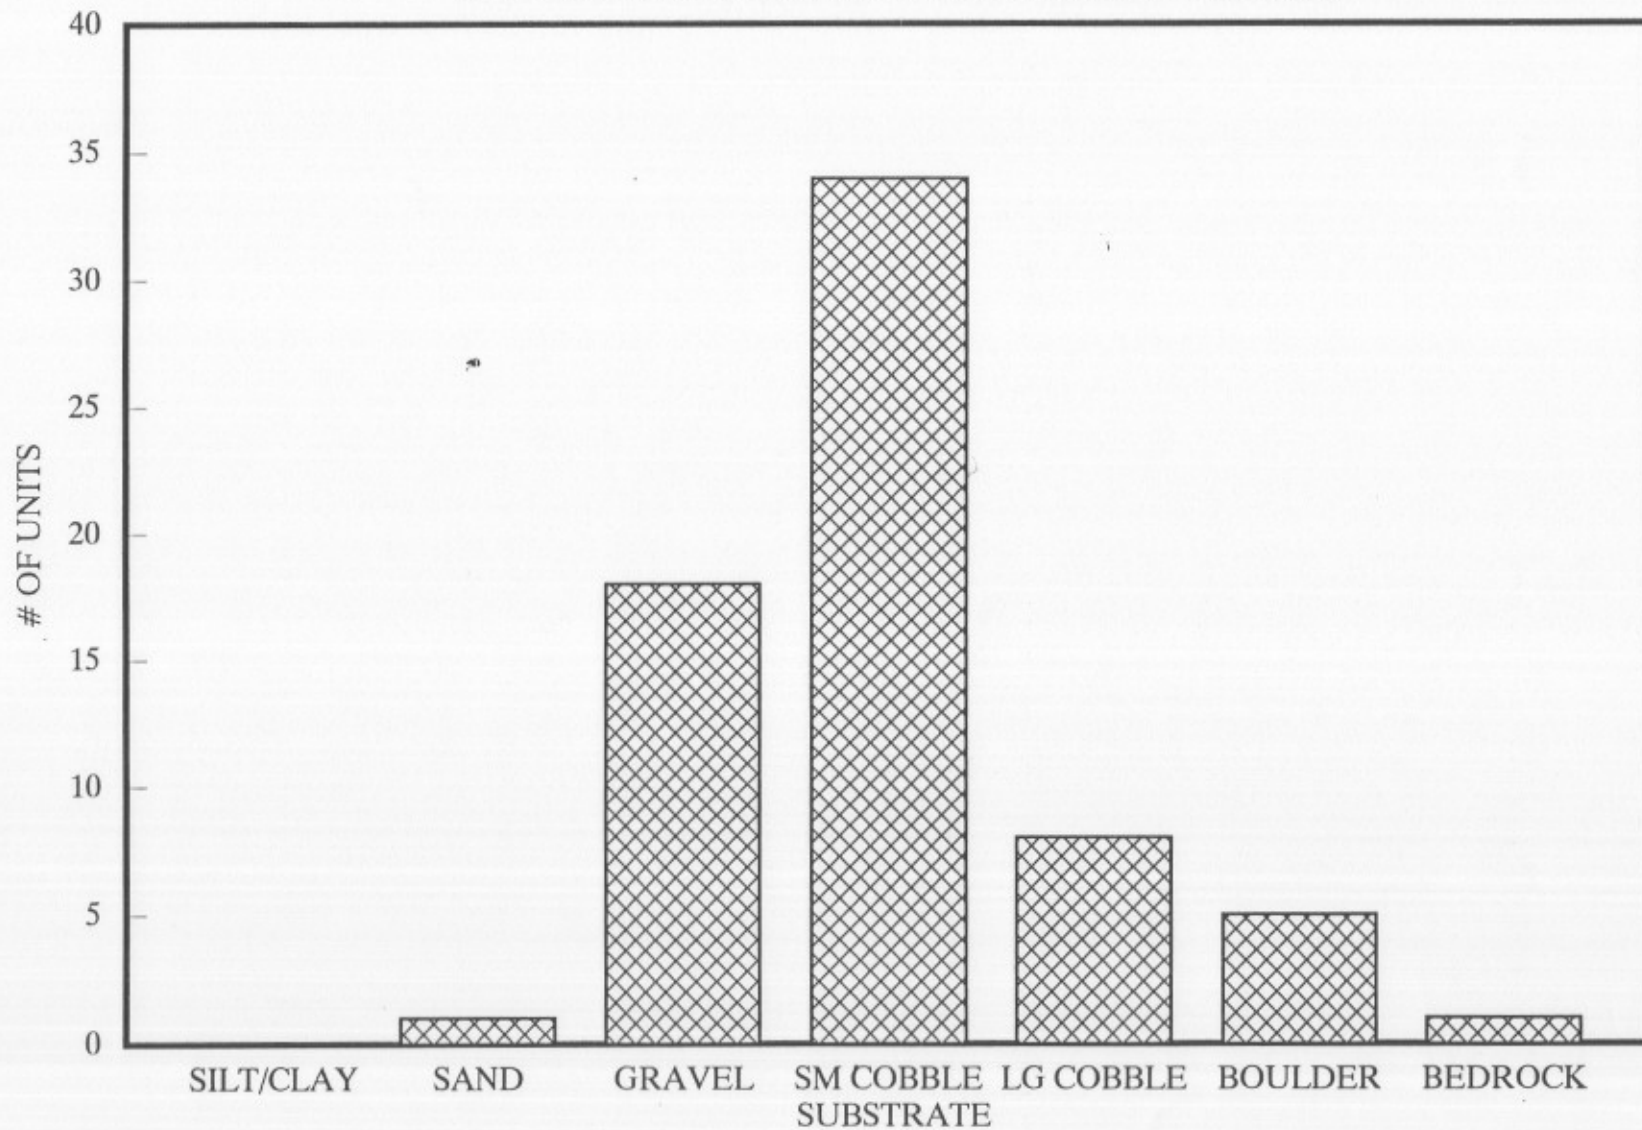
GRAPH 8

Table 6 summarizes the dominant substrate by habitat type. Small cobble was the dominant substrate observed in 34 of the 67 low gradient riffles (50.7%). Gravel was the next most frequently observed dominant substrate type, and occurred in 26.9% of the low gradient riffles (Graph 8).

Fifty-two of the 67 low gradient riffles had gravel or small cobble as the dominant substrate. This is generally considered good for spawning salmonids.

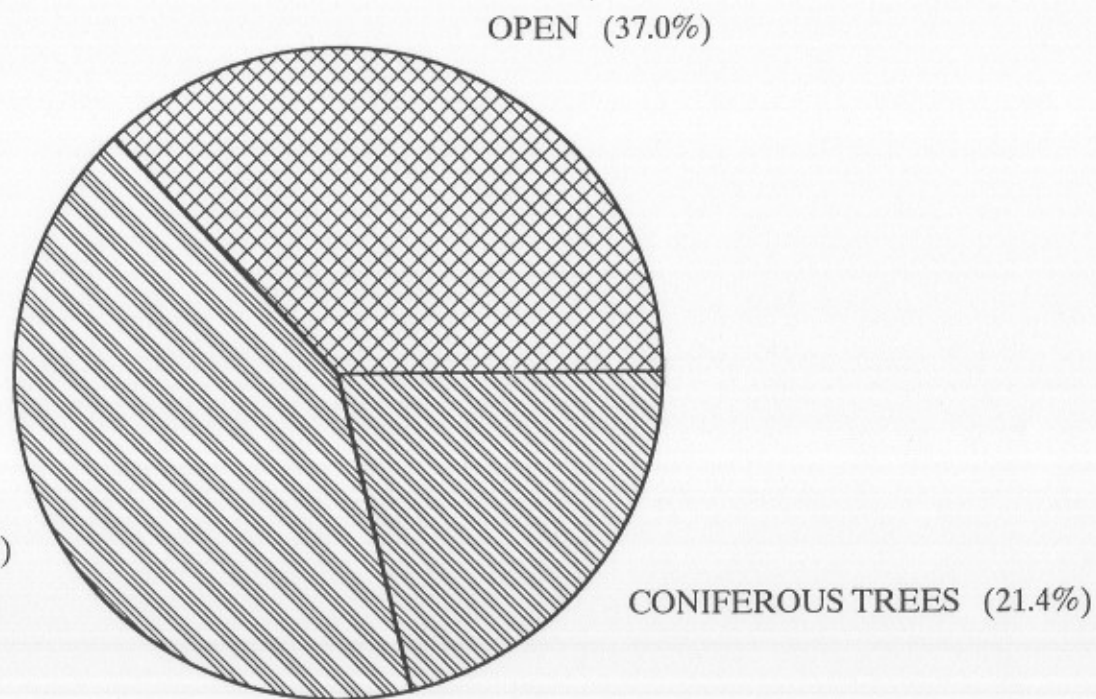
Thirty-seven percent of the survey reach lacked shade canopy. Of the 63% of the stream covered with canopy, 66% was composed of deciduous trees, and 34% was composed of coniferous trees.

Graph 9 describes the canopy in Standley Creek.

The mean percent canopy for the stream was 63%. This is a relatively high percentage of canopy, since 80 percent is generally considered optimum in these north coast streams.

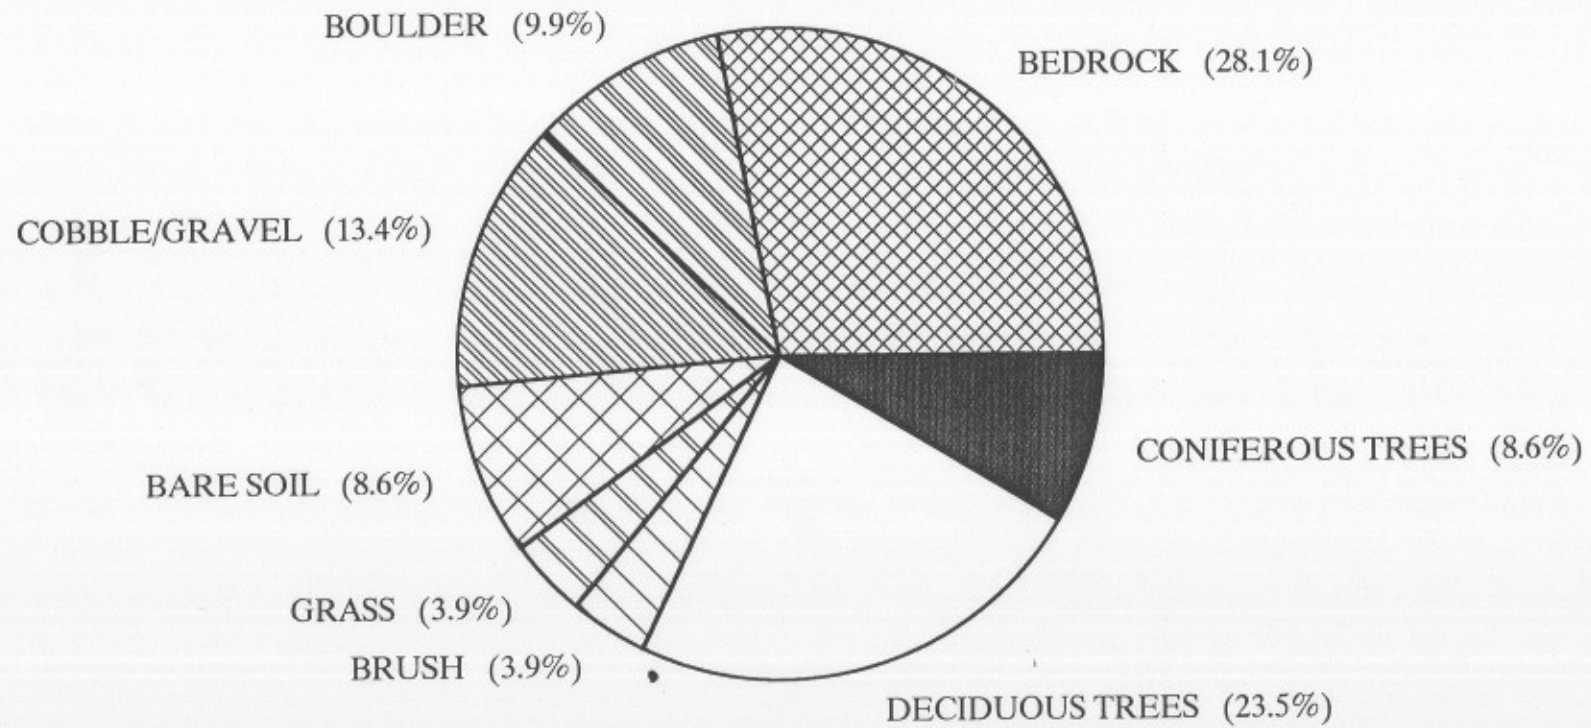
GRAPH 10

Table 2 summarizes the mean percentage of the right and left stream banks covered with vegetation by habitat type. For the stream reach surveyed, the mean percent right bank vegetated was 42.4%. The mean percent left bank vegetated was 37.5%. The dominant elements composing the structure of the stream banks consisted of 27.9% bedrock, 9.8% boulder, 14.3% cobble/gravel, 8.5% bare soil, 3.8% grass, 3.8% brush. Additionally, 23.4% of the banks were covered with deciduous trees, and 8.5% with coniferous trees, including downed trees, logs, and root wads (Graph 10).
