STREAM INVENTORY REPORT

Glenbrook Gulch

A stream inventory was conducted from September 25 to October 2, 2013 on Glenbrook Gulch. The survey began at the confluence with Kaisen Gulch and extended upstream 0.6 miles.

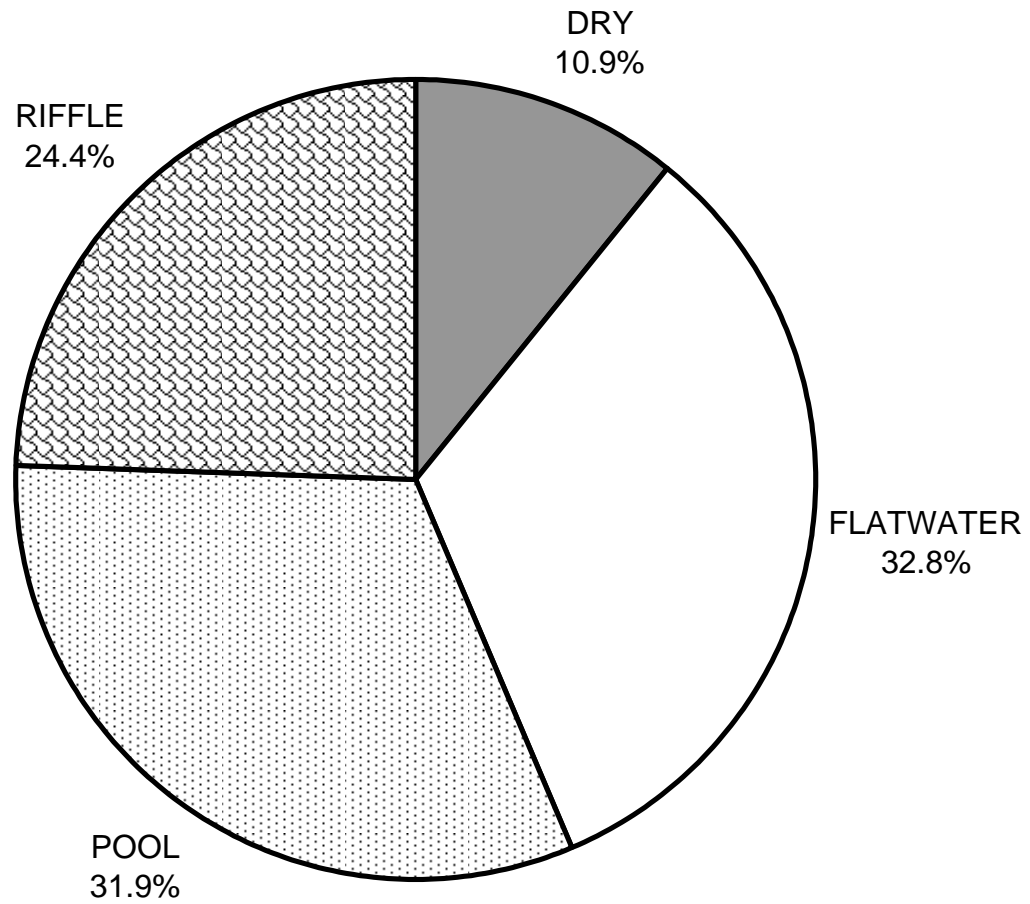
GRAPH 1

Table 1 summarizes the Level II riffle, flatwater, and pool habitat types. Based on frequency of occurrence there were 33% flatwater units, 32% pool units, 24% riffle units, and 11% dry units (Graph 1). Based on total length of Level II habitat types there were 48% flatwater units, 21% pool units, 20% riffle units, and 12% dry units (Graph 2).

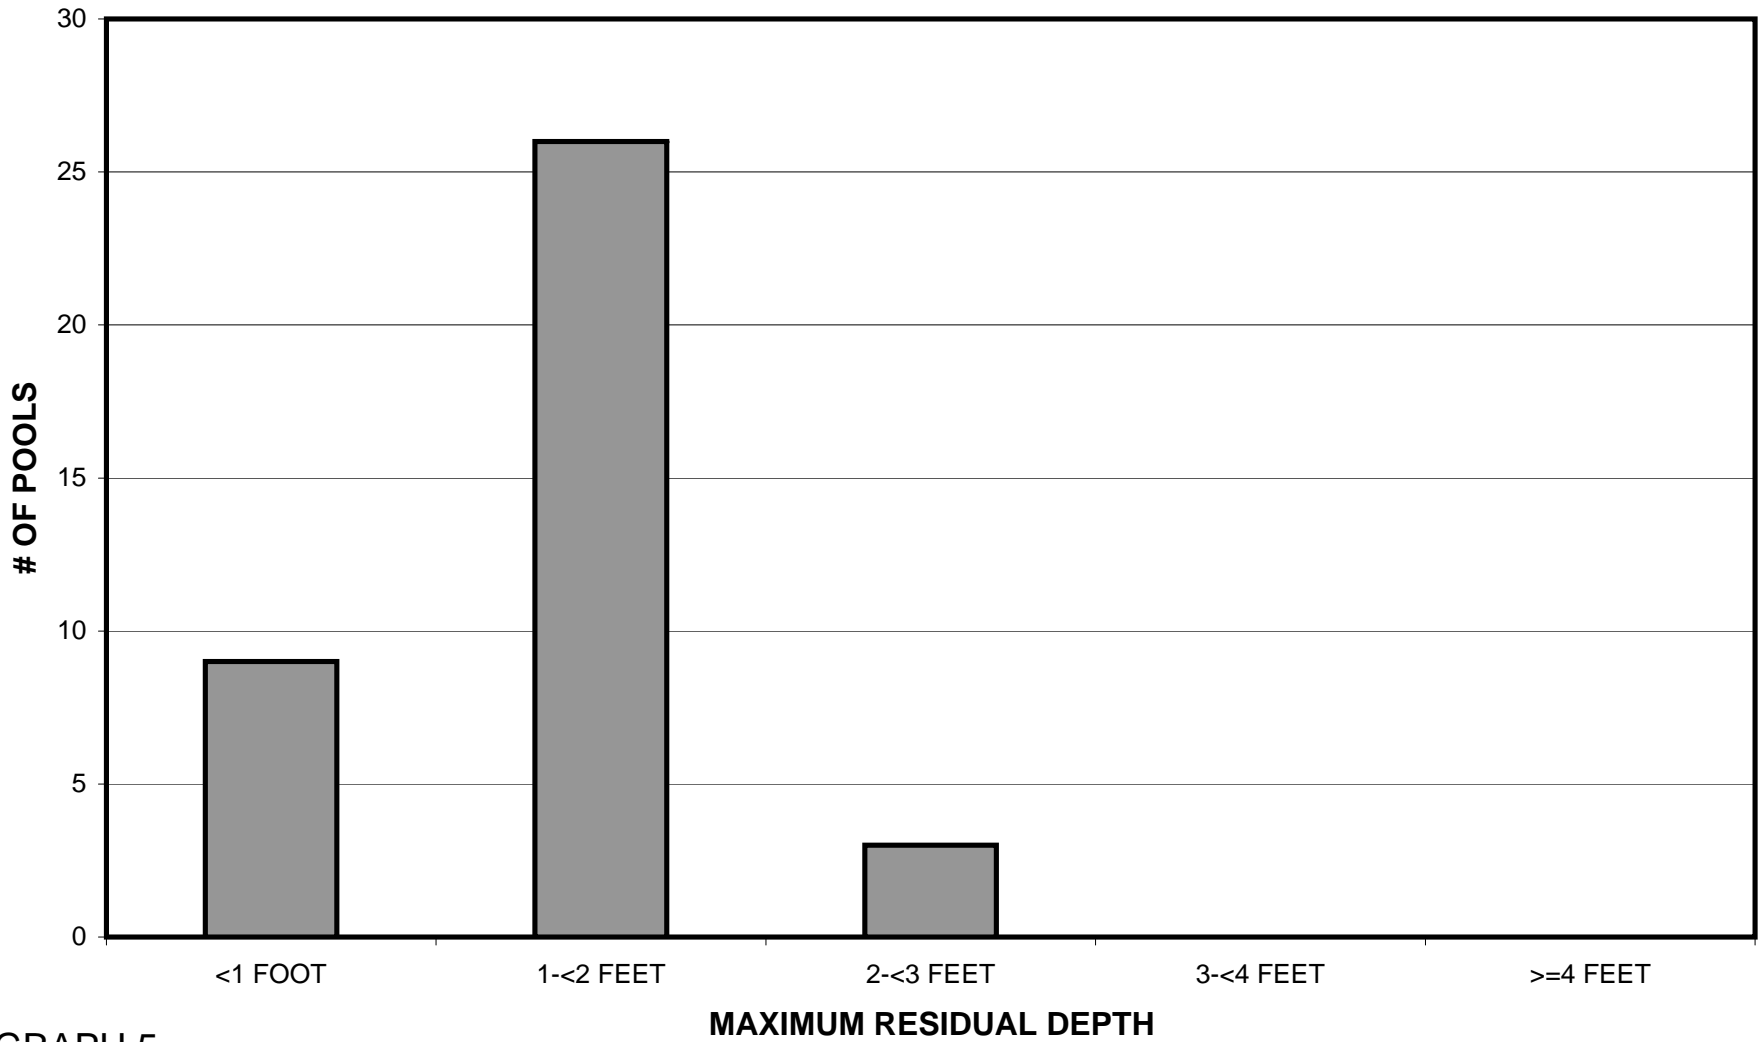
GRAPH 5

Table 4 is a summary of maximum residual pool depths by pool habitat types. Pool quality for salmonids increases with depth. Three of the 38 pools (8%) had a residual depth of two feet or greater (Graph 5).

Flatwater habitat types comprised 48% of the total length of this survey, riffles 20%, and pools 21%. Three of the 38 (8%) pools had a maximum residual depth greater than two feet. In general, pool enhancement projects are considered when primary pools comprise less than 40% of the length of total stream habitat. In first and second order streams, a primary pool is defined to have a maximum residual depth of at least two feet, occupy at least half the width of the low flow channel, and be as long as the low flow channel width. Installing structures that will increase or deepen pool habitat is recommended.

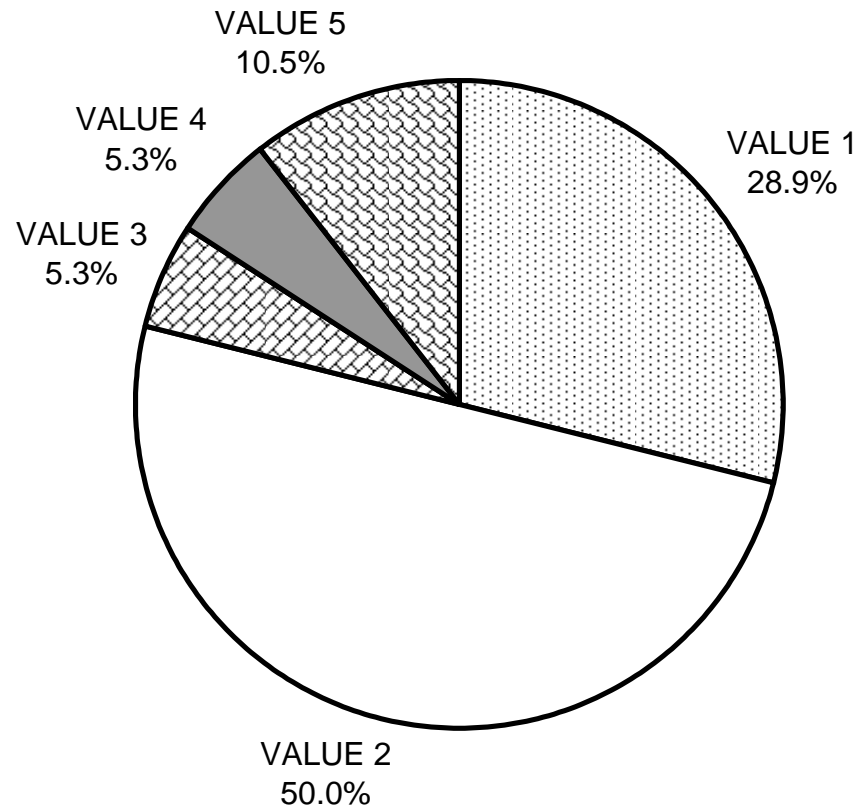
GRAPH 6

The depth of cobble embeddedness was estimated at pool tail-outs. Of the 38 pool tail-outs measured, 11 had a value of 1 (29%); 19 had a value of 2 (50%); two had a value of 3 (5%); two had a value of 4 (5%); four had a value of 5 (11%) (Graph 6). On this scale, a value of 1 indicates the best spawning conditions and a value of 4 the worst. Additionally, a value of 5 was assigned to tail-outs deemed not suitable for spawning due to inappropriate substrate such as bedrock, log sills, boulders, or other considerations.

Thirty of the 38 pool tail-outs measured had embeddedness ratings of 1 or 2. Four of the pool tail-outs had embeddedness ratings of 3 or 4. Four of the pool tail-outs had a rating of 5, which is considered not suitable for spawning. Cobble embeddedness measured to be 25% or less, a rating of 1, is considered to indicate good quality spawning substrate for salmon and steelhead.

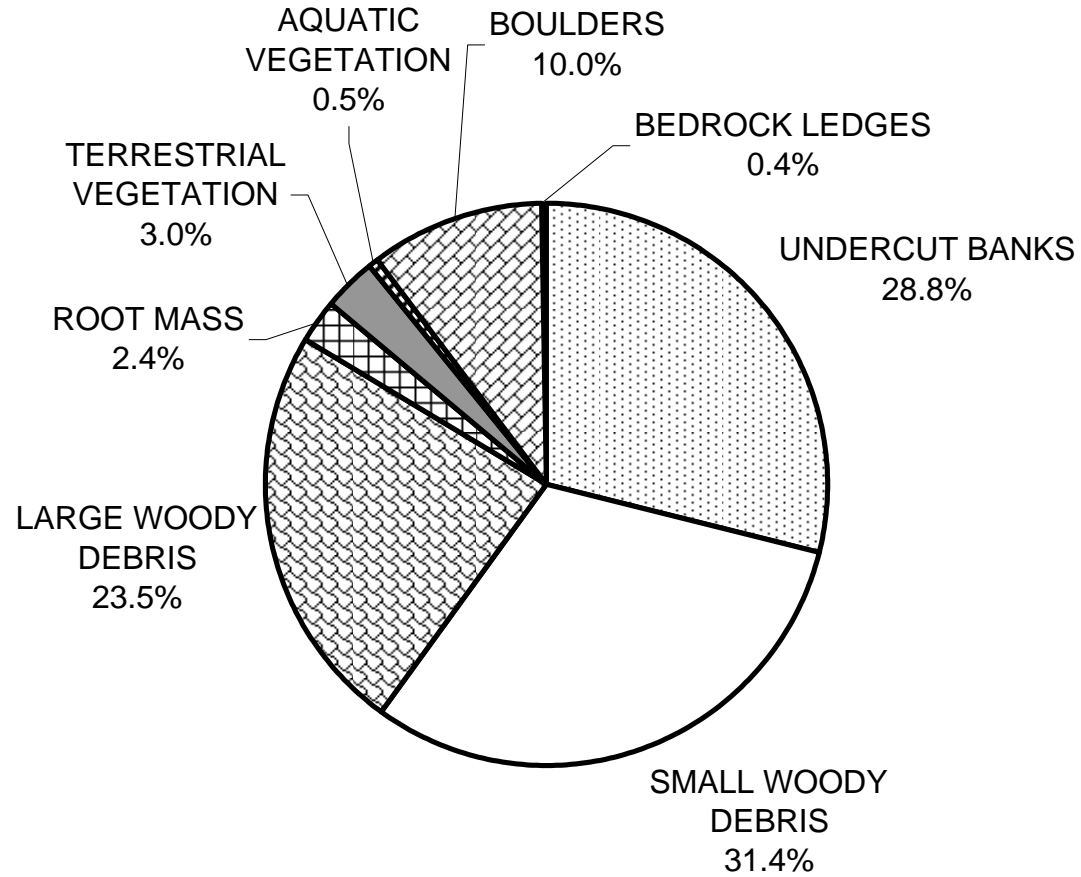
GRAPH 7

Table 5 summarizes mean percent cover by habitat type. Undercut banks are the dominant cover type in Glenbrook Gulch. Graph 7 describes the pool cover in Glenbrook Gulch. Small woody debris is the dominant pool cover type followed by undercut banks.

The mean shelter rating for pools is 26. The shelter rating in the flatwater habitats is 11. A pool shelter rating of approximately 100 is desirable. The amount of cover that now exists is being provided primarily by undercut banks in Glenbrook Gulch. Small woody debris is the dominant cover type in pools followed by undercut banks. Log and root wad cover structures in the pool and flatwater habitats would enhance both summer and winter salmonid habitat. Log cover structures provide rearing fry with protection from predation, rest from water velocity, and also divide territorial units to reduce density related competition.

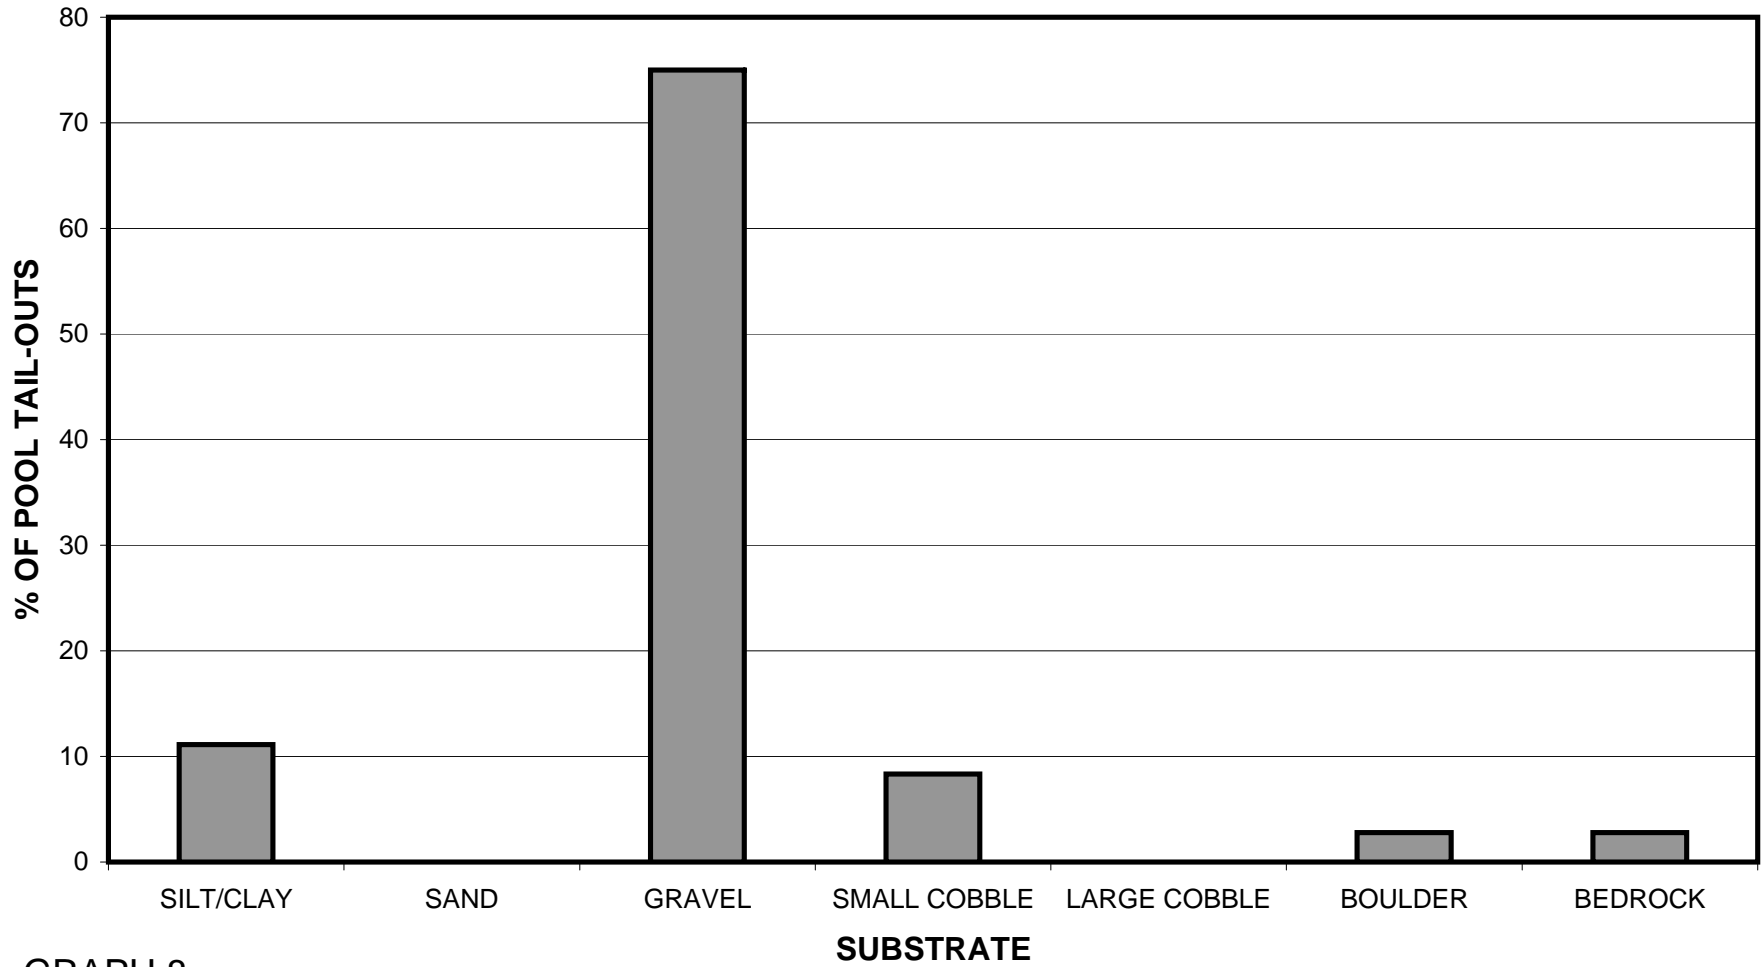
GRAPH 8

Table 6 summarizes the dominant substrate by habitat type. Graph 8 depicts the dominant substrate observed in pool tail-outs. Gravel was the dominant substrate observed in 75% of the pool tail-outs. Silt/clay was the next most frequently observed dominant substrate type and occurred in 11% of the pool tail-outs.

Thirty of the 36 pool tail-outs measured had gravel or small cobble as the dominant substrate. This is generally considered good for spawning salmonids.

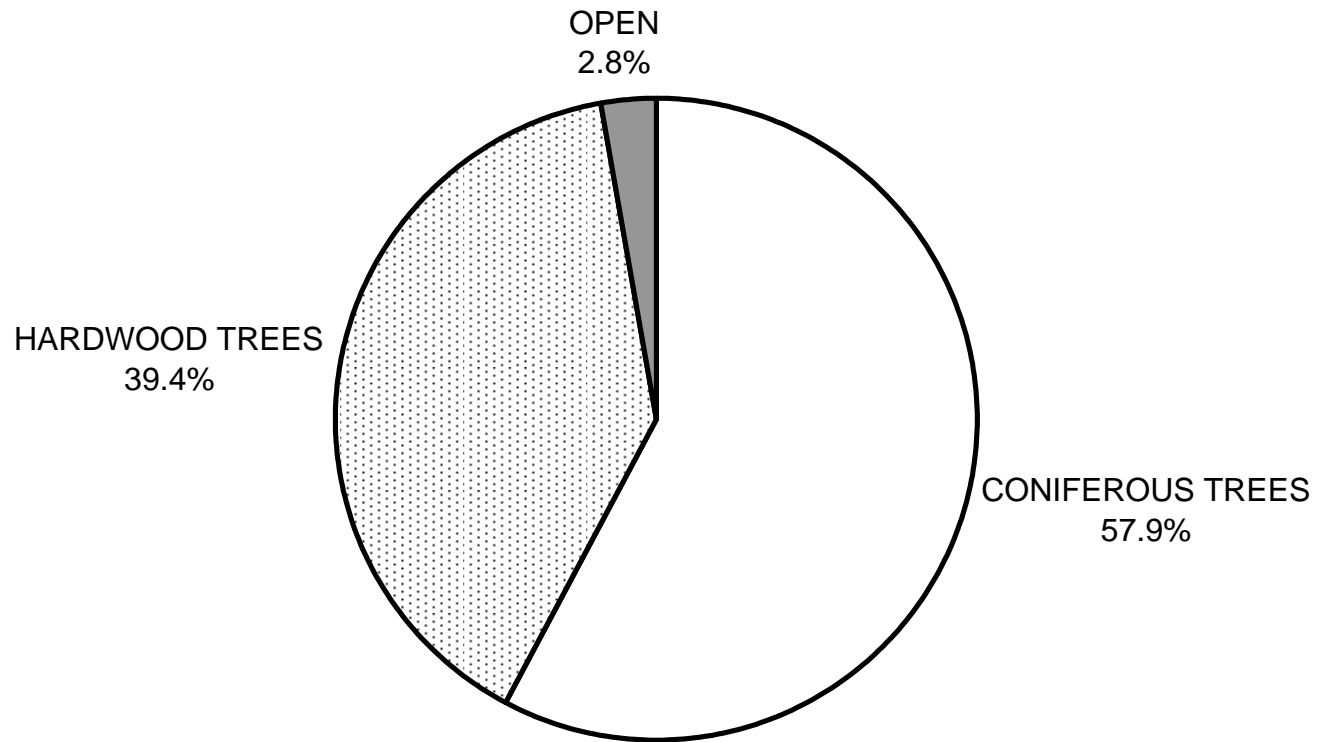
GRAPH 9

The mean percent canopy density for the surveyed length of Glenbrook Gulch was 97%. Three percent of the canopy was open. Of the canopy present, the mean percentages of hardwood and coniferous trees were 40% and 60%, respectively. Graph 9 describes the mean percent canopy in Glenbrook Gulch.

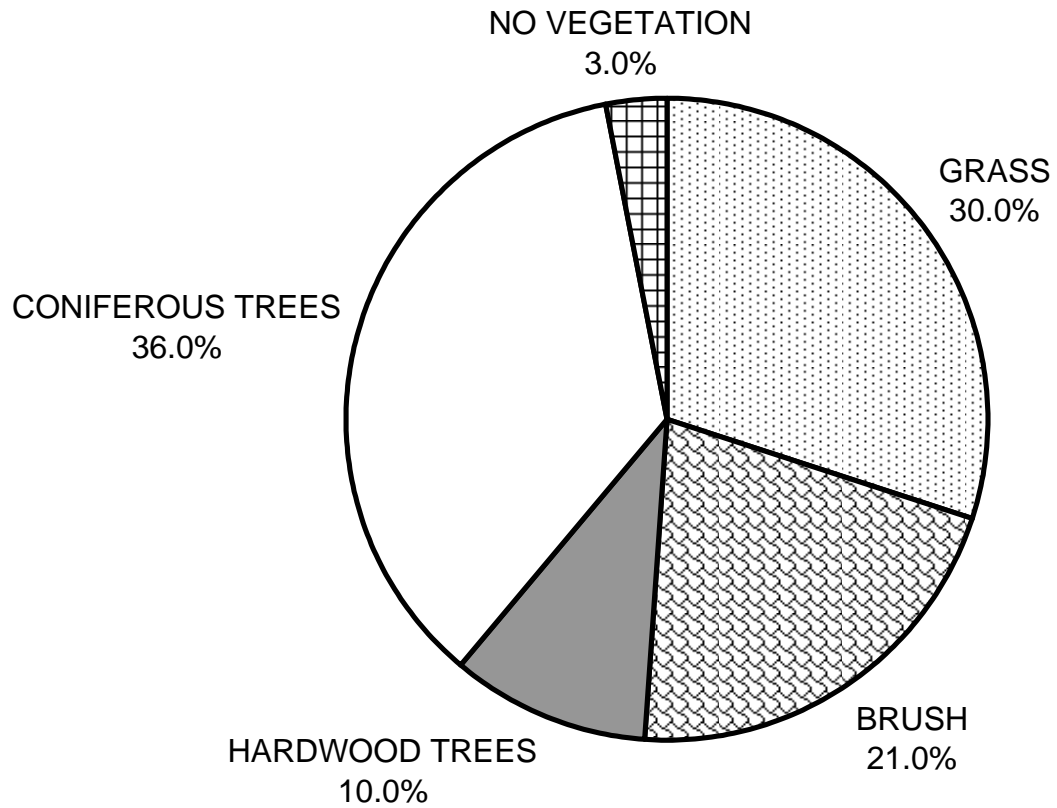
GRAPH 11

For the stream reach surveyed, the mean percent right bank vegetated was 93%. The mean percent left bank vegetated was 96%. The dominant elements composing the structure of the stream banks consisted of 59% sand/silt/clay, 33% cobble/gravel, and 8% bedrock (Graph 10). Coniferous trees were the dominant vegetation type observed in 36% of the units surveyed. Additionally, 30% of the units surveyed had grass as the dominant vegetation type, and 21% had brush as the dominant vegetation type (Graph 11).
