STREAM INVENTORY REPORT

“Nelson Gulch”

A stream inventory was conducted on May 14 and May 15, 2012 on an unnamed tributary to Big River commonly known as, and herein after referred to as, Nelson Gulch. The survey began at the confluence with Big River and extended upstream 0.5 miles.

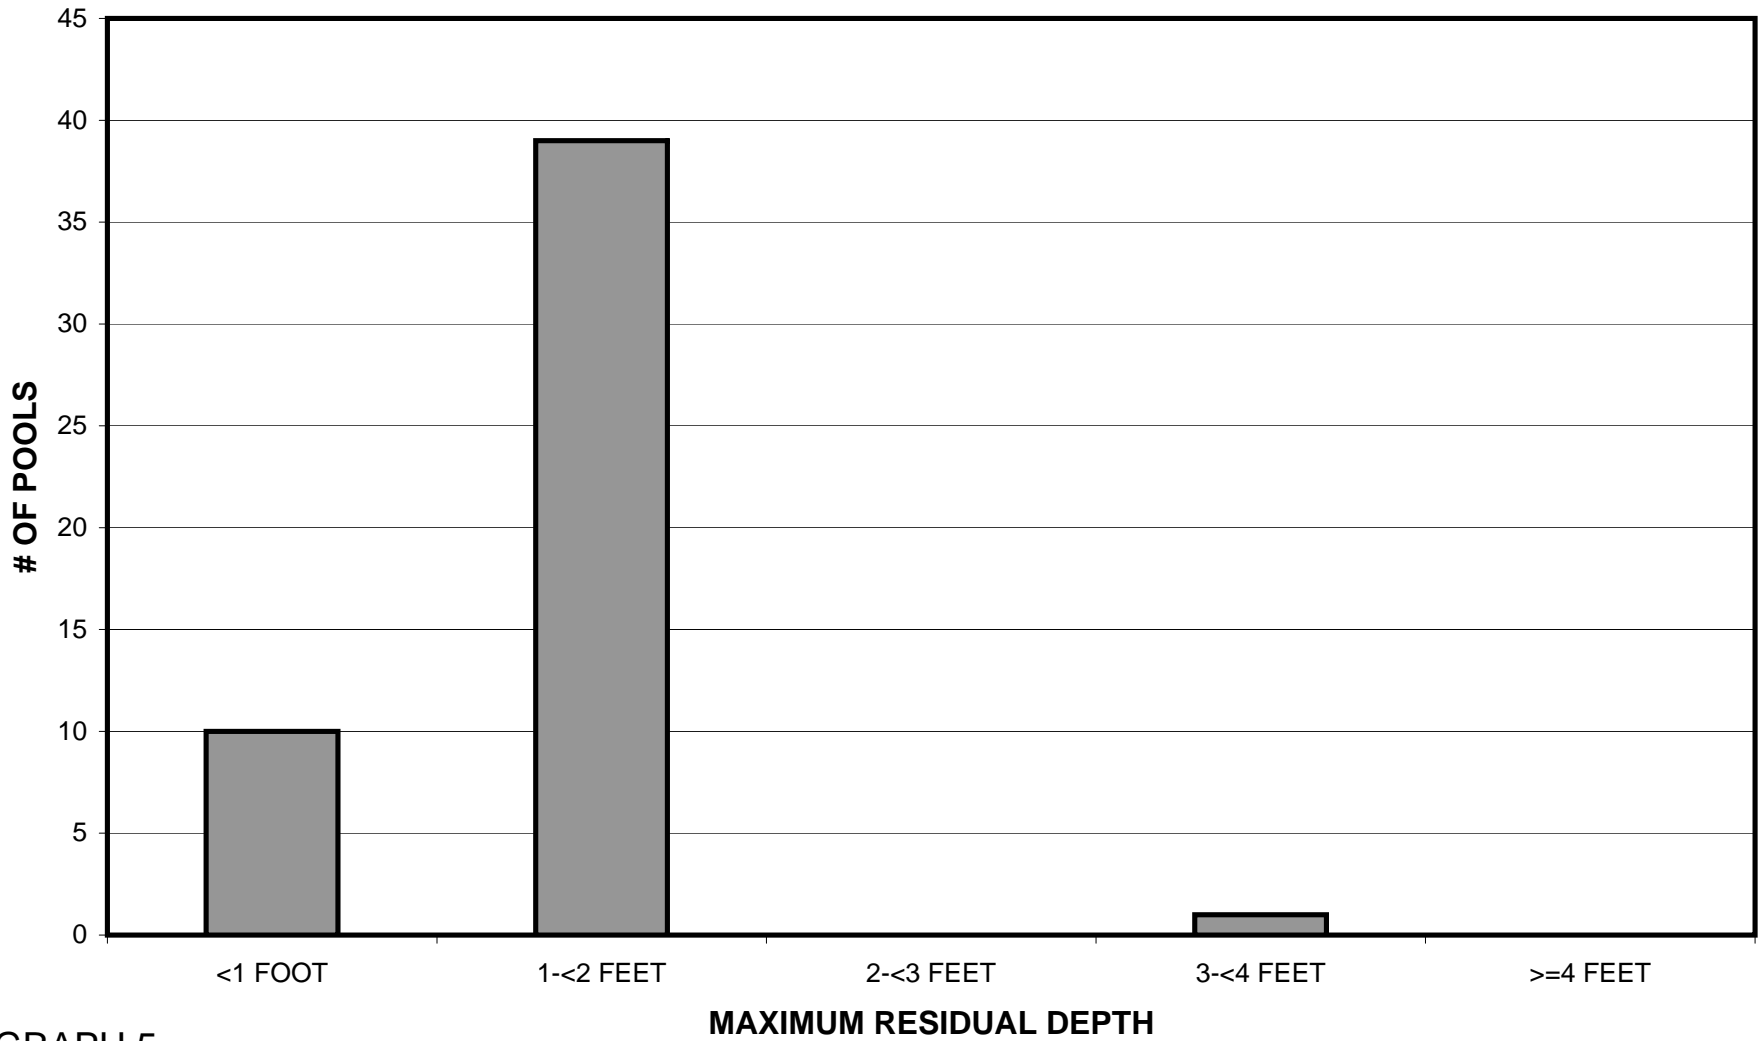
GRAPH 5

Table 4 is a summary of maximum residual pool depths by pool habitat types. Pool quality for salmonids increases with depth. One of the 50 pools (2%) had a residual depth of two feet or greater (Graph 5).

Flatwater habitat types comprised 41% of the total length of this survey, riffles 33%, and pools 21%. One of the 50 (2%) pools had a maximum residual depth greater than two feet. In general,

pool enhancement projects are considered when primary pools comprise less than 40% of the length of total stream habitat. In first and second order streams, a primary pool is defined to have a maximum residual depth of at least two feet, occupy at least half the width of the low flow channel, and be as long as the low flow channel width. In Reach 1, installing large wood structures that will increase or deepen pool habitat is recommended.

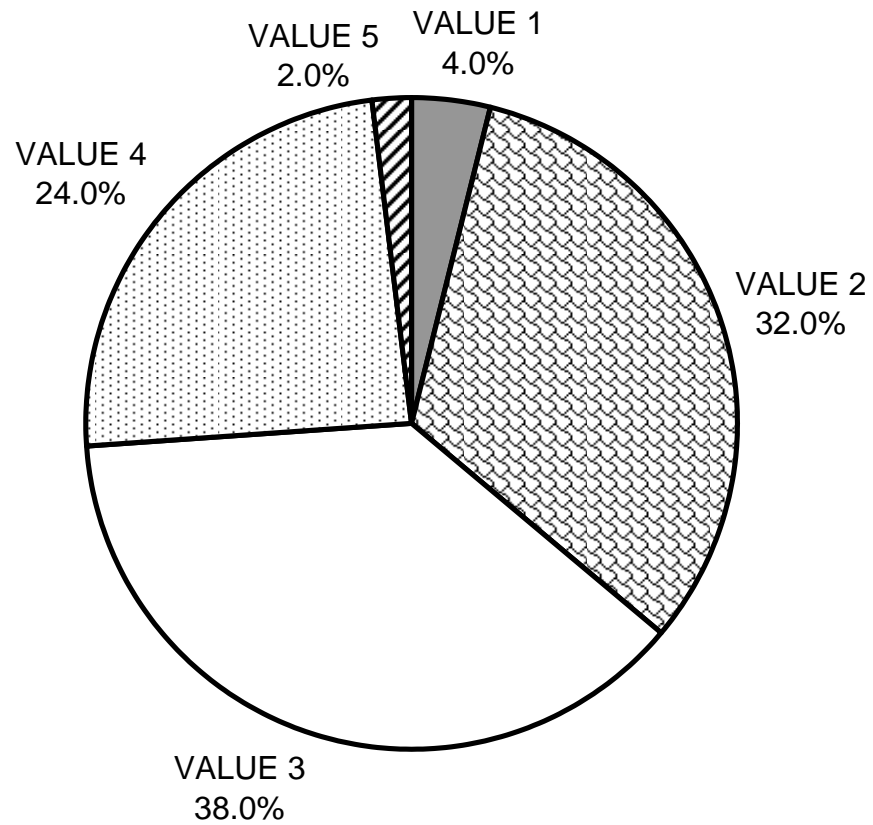
GRAPH 6

The depth of cobble embeddedness was estimated at pool tail-outs. Of the 50 pool tail-outs measured, two had a value of 1 (4%); 16 had a value of 2 (32%); 19 had a value of 3 (38%); 12 had a value of 4 (24%); and one had a value of 5 (2%); (Graph 6). On this scale, a value of 1 indicates the best spawning conditions and a value of 4 the worst. Additionally, a value of 5 was assigned to tail-outs deemed not suitable for spawning due to inappropriate substrate such as bedrock, log sills, boulders, or other considerations.

Eighteen of the 50 pool tail-outs measured had embeddedness ratings of 1 or 2. Thirty-one of the pool tail-outs had embeddedness ratings of 3 or 4. One of the pool tail-outs had a rating of 5, which is considered not suitable for spawning. Cobble embeddedness measured to be 25% or less, a rating of 1, is considered to indicate good quality spawning substrate for salmon and steelhead. Sediment sources in Nelson Gulch should be mapped and rated according to their potential sediment yields, and control measures should be taken.

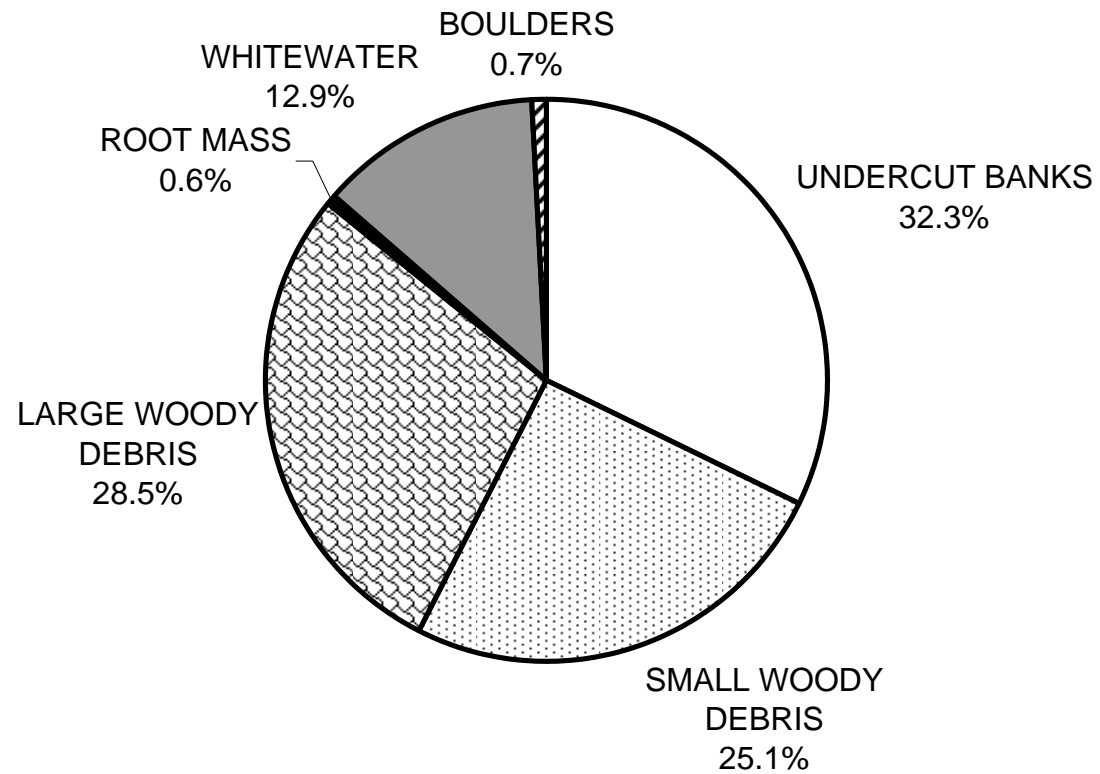
GRAPH 7

Table 5 summarizes mean percent cover by habitat type. Undercut banks are the dominant cover type in Nelson Gulch. Graph 7 describes the pool cover in Nelson Gulch. Undercut banks are the dominant pool cover type, followed by large woody debris.

The mean shelter rating for pools is 12. The shelter rating in the flatwater habitats is 2. A pool shelter rating of approximately 100 is desirable. The amount of cover that now exists is being provided primarily by undercut banks in Nelson Gulch. Undercut banks are the dominant cover type in pools followed by large woody debris. Log and root wad cover structures in the pool and flatwater habitats would enhance both summer and winter salmonid habitat. Log cover structures provide rearing fry with protection from predation, rest from water velocity, and also divide territorial units to reduce density related competition.

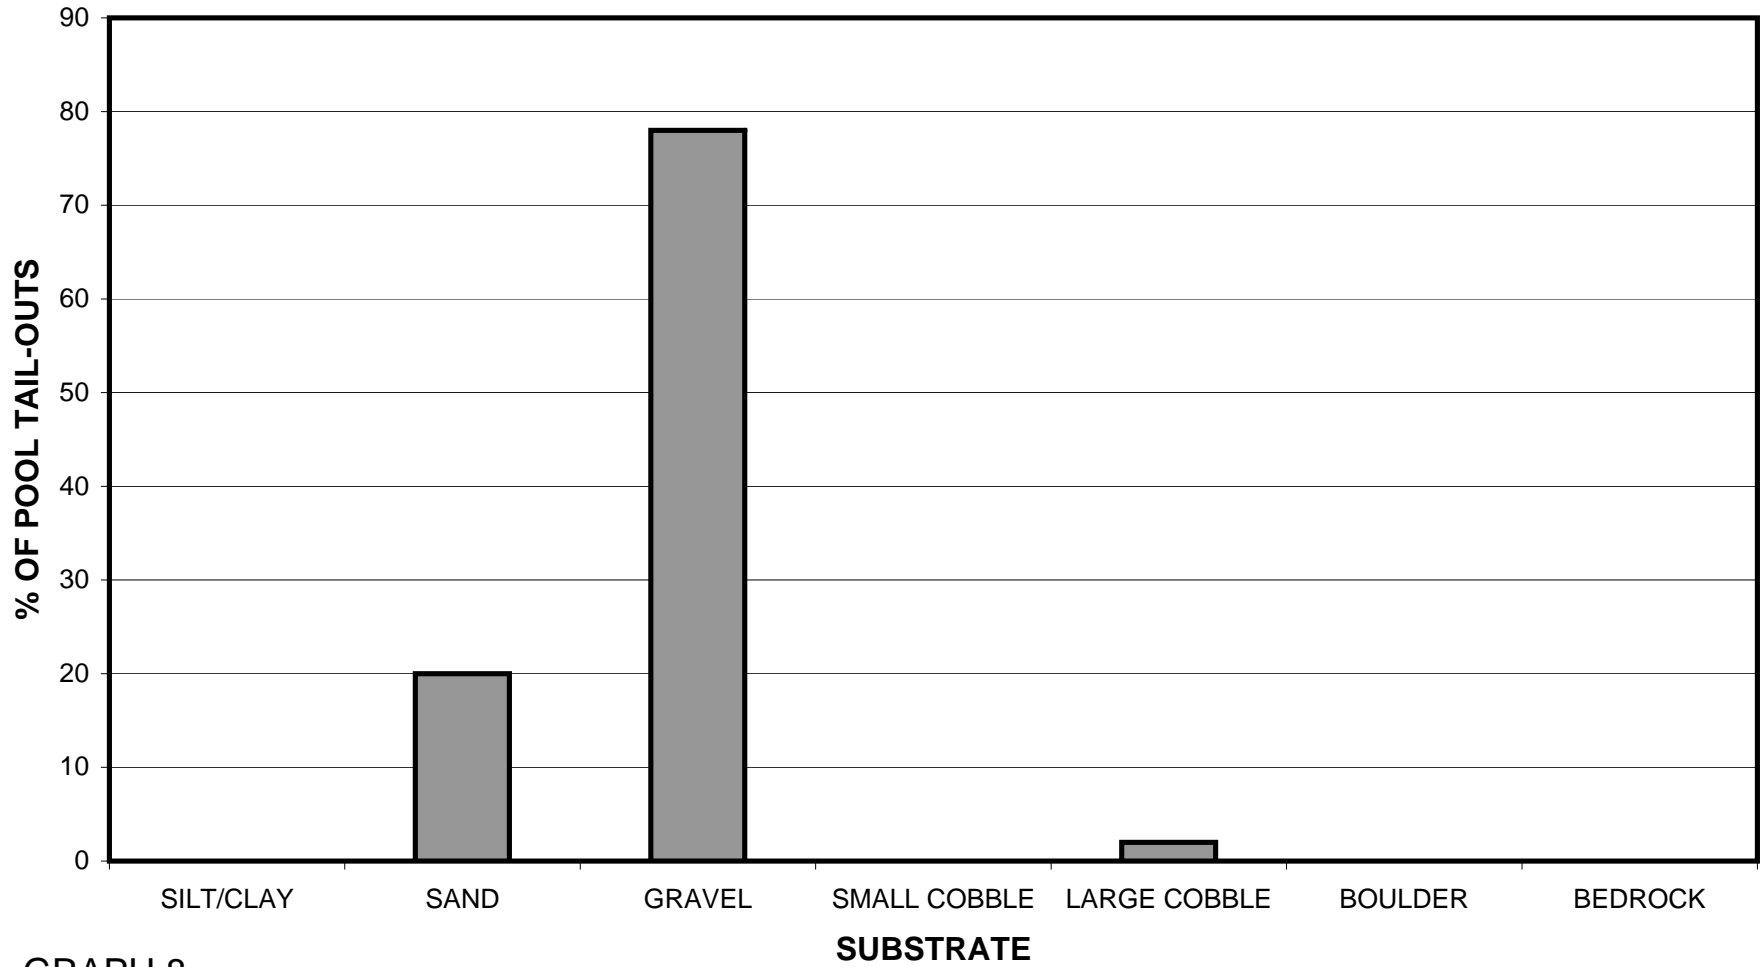
GRAPH 8

Table 6 summarizes the dominant substrate by habitat type. Graph 8 depicts the dominant substrate observed in pool tail-outs. Gravel was the dominant substrate observed in 78% of the pool tail-outs. Sand was the next most frequently observed dominant substrate type and occurred in 20% of the pool tail-outs.

Thirty-nine of the 50 pool tail-outs measured had gravel or small cobble as the dominant substrate. This is generally considered good for spawning salmonids.

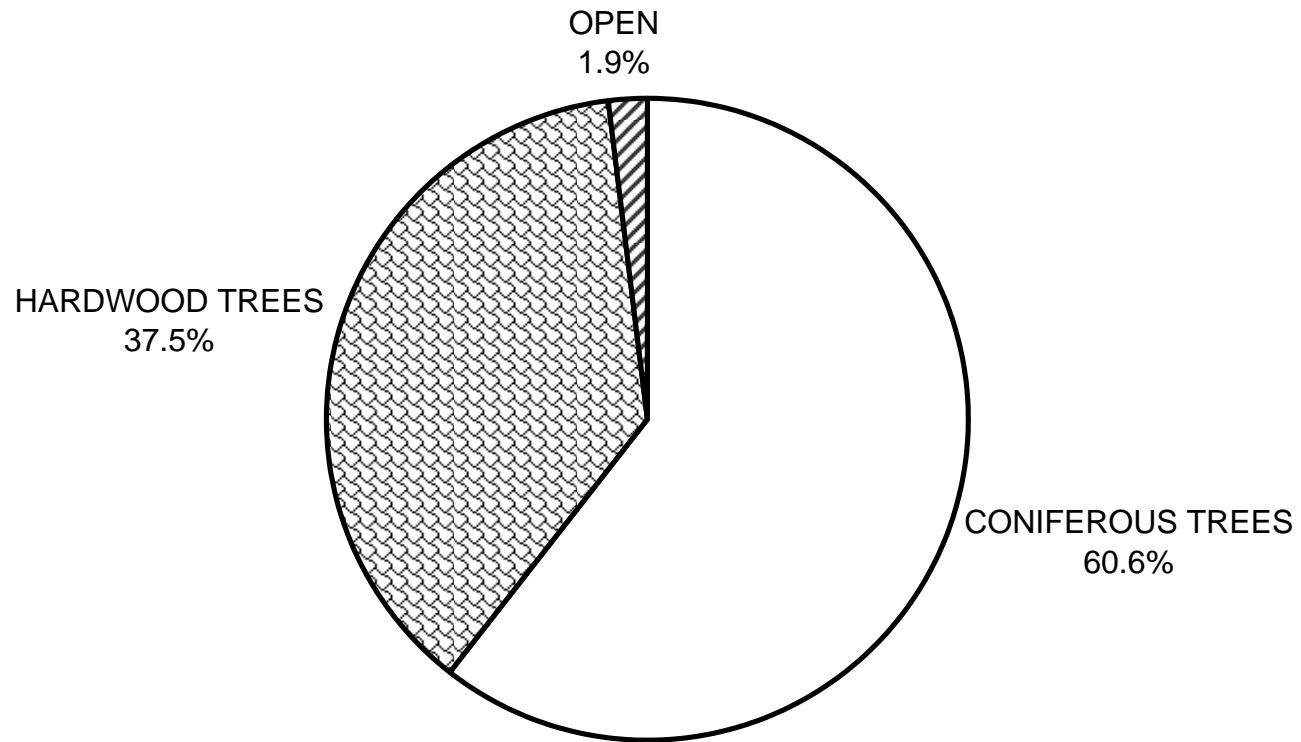
GRAPH 9

The mean percent canopy density for the surveyed length of Nelson Gulch was 98%. Two percent of the canopy was open. Of the canopy present, the mean percentages of hardwood and coniferous trees were 38% and 62%, respectively. Graph 9 describes the mean percent canopy in Nelson Gulch.

The mean percent canopy density for the stream was 98%. Reach 1 had a canopy density of 98%, Reach 2 had a canopy density of 98%. In general, revegetation projects are considered when canopy density is less than 80%. The percentage of right and left bank covered with vegetation was 100% and 100%, respectively.
