STREAM INVENTORY REPORT

Unnamed Tributary to Brush Creek

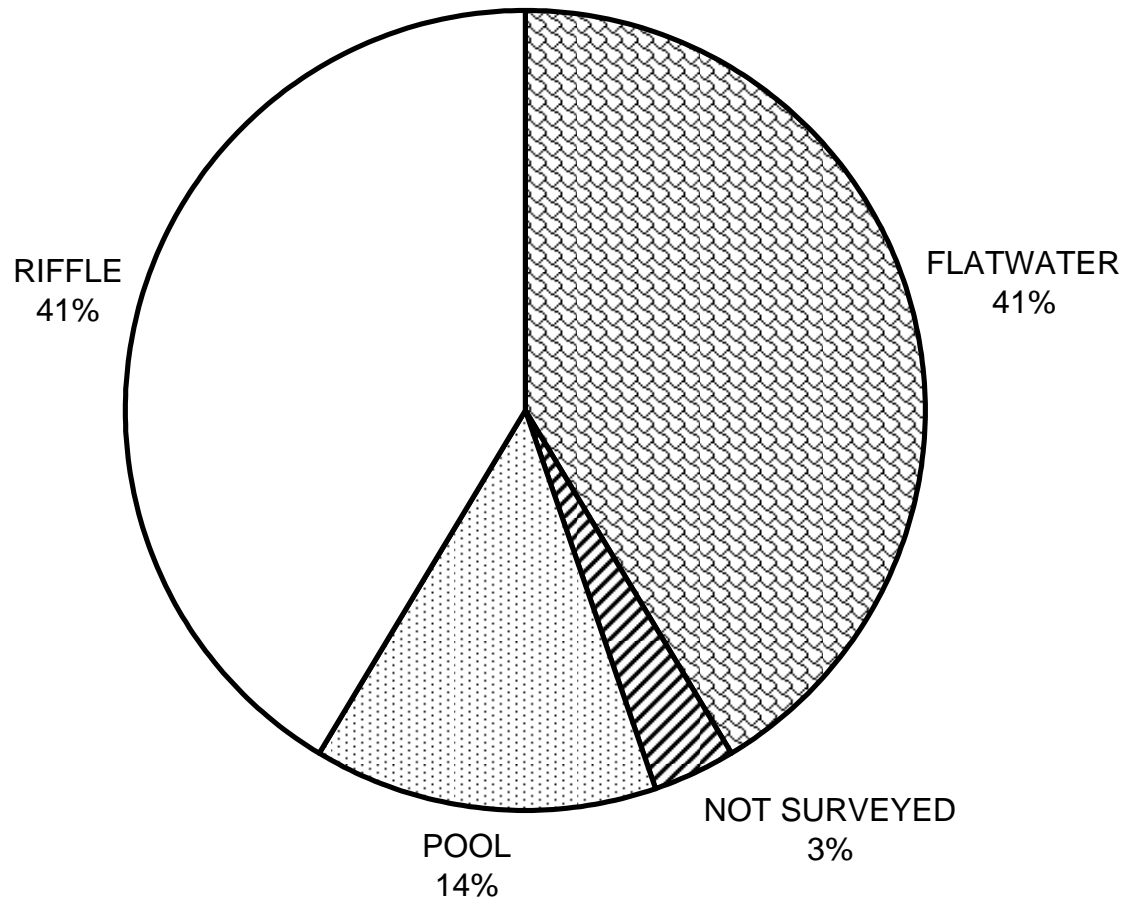
GRAPH 1

Table 1 summarizes the Level II riffle, flatwater, and pool habitat types. Based on frequency of occurrence there were 41% riffle units, 41% flatwater units, and 14% pool units (Graph 1). Based on total length of Level II habitat types there were 53% riffle units, 40% flatwater units, and 6% non surveyed units (Graph 2).

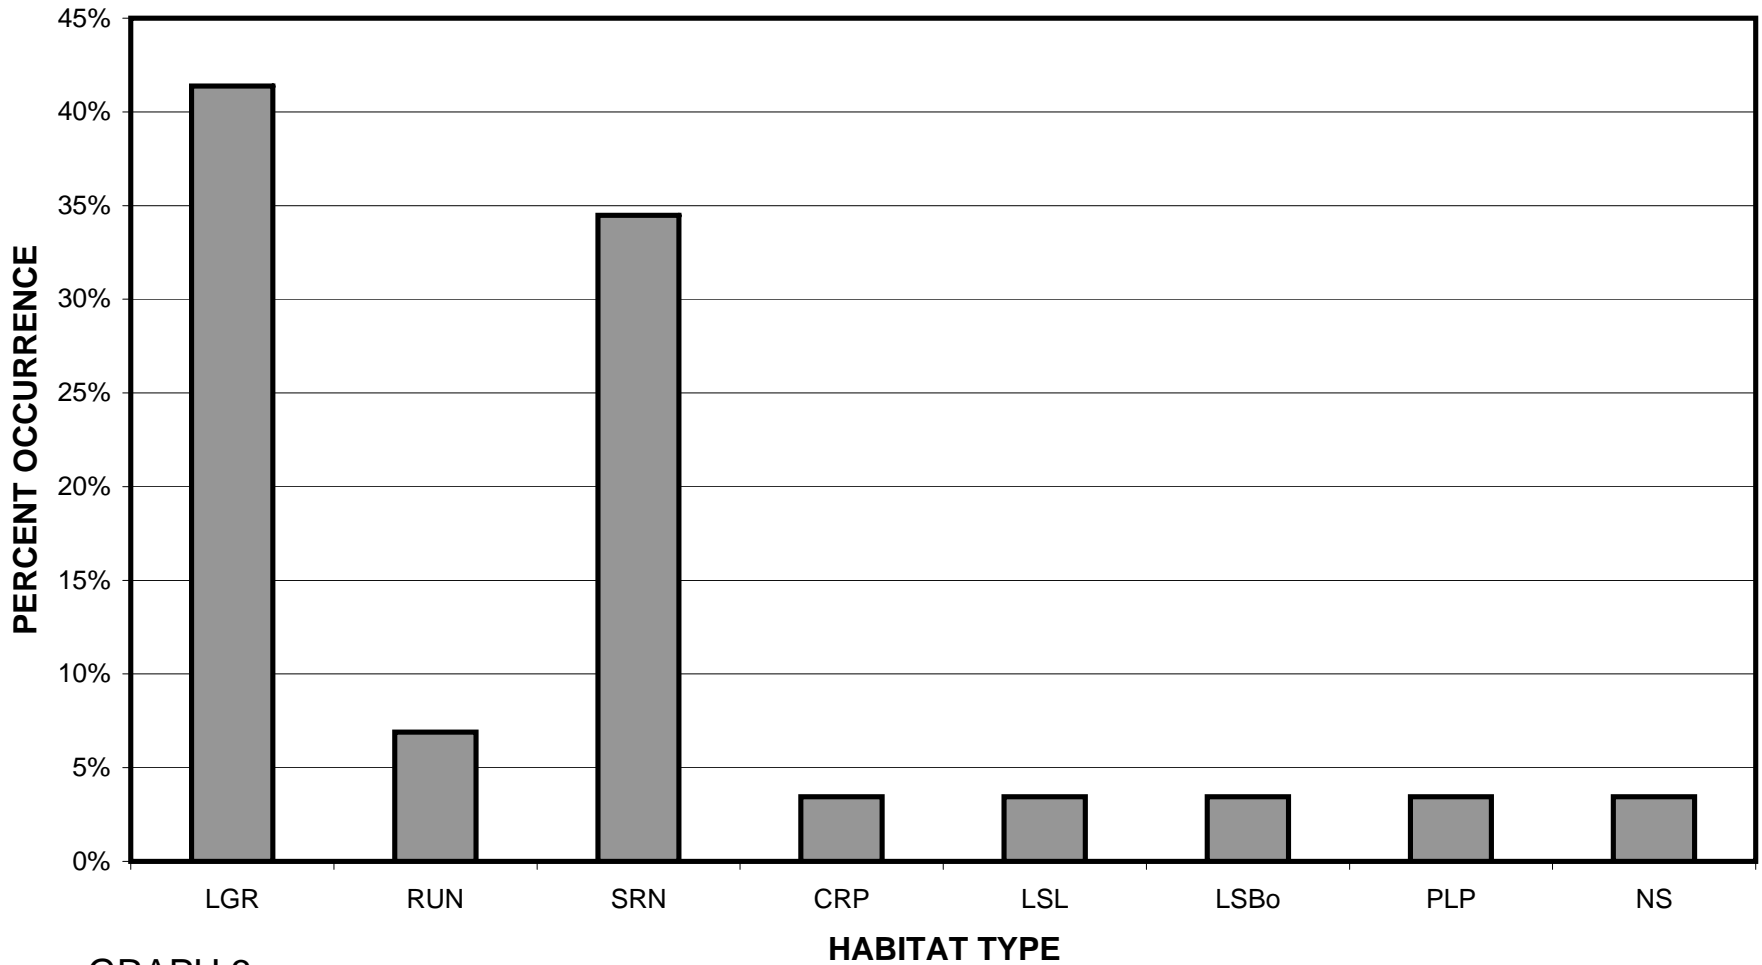
GRAPH 3

Seven Level IV habitat types were identified (Table 2). The most frequent habitat types by percent occurrence were low gradient riffles, 41%; step runs, 34%; and runs, 7% (Graph 3). Based on percent total length, low gradient riffles made up 53%, step runs 36%, and non surveyed units 6%.

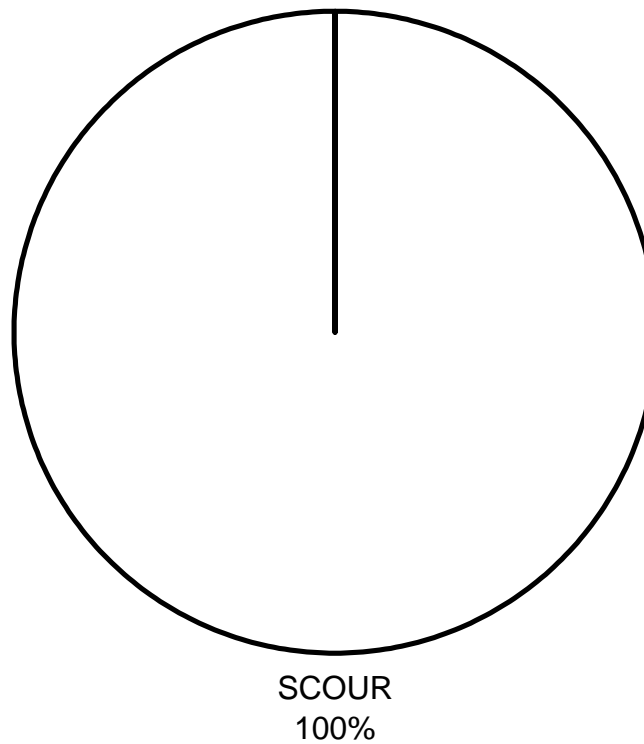
GRAPH 4

A total of four pools were identified (Table 3). All pools encountered were scour pools (Graph 4).

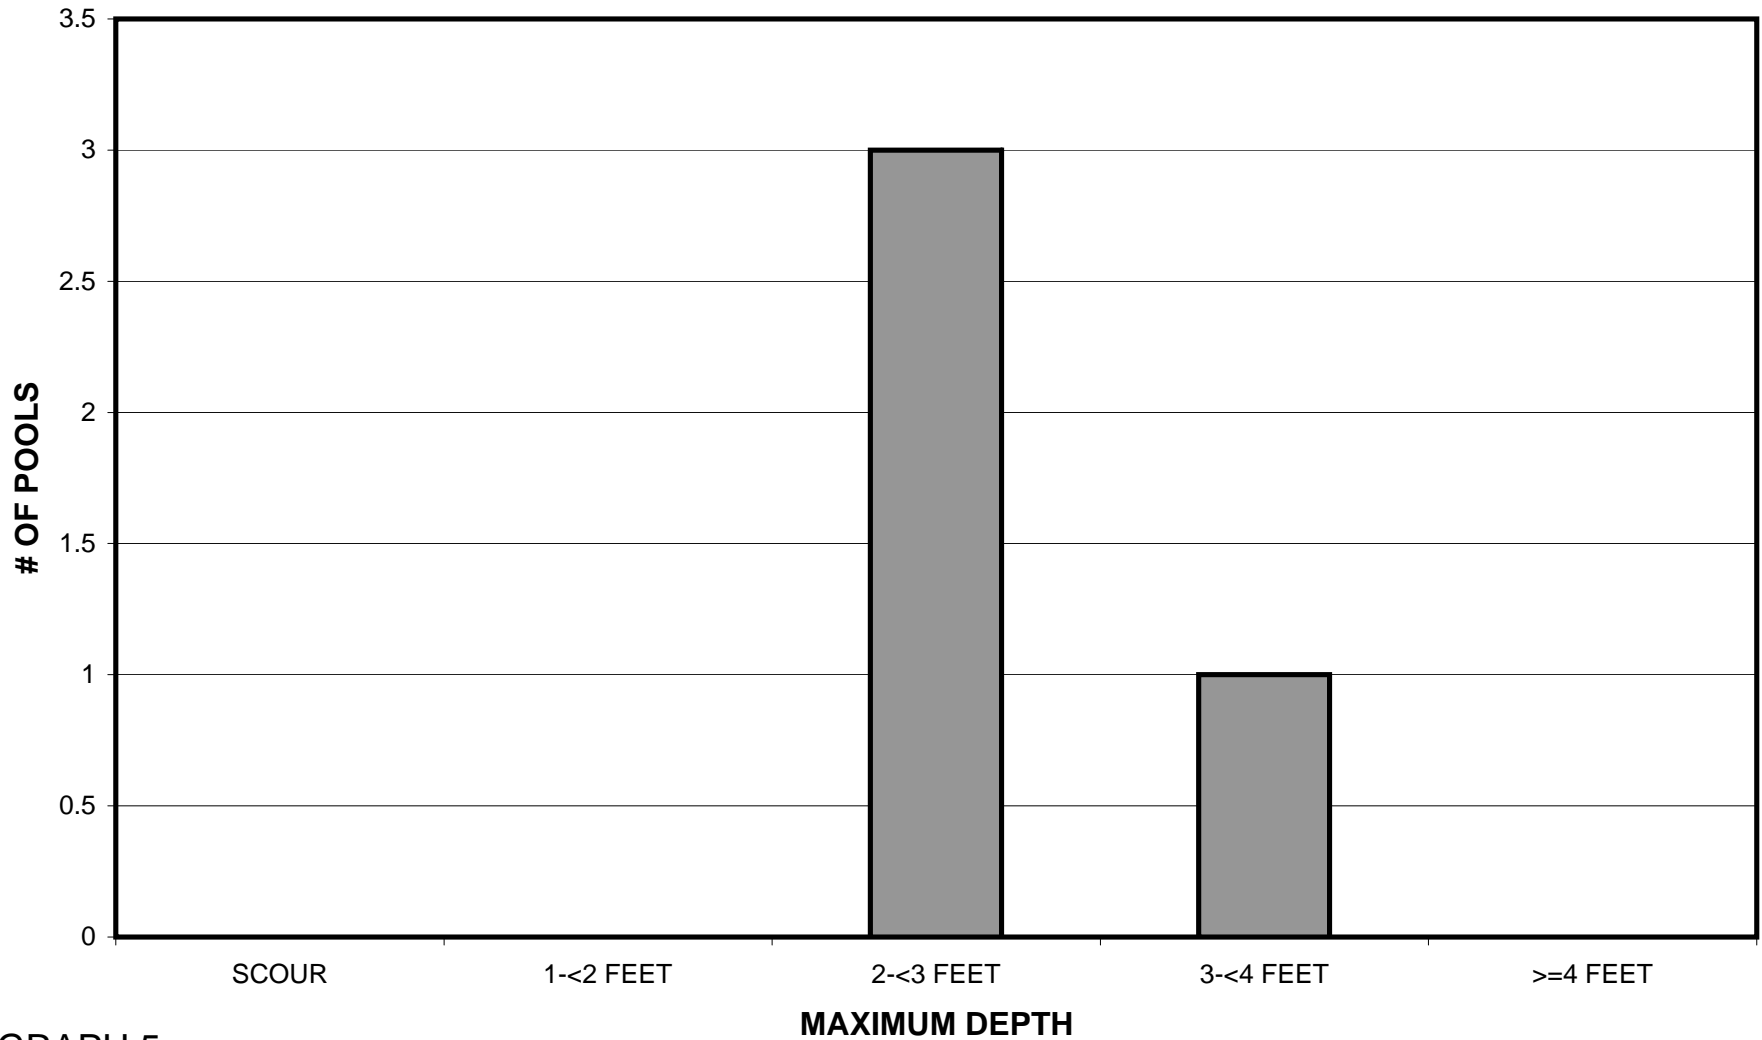
GRAPH 5

Table 4 is a summary of maximum residual pool depths by pool habitat types. Pool quality for salmonids increases with depth. All of the four pools (100%) had a residual depth of two feet or greater (Graph 5).

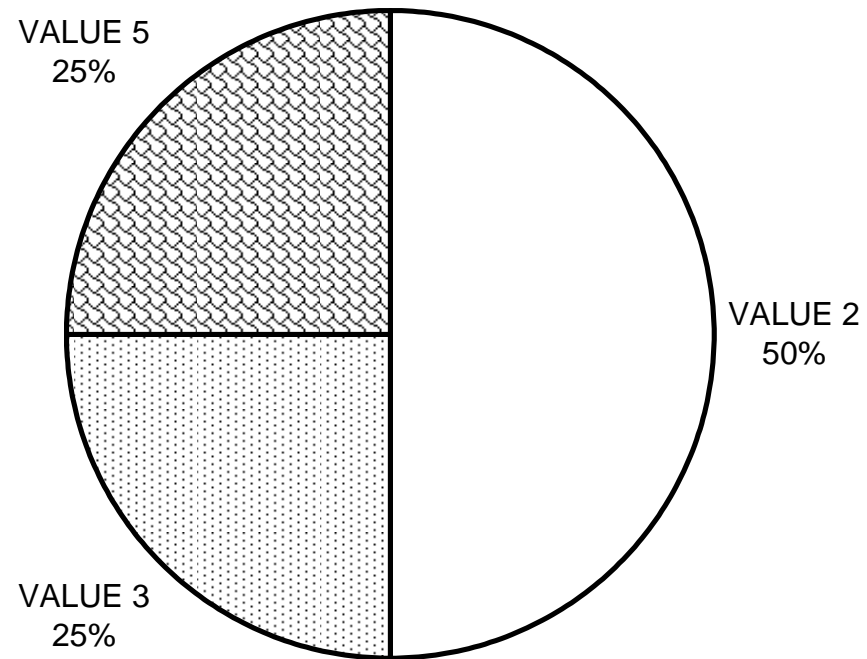
GRAPH 6

The depth of cobble embeddedness was estimated at pool tail-outs. Of the four pool tail-outs measured, two had a value of 2 (50%); one had a value of 3 (25%); and one had a value of 5 (25%) (Graph 6). On this scale, a value of 1 indicates the best spawning conditions and a value of 4 the worst. Additionally, a value of 5 was assigned to tail-outs deemed unsuited for spawning due to inappropriate substrate like bedrock, log sills, and boulders.

Two of the four pool tail-outs measured had embeddedness ratings of 1 or 2. One of the pool tail-outs had embeddedness ratings of 3 or 4. One of the pool tail-outs had a rating of 5, which is considered unsuitable for spawning. Cobble embeddedness measured to be 25% or less, a rating of 1, is considered to indicate good quality spawning substrate for salmon and steelhead. Sediment sources in the unnamed tributary should be mapped and rated according to their potential sediment yields, and control measures should be taken.

- 5) Inventory and map sources of stream bank erosion and prioritize them according to present and potential sediment yield. Identified sites should then be treated to reduce the amount of fine sediments entering the stream.

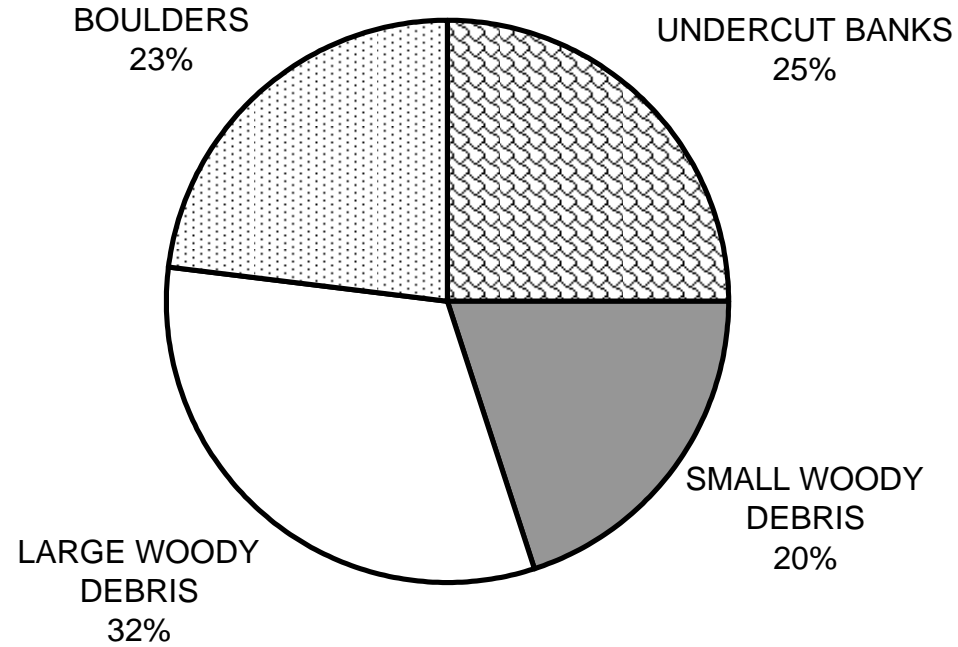
GRAPH 7

Table 5 summarizes mean percent cover by habitat type. Large woody debris is the dominant cover type in the unnamed tributary. Graph 7 describes the pool cover in the unnamed tributary. Large woody debris is the dominant pool cover type followed by undercut banks.

The mean shelter rating for pools was 66. The shelter rating in the flatwater habitats was 8. A pool shelter rating of approximately 100 is desirable. The amount of cover that now exists is being provided primarily by large woody debris in the unnamed tributary. Large woody debris is the dominant cover type in pools followed by undercut banks. Log and root wad cover structures in the pool and flatwater habitats would enhance both summer and winter salmonid habitat. Log cover structures provide rearing fry with protection from predation, rest from water velocity, and also divide territorial units to reduce density related competition.

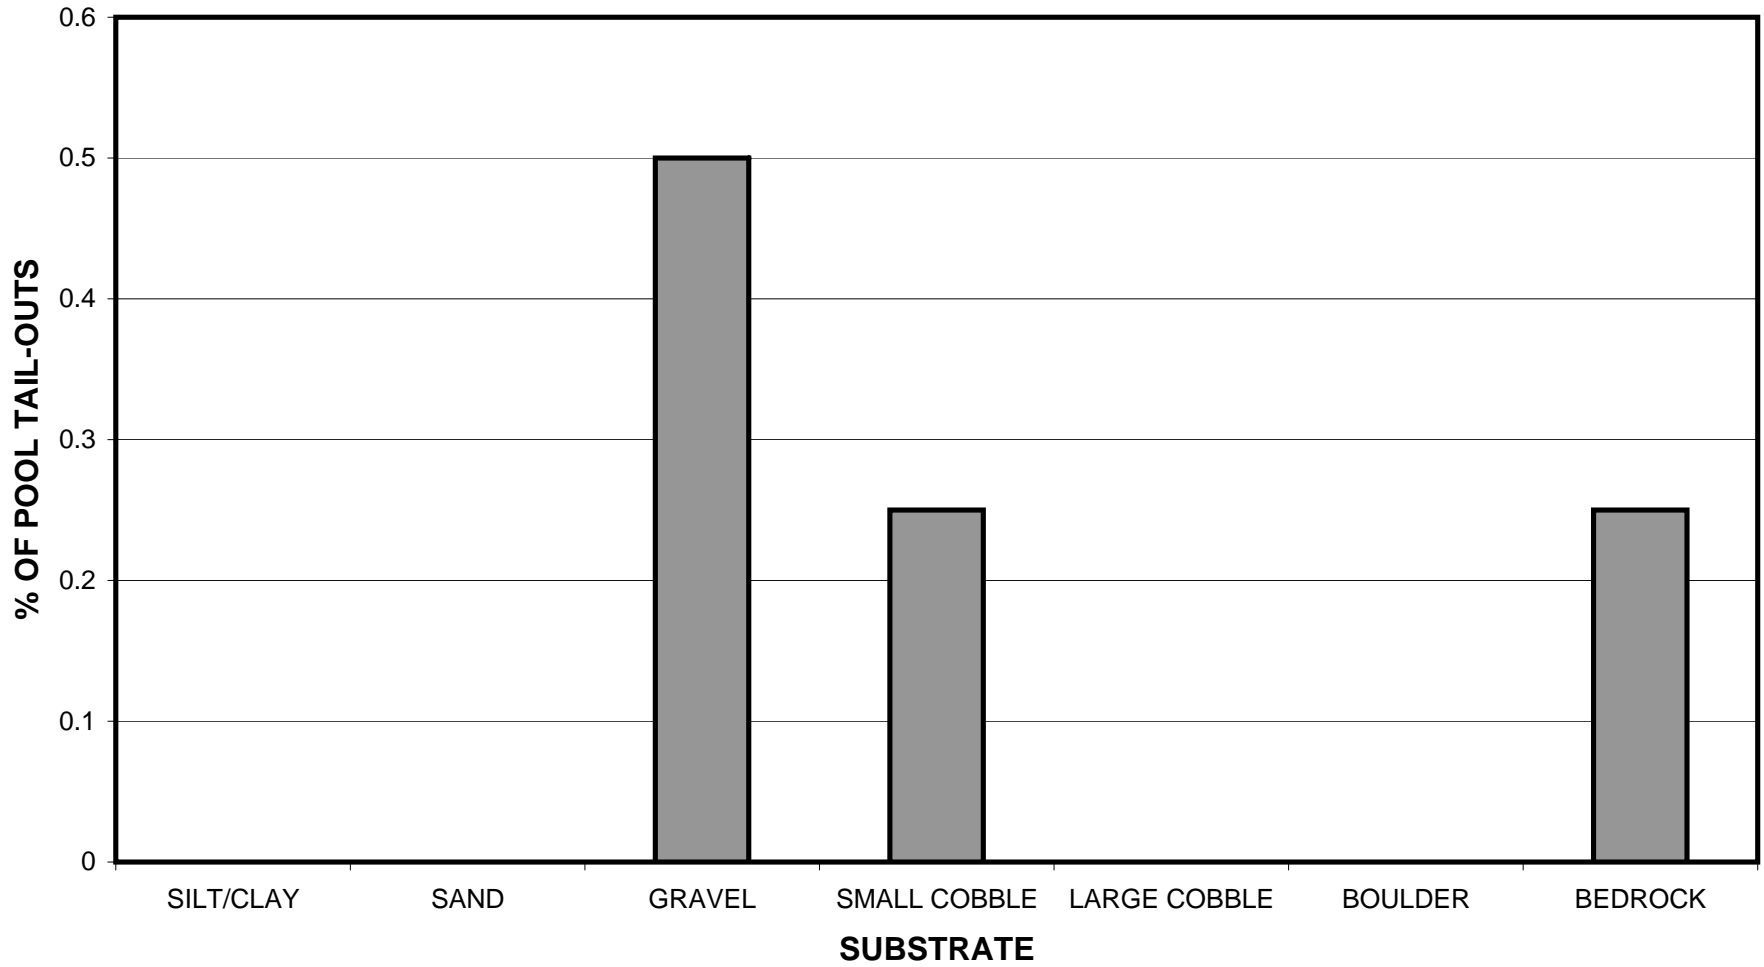
GRAPH 8

Table 6 summarizes the dominant substrate by habitat type. Graph 8 depicts the dominant substrate observed in pool tail-outs. Gravel was the dominant substrate observed in 50% of pool tail-outs while small cobble was the next most frequently observed substrate type, at 25%.

Three of the four pool tail-outs measured had gravel or small cobble as the dominant substrate. This is generally considered good for spawning salmonids.

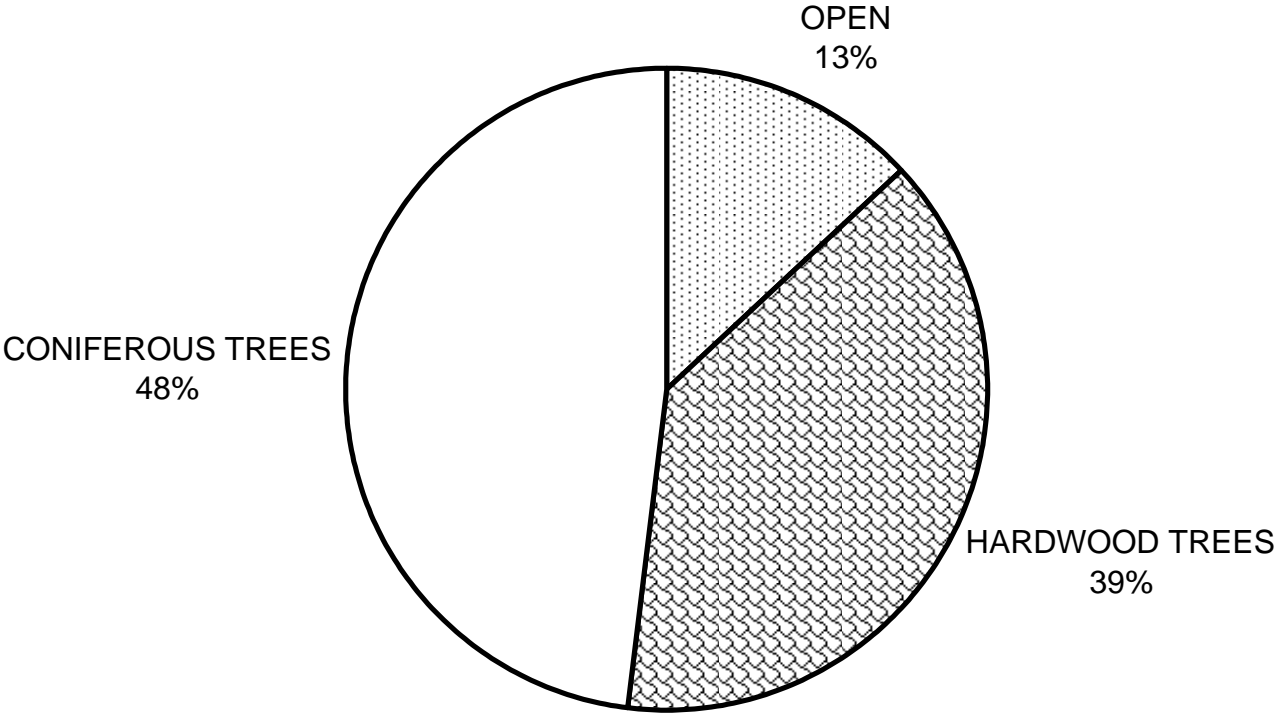
GRAPH 9

The mean percent canopy density for the surveyed length of the unnamed tributary was 87%. The mean percentages of hardwood and coniferous trees were 45% and 55%, respectively. Thirteen percent of the canopy was open. Graph 9 describes the mean percent canopy in the unnamed tributary.

The mean percent canopy density for the stream was 87%. In general, revegetation projects are considered when canopy density is less than 80%.

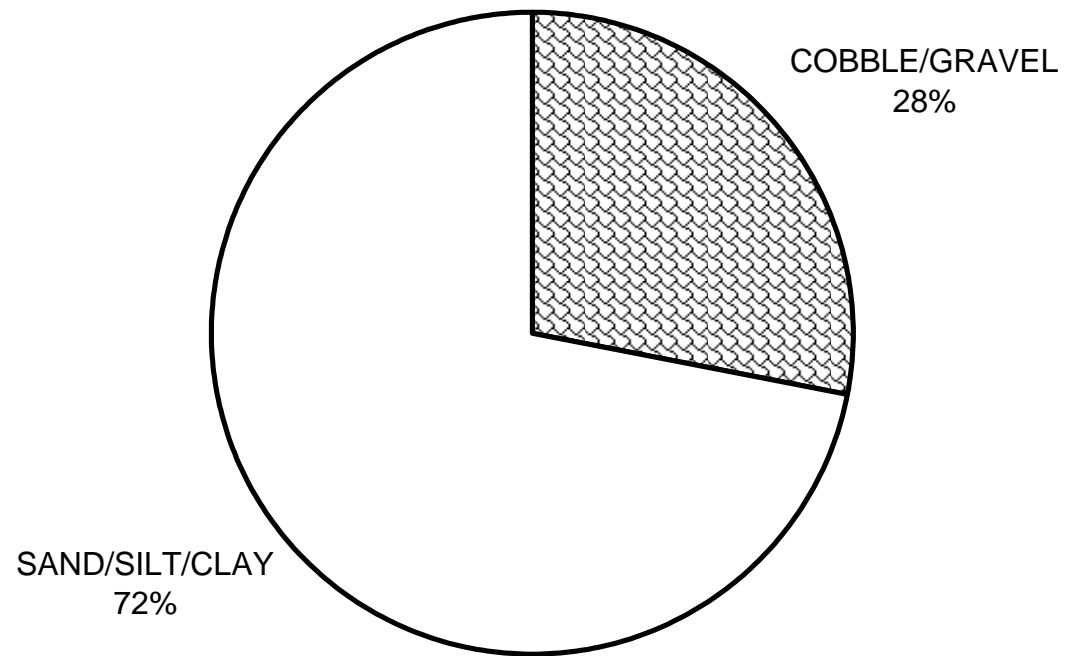
GRAPH 10

For the stream reach surveyed, the mean percent right bank vegetated was 49%. The mean percent left bank vegetated was 54%. The dominant elements composing the structure of the stream banks consisted of 28% cobble/gravel, and 72% sand/silt/clay (Graph 10).

The percentage of right and left bank covered with vegetation was low at 49% and 54%, respectively. In areas of stream bank erosion or where bank vegetation is sparse, planting endemic species of coniferous and hardwood trees, in conjunction with bank stabilization, is recommended.

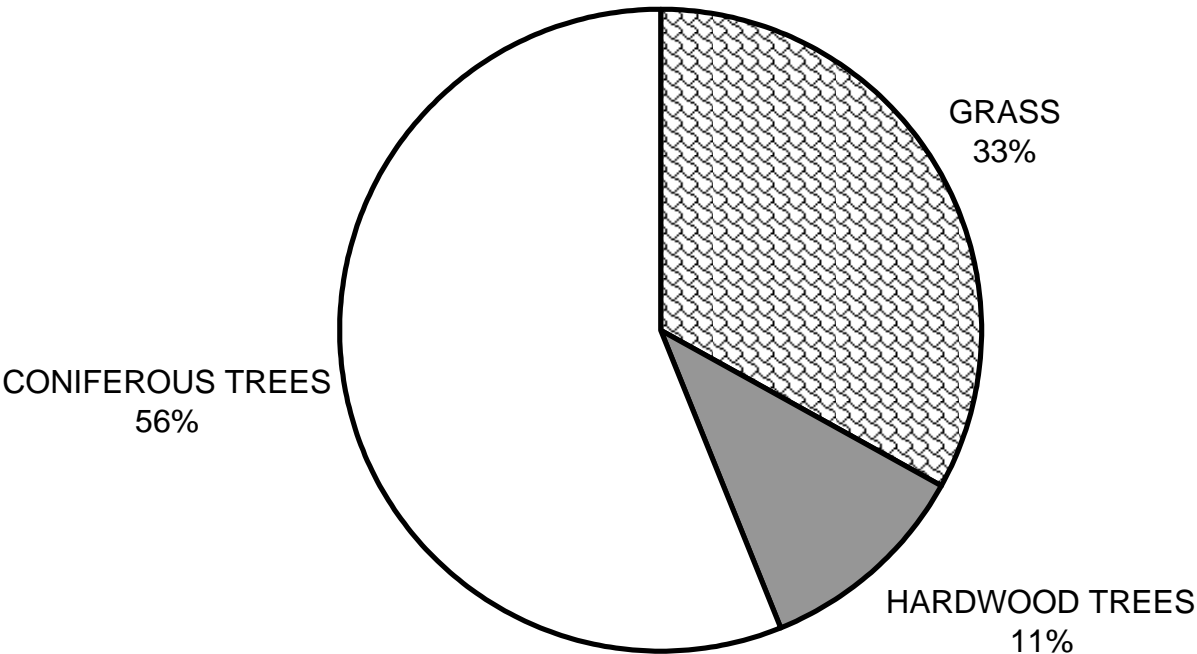
GRAPH 11

Coniferous trees were the dominant vegetation type observed in 56% of the units surveyed. Additionally, 33% of the units surveyed had grass as the dominant vegetation type, and 11% had hardwood trees as the dominant vegetation type (Graph 11).
