# **STREAM INVENTORY REPORT**

## **Little River (Mendocino County)**

The habitat field inventory was conducted May 26-28, 1999 and June 1-2, 1999 by Adrienne Carr and Jennifer Jenkins (WSP/AmeriCorps). The total length of stream surveyed was 19,933 feet.

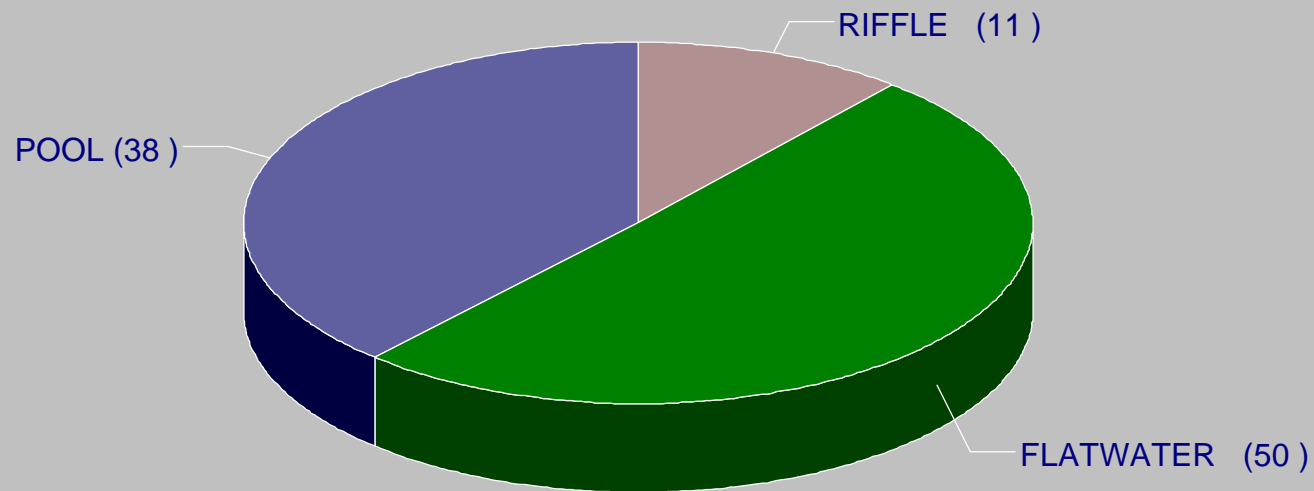
GRAPH 1

Based on frequency of occurrence of Level II habitat types, there were 11% riffle units, 50% flatwater units, and 38% pool units (Table 1, Graph 1). Based on total length of Level II habitat types, there were 4% riffle units, 71% flatwater units, and 22% pool units (Table 1, Graph 2).

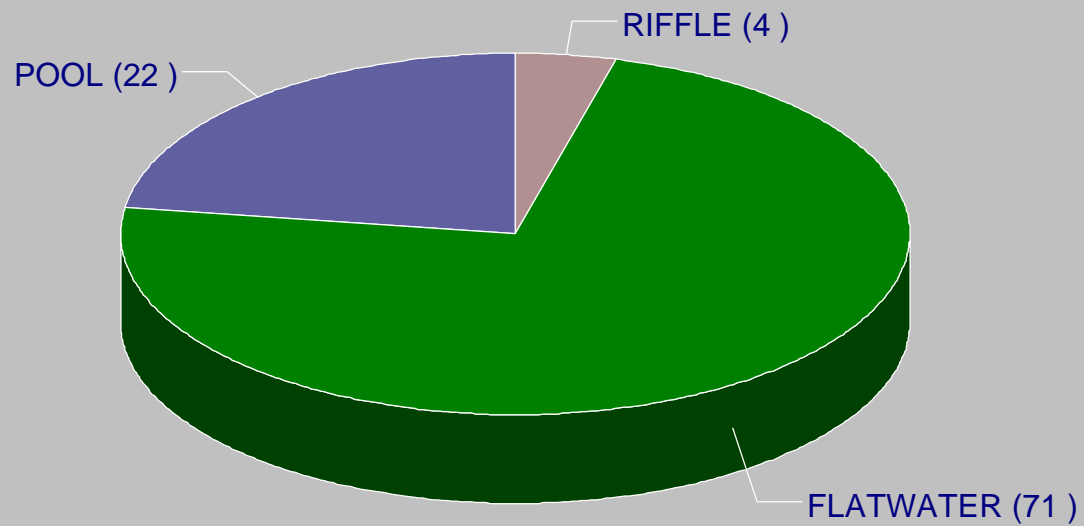
GRAPH 2

Flatwater habitat types comprised 71% of the total length of the survey, riffles 4%, and pools 22%. Primary pools composed 17% of the length surveyed. DFG data indicate that the better

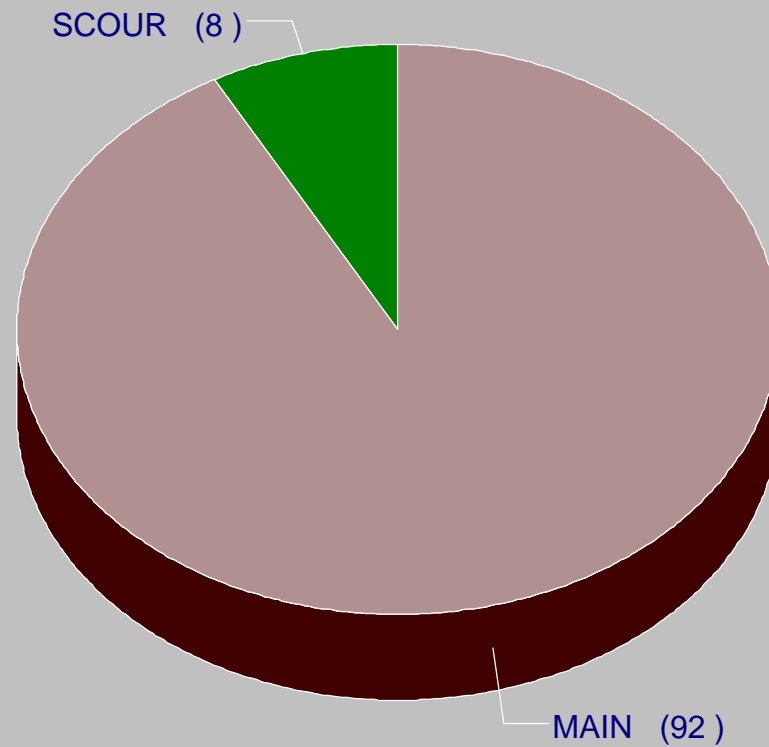
GRAPH 4

A total of 87 pools were identified (Table 3). Main channel pools were most frequently encountered at 92% (Graph 4) and comprised 91% of the total length of all pools. Of the 87 pools, 58 (67%) had a depth of two feet or greater (Table 4, Graph 5).

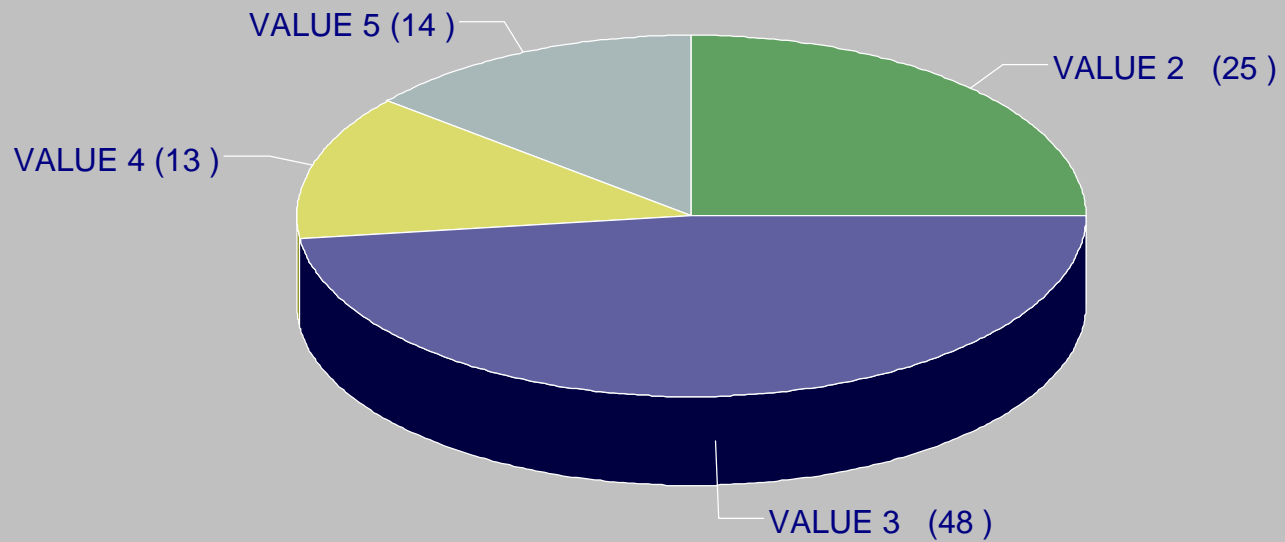
GRAPH 6

Of the 87 pool tail crest embeddedness estimates, none had a value of 1 (0%), 22 had a value of 2 (25%), 42 had a value of 3 (48%), 11 had a value of 4 (13%), and 12 had a value of 5 (14%) (Graph 6).

The prevalence of gravel as the dominant pool tail crest substrate is considered generally suitable for salmonid spawning. However most embeddedness ratings were 2 or 3, indicating lower spawning substrate quality due to presence of fine sediments. None of the pool tail crests sampled had the highest quality rating of 1. Fine sediments need to be controlled at the source.

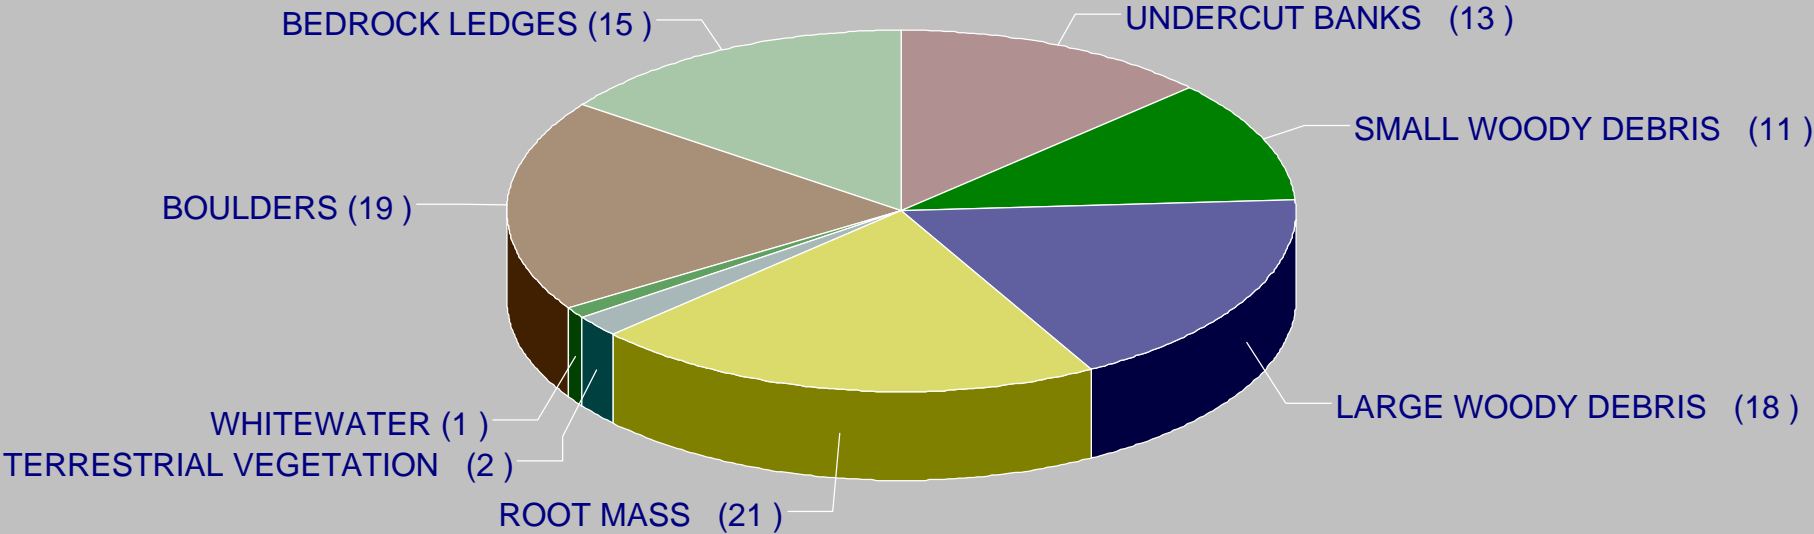
GRAPH 7

Cover in Little River was provided by a mix of undercut banks, small and large woody debris, root masses, terrestrial vegetation, and boulders (Table 5). Except for terrestrial vegetation, the same types also provided the main cover in pools (Graph 7).

The shelter ratings for riffle, flatwater, and pool habitats are lower than desirable for salmonids. The pool shelter rating of 13 is much lower than the desirable pool rating of 100. The low level of cover that now exists is provided by a mix of boulders, undercut banks, root wads, and large and small instream wood. Greatly increased log and root wad cover in the pool and flatwater habitats is needed for both summer and winter salmonid habitat. Log cover structure provides rearing fry with protection from predation, shelter from winter's high water velocities, and divides territorial units to reduce density related competition.

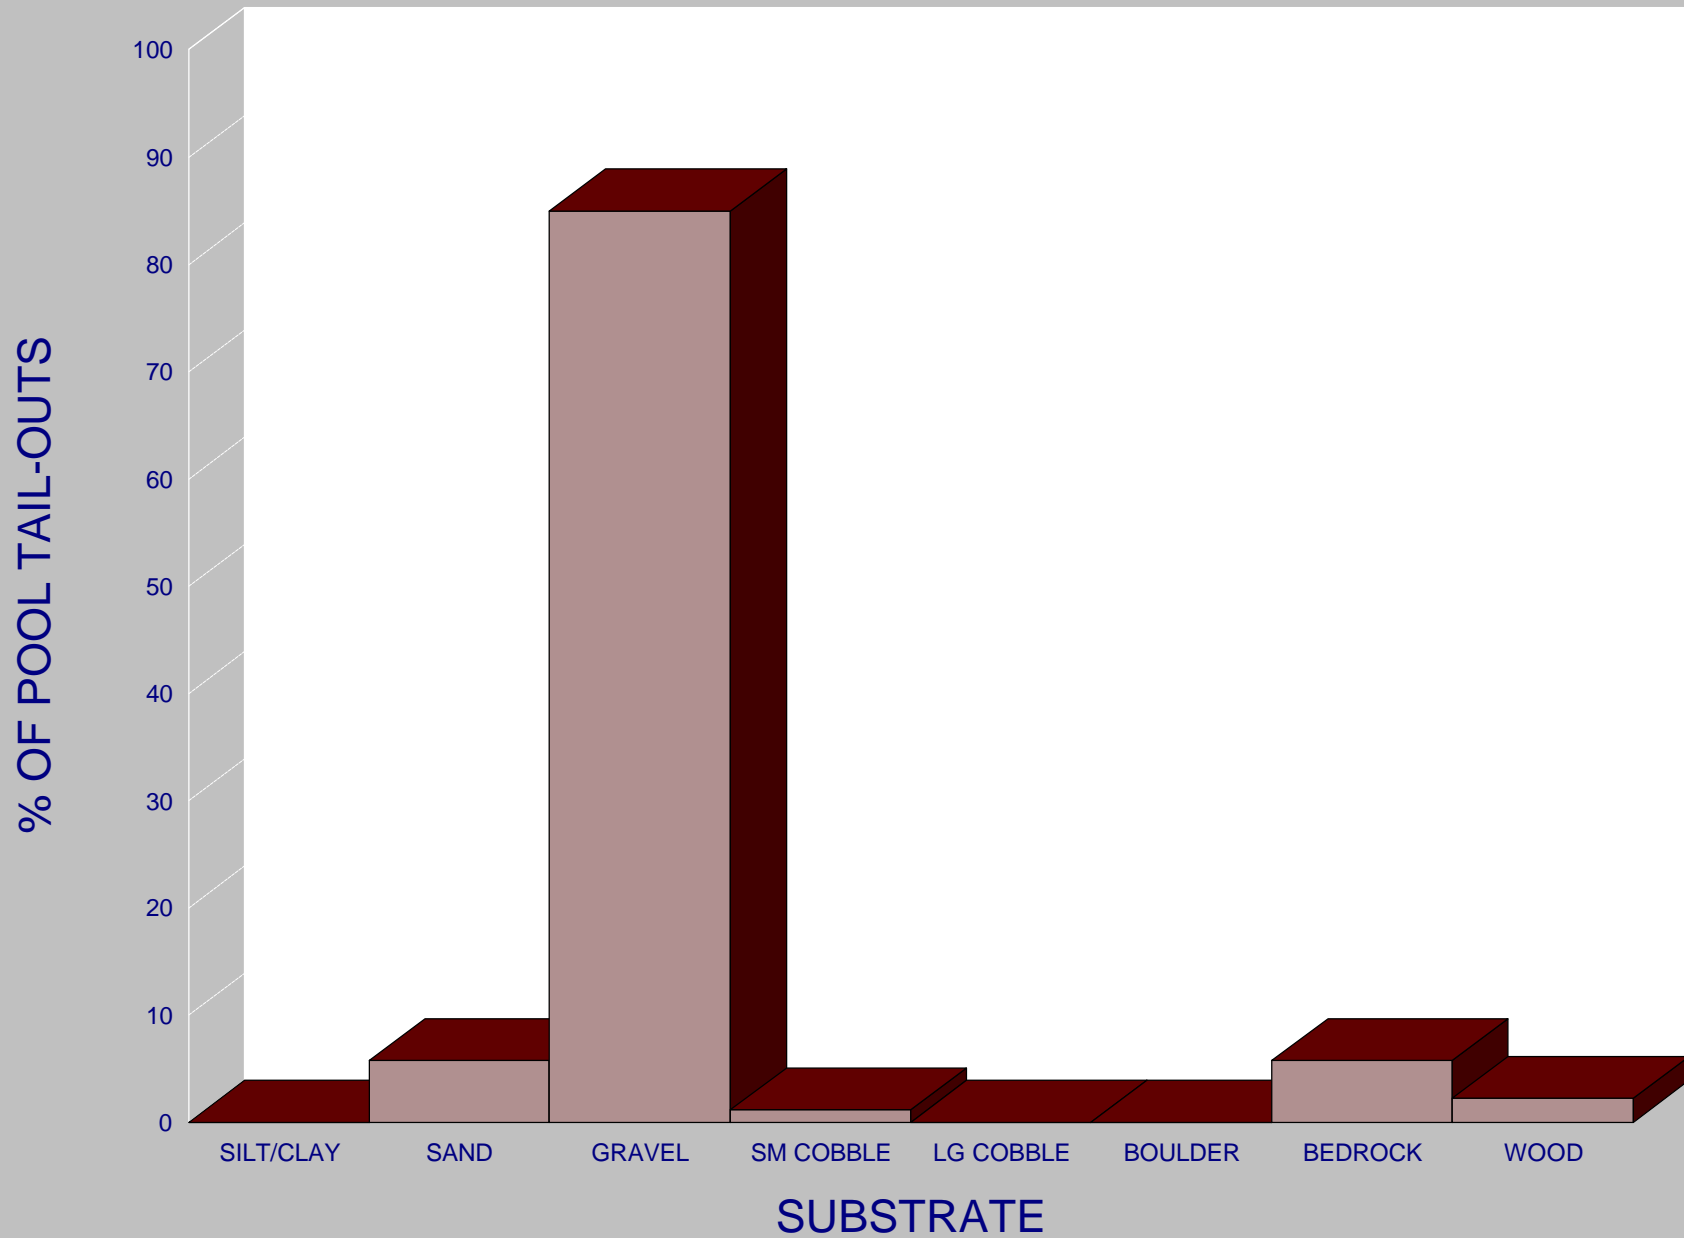
GRAPH 8

were dominated by gravel and 1 by sand. Of the 5 step runs fully measured, 3 were dominated by gravel and 2 by small cobble. Of the 12 mid channel pools fully measured, 8 were dominated by gravel, 3 by sand, and 1 by small cobble. The dominant pool tail crest substrate was gravel in 85% of the samples, followed by sand and bedrock (6% each) (Graph 8).

The frequency of sand as a dominant substrate in pools further indicates the need to control sources of fine sediment. Some apparent sources were recent failures in the riparian road.

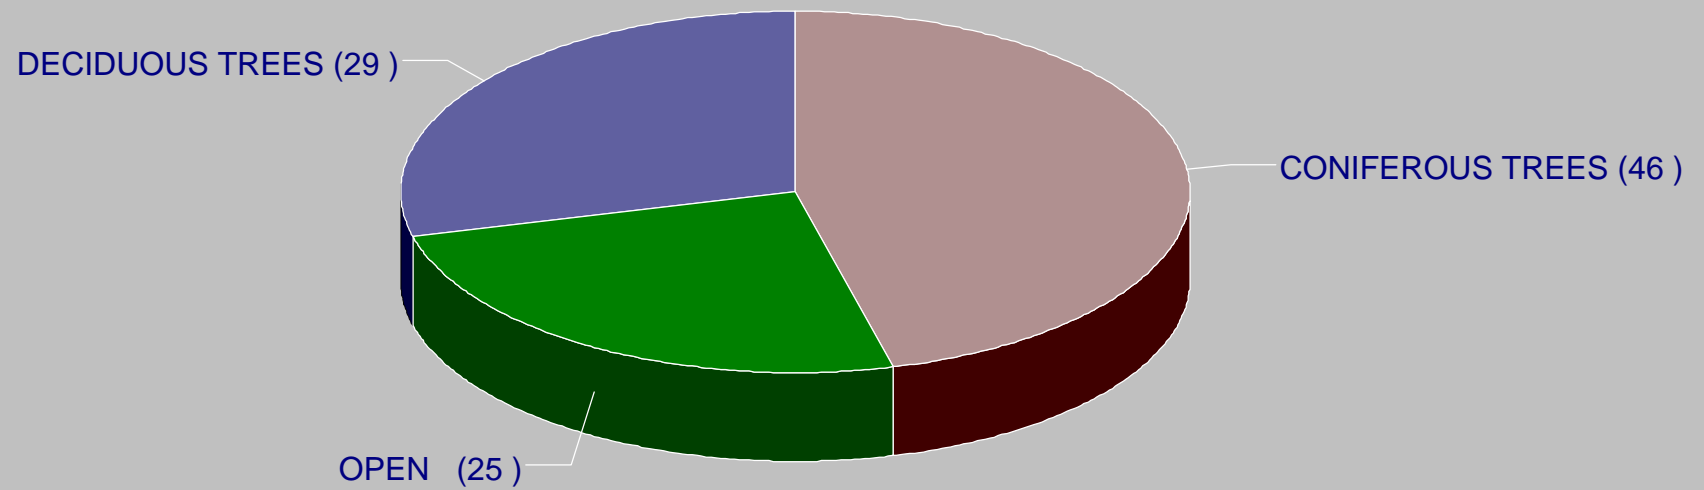
GRAPH 9

Mean percent canopy for the stream reach surveyed was 75%, with conifers the main component (Table 7, Graph 9).

The mean percent canopy density of 75% is slightly lower than 80%, the general level below which canopy revegetation projects are considered.

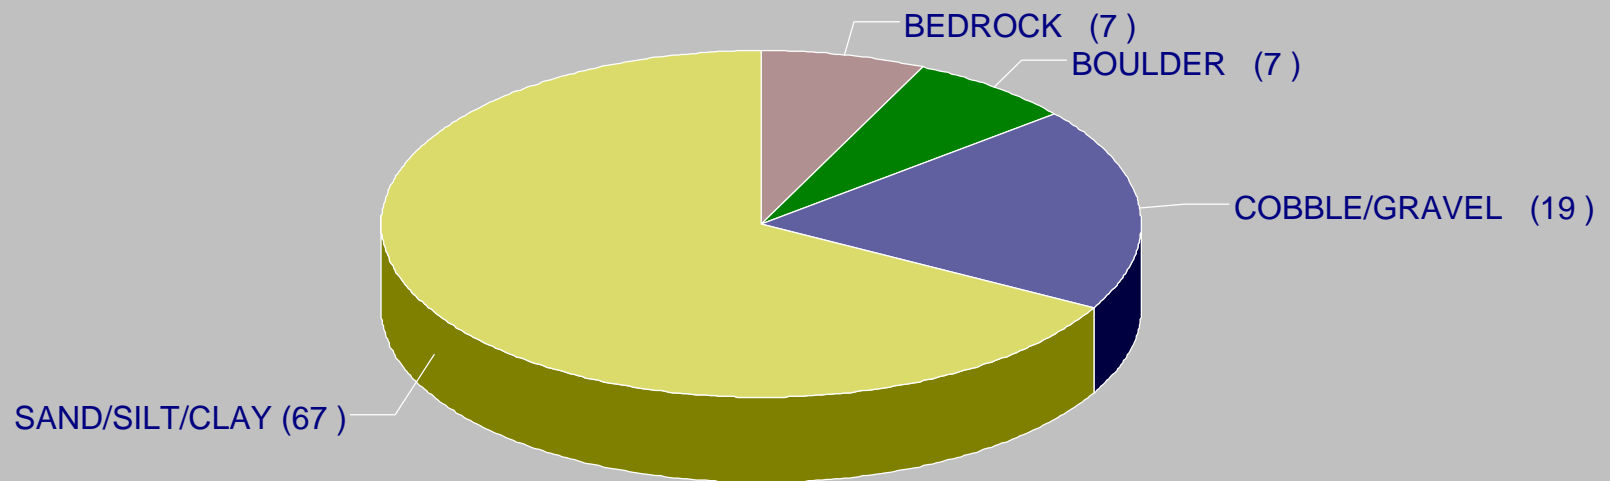
GRAPH 10

Sand/silt/clay dominated the streambank substrate in 67% of the fully sampled units. Other values were cobble/gravel 19%, boulder 7%, and bedrock 7% (Graph 10). In the fully sampled units, right streambanks had an average of 93% vegetative cover, and left streambanks had an average of 90% vegetative cover (Table 7). Streambank vegetation was mainly deciduous trees, brush, and coniferous trees (Graph 11).

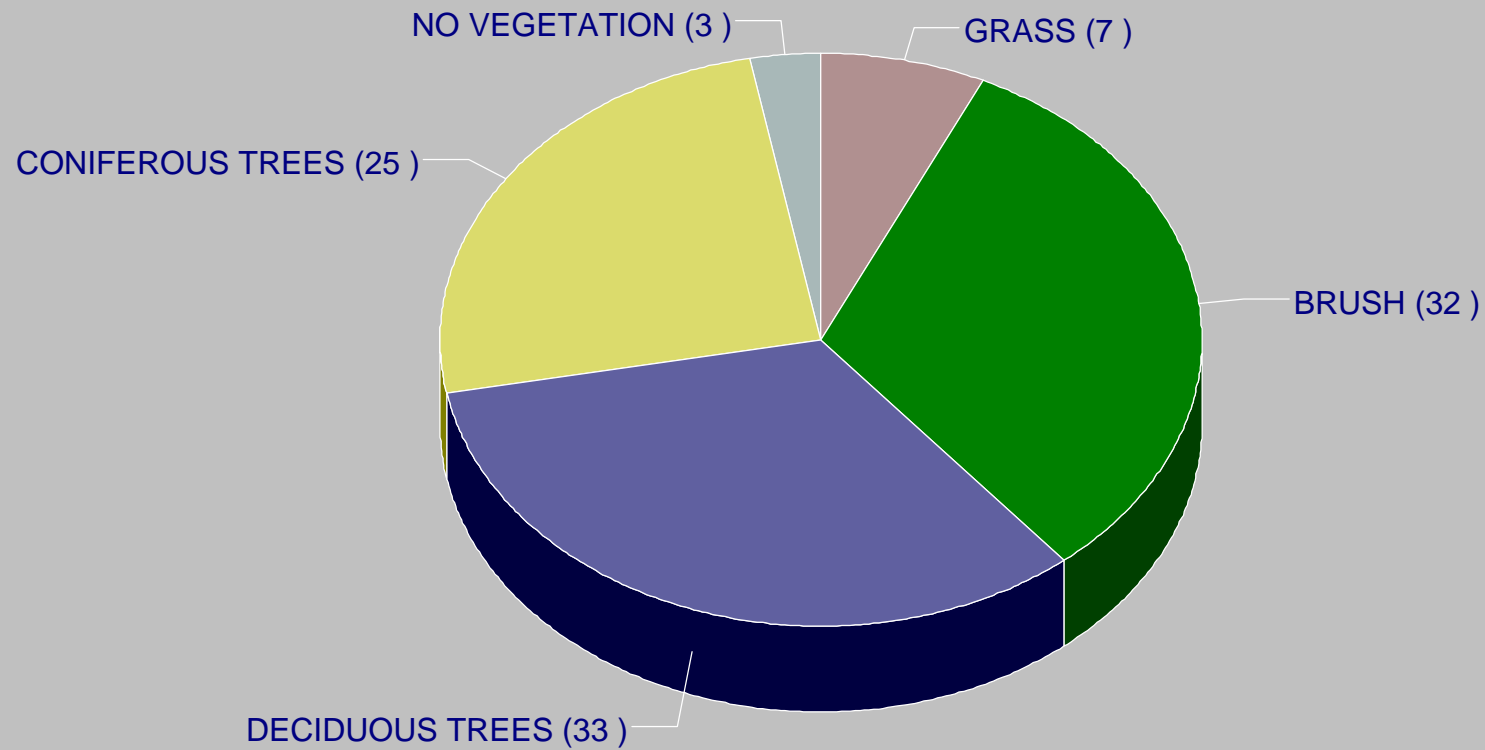
GRAPH 11

The streambank vegetation coverage values of 90% and 93% are high enough to place a generally low priority on streambank revegetation efforts.
