# STREAM INVENTORY REPORT

## Bailey Creek

A stream inventory was conducted June 5 to June 18, 2012 on Bailey Creek. The survey began at the confluence with South Branch North Fork Navarro River and extended upstream 1.3 miles.

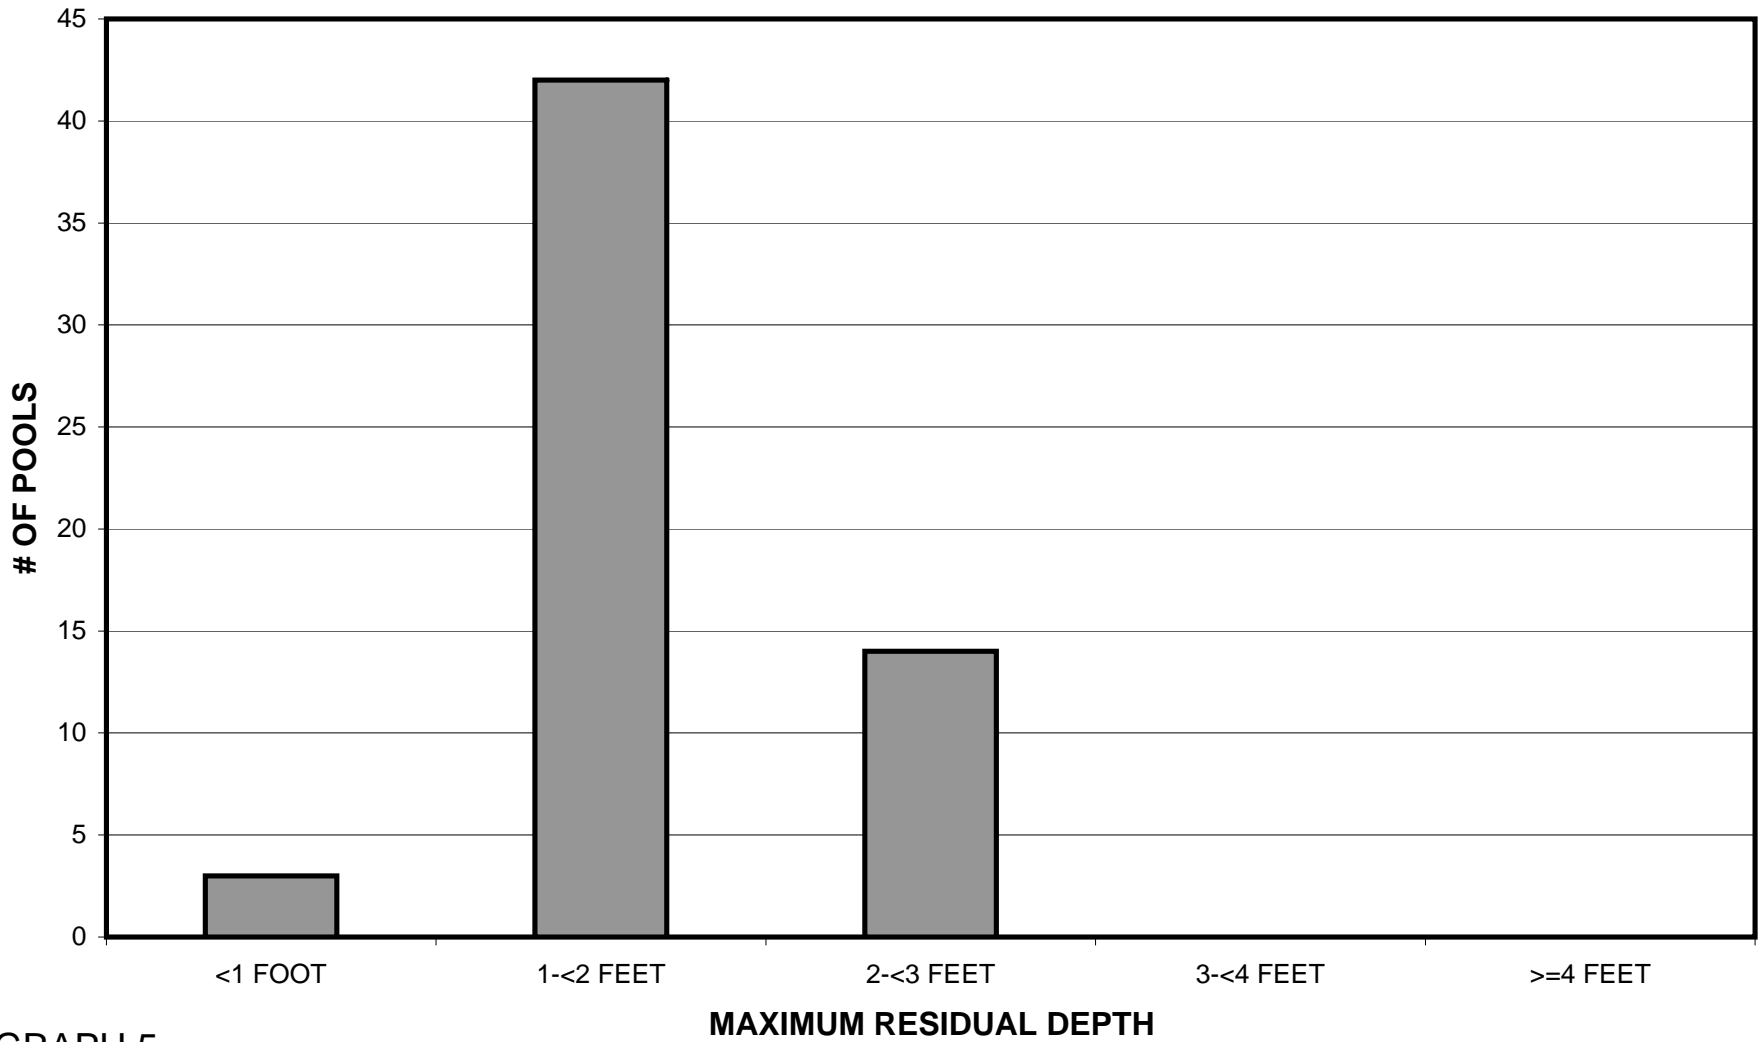
GRAPH 5

Table 4 is a summary of maximum residual pool depths by pool habitat types. Pool quality for salmonids increases with depth. Fourteen of the 59 pools (24%) had a residual depth of two feet or greater (Graph 5).

Flatwater habitat types comprised 56% of the total length of this survey, riffles 15%, and pools 27%. Fourteen of the 59 (24%) pools had a maximum residual depth greater than 2 feet. In general, pool enhancement projects are considered when primary pools comprise less than 40% of the length of total stream habitat. In first and second order streams, a primary pool is defined to have a maximum residual depth of at least two feet, occupy at least half the width of the low flow channel, and be as long as the low flow channel width. Installing large wood structures that will increase or deepen pool habitat is recommended.

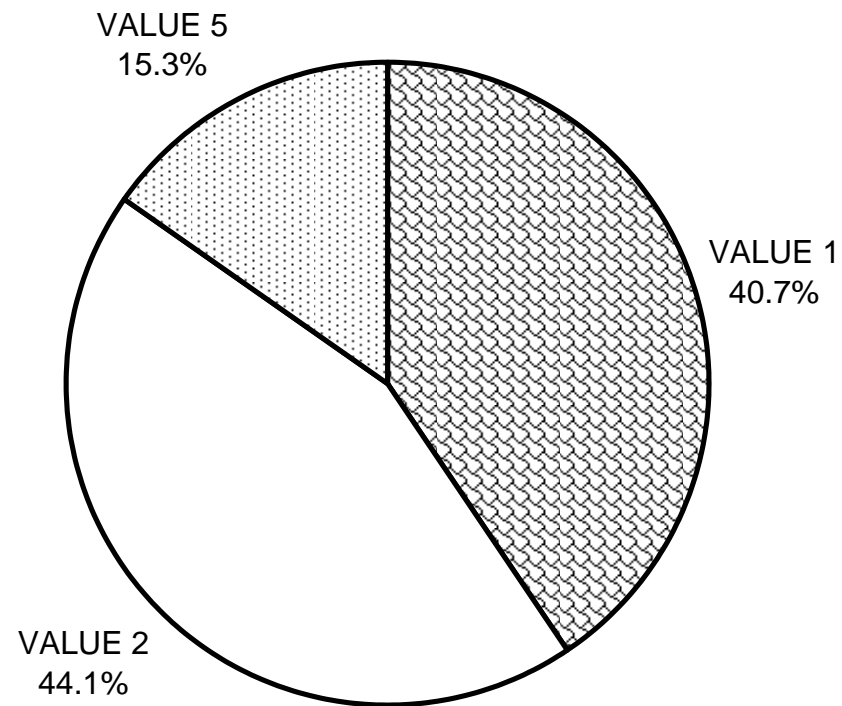
GRAPH 6

The depth of cobble embeddedness was estimated at pool tail-outs. Of the 59 pool tail-outs measured, 24 had a value of 1 (40.7%); 26 had a value of 2 (44.1%); and nine had a value of 5 (15.3%) (Graph 6). On this scale, a value of 1 indicates the best spawning conditions and a value of 4 the worst. Additionally, a value of 5 was assigned to tail-outs deemed not suitable for spawning due to inappropriate substrate such as bedrock, log sills, boulders, or other considerations.

Fifty of the 59 pool tail-outs measured had embeddedness ratings of 1 or 2. None of the pool tail-outs had embeddedness ratings of 3 or 4. Nine of the pool tail-outs had a rating of 5, which is considered unsuitable for spawning. Cobble embeddedness measured to be 25% or less, a rating of 1, is considered to indicate good quality spawning substrate for salmon and steelhead.

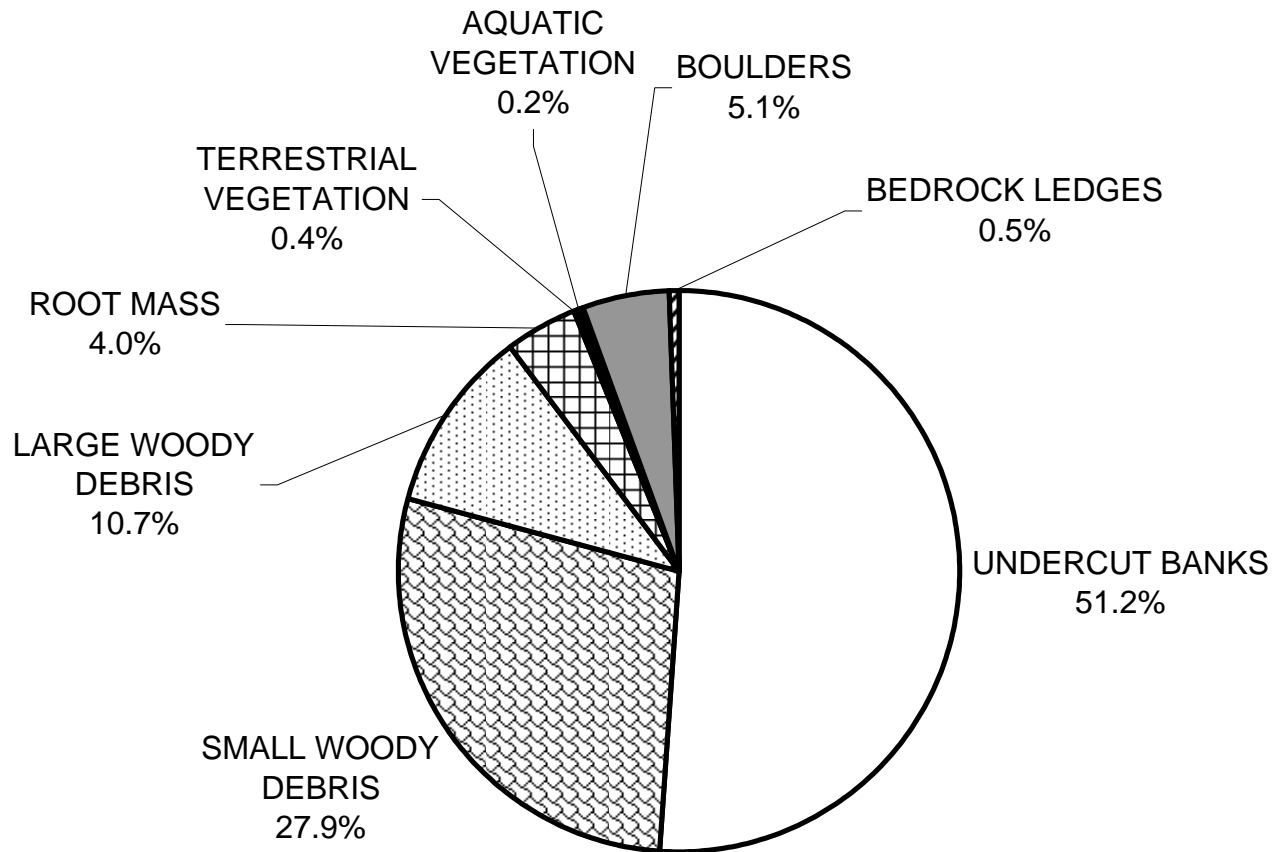
GRAPH 7

Table 5 summarizes mean percent cover by habitat type. Undercut banks are the dominant cover type in Bailey Creek. Graph 7 describes the pool cover in Bailey Creek. Undercut banks are the dominant pool cover type followed by small woody debris.

The mean shelter rating for pools is 6. The shelter rating in the flatwater habitats is 1. A pool shelter rating of approximately 100 is desirable. The amount of cover that now exists is being provided primarily by undercut banks in Bailey Creek. Undercut banks are the dominant cover type in pools followed by small woody debris. Log and root wad cover structures in the pool and flatwater habitats would enhance both summer and winter salmonid habitat. Log cover structures provide rearing fry with protection from predation, rest from water velocity, and also divide territorial units to reduce density related competition.

- 5) Increase woody cover in the pools and flatwater habitat units. Most of the existing cover in the pools is from undercut banks. Adding high quality complexity with woody cover in the pools is desirable.

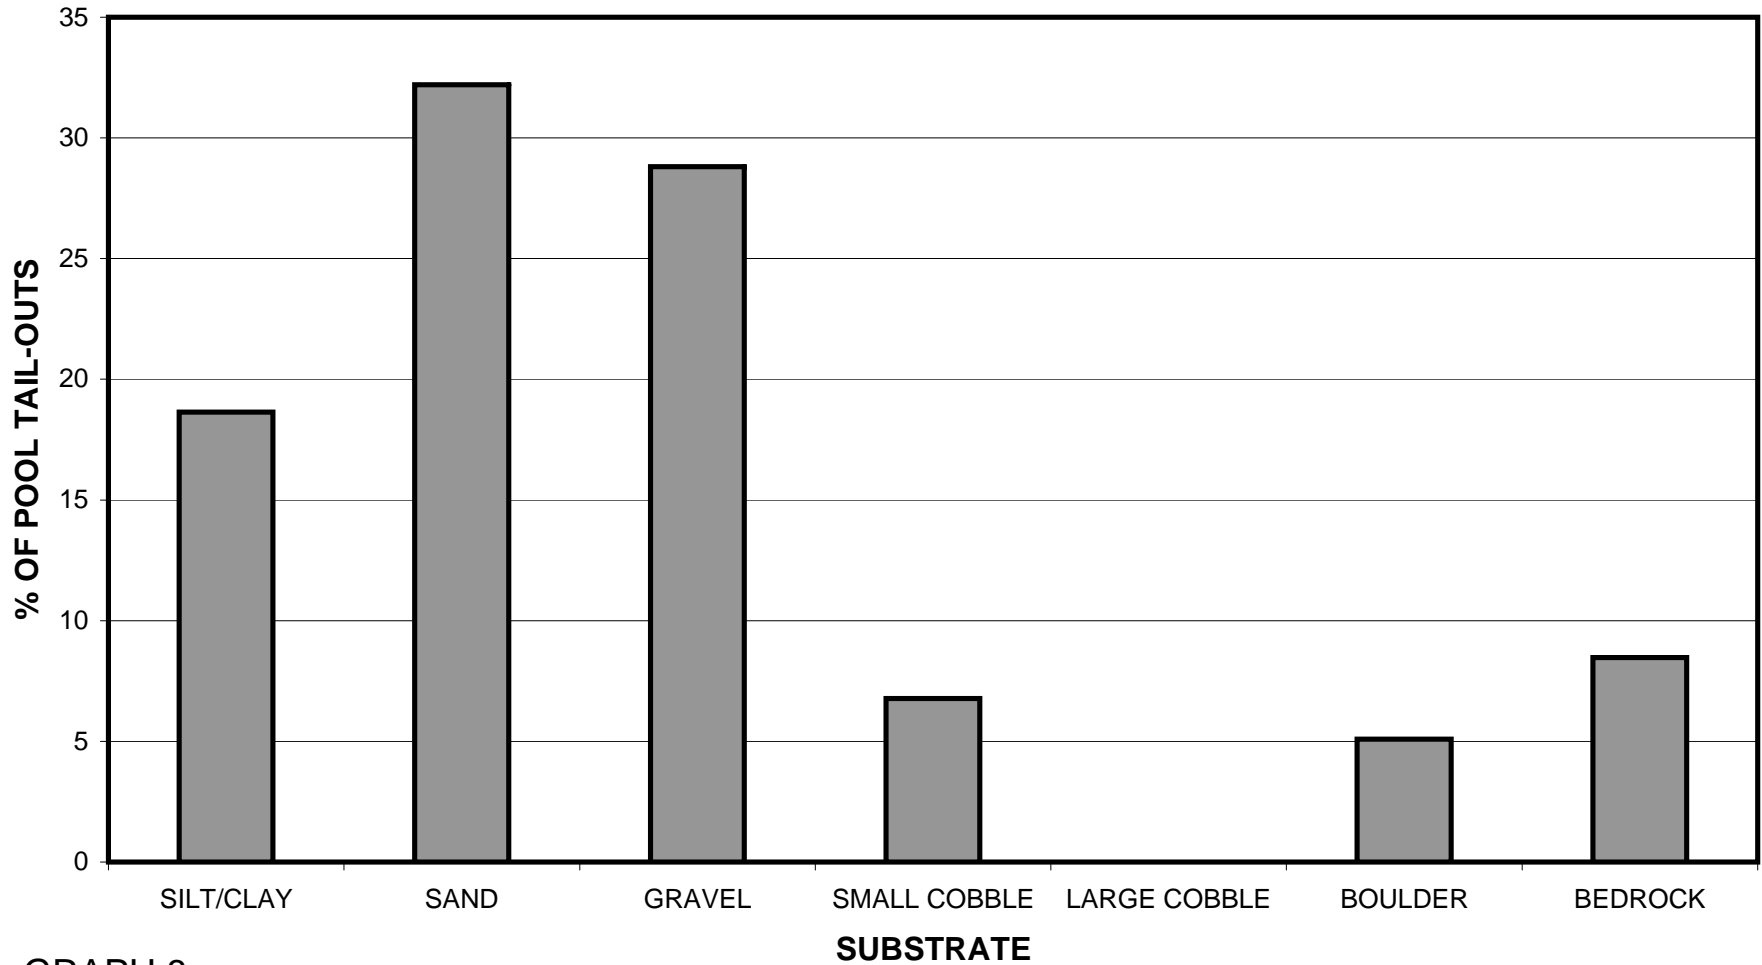
GRAPH 8

Table 6 summarizes the dominant substrate by habitat type. Graph 8 depicts the dominant substrate observed in pool tail-outs. Sand was the dominant substrate observed in 32% of the pool tail-outs. Gravel was the next most frequently observed dominant substrate type and occurred in 29% of the pool tail-outs.

Thirty-eight of the 59 pool tail-outs had silt, sand, large cobble, boulders or bedrock as the dominant substrate. This is generally considered unsuitable for spawning salmonids.

- 6) Suitable size spawning substrate on Bailey Creek is limited to relatively few reaches. Projects should be designed at suitable sites to trap and sort spawning gravel.

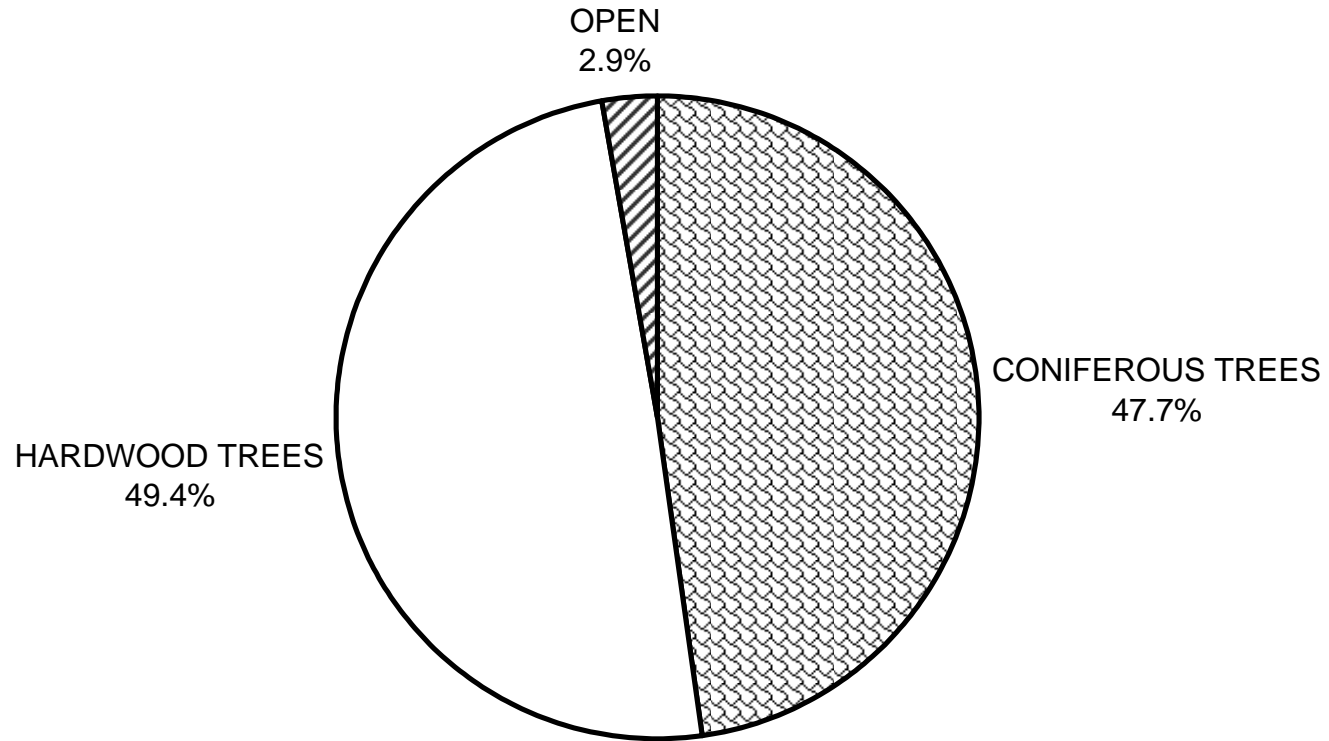
GRAPH 9

The mean percent canopy density for the surveyed length of Bailey Creek was 97%. Three percent of the canopy was open. Of the canopy present, the mean percentages of hardwood and coniferous trees were 51% and 49%, respectively. Graph 9 describes the mean percent canopy in Bailey Creek.
