# STREAM INVENTORY REPORT

## Indian Creek

A stream inventory was conducted during July 2, 2007 to September 21, 2007 on Indian Creek. The survey began at the confluence with Navarro River and extended upstream 7.5 miles.

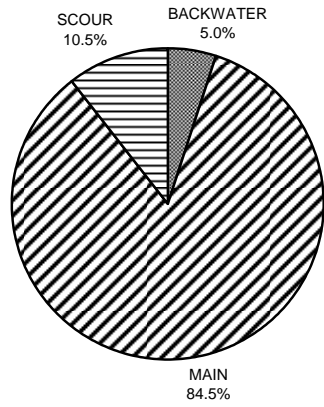
GRAPH 4

A total of 181 pools were identified (Table 3). Main channel pools were the most frequently encountered at 85%, and comprised 87% of the total length of all pools (Graph 4).

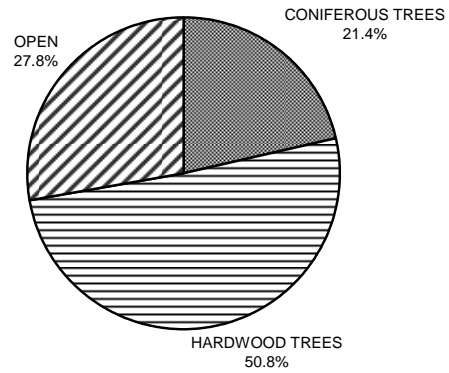
GRAPH 9

The mean percent canopy density for the surveyed length of Indian Creek was 72%. Of the canopy present, the mean percentages of hardwood and coniferous trees were 70% and 30%, respectively. Twenty-eight percent of the canopy was open. Graph 9 describes the mean percent canopy in Indian Creek.

The mean percent canopy density for the stream was 72%. Reach 1 had a canopy density of 61%, Reach 2 had a canopy density of 79%, Reach 3 had a canopy density of 72%, Reach 4 had

a canopy density of 59%, and Reach 5 had a canopy density of 69%. In general, revegetation projects are considered when canopy density is less than 80%.

- 4) Increase the canopy on Indian Creek by planting appropriate native vegetation like willow, alder, redwood, and Douglas fir along the stream where shade canopy is not at acceptable levels. The reaches above this survey section should be inventoried and treated as well, since the water flowing here is affected from upstream. In many cases, planting will need to be coordinated to follow bank stabilization or upslope erosion control projects.

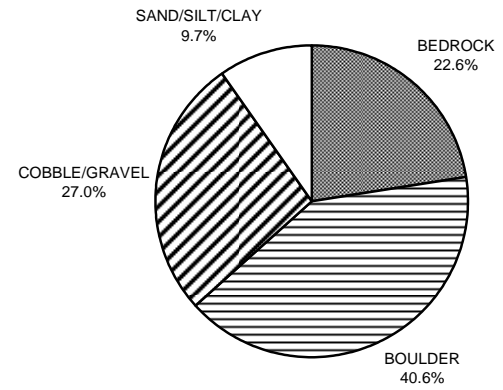
GRAPH 10

For the stream reach surveyed, the mean percent right bank vegetated was 32%. The mean percent left bank vegetated was 31%. The dominant elements composing the structure of the stream banks consisted of 41% boulder, 27% cobble/gravel, 22% bedrock, and 10% sand/silt/clay (Graph 10). Hardwood trees were the dominant vegetation type observed in 58% of the units surveyed. Additionally, 11% of the units surveyed had coniferous trees as the dominant vegetation type (Graph 11).

The percentage of right and left bank covered with vegetation was low at 32% and 31%, respectively. In areas of stream bank erosion or where bank vegetation is sparse, planting endemic species of coniferous and hardwood trees, in conjunction with bank stabilization, is recommended.

- 11) Replanting unstable stream banks with alder seedlings and willow cuttings.
