STREAM INVENTORY REPORT

Mill Creek

A stream inventory was conducted from October 14 to October 22, 2013 on Mill Creek. The survey began at the confluence with Navarro River and extended upstream 6.8 miles.

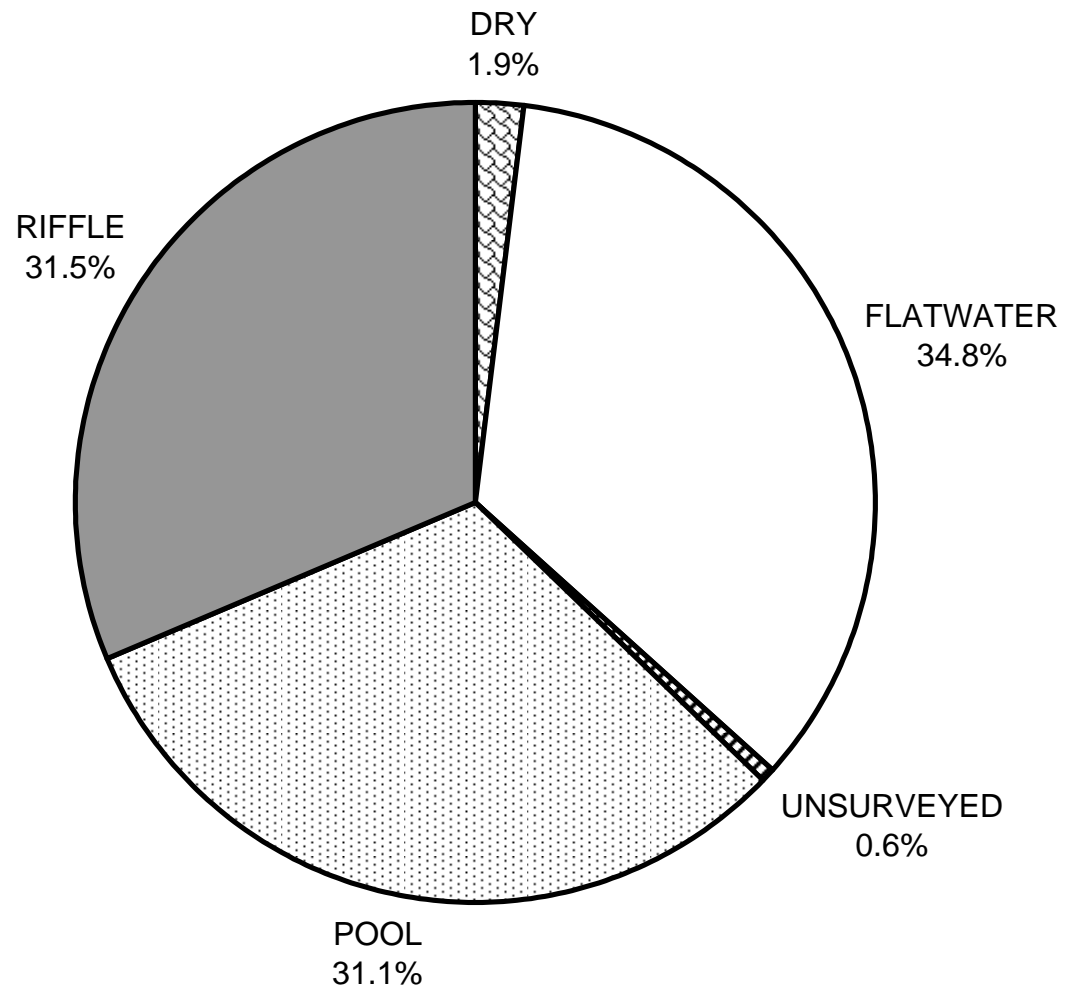
GRAPH 1

Table 1 summarizes the Level II riffle, flatwater, and pool habitat types. Based on frequency of occurrence there were 35% flatwater units, 32% riffle units, 31% pool units, and 2% dry units (Graph 1). Based on total length of Level II habitat types there were 52% flatwater units, 31% pool units, 15% riffle units, and 2% dry units (Graph 2).

MILL CREEK 2013 HABITAT TYPES BY PERCENT OCCURRENCE

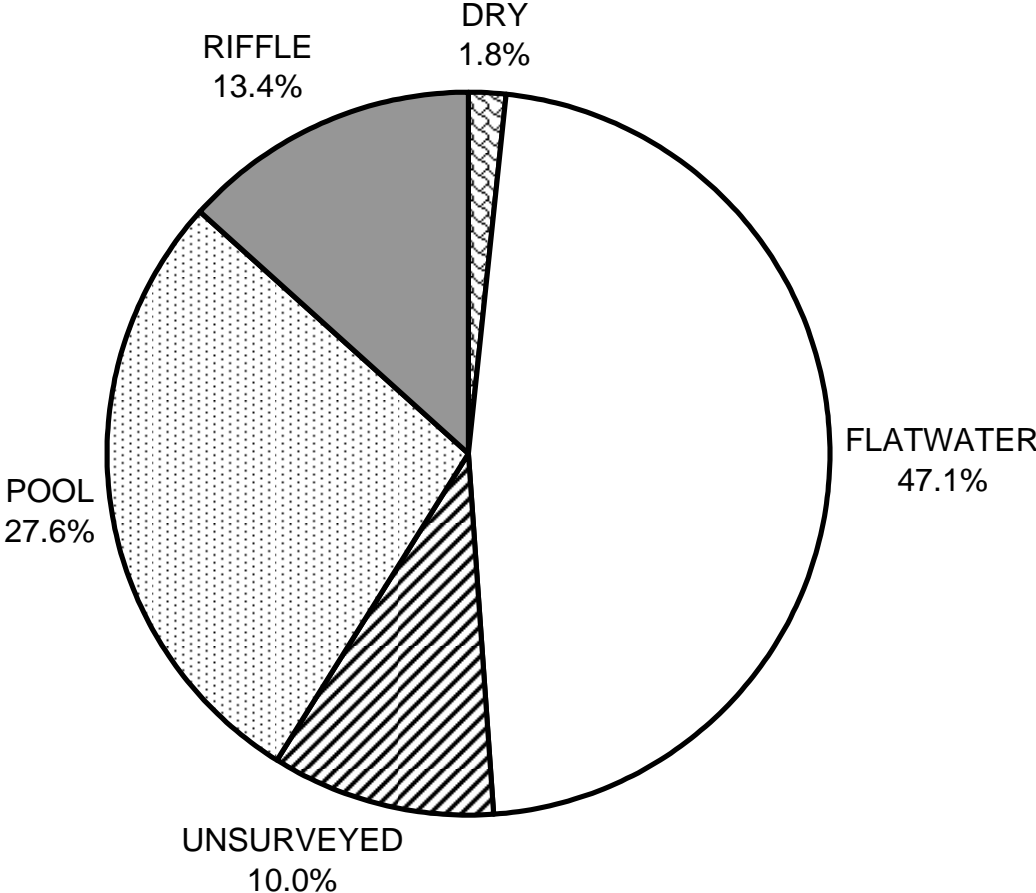
GRAPH 2

**MILL CREEK 2013
HABITAT TYPES BY PERCENT TOTAL LENGTH**

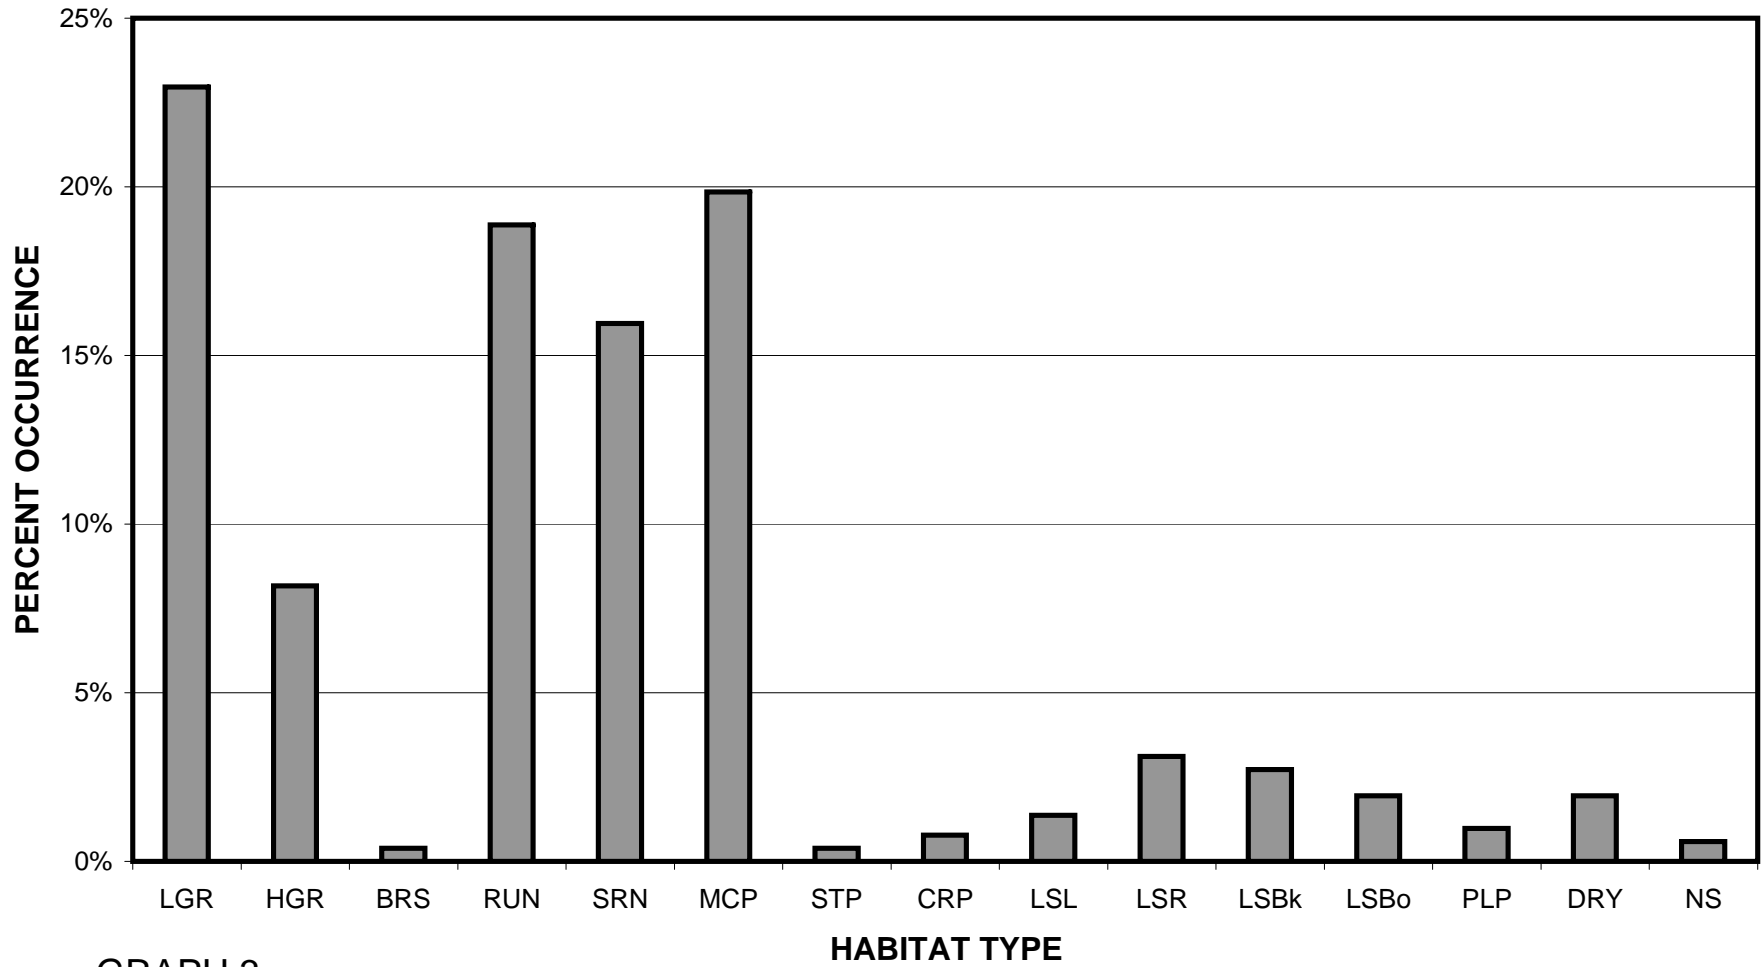
GRAPH 3

Fourteen Level IV habitat types were identified (Table 2). The most frequent habitat types by percent occurrence were low gradient riffle units, 23%; mid-channel pool units, 20%; and run units 19% (Graph 3). Based on percent total length, step run units made up 35%, mid-channel pool units 22%, and run units 17%.

HABITAT TYPES BY PERCENT OCCURRENCE

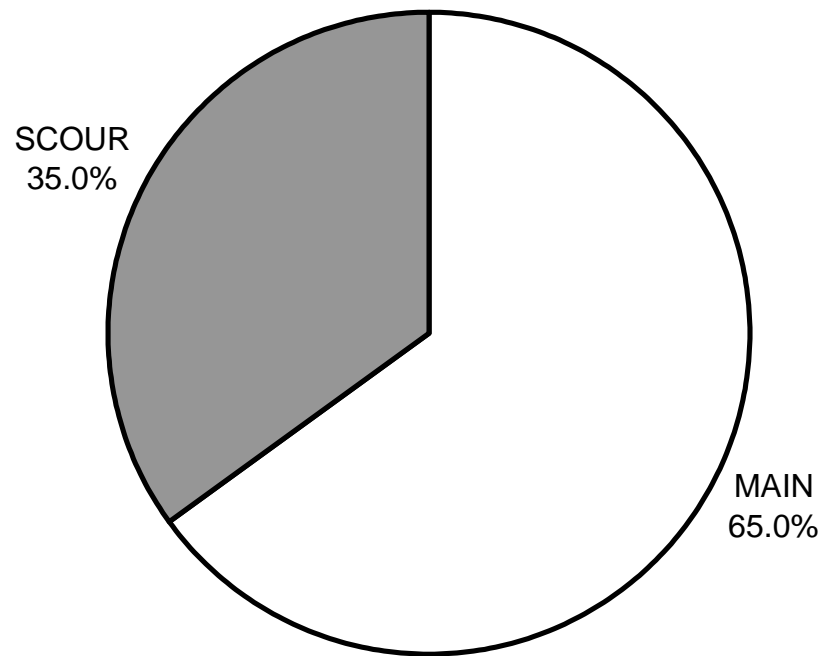
GRAPH 4

A total of 160 pools were identified (Table 3). Main channel pools were the most frequently encountered at 65% (Graph 4), and comprised 72% of the total length of all pools (Table 3).

**MILL CREEK 2013
POOL TYPES BY PERCENT OCCURRENCE**

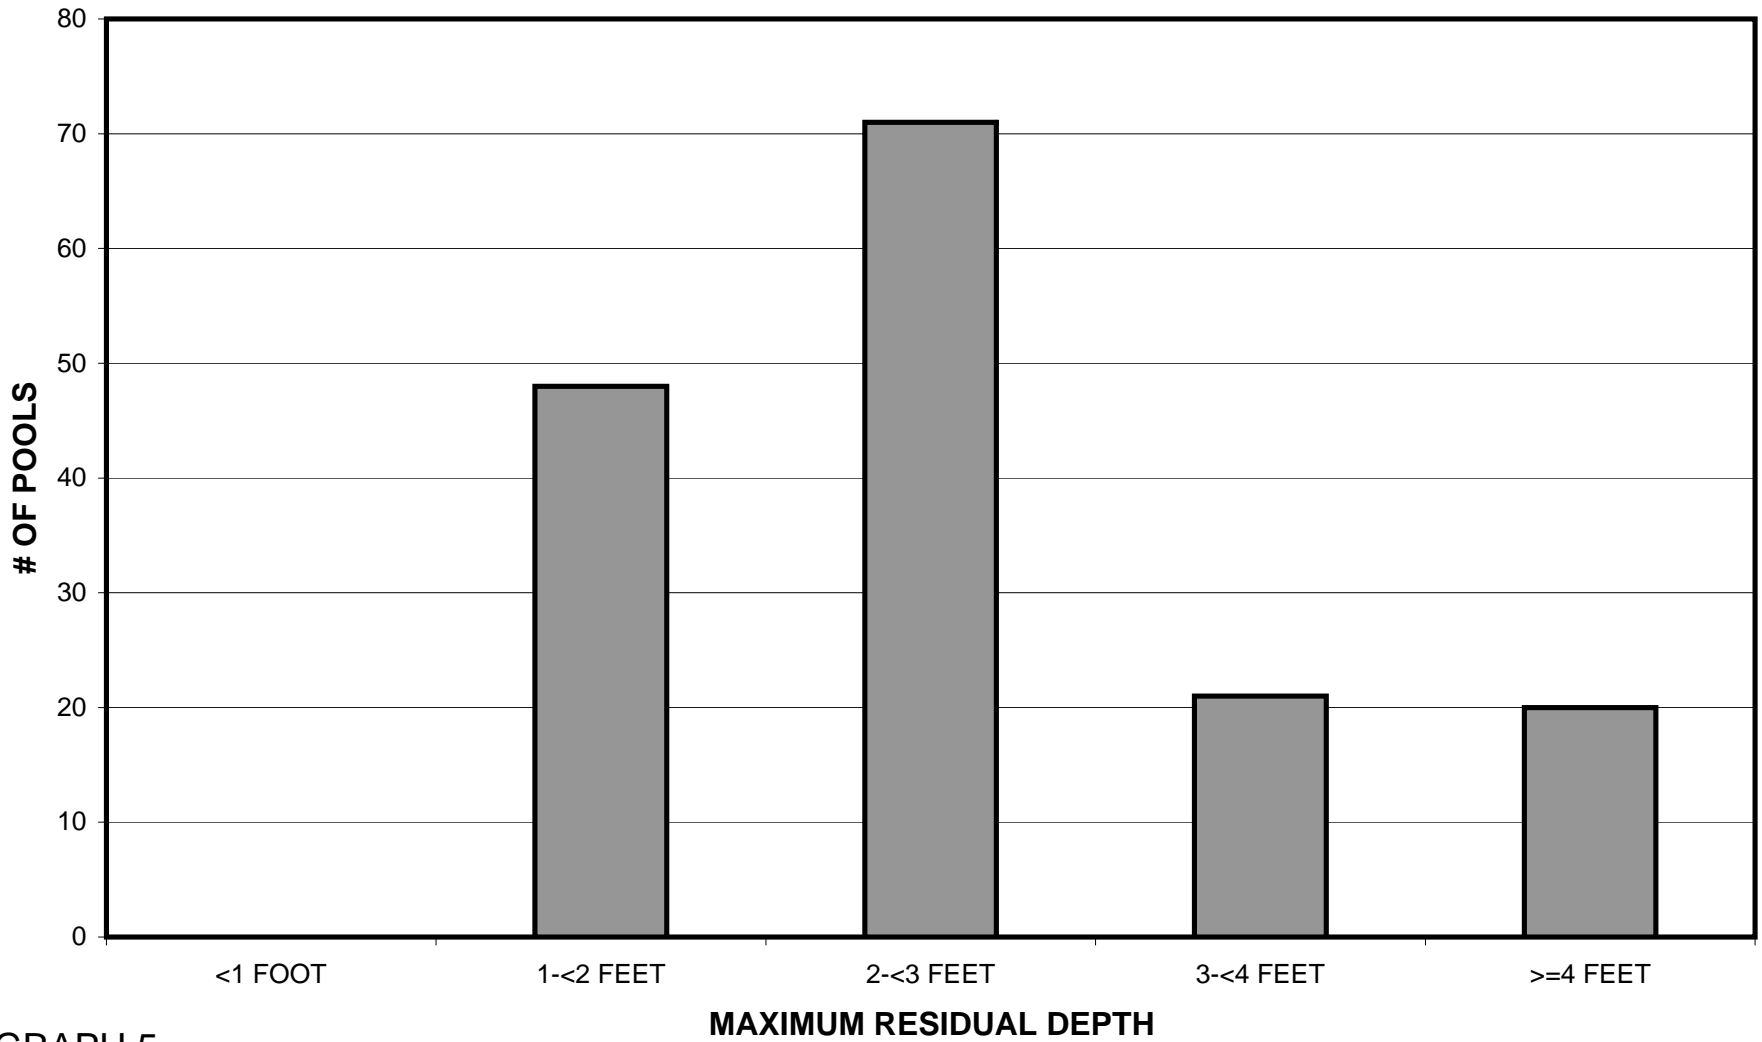
GRAPH 5

Table 4 is a summary of maximum residual pool depths by pool habitat types. Pool quality for salmonids increases with depth. One hundred twelve of the 160 pools (70%) had a residual depth of two feet or greater (Graph 5).

Flatwater habitat types comprised 52% of the total length of this survey, riffles 15%, and pools 31%. One hundred twelve of the 160 (70%) pools had a maximum residual depth greater than two feet. In general, pool enhancement projects are considered when primary pools comprise less than 40% of the length of total stream habitat. In first and second order streams, a primary pool is defined to have a maximum residual depth of at least two feet, occupy at least half the width of the low flow channel, and be as long as the low flow channel width. Installing structures that will increase or deepen pool habitat is recommended.

MILL CREEK 2013 MAXIMUM DEPTH IN POOLS

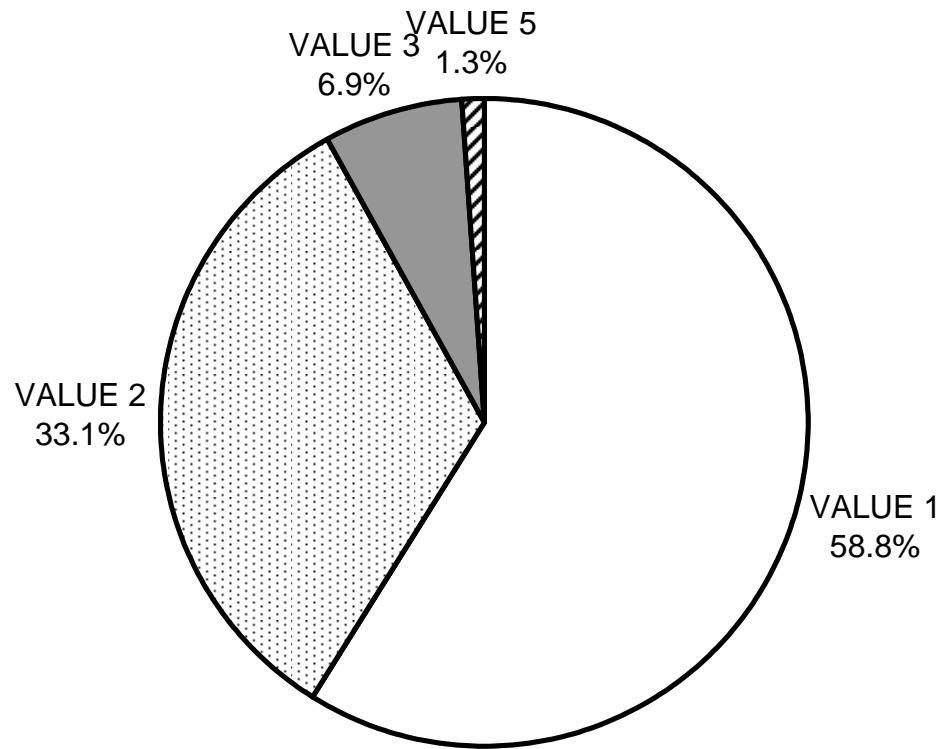
GRAPH 6

The depth of cobble embeddedness was estimated at pool tail-outs. Of the 160 pool tail-outs measured, 94 had a value of 1 (58.8%); 53 had a value of 2 (33.1%); 11 had a value of 3 (6.9%); and 2 had a value of 5 (1.2%) (Graph 6). On this scale, a value of 1 indicates the best spawning

conditions and a value of 4 the worst. Additionally, a value of 5 was assigned to tail-outs deemed not suitable for spawning due to inappropriate substrate such as bedrock, log sills, boulders, or other considerations.

One hundred forty-seven of the 160 pool tail-outs measured had embeddedness ratings of 1 or 2. Eleven of the pool tail-outs had embeddedness ratings of 3 or 4. Two of the pool tail-outs had a

rating of 5, which is considered unsuitable for spawning. Cobble embeddedness measured to be 25% or less, a rating of 1, is considered to indicate good quality spawning substrate for salmon and steelhead. Sediment sources in Mill Creek should be mapped and rated according to their potential sediment yields, and control measures should be taken.

MILL CREEK 2013 PERCENT EMBEDDEDNESS

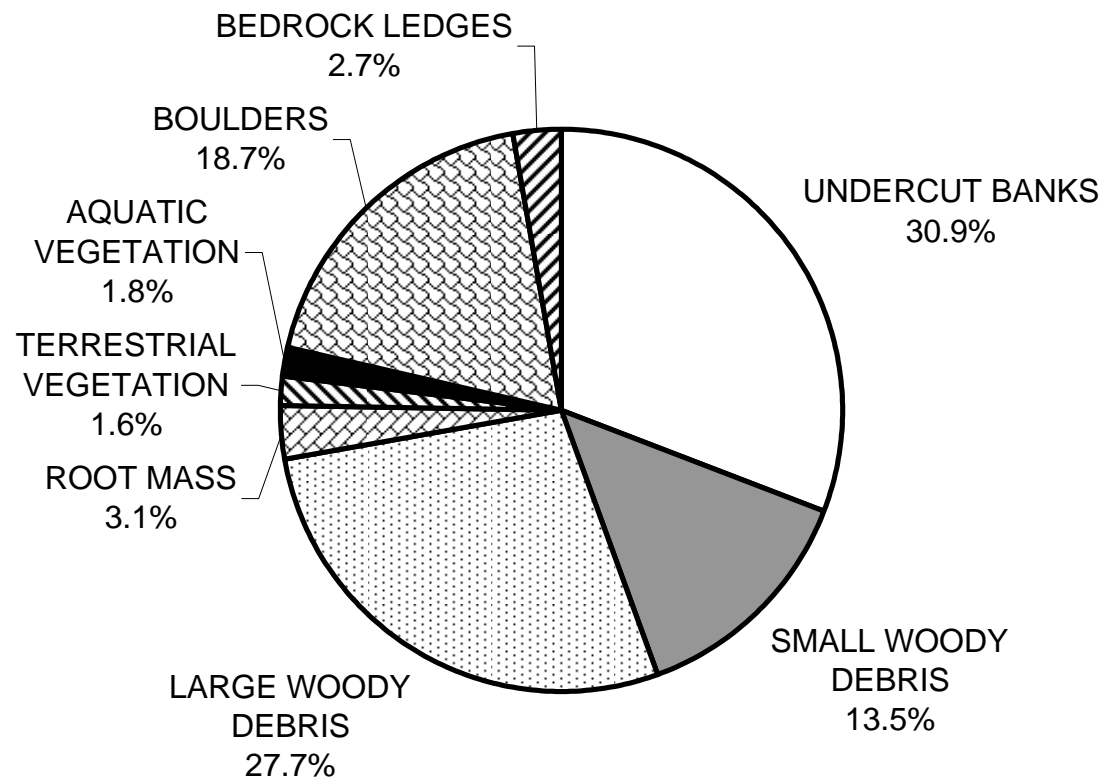
GRAPH 7

Table 5 summarizes mean percent cover by habitat type. Undercut banks are the dominant cover type in Mill Creek. Graph 7 describes the pool cover in Mill Creek. Undercut banks are the dominant pool cover type followed by large woody debris.

The mean shelter rating for pools is 8. The shelter rating in the flatwater habitats is 1. A pool shelter rating of approximately 100 is desirable. The amount of cover that now exists is being provided primarily by undercut banks in Mill Creek. Undercut banks are the dominant cover type in pools followed by large woody debris. Log and root wad cover structures in the pool and flatwater habitats would enhance both summer and winter salmonid habitat. Log cover structures provide rearing fry with protection from predation, rest from water velocity, and also divide territorial units to reduce density related competition.

MILL CREEK 2013 MEAN PERCENT COVER TYPES IN POOLS

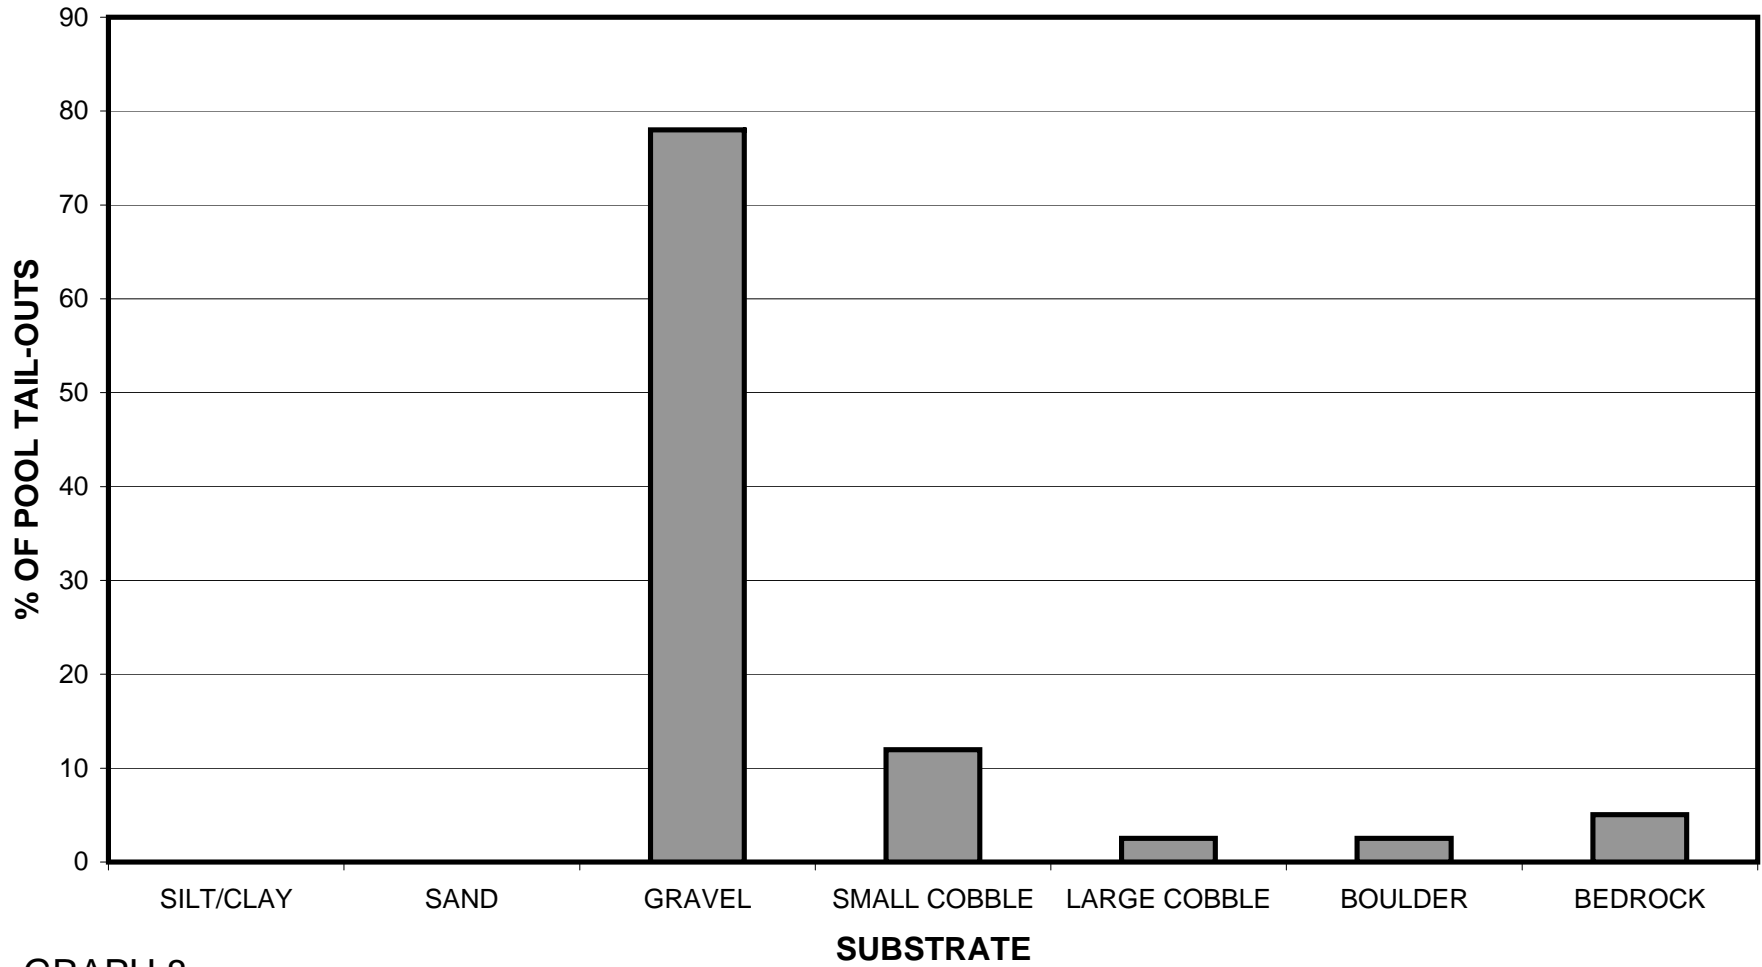
GRAPH 8

Table 6 summarizes the dominant substrate by habitat type. Graph 8 depicts the dominant substrate observed in pool tail-outs. Gravel was the dominant substrate observed in 78% of the pool tail-outs. Small cobble was the next most frequently observed dominant substrate type and occurred in 12% of the pool tail-outs.

One hundred forty-four of the 160 pool tail-outs measured had gravel or small cobble as the dominant substrate. This is generally considered good for spawning salmonids.

MILL CREEK 2013 SUBSTRATE COMPOSITION IN POOL TAIL-OUTS

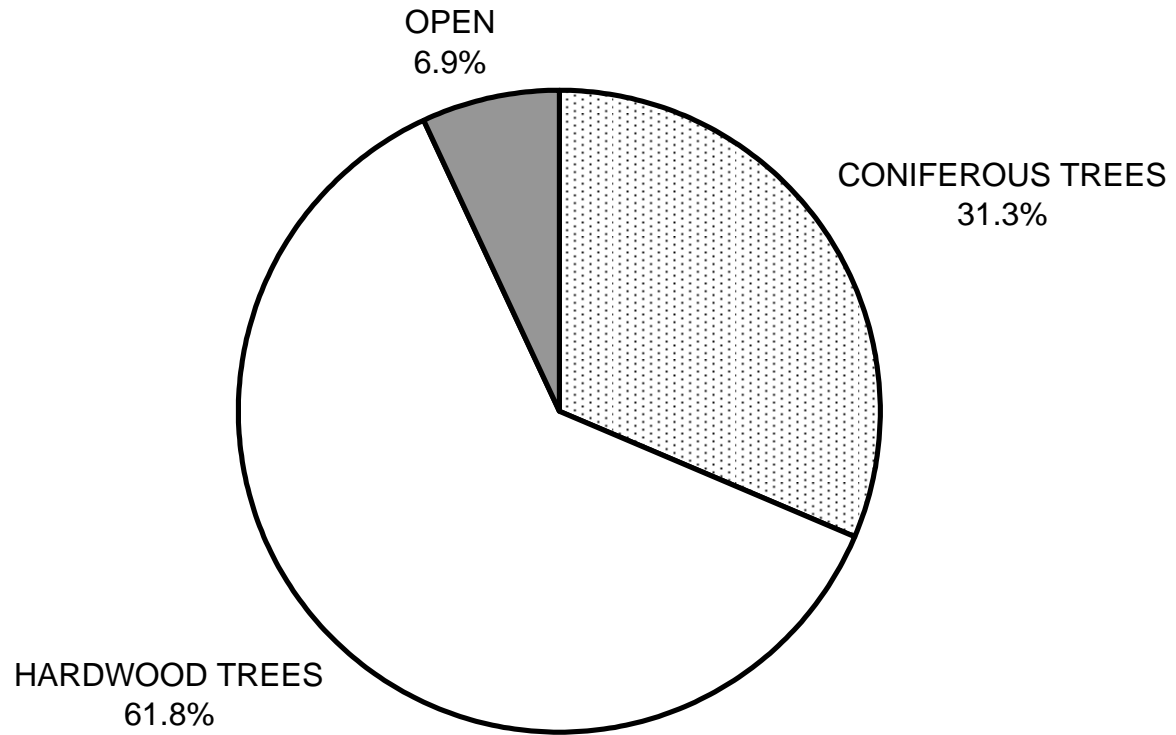
GRAPH 9

The mean percent canopy density for the surveyed length of Mill Creek was 93%. Seven percent of the canopy was open. Of the canopy present, the mean percentages of hardwood and coniferous trees were 66% and 34%, respectively. Graph 9 describes the mean percent canopy in Mill Creek.

The mean percent canopy density for the stream was 93%. Reach 1 had a canopy density of 93%, Reach 2 had a canopy density of 94%. The percentage of right and left bank covered with vegetation was 97% and 96%, respectively.

MILL CREEK 2013 MEAN PERCENT CANOPY

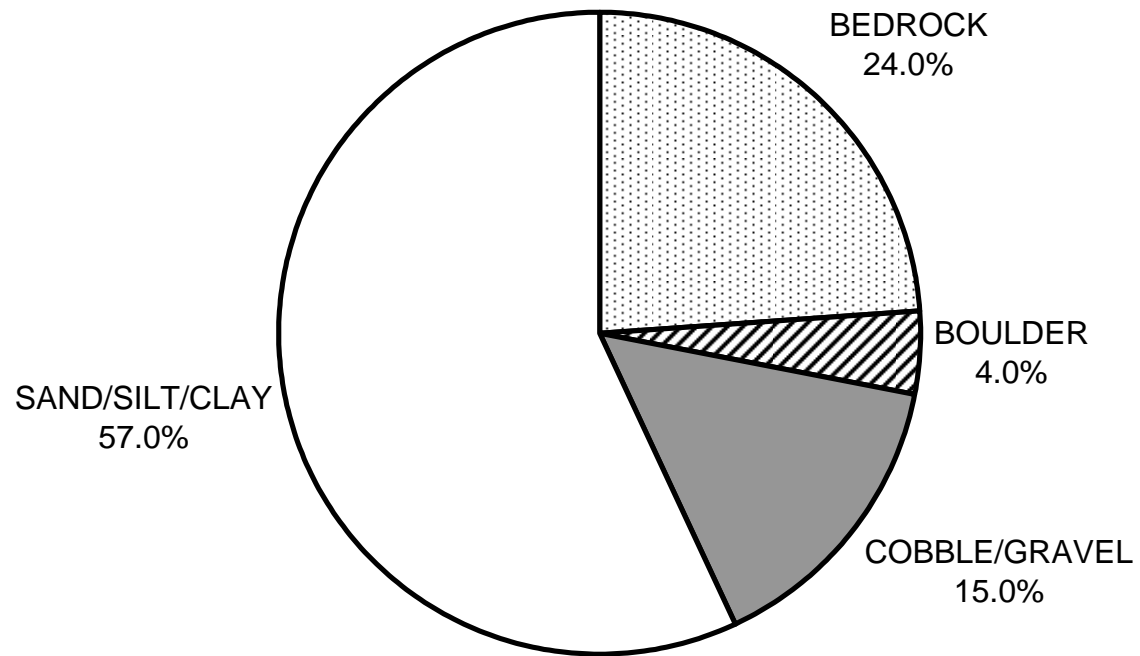
GRAPH 10

For the stream reach surveyed, the mean percent right bank vegetated was 97%. The mean percent left bank vegetated was 96%. The dominant elements composing the structure of the stream banks consisted of 57% sand/silt/clay, 24% bedrock, 15% cobble/gravel, and 4% boulder (Graph 10). Hardwood trees were the dominant vegetation type observed in 54% of the units surveyed. Additionally, 29% of the units surveyed had coniferous trees as the dominant vegetation type, and 14% had brush as the dominant vegetation type (Graph 11).

**MILL CREEK 2013
DOMINANT BANK COMPOSITION IN SURVEY REACH**

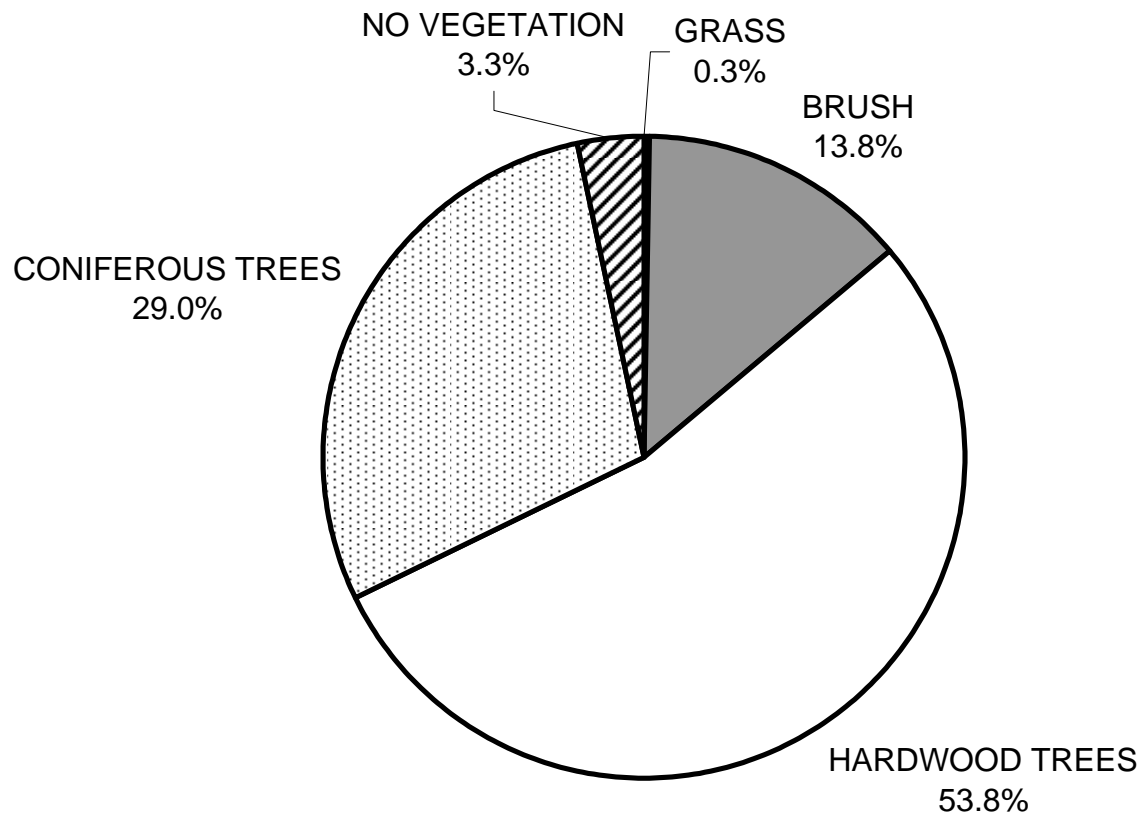
GRAPH 11

MILL CREEK 2013 DOMINANT BANK VEGETATION IN SURVEY REACH
