STREAM INVENTORY REPORT

North Branch North Fork Navarro River

A stream inventory was conducted from July 17 to July 23, 2012 on North Branch North Fork Navarro River. The survey began at the confluence with North Fork Navarro River and extended upstream 4.6 miles.

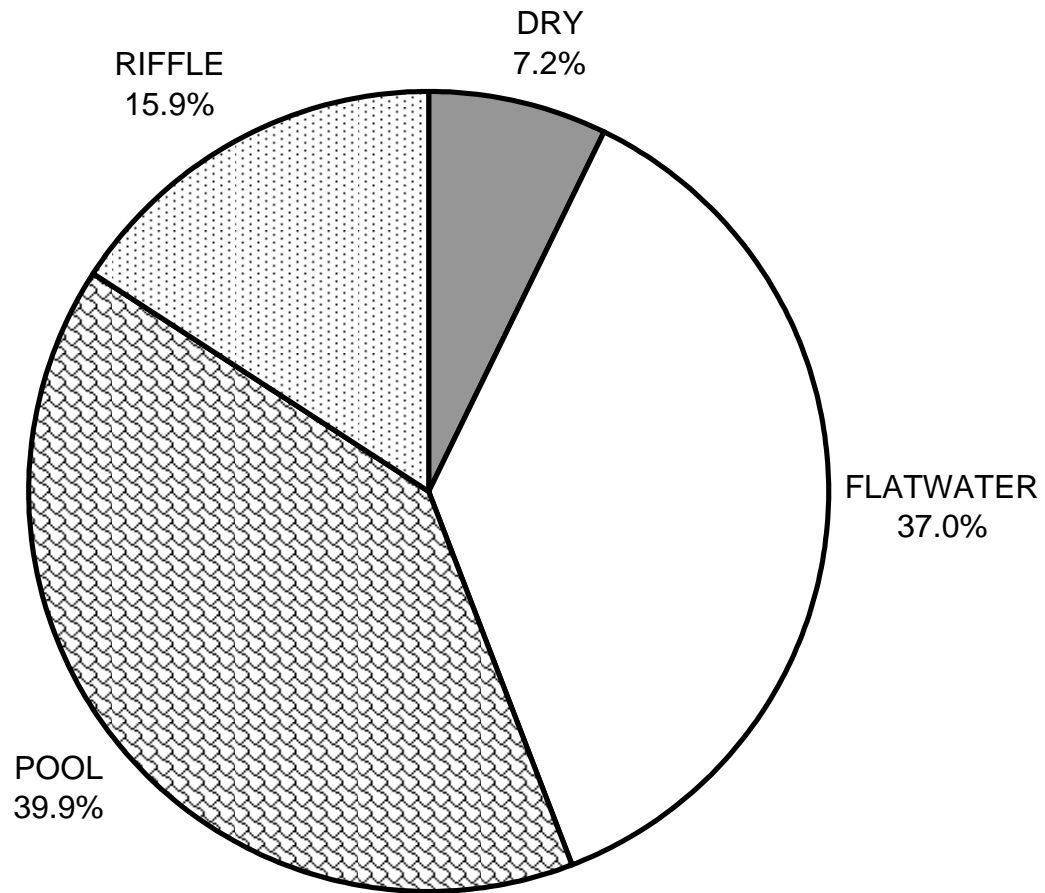
GRAPH 1

Table 1 summarizes the Level II riffle, flatwater, and pool habitat types. Based on frequency of occurrence there were 40% pool units, 37% flatwater units, 16% riffle units, and 7% dry units (Graph 1). Based on total length of Level II habitat types there were 42% pool units, 40% flatwater units, 13% dry units, and 5% riffle units (Graph 2).

NORTH BRANCH NORTH FORK NAVARRO RIVER 2012 HABITAT TYPES BY PERCENT OCCURRENCE

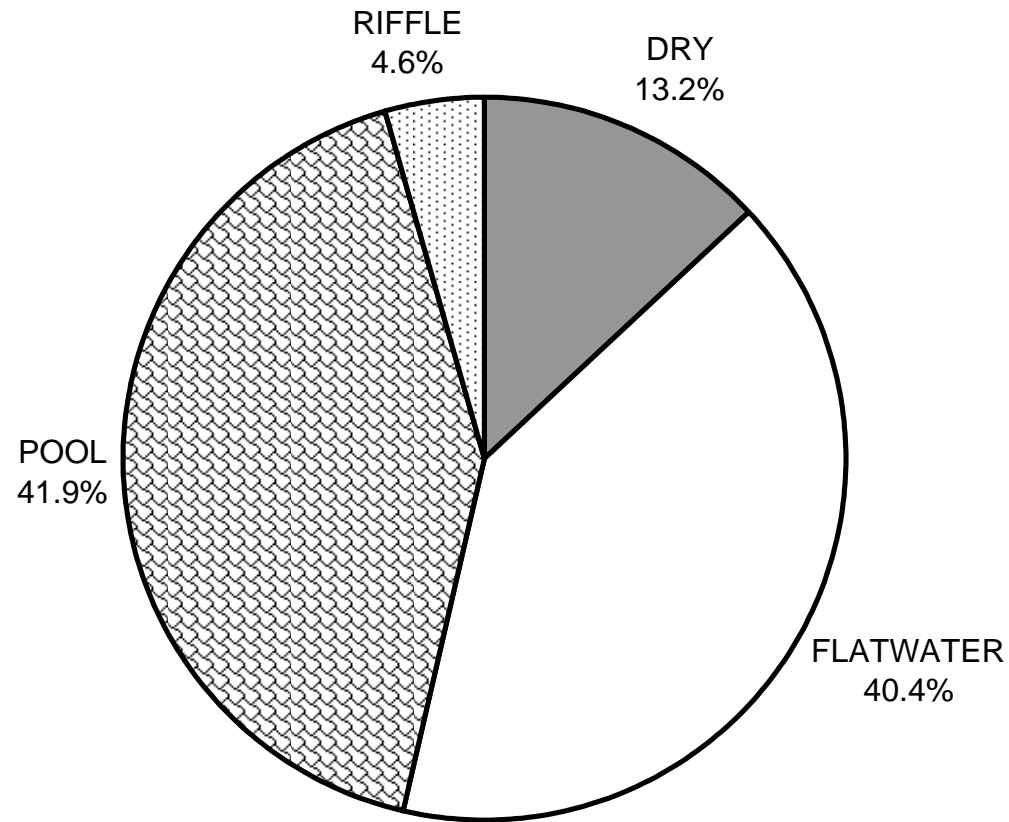
GRAPH 2

NORTH BRANCH NORTH FORK NAVARRO RIVER 2012 HABITAT TYPES BY PERCENT TOTAL LENGTH

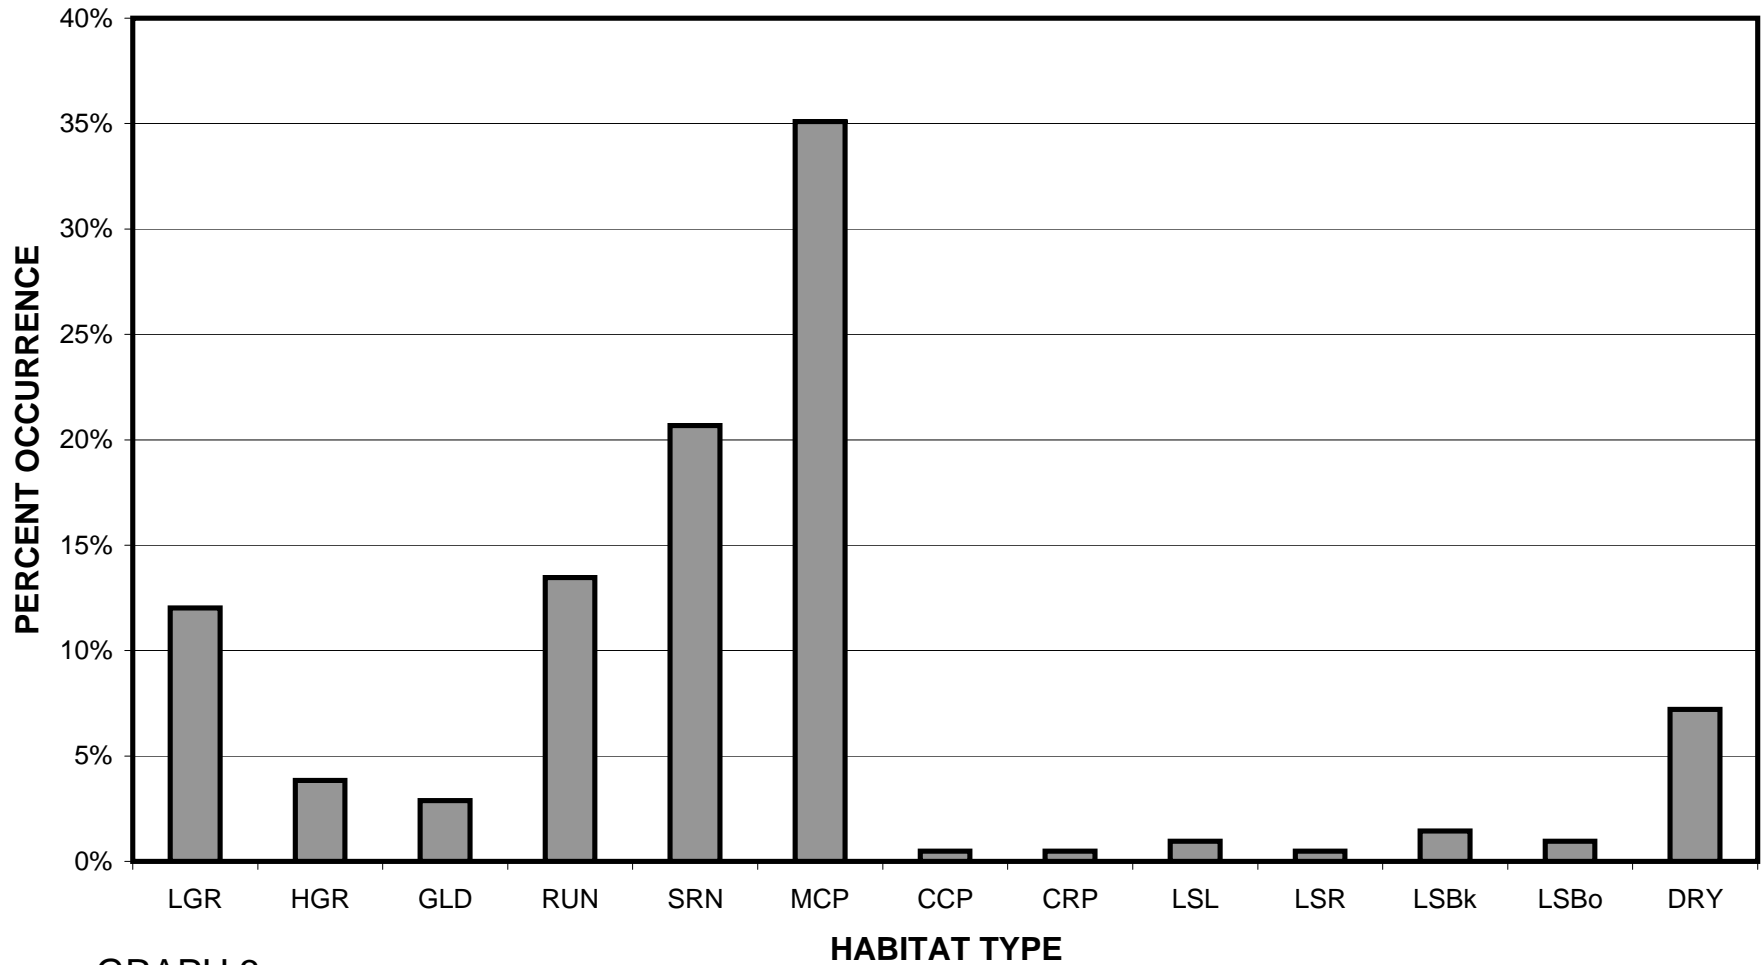
GRAPH 3

Thirteen Level IV habitat types were identified (Table 2). The most frequent habitat types by percent occurrence were mid-channel pool units, 35%; step run units, 21%; and run units, 14% (Graph 3). Based on percent total length, mid-channel pool units made up 39%, step run units 29%, and dry units 13%.

NORTH BRANCH NORTH FORK NAVARRO RIVER 2012 HABITAT TYPES BY PERCENT OCCURRENCE

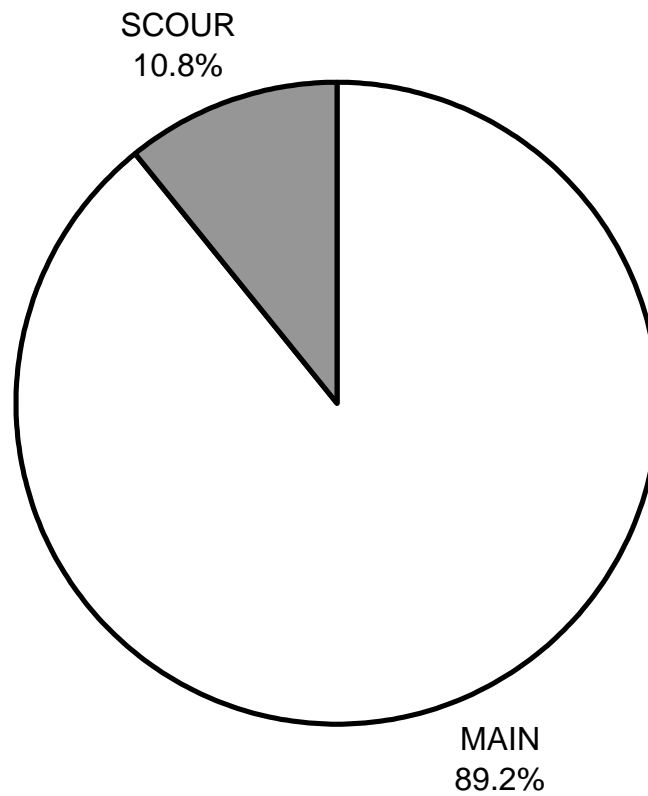
GRAPH 4

A total of 83 pools were identified (Table 3). Main channel pools were the most frequently encountered at 89% (Graph 4), and comprised 93% of the total length of all pools (Table 3).

**NORTH BRANCH NORTH FORK NAVARRO RIVER 2012
POOL TYPES BY PERCENT OCCURRENCE**

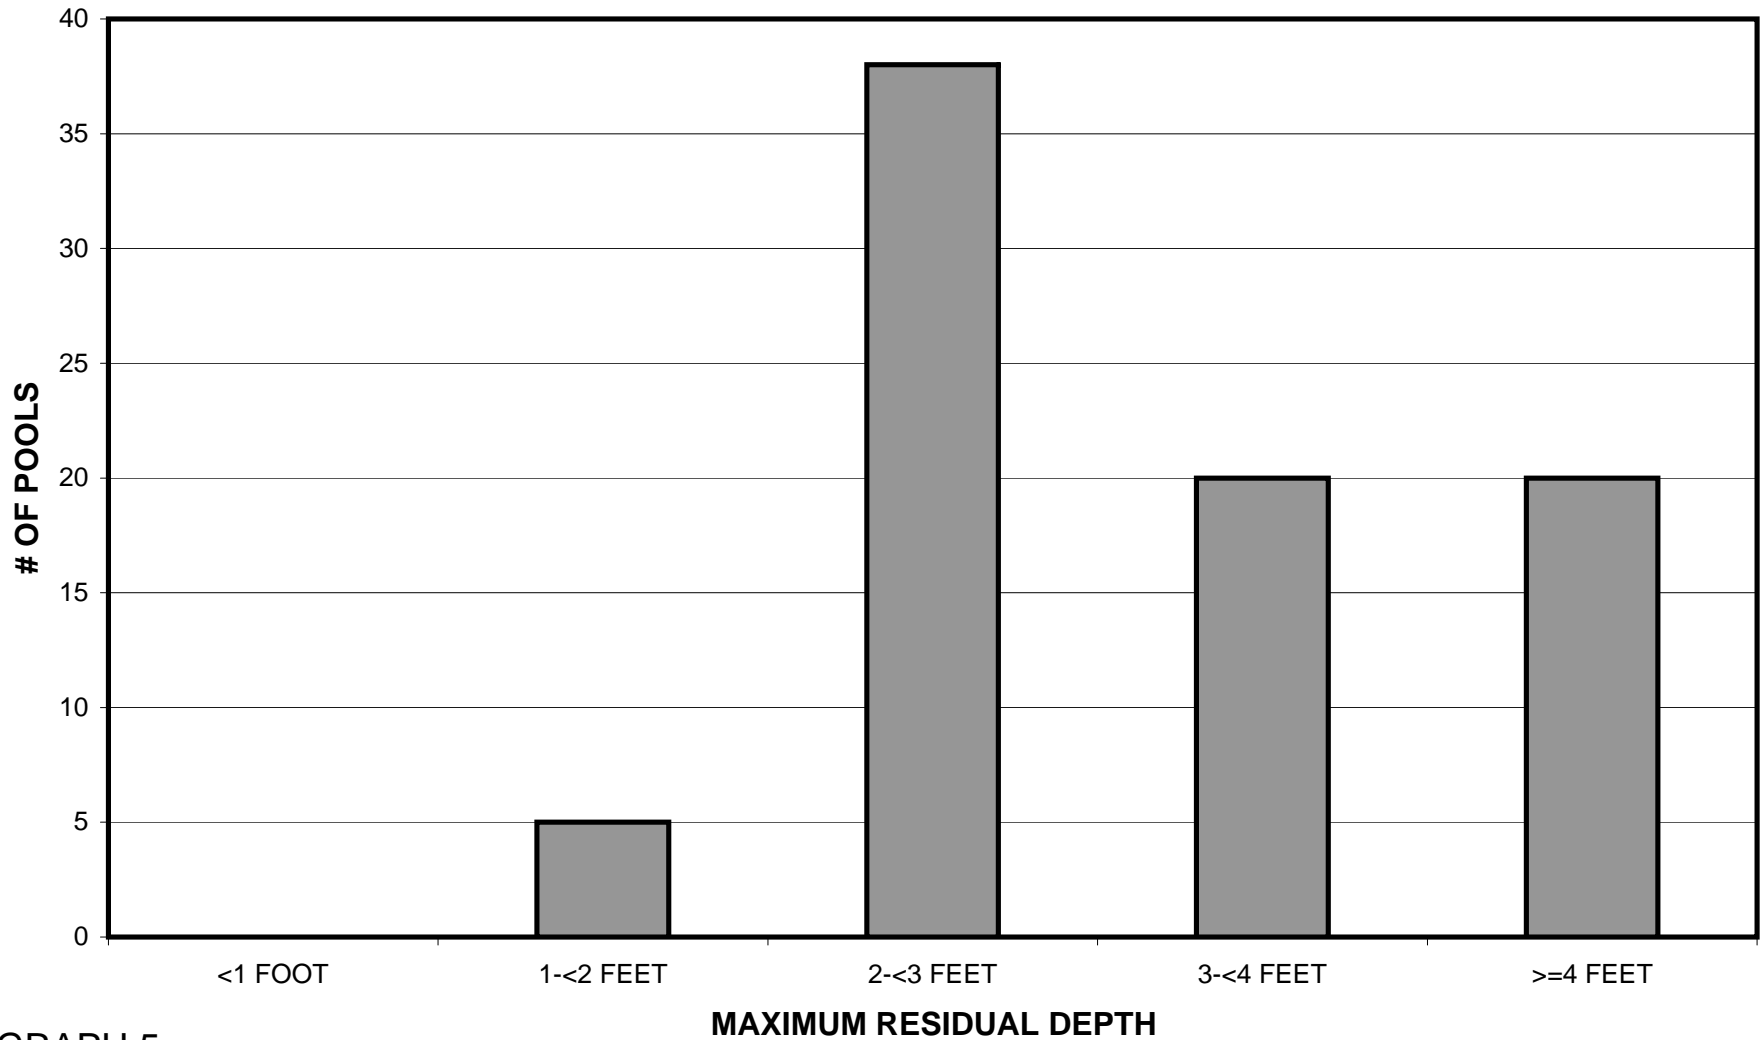
GRAPH 5

Table 4 is a summary of maximum residual pool depths by pool habitat types. Pool quality for salmonids increases with depth. Forty of the 83 pools (48%) had a residual depth of three feet or greater (Graph 5).

NORTH BRANCH NORTH FORK NAVARRO RIVER 2012 MAXIMUM DEPTH IN POOLS

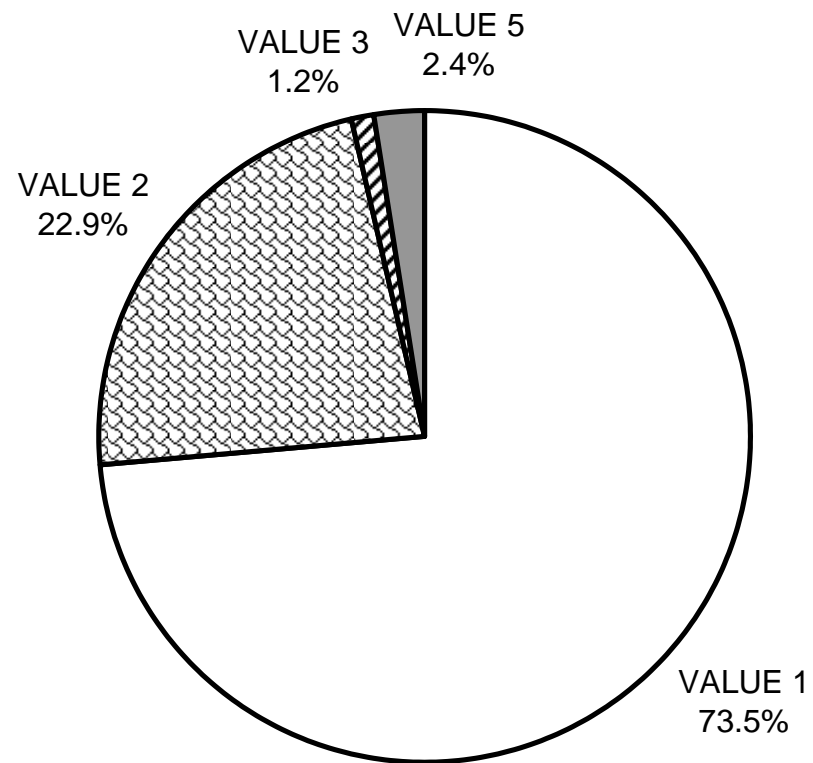
GRAPH 6

The depth of cobble embeddedness was estimated at pool tail-outs. Of the 83 pool tail-outs measured, 61 had a value of 1 (73.5%); 19 had a value of 2 (22.9%); one had a value of 3 (1.2%); two had a value of 5 (2.4%) (Graph 6). On this scale, a value of 1 indicates the best spawning conditions and a value of 4 the worst. Additionally, a value of 5 was assigned to tail-outs deemed not suitable for spawning due to inappropriate substrate such as bedrock, log sills, boulders, or other considerations.

NORTH BRANCH NORTH FORK NAVARRO RIVER 2012 PERCENT EMBEDDEDNESS

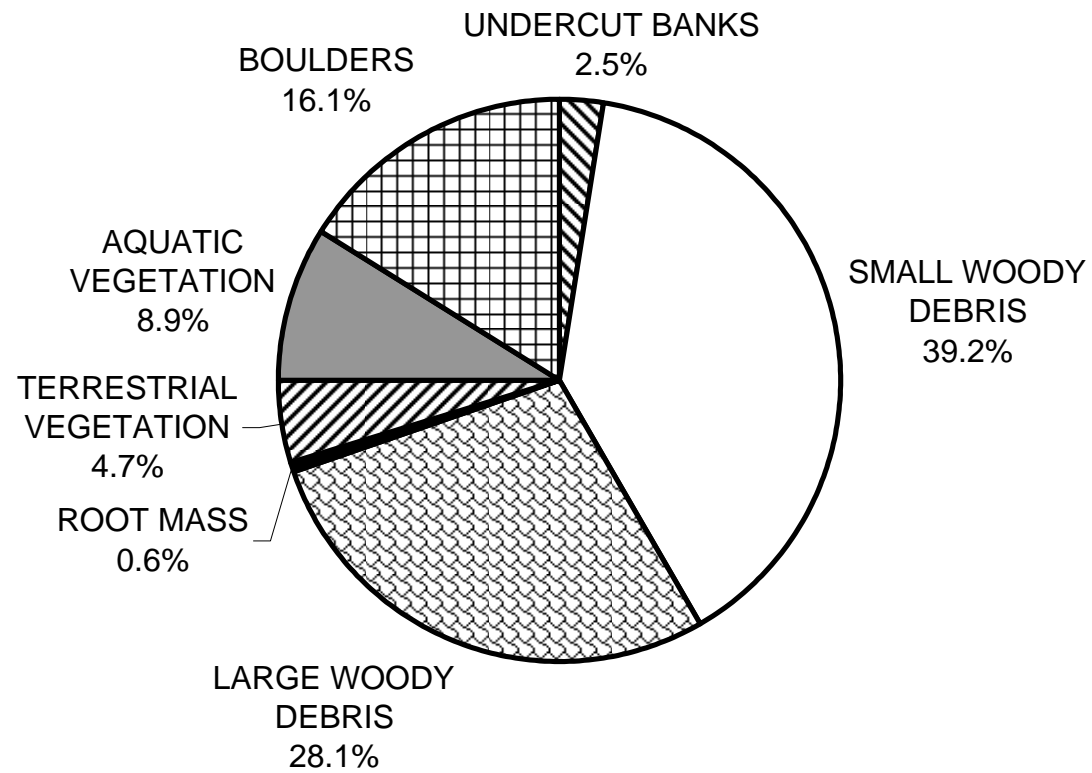
GRAPH 7

Table 5 summarizes mean percent cover by habitat type. Small woody debris is the dominant cover type in North Branch North Fork Navarro River. Graph 7 describes the pool cover in North Branch North Fork Navarro River. Small woody debris is the dominant pool cover type followed by large woody debris.

NORTH BRANCH NORTH FORK NAVARRO RIVER 2012 MEAN PERCENT COVER TYPES IN POOLS

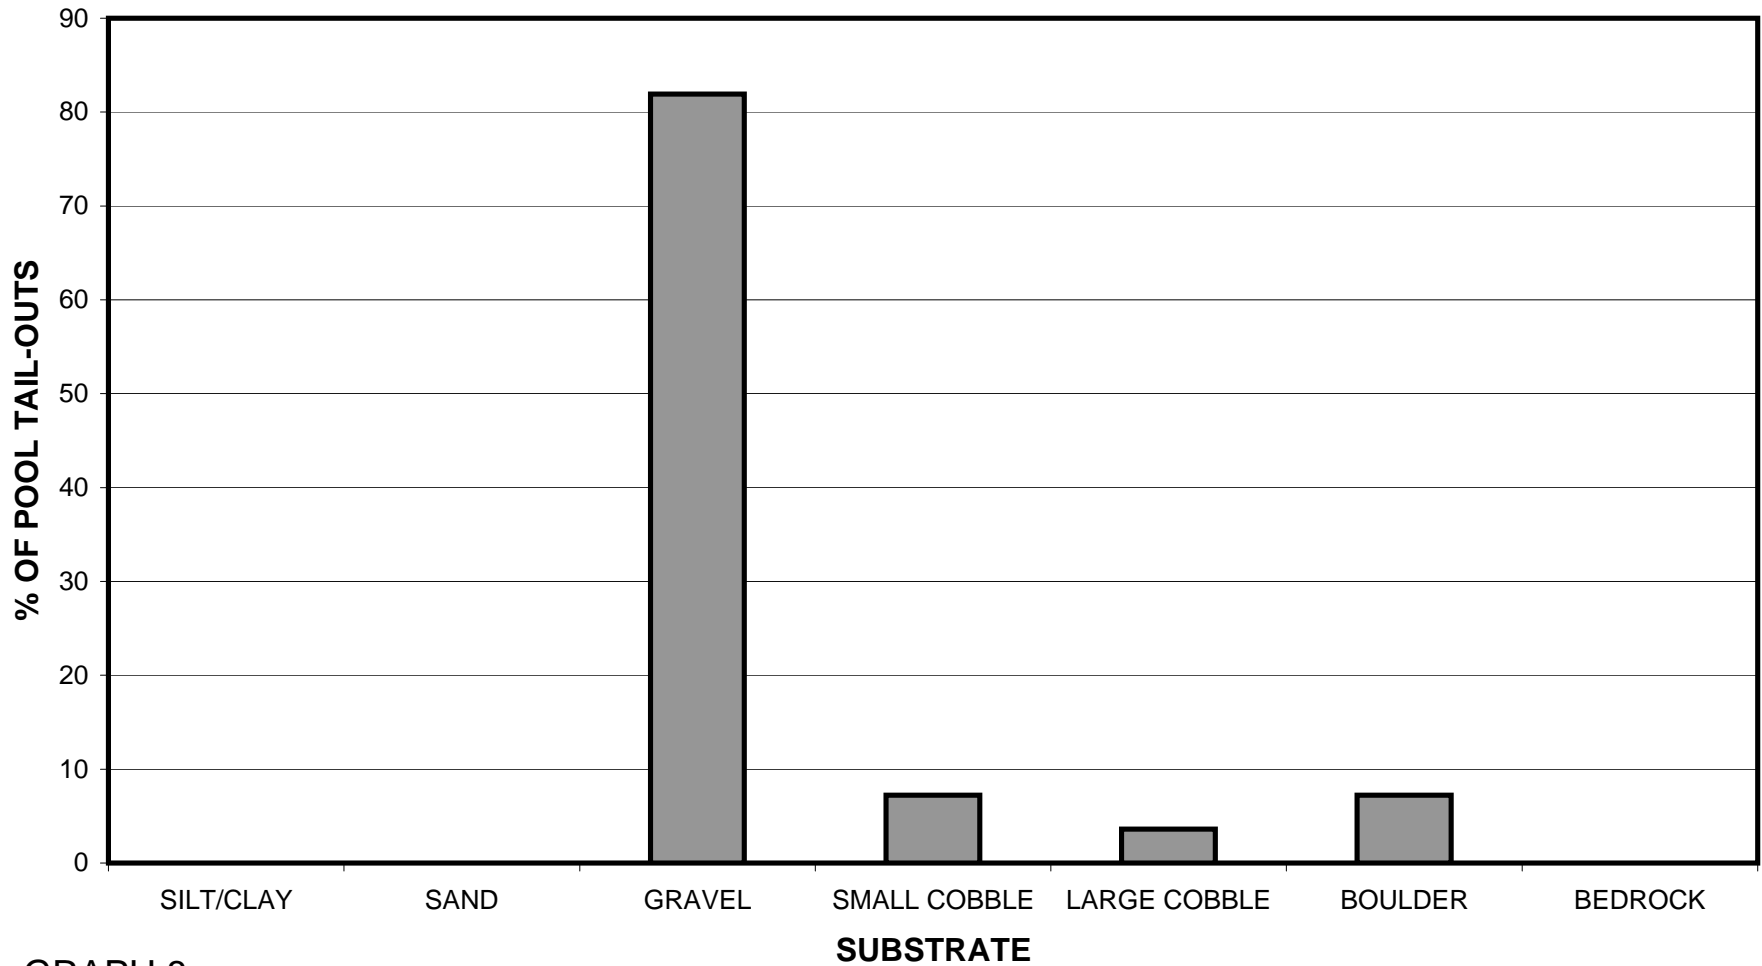
GRAPH 8

Table 6 summarizes the dominant substrate by habitat type. Graph 8 depicts the dominant substrate observed in pool tail-outs. Gravel was the dominant substrate observed in 82% of the pool tail-outs. Small cobble and boulders were the next most frequently observed dominant substrate types; each occurring in 7% of the pool tail-outs.

NORTH BRANCH NORTH FORK NAVARRO RIVER 2012 SUBSTRATE COMPOSITION IN POOL TAIL-OUTS

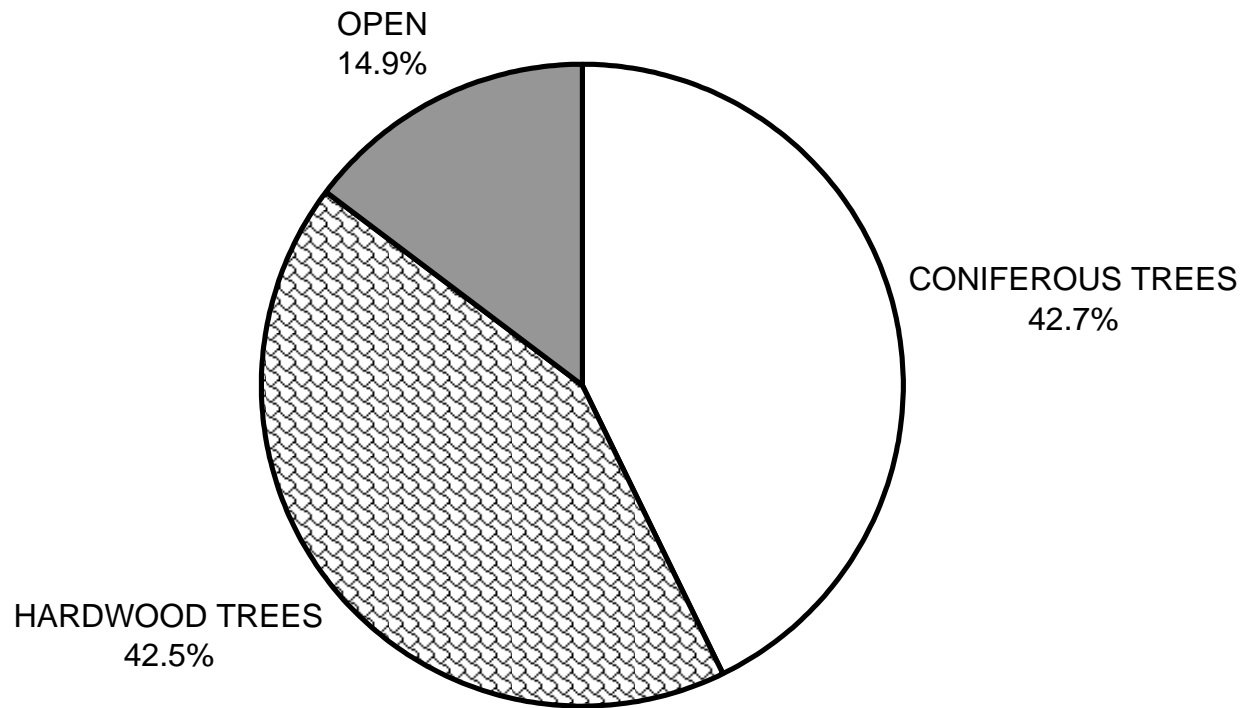
GRAPH 9

The mean percent canopy density for the surveyed length of North Branch North Fork Navarro River was 85%. Fifteen percent of the canopy was open. Of the canopy present, the mean percentages of hardwood and coniferous trees were 50% and 50%, respectively. Graph 9 describes the mean percent canopy in North Branch North Fork Navarro River.

**NORTH BRANCH NORTH FORK NAVARRO RIVER 2012
MEAN PERCENT CANOPY**

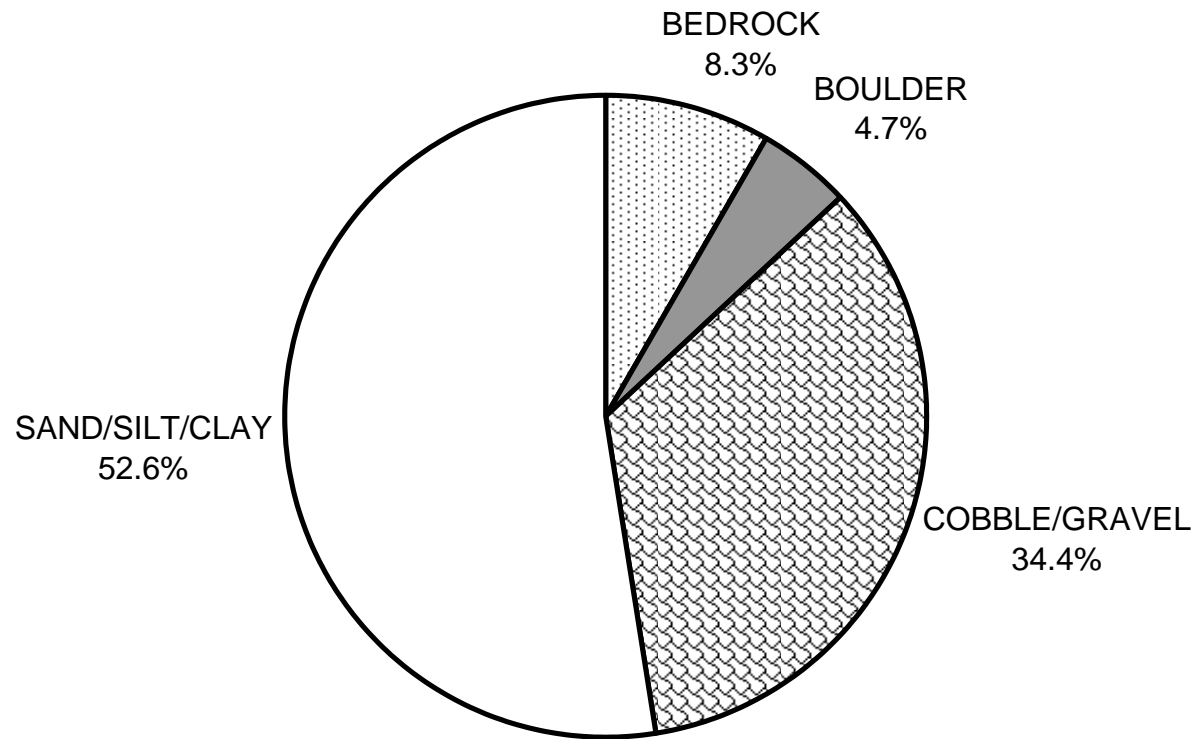
GRAPH 10

For the stream reach surveyed, the mean percent right bank vegetated was 99%. The mean percent left bank vegetated was 100%. The dominant elements composing the structure of the stream banks consisted of 53% sand/silt/clay, 34% cobble/gravel, 8% bedrock, and 5% boulder (Graph 10). Coniferous trees were the dominant vegetation type observed in 57% of the units surveyed. Additionally, 41% of the units surveyed had deciduous trees as the dominant vegetation type, and 1% had no vegetation (Graph 11).

NORTH BRANCH NORTH FORK NAVARRO RIVER 2012 DOMINANT BANK COMPOSITION IN SURVEY REACH

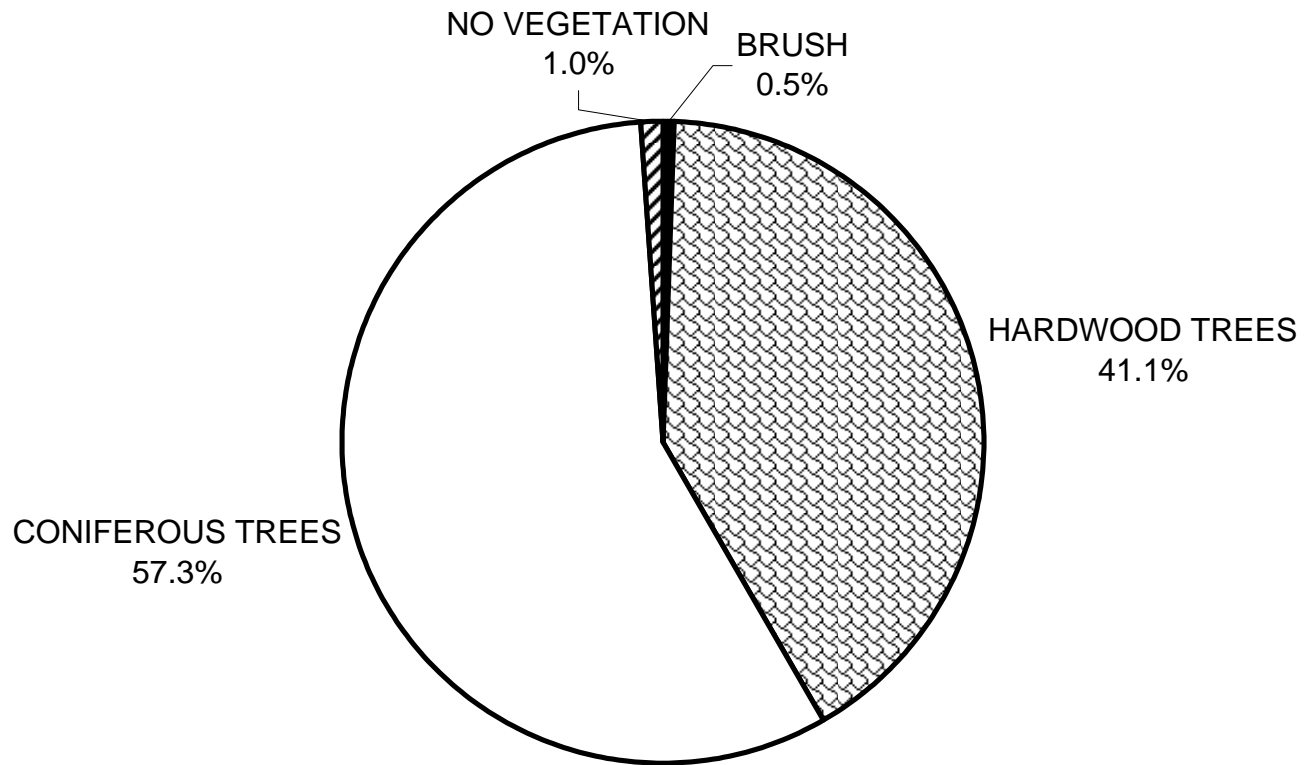
GRAPH 11

NORTH BRANCH NORTH FORK NAVARRO RIVER 2012 DOMINANT BANK VEGETATION IN SURVEY REACH
