# STREAM INVENTORY REPORT

## Rose Creek

A stream inventory was conducted from May 9 to May 30, 2012 on Rose Creek. The survey began at the confluence with South Branch North Fork Navarro River and extended upstream 1.1 miles. A stream inventory and report was also completed for one tributary to Rose Creek.

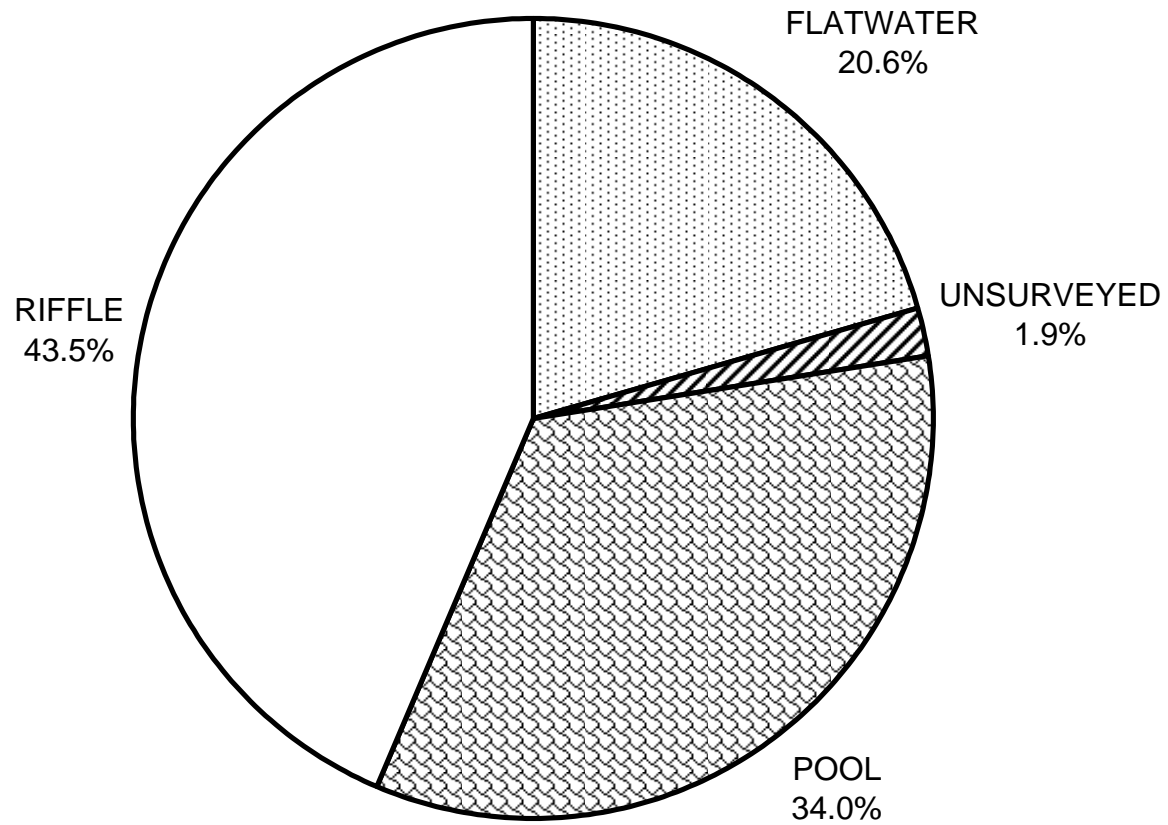
GRAPH 1

Table 1 summarizes the Level II riffle, flatwater, and pool habitat types. Based on frequency of occurrence there were 44% riffle units, 34% pool units, 21% flatwater units, and 2% unsurveyed units (Graph 1). Based on total length of Level II habitat types there were 59% riffle units, 22% flatwater units, 18% pool units, and 1% unsurveyed units (Graph 2).

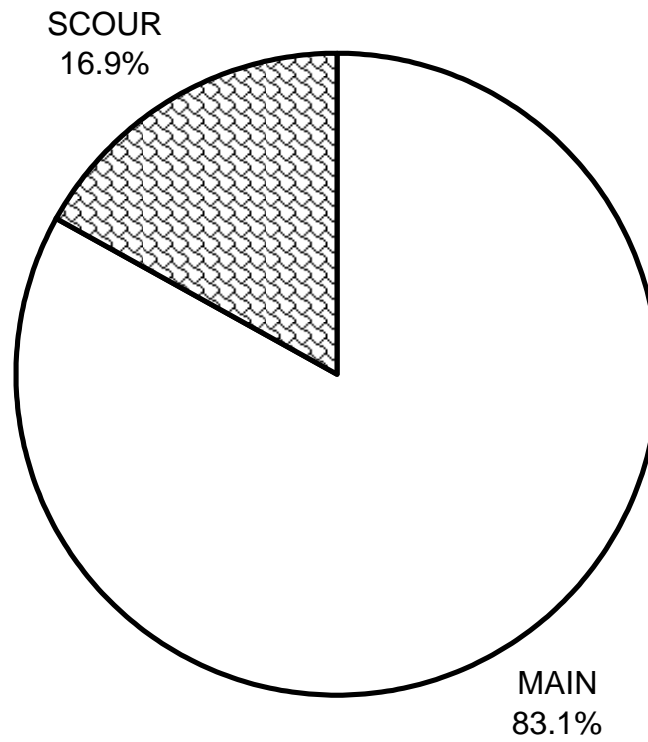
GRAPH 4

A total of 71 pools were identified (Table 3). Main channel pools were the most frequently encountered at 83% (Graph 4), and comprised 85% of the total length of all pools (Table 3).

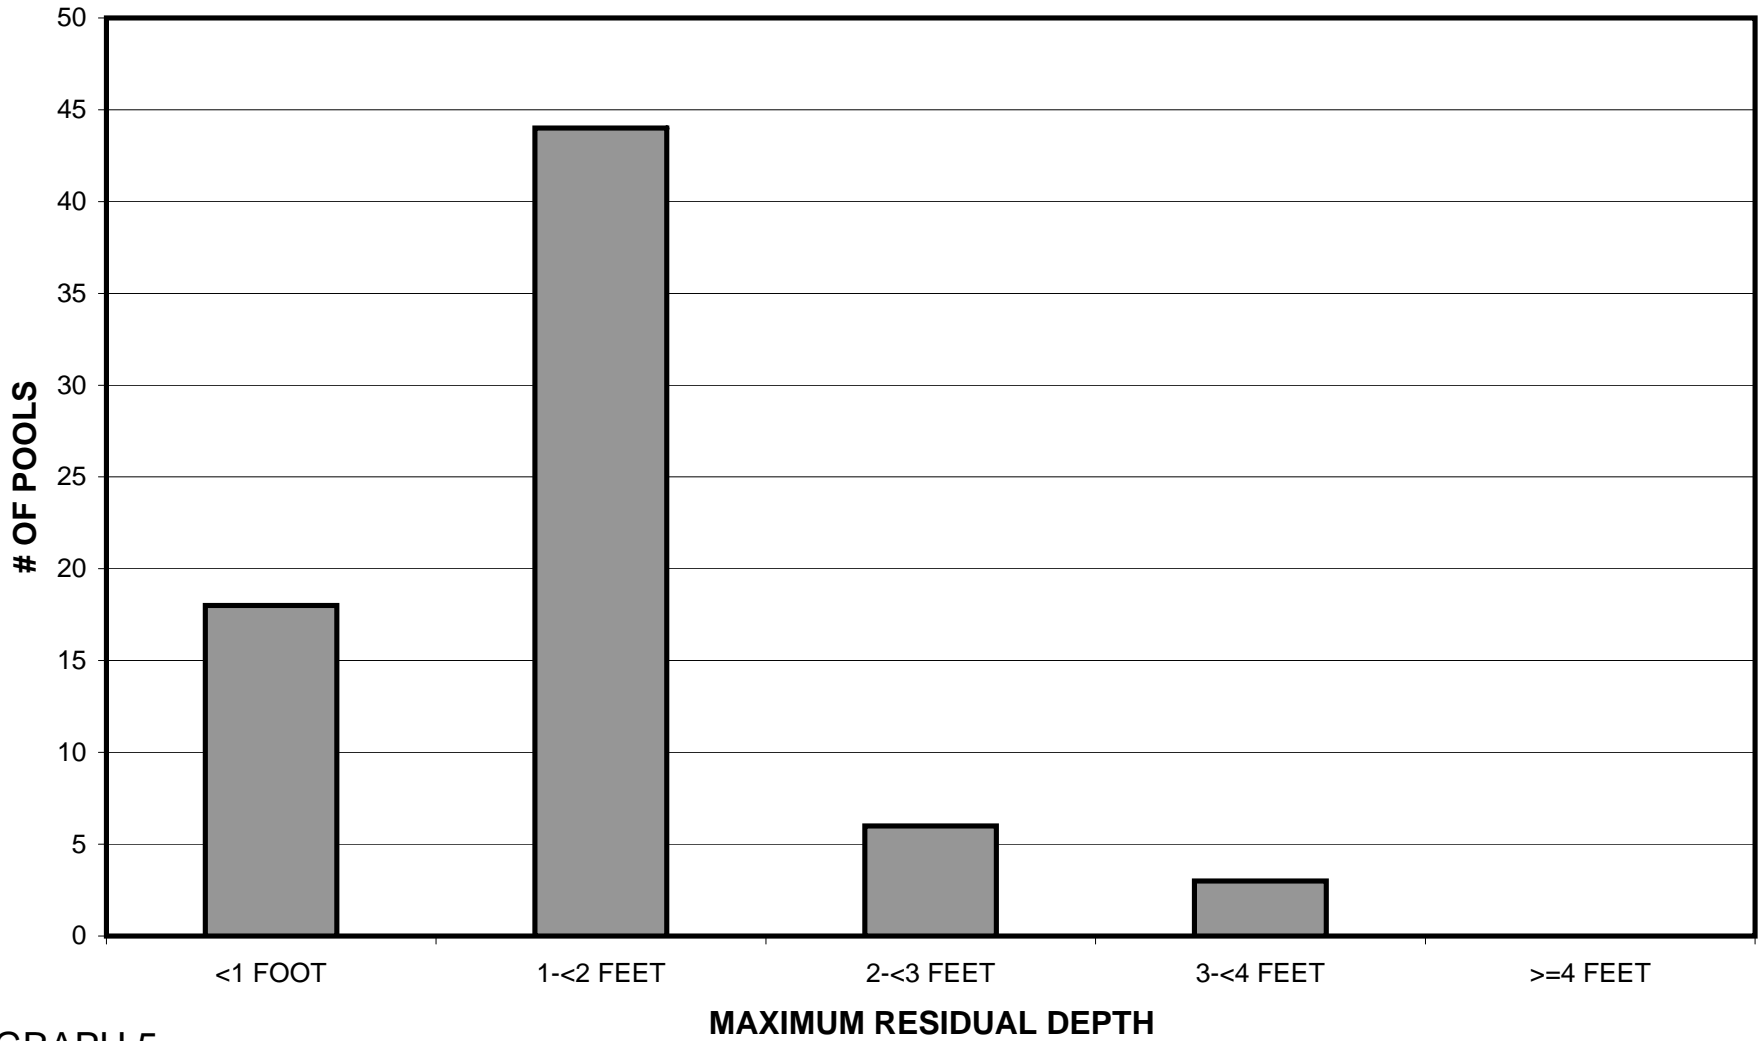
GRAPH 5

Table 4 is a summary of maximum residual pool depths by pool habitat types. Pool quality for salmonids increases with depth. Nine of the 71 pools (13%) had a residual depth of two feet or greater (Graph 5).

Flatwater habitat types comprised 22% of the total length of this survey, riffles 59%, and pools 18%. Nine of the 71 (13%) pools had a maximum residual depth greater than 2 feet. In general, pool enhancement projects are considered when primary pools comprise less than 40% of the length of total stream habitat. In first and second order streams, a primary pool is defined to have a maximum residual depth of at least two feet, occupy at least half the width of the low flow channel, and be as long as the low flow channel width.

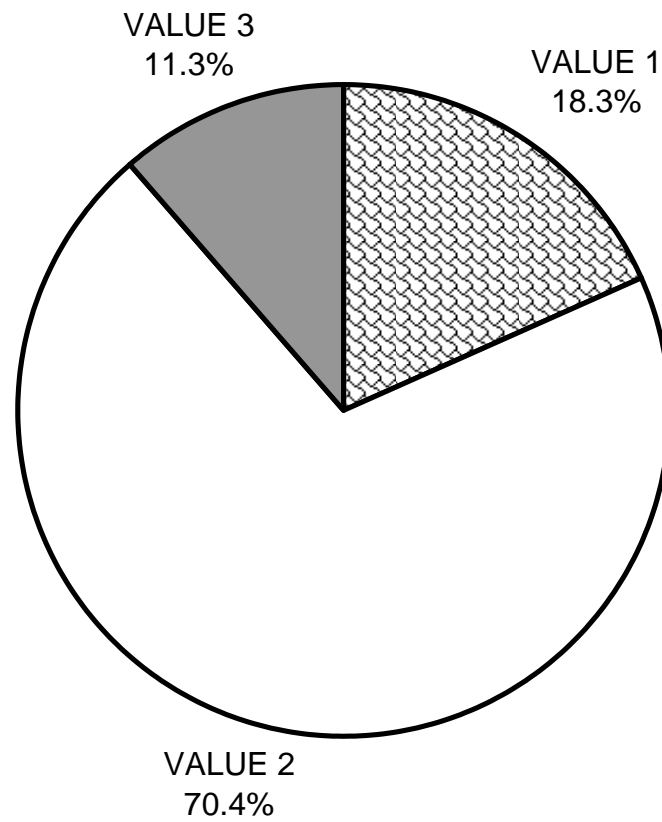
GRAPH 6

The depth of cobble embeddedness was estimated at pool tail-outs. Of the 71 pool tail-outs measured, 13 had a value of 1 (18.3%); 50 had a value of 2 (70.4%); 8 had a value of 3 (11.3%) (Graph 6). On this scale, a value of 1 indicates the best spawning conditions and a value of 4 the worst.

Sixty-three of the 71 pool tail-outs measured had embeddedness ratings of 1 or 2. Eight of the pool tail-outs had embeddedness ratings of 3 or 4. Cobble embeddedness measured to be 25% or less, a rating of 1, is considered to indicate good quality spawning substrate for salmon and steelhead.

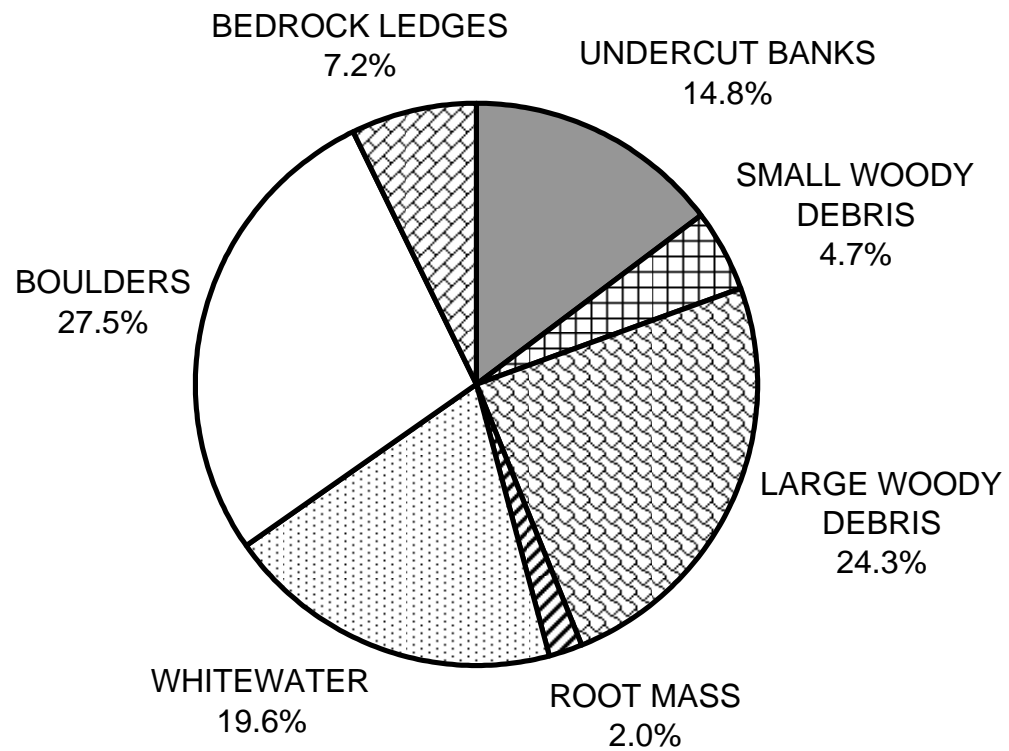
GRAPH 7

Table 5 summarizes mean percent cover by habitat type. Boulders are the dominant cover type in Rose Creek. Graph 7 describes the pool cover in Rose Creek. Boulders are the dominant pool cover type followed by large woody debris.

The mean shelter rating for pools is 14. The shelter rating in the flatwater habitats is 6. A pool shelter rating of approximately 100 is desirable. The amount of cover that now exists is being provided primarily by boulders in Rose Creek. Boulders are the dominant cover type in pools followed by large woody debris. Log and root wad cover structures in the pool and flatwater habitats would enhance both summer and winter salmonid habitat. Log cover structures provide rearing fry with protection from predation, rest from water velocity, and also divide territorial units to reduce density related competition.

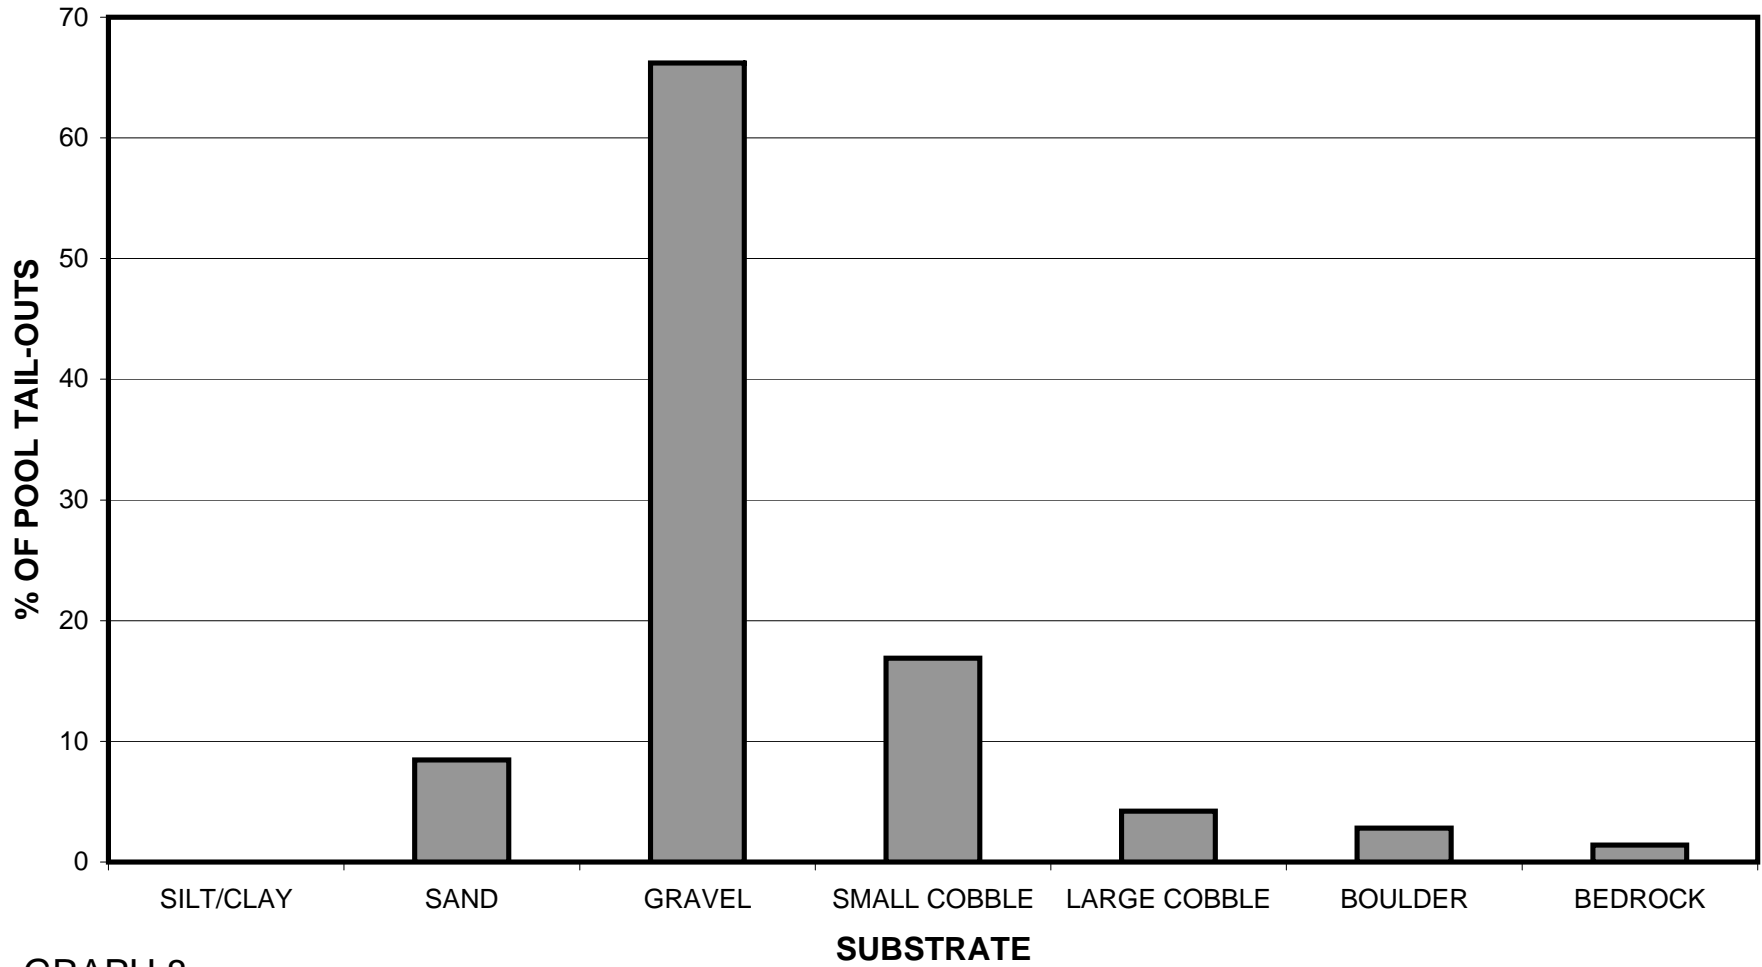
GRAPH 8

Table 6 summarizes the dominant substrate by habitat type. Graph 8 depicts the dominant substrate observed in pool tail-outs. Gravel was the dominant substrate observed in 66% of the pool tail-outs. Small cobble was the next most frequently observed dominant substrate type and occurred in 17% of the pool tail-outs.

Fifty-nine of the 71 pool tail-outs measured had gravel or small cobble as the dominant substrate. This is generally considered good for spawning salmonids.

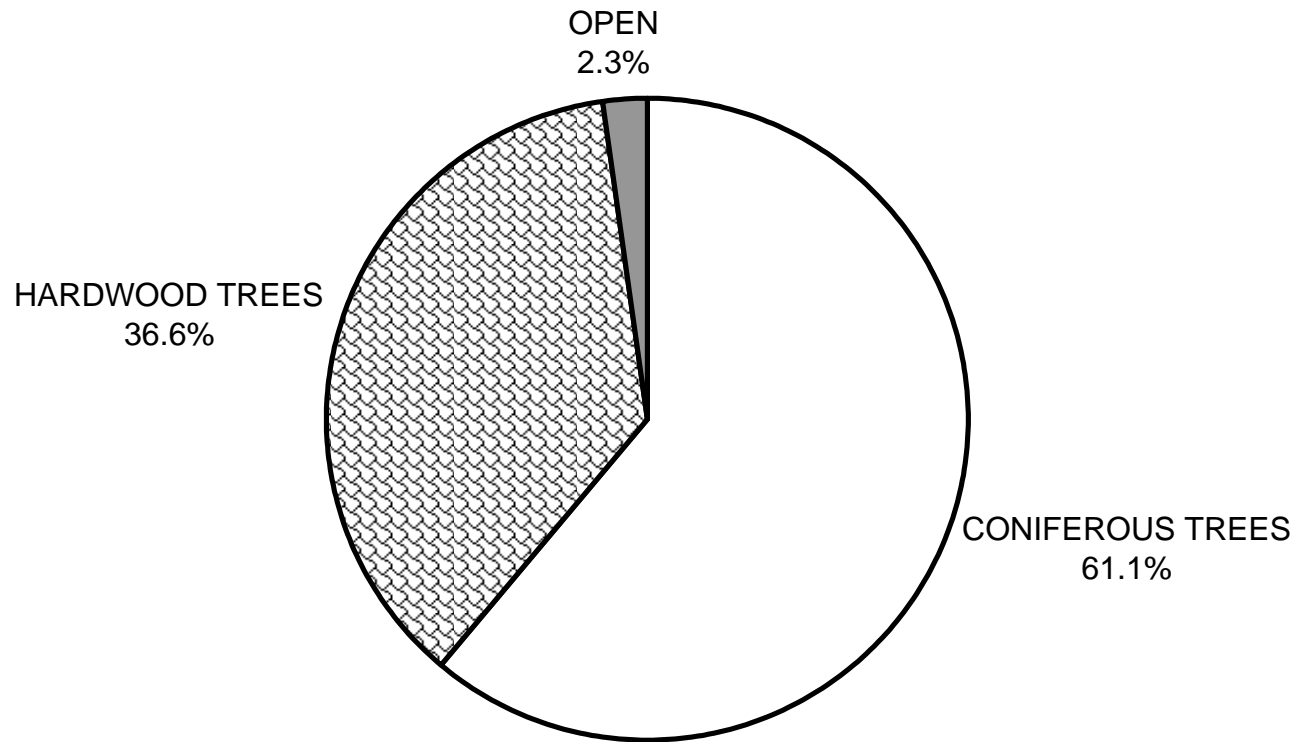
GRAPH 9

The mean percent canopy density for the surveyed length of Rose Creek was 98%. Two percent of the canopy was open. Of the canopy present, the mean percentages of hardwood and coniferous trees were 37% and 63%, respectively. Graph 9 describes the mean percent canopy in Rose Creek.

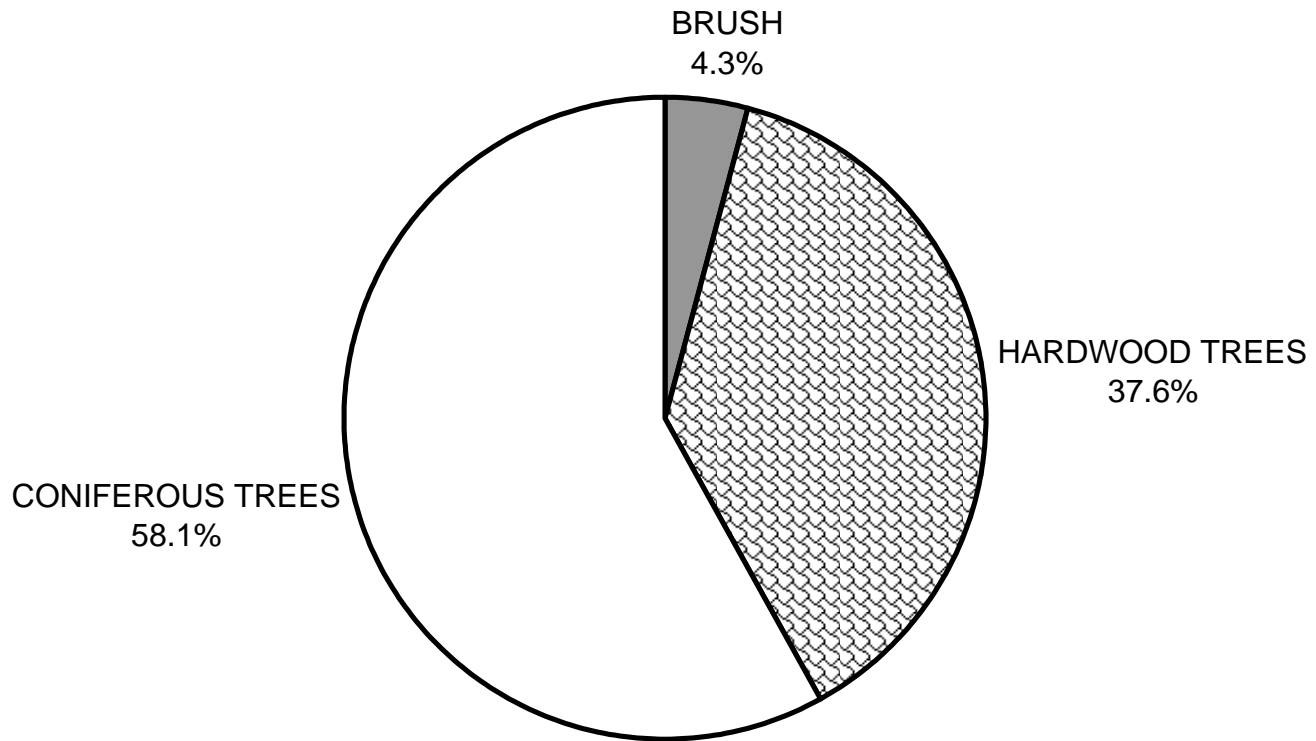
GRAPH 11

For the stream reach surveyed, the mean percent right bank vegetated was 97%. The mean percent left bank vegetated was 98%. The dominant elements composing the structure of the stream banks consisted of 81% sand/silt/clay, 18% bedrock, 1% boulder, and 1% cobble/gravel (Graph 10). Coniferous trees were the dominant vegetation type observed in 58% of the units surveyed. Additionally, 38% of the units surveyed had deciduous trees as the dominant vegetation type, and 4% had brush as the dominant vegetation type (Graph 11).
