# **STREAM INVENTORY REPORT**

## **South Branch North Fork Navarro River**

A stream inventory was conducted from July 22 to August 14, 2013 on South Branch North Fork Navarro River. The survey began at the confluence with the North Fork Navarro River and extended upstream 18.1 miles.

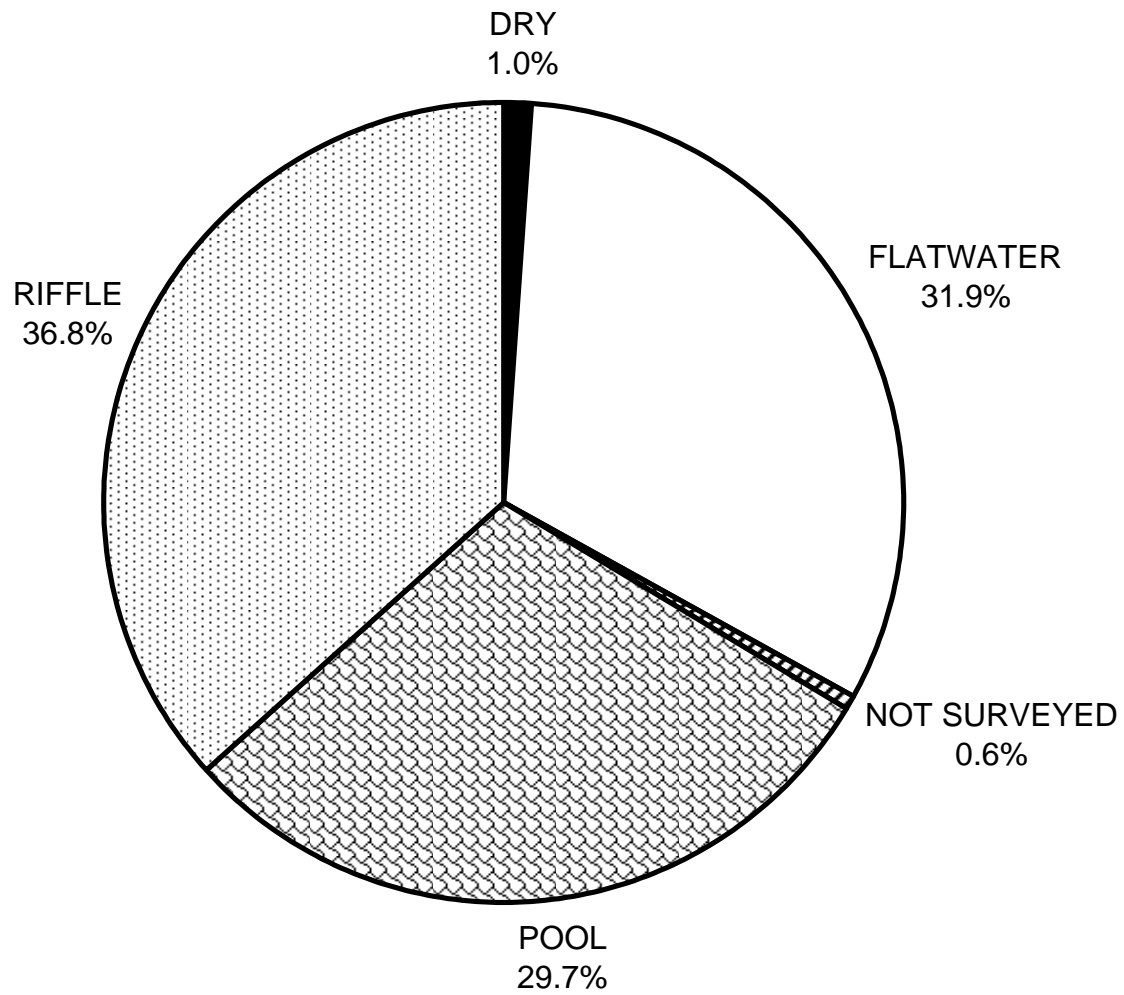
GRAPH 1

Table 1 summarizes the Level II riffle, flatwater, and pool habitat types. Based on frequency of occurrence there were 37% riffle units, 32% flatwater units, 30% pool units, 1% dry units, and 1% unsurveyed units (Graph 1). Based on total length of Level II habitat types there were 42% flatwater units, 30% riffle units, 28% pool units, and 1% dry units (Graph 2).

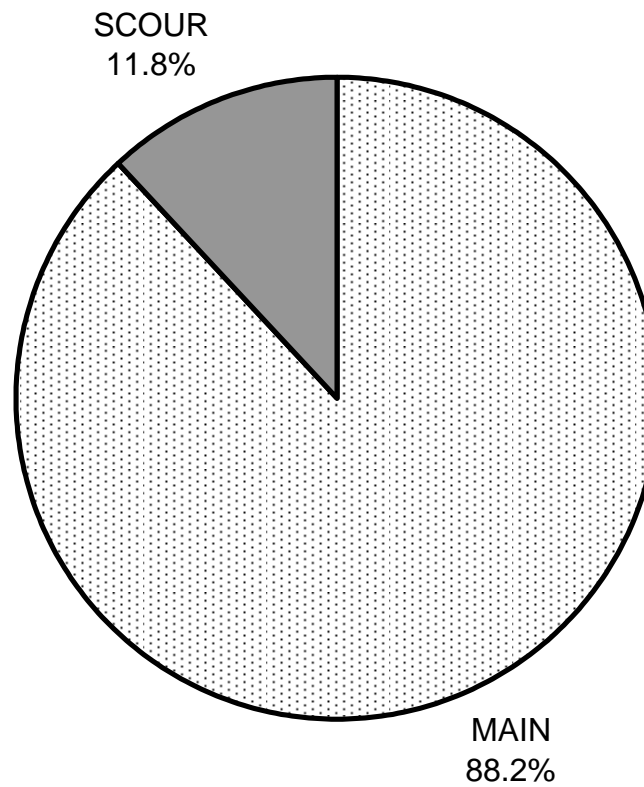
GRAPH 4

A total of 372 pools were identified (Table 3). Main channel pools were the most frequently encountered at 88% (Graph 4), and comprised 88% of the total length of all pools (Table 3).

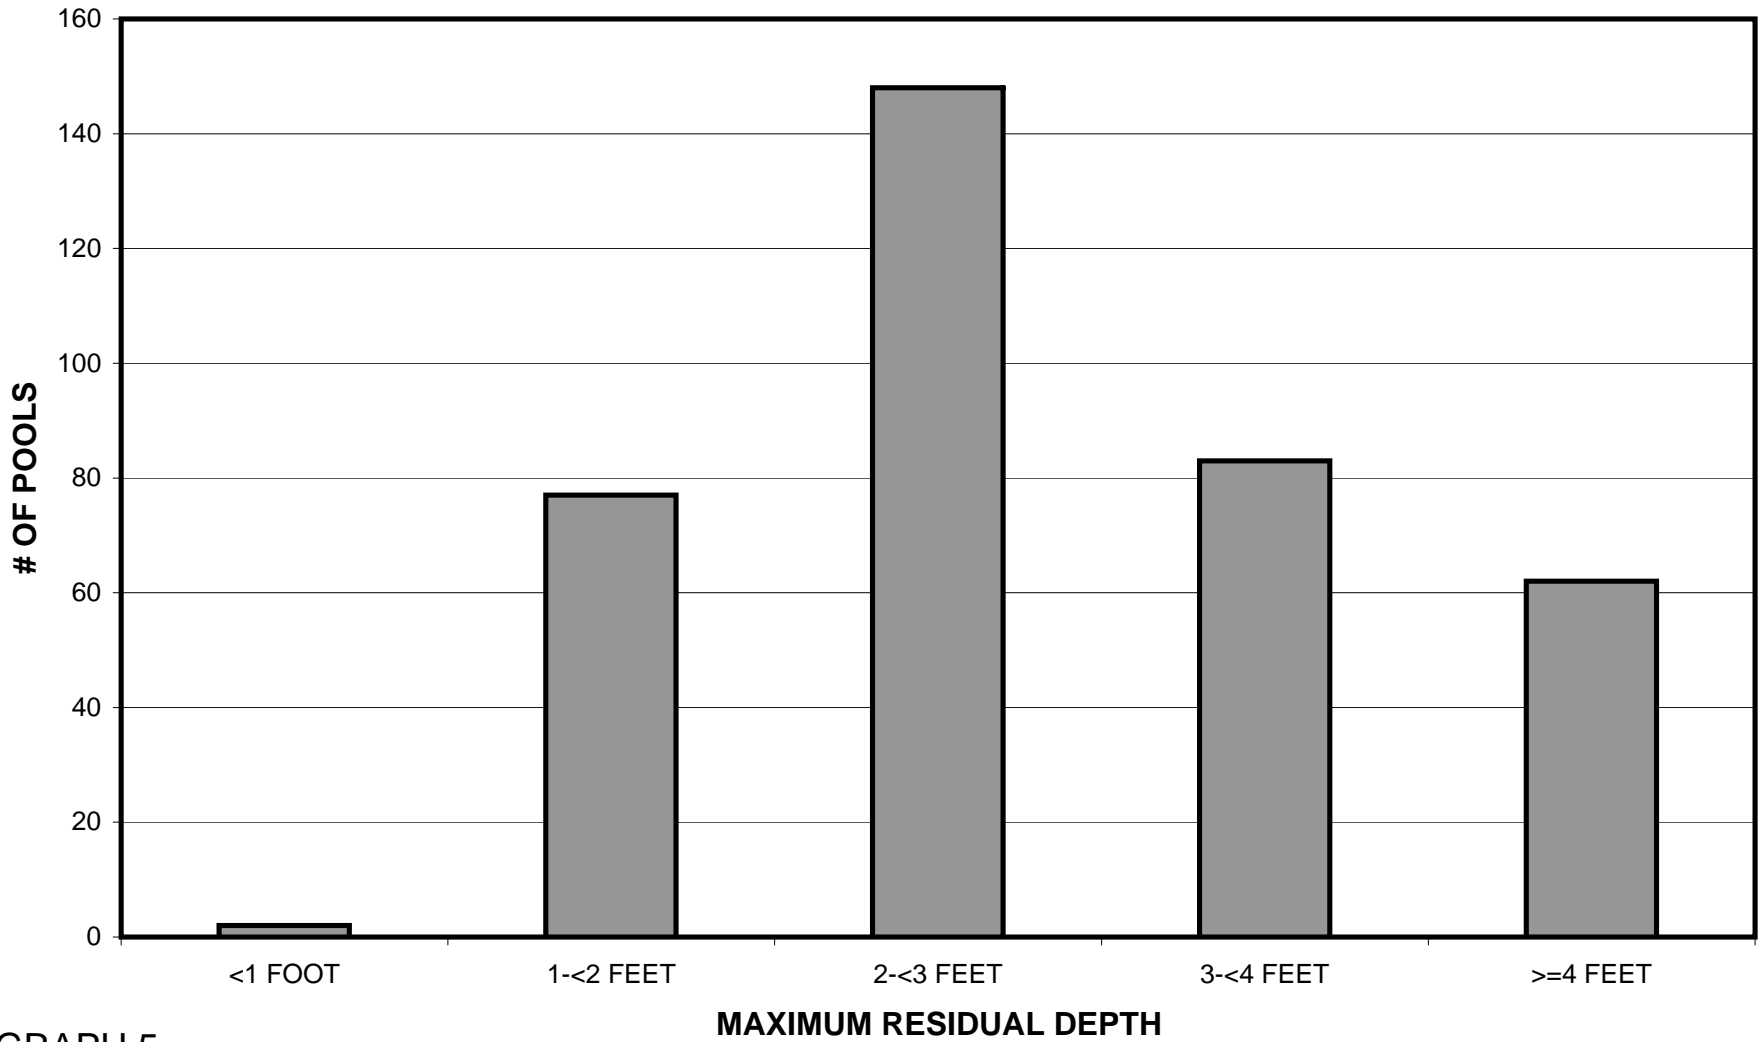
GRAPH 5

Table 4 is a summary of maximum residual pool depths by pool habitat types. Pool quality for salmonids increases with depth. One hundred forty-five of the 372 pools (39%) had a residual depth of three feet or greater (Graph 5).

Flatwater habitat types comprised 42% of the total length of this survey, riffles 30%, and pools 28%. One hundred forty-five of the 372 (39%) pools had a maximum residual depth greater than three feet. In general, pool enhancement projects are considered when primary pools comprise less than 40% of the length of total stream habitat. In third and fourth order streams, a primary pool is defined to have a maximum residual depth of at least three feet, occupy at least half the width of the low flow channel, and be as long as the low flow channel width. Installing structures that will increase or deepen pool habitat is recommended.

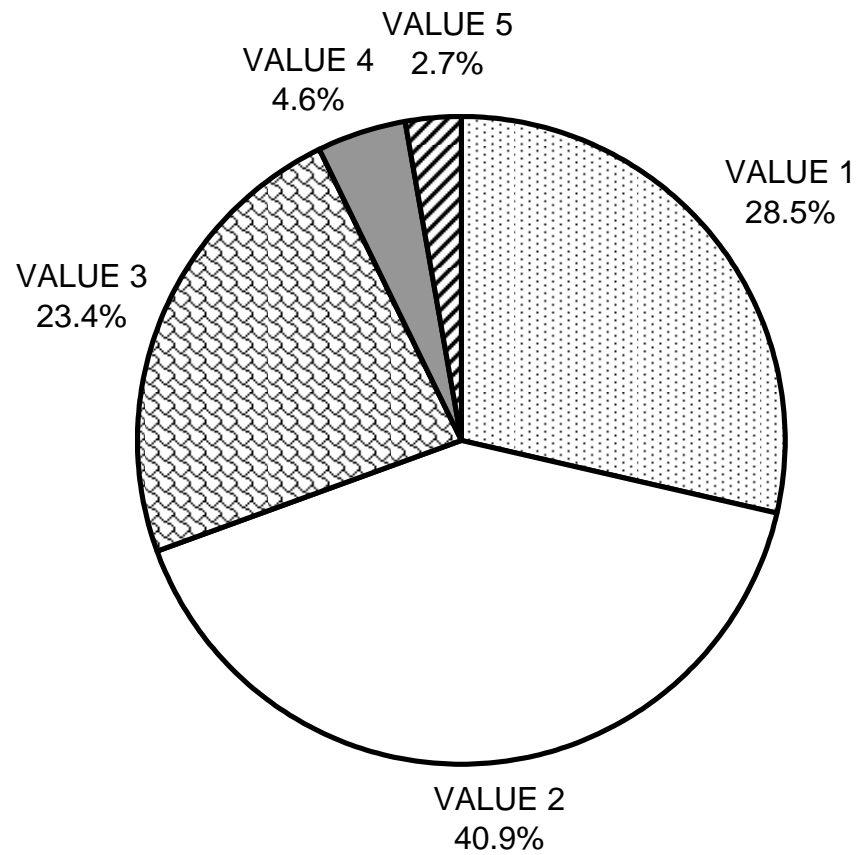
GRAPH 6

The depth of cobble embeddedness was estimated at pool tail-outs. Of the 372 pool tail-outs measured, 106 had a value of 1 (29%); 152 had a value of 2 (41%); 87 had a value of 3 (23%); 17 had a value of 4 (5%); 10 had a value of 5 (3%); (Graph 6). On this scale, a value of 1 indicates the best spawning conditions and a value of 4 the worst. Additionally, a value of 5 was assigned to tail-outs deemed not suitable for spawning due to inappropriate substrate such as bedrock, log sills, boulders, or other considerations.

Two hundred fifty-eight of the 372 pool tail-outs measured had embeddedness ratings of 1 or 2. One hundred four of the pool tail-outs had embeddedness ratings of 3 or 4. Ten of the pool tail-outs had a rating of 5, which is considered not suitable for spawning. Cobble embeddedness measured to be 25% or less, a rating of 1, is considered to indicate good quality spawning substrate for salmon and steelhead. Sediment sources in South Branch North Fork Navarro River should be mapped and rated according to their potential sediment yields, and control measures should be taken.

- 4) Inventory and map sources of stream bank erosion and prioritize them according to present and potential sediment yield. Identified sites should then be treated to reduce the amount of fine sediments entering the stream.

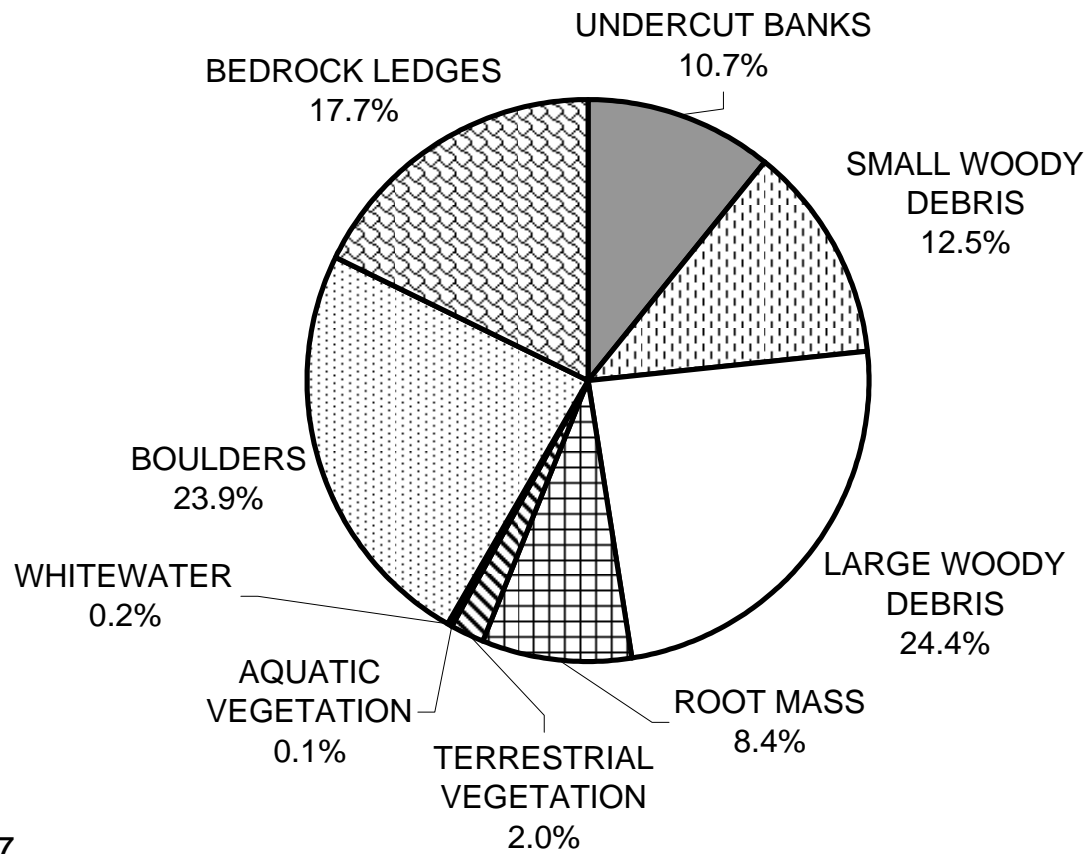
GRAPH 7

Table 5 summarizes mean percent cover by habitat type. Boulders are the dominant cover type in South Branch North Fork Navarro River. Graph 7 describes the pool cover in South Branch North Fork Navarro River. Large woody debris is the dominant pool cover type followed by boulders.

The mean shelter rating for pools is 26. The shelter rating in the flatwater habitats is 7. A pool shelter rating of approximately 100 is desirable. The amount of cover that now exists is being provided primarily by boulders in South Branch North Fork Navarro River. Large woody debris is the dominant cover type in pools followed by boulders. Log and root wad cover structures in the pool and flatwater habitats would enhance both summer and winter salmonid habitat. Log cover structures provide rearing fry with protection from predation, rest from water velocity, and also divide territorial units to reduce density related competition.

- 3) Increase woody cover in the pools and flatwater habitat units. Most of the existing cover in the pools is from large woody debris. Adding high quality complexity with woody cover in the pools is desirable.

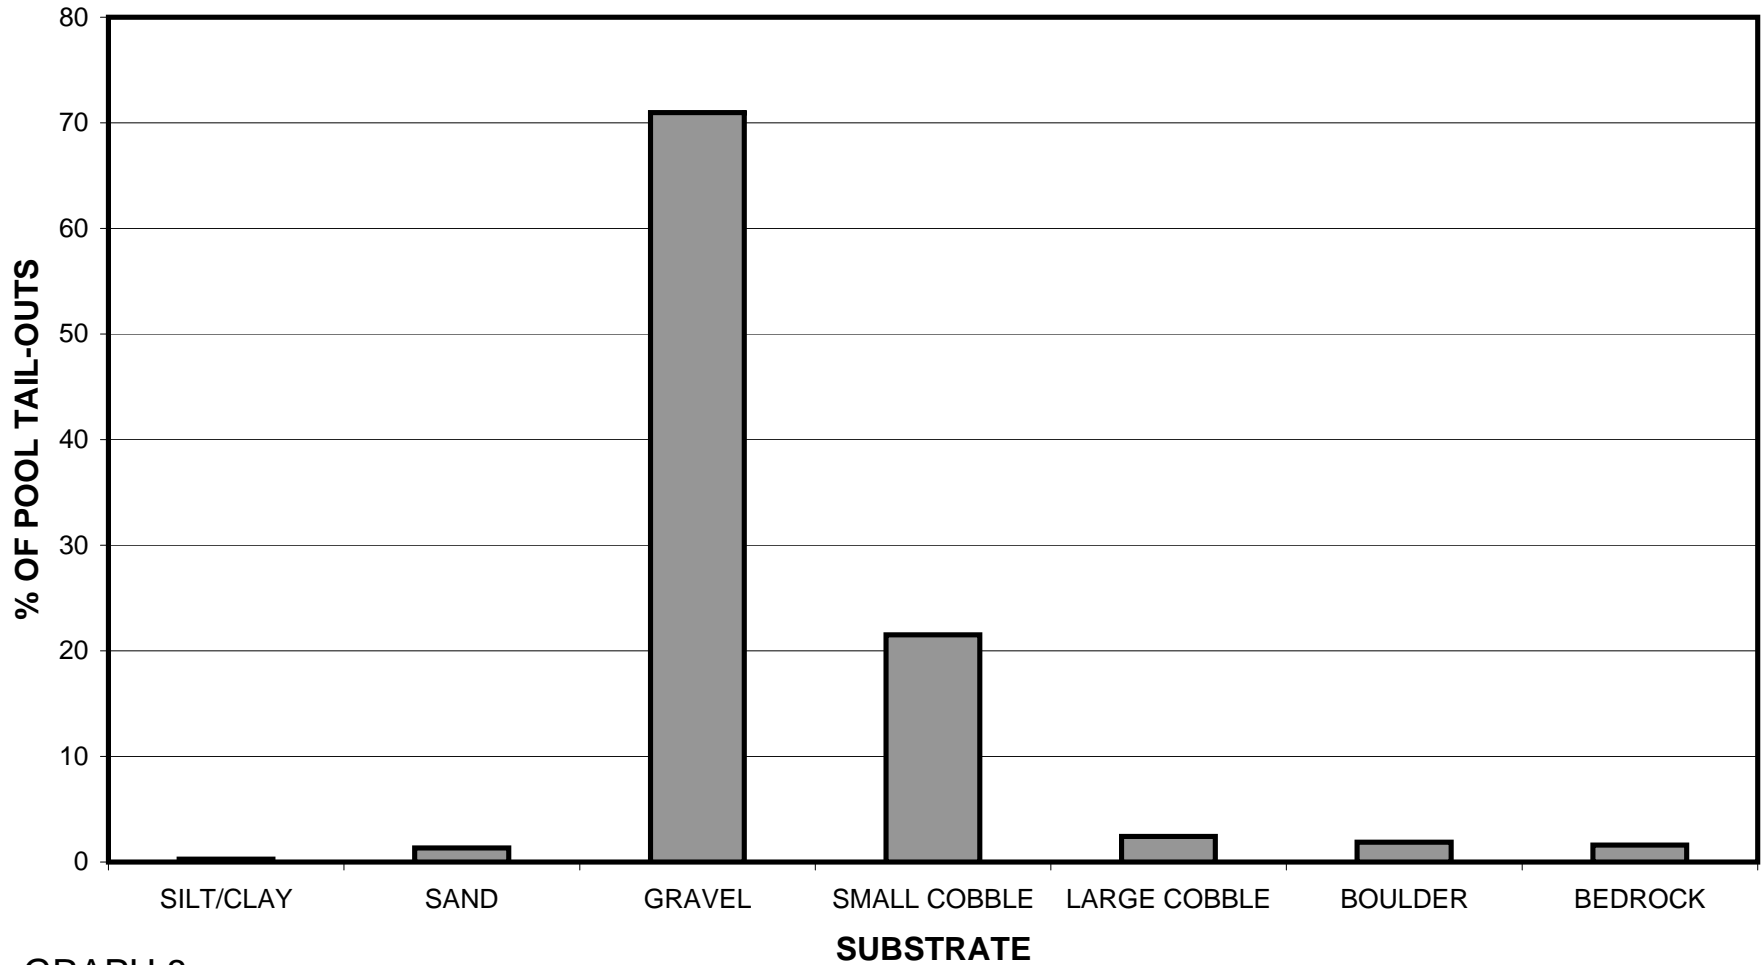
GRAPH 8

Table 6 summarizes the dominant substrate by habitat type. Graph 8 depicts the dominant substrate observed in pool tail-outs. Gravel was the dominant substrate observed in 71% of the pool tail-outs. Small cobble was the next most frequently observed dominant substrate type and occurred in 22% of the pool tail-outs.

Three hundred forty-four of the 372 pool tail-outs measured had gravel or small cobble as the dominant substrate. This is generally considered good for spawning salmonids.

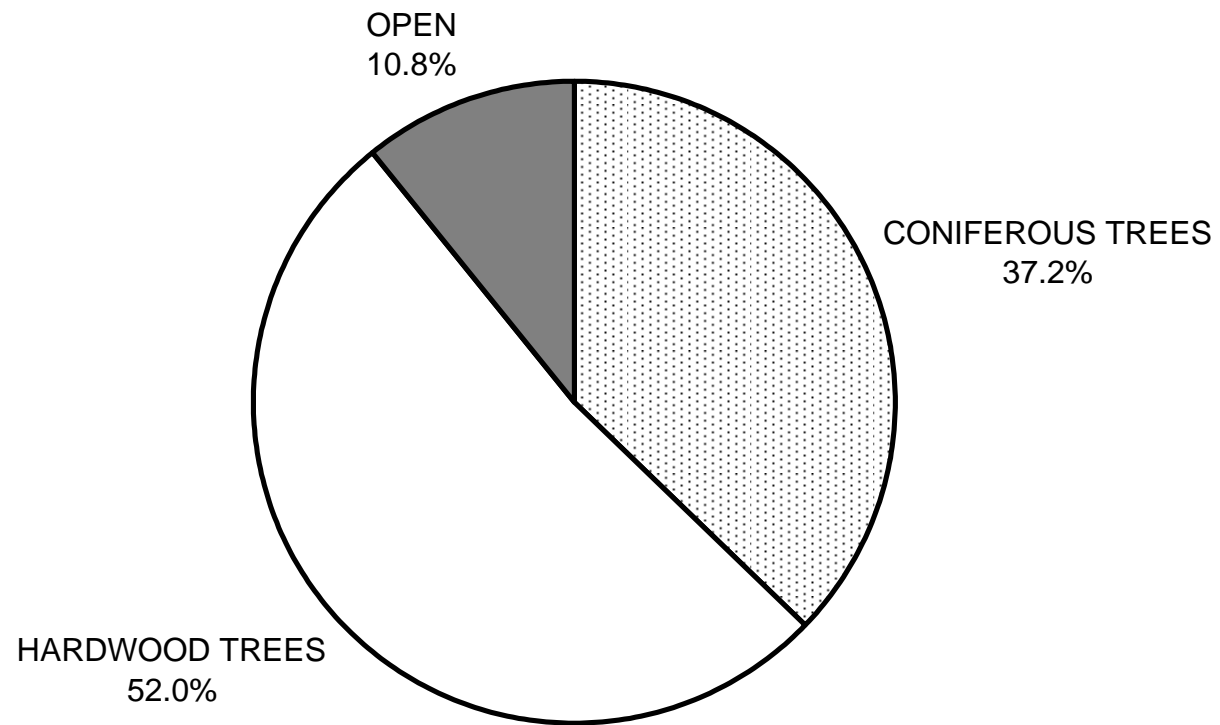
GRAPH 9

The mean percent canopy density for the surveyed length of South Branch North Fork Navarro River was 89%. Eleven percent of the canopy was open. Of the canopy present, the mean percentages of hardwood and coniferous trees were 58% and 42%, respectively. Graph 9 describes the mean percent canopy in South Branch North Fork Navarro River.

The mean percent canopy density for the stream was 89%. Reach 1 had a canopy density of 87%, Reach 2 had a canopy density of 91%, Reach 3 had a canopy density of 93%, and Reach 4 had a canopy density of 98%. The percentage of right and left bank covered with vegetation was 97% and 97%, respectively.

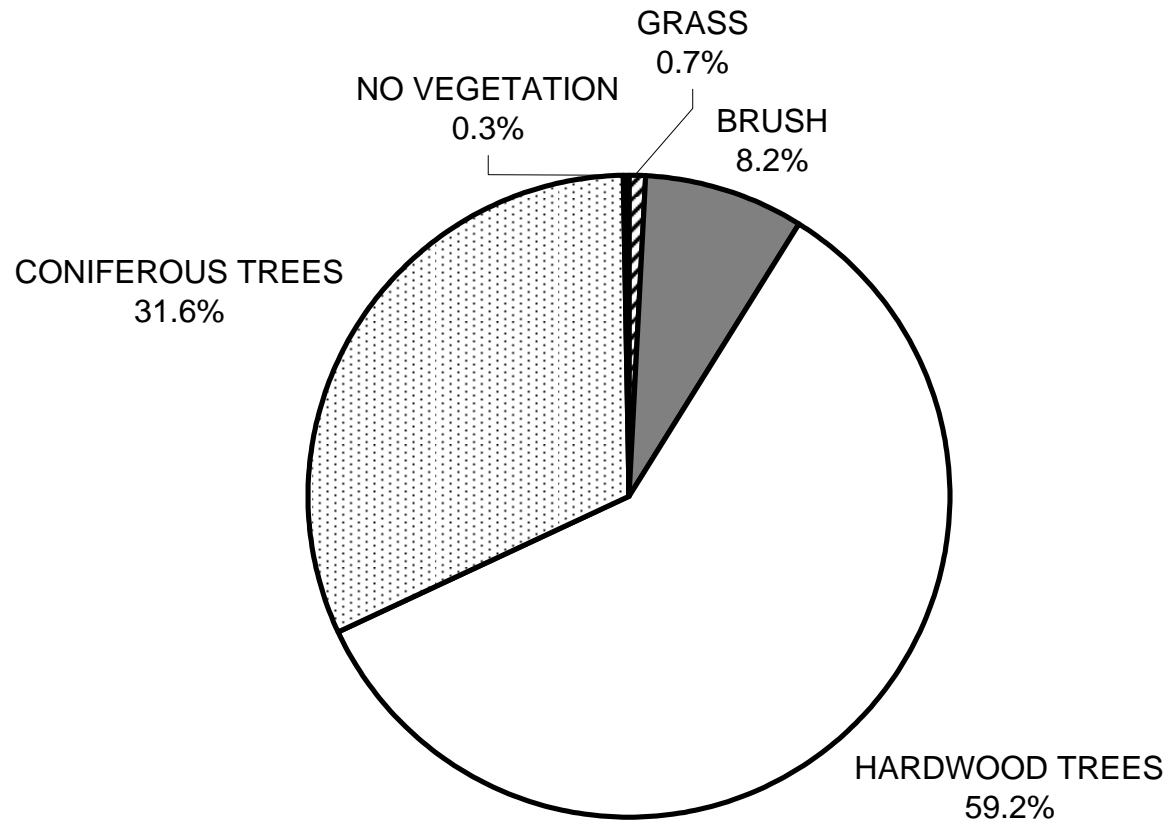
GRAPH 11

For the stream reach surveyed, the mean percent right bank vegetated was 97%. The mean percent left bank vegetated was 97%. The dominant elements composing the structure of the stream banks consisted of 38% cobble/gravel, 31% sand/silt/clay, 25% bedrock, and 7% boulders (Graph 10). Hardwood trees were the dominant vegetation type observed in 59% of the units surveyed. Additionally, 32% of the units surveyed had coniferous trees as the dominant vegetation type, and 8% had brush as the dominant vegetation type (Graph 11).
