STREAM INVENTORY REPORT

Tank 4 Gulch

A stream inventory was conducted on August 22, 2012 on Tank 4 Gulch. The survey began at the confluence with Flynn Creek and extended upstream 0.4 miles.

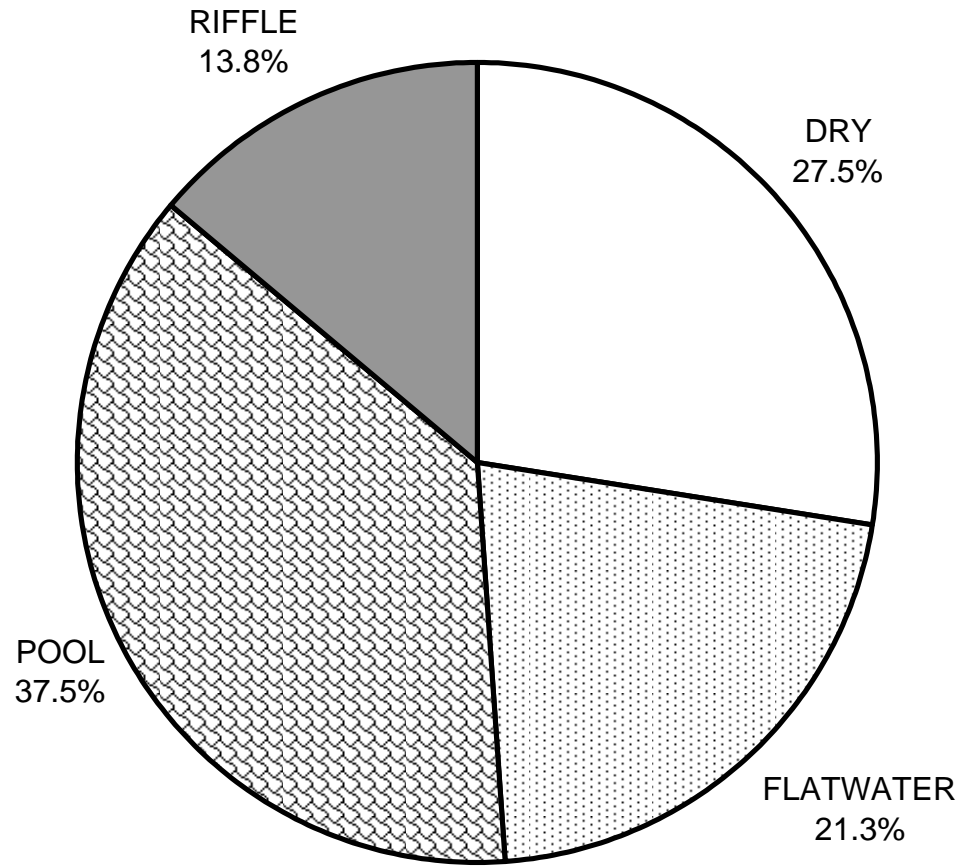
GRAPH 1

Table 1 summarizes the Level II riffle, flatwater, and pool habitat types. Based on frequency of occurrence there were 38% pool units, 28% dry units, 21% flatwater units, and 14% riffle units (Graph 1). Based on total length of Level II habitat types there were 45% dry units, 32% pool units, 16% flatwater units, and 7% riffle units (Graph 2).

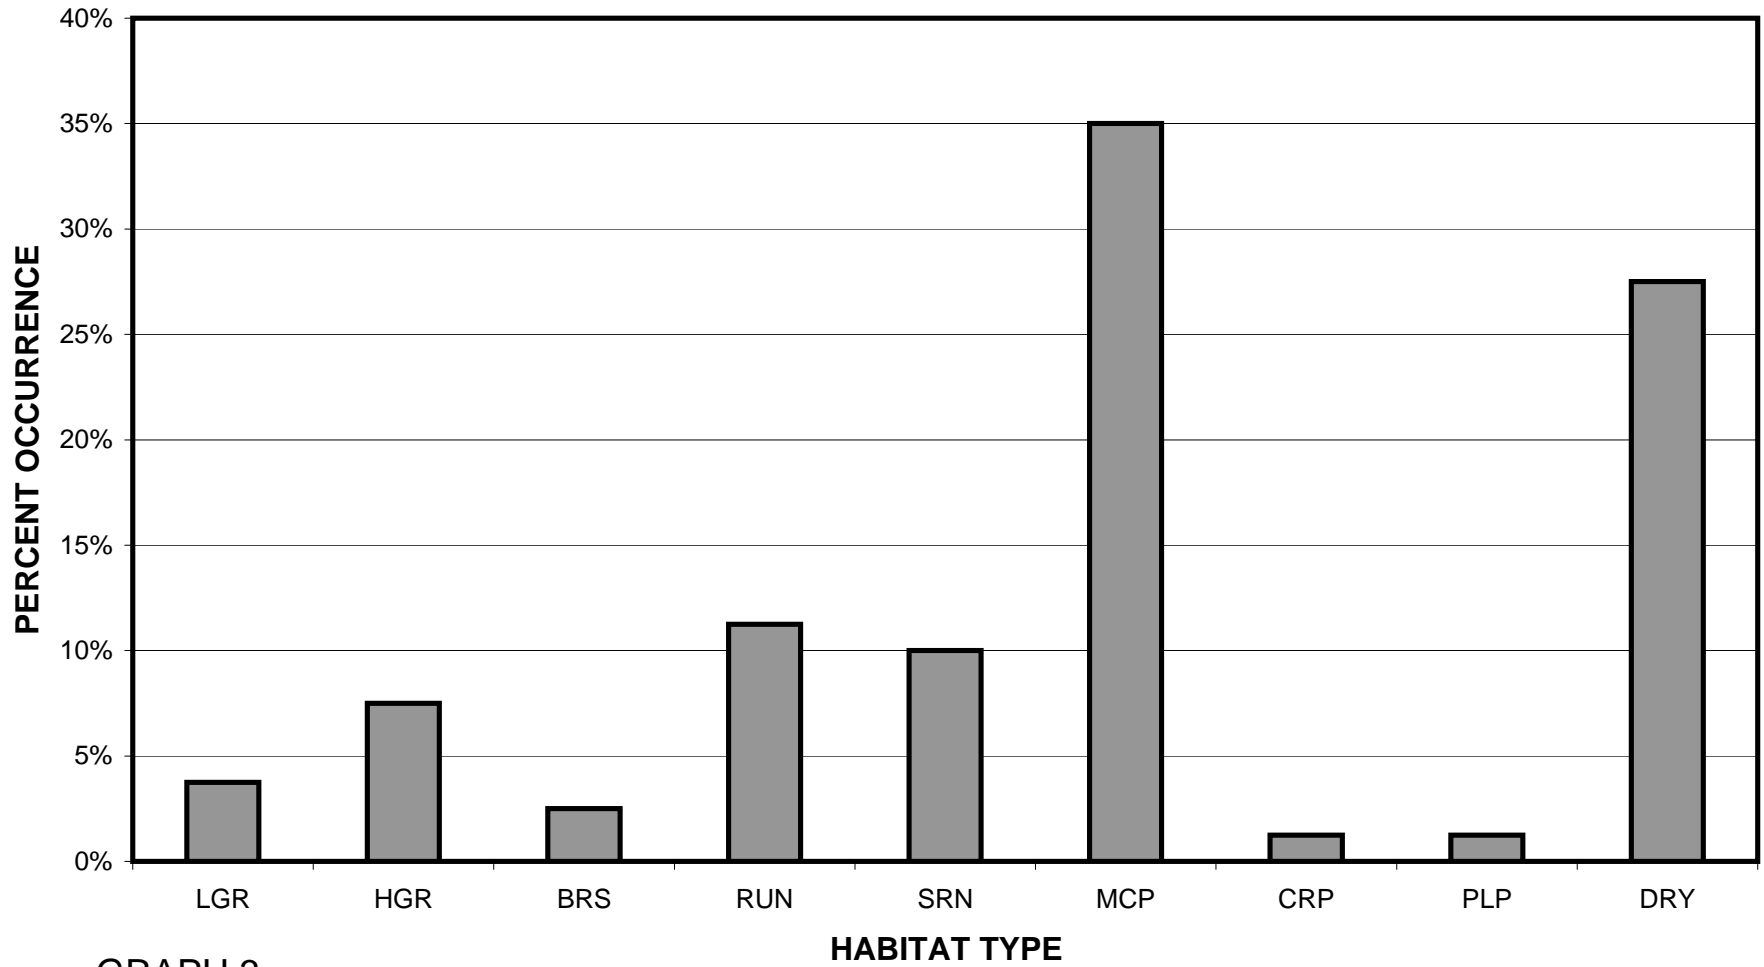
GRAPH 3

Nine Level IV habitat types were identified (Table 2). The most frequent habitat types by percent occurrence were mid-channel pool units, 35%; dry units, 28%; and run units, 11% (Graph 3). Based on percent total length, dry units made up 45%, mid-channel pool units 31%, and step run units 12%.

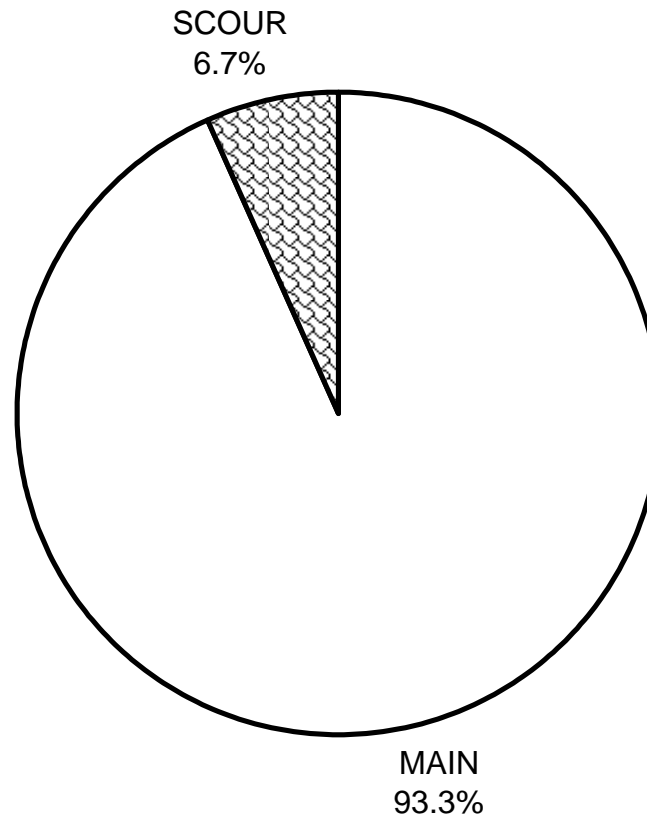
GRAPH 4

A total of 30 pools were identified (Table 3). Main channel pools were the most frequently encountered at 93% (Graph 4), and comprised 96% of the total length of all pools (Table 3).

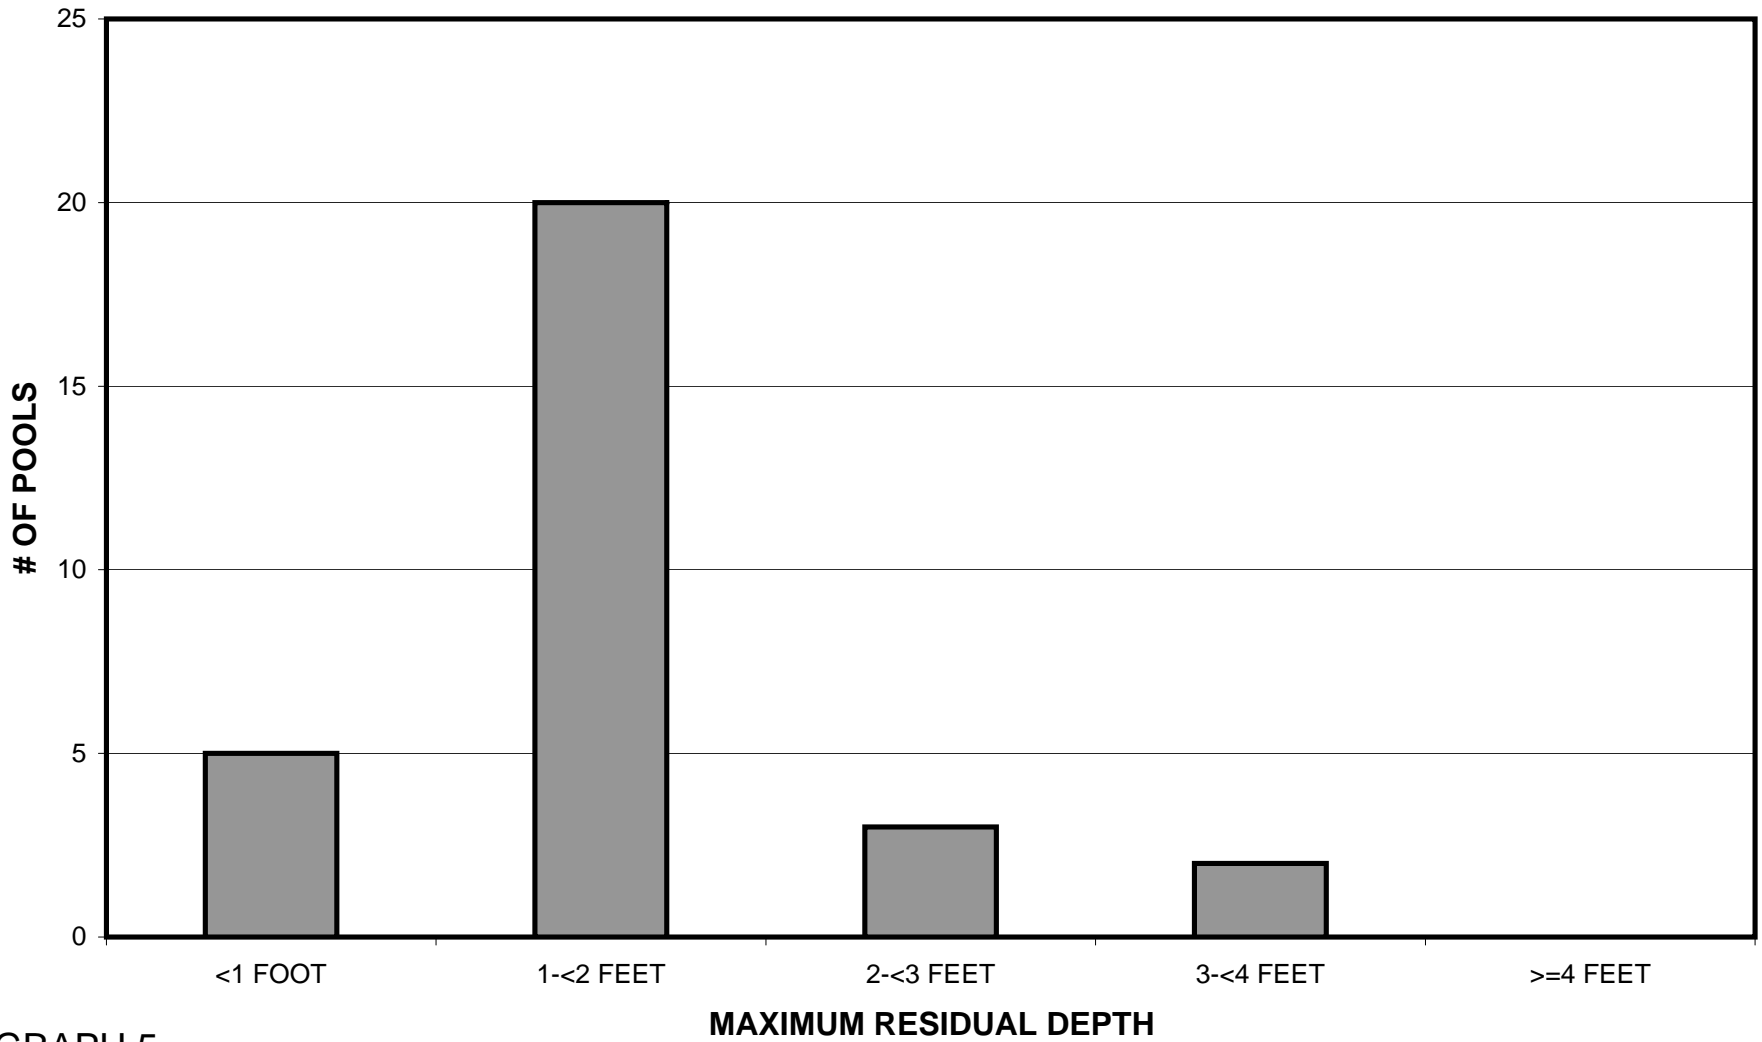
GRAPH 5

Table 4 is a summary of maximum residual pool depths by pool habitat types. Pool quality for salmonids increases with depth. Five of the 30 pools (17%) had a residual depth of two feet or greater (Graph 5).

Flatwater habitat types comprised 16% of the total length of this survey, riffles 7%, and pools 32%. Five of the 30 (17%) pools had a maximum residual depth greater than 2 feet. In general, pool enhancement projects are considered when primary pools comprise less than 40% of the length of total stream habitat. In first and second order streams, a primary pool is defined to have a maximum residual depth of at least two feet, occupy at least half the width of the low flow channel, and be as long as the low flow channel width. Installing large wood structures that will increase or deepen pool habitat is recommended.

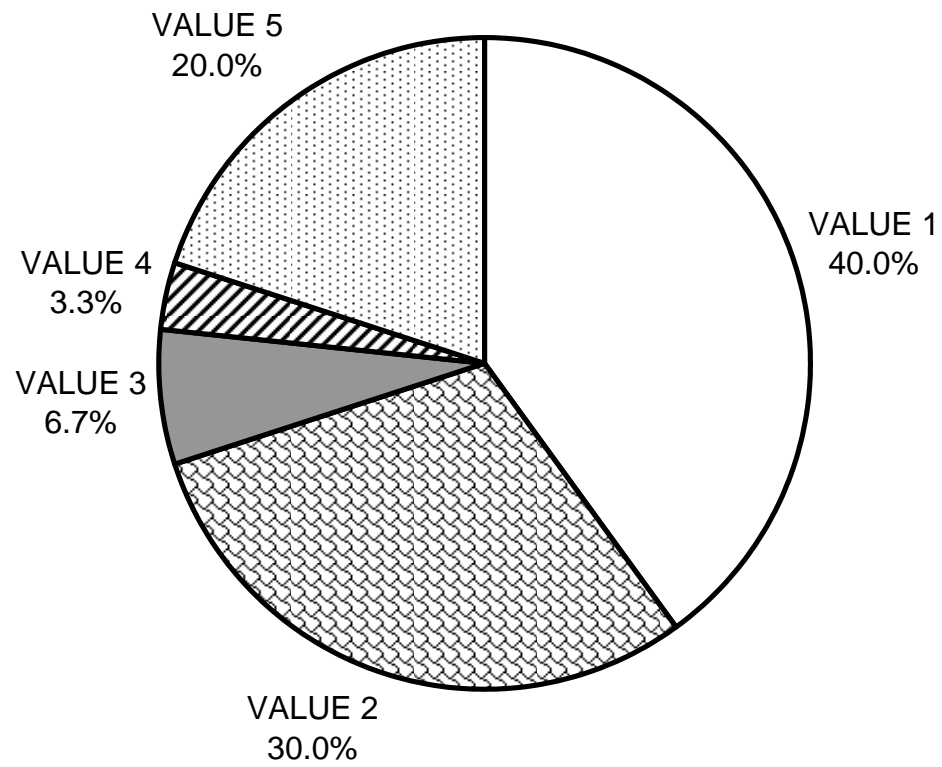
GRAPH 6

The depth of cobble embeddedness was estimated at pool tail-outs. Of the 30 pool tail-outs measured, 12 had a value of 1 (40%); nine had a value of 2 (30%); two had a value of 3 (6.7%); one had a value of 4 (3.3%); six had a value of 5 (20%) (Graph 6). On this scale, a value of 1 indicates the best spawning conditions and a value of 4 the worst. Additionally, a value of 5 was assigned to tail-outs deemed not suitable for spawning due to inappropriate substrate such as bedrock, log sills, boulders, or other considerations.

Twenty-one of the 30 pool tail-outs measured had embeddedness ratings of 1 or 2. Three of the pool tail-outs had embeddedness ratings of 3 or 4. Six of the pool tail-outs had a rating of 5, which is considered not suitable for spawning. Cobble embeddedness measured to be 25% or less, a rating of 1, is considered to indicate good quality spawning substrate for salmon and steelhead.

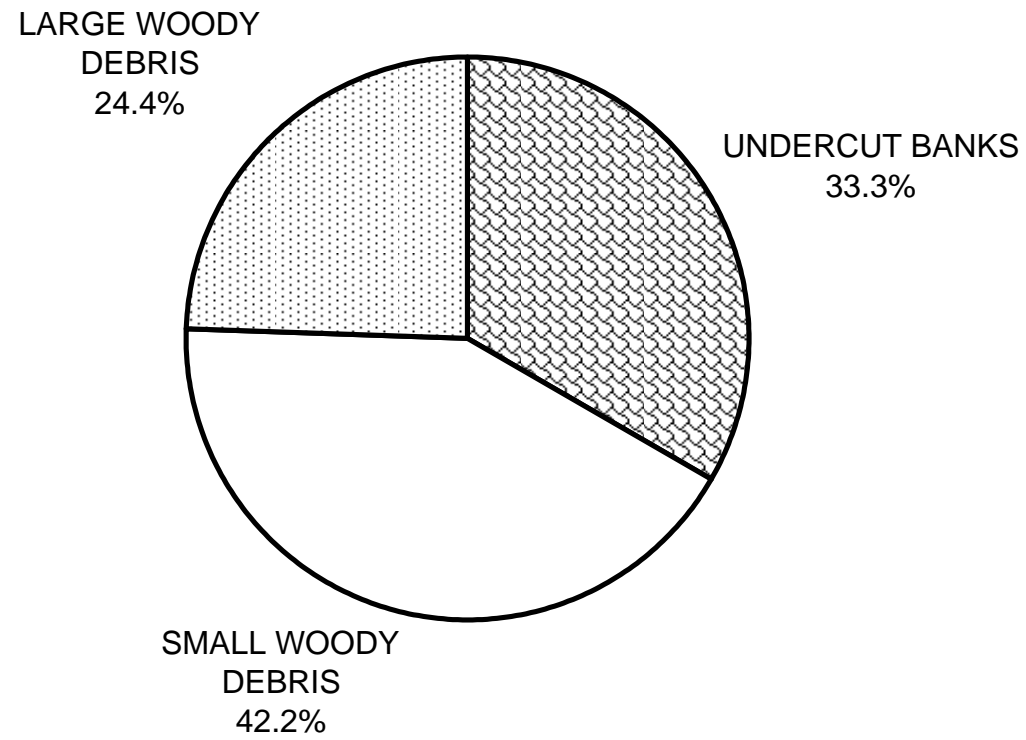
GRAPH 7

Table 5 summarizes mean percent cover by habitat type. Small woody debris is the dominant cover type in Tank 4 Gulch. Graph 7 describes the pool cover in Tank 4 Gulch. Small woody debris is the dominant pool cover type followed by undercut banks.

The mean shelter rating for pools is 2. The shelter rating in the flatwater habitats is 0. A pool shelter rating of approximately 100 is desirable. The amount of cover that now exists is being provided primarily by small woody debris in Tank 4 Gulch. Small woody debris is the dominant cover type in pools followed by undercut banks. Log and root wad cover structures in the pool and flatwater habitats would enhance both summer and winter salmonid habitat. Log cover structures provide rearing fry with protection from predation, rest from water velocity, and also divide territorial units to reduce density related competition.

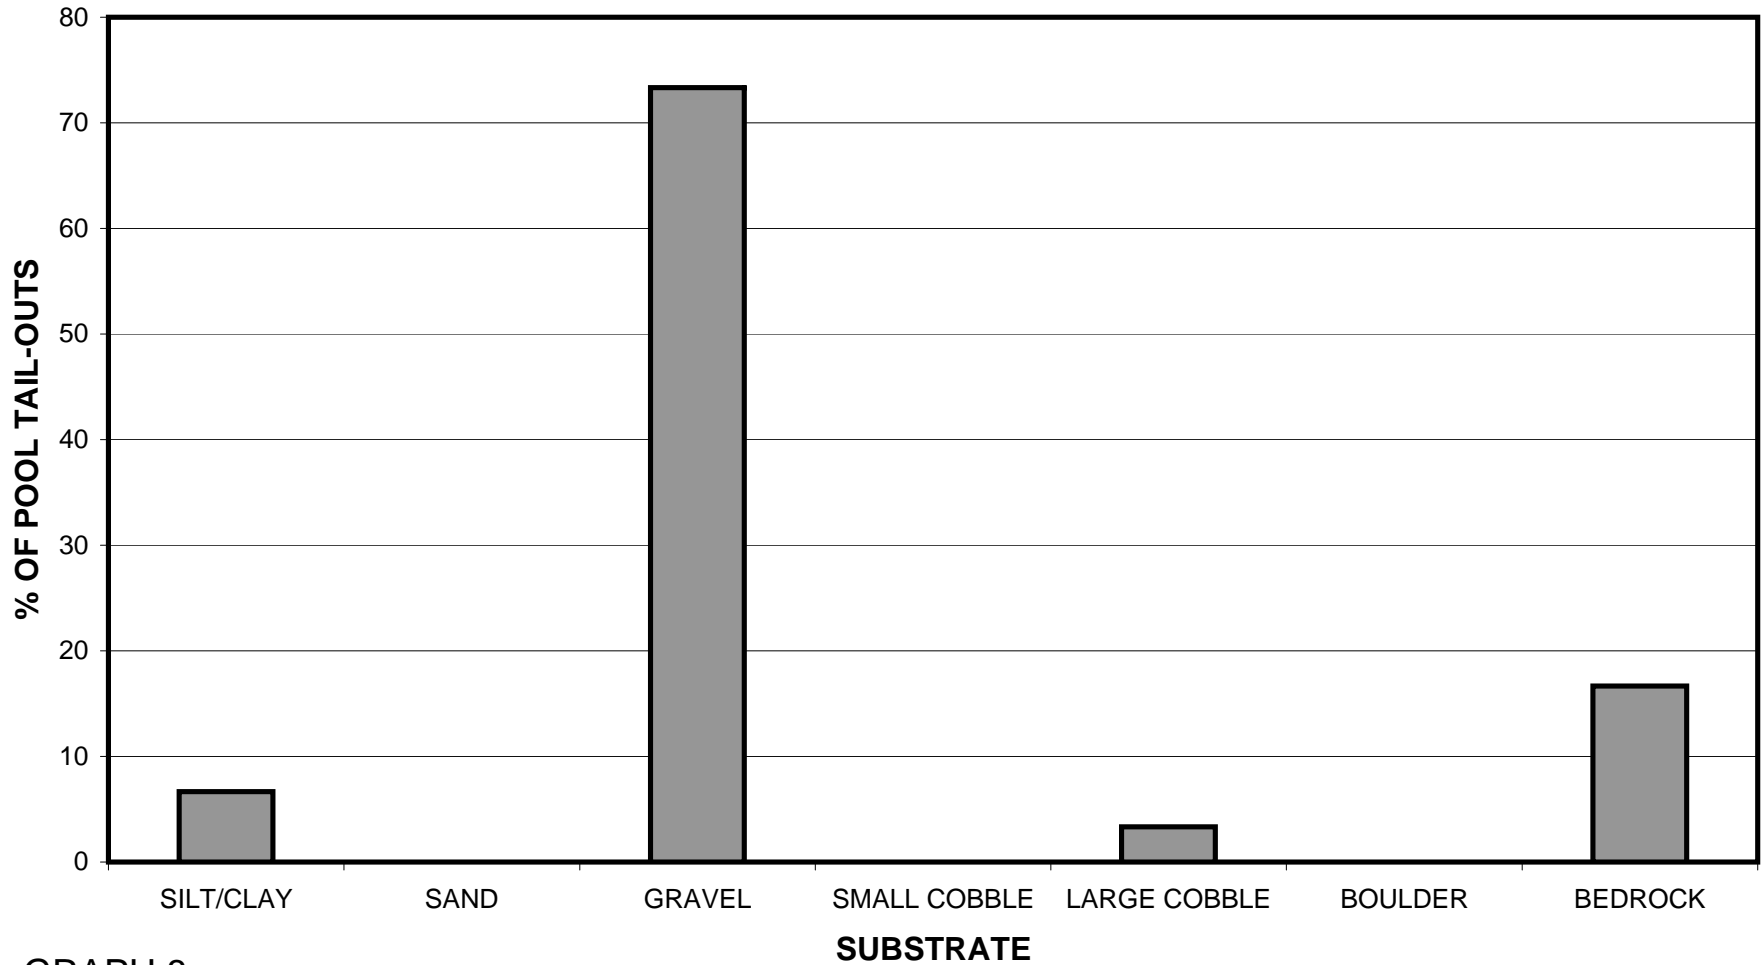
GRAPH 8

Table 6 summarizes the dominant substrate by habitat type. Graph 8 depicts the dominant substrate observed in pool tail-outs. Gravel was the dominant substrate observed in 73% of the pool tail-outs. Bedrock was the next most frequently observed dominant substrate type and occurred in 17% of the pool tail-outs.

Twenty-two of the 30 pool tail-outs measured had gravel or small cobble as the dominant substrate. This is generally considered good for spawning salmonids.

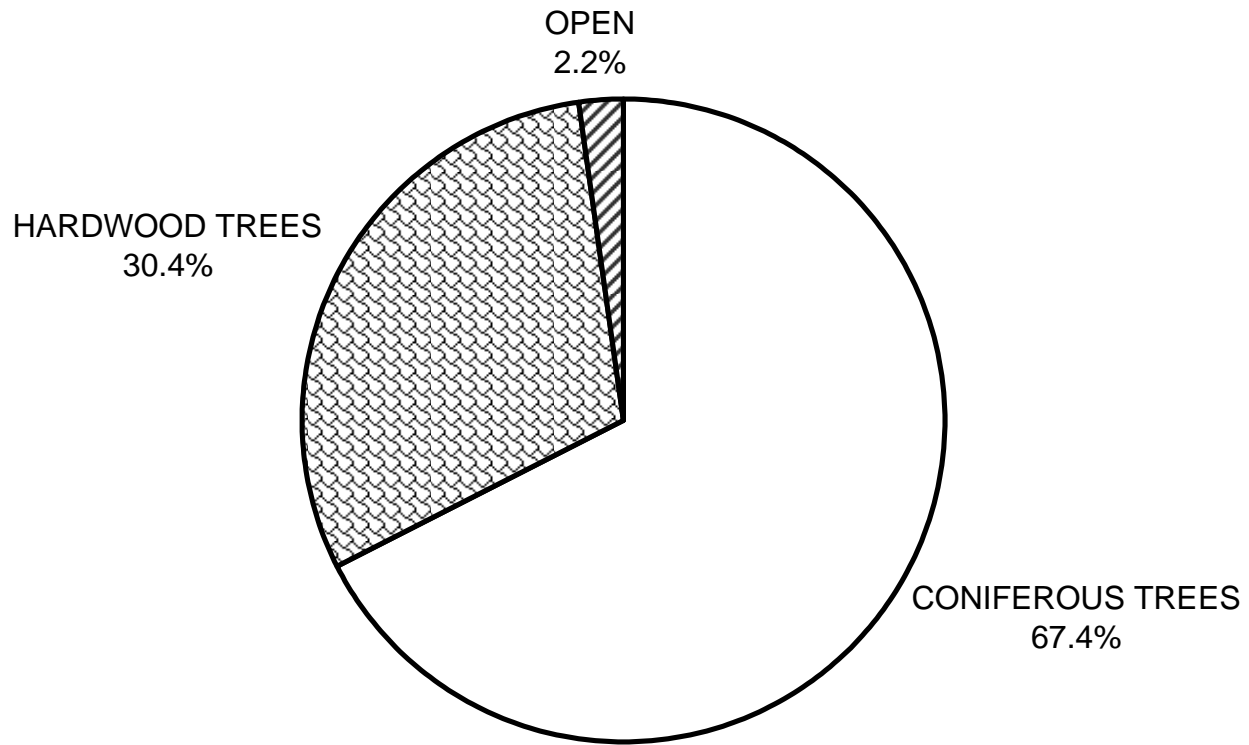
GRAPH 9

The mean percent canopy density for the surveyed length of Tank 4 Gulch was 98%. Two percent of the canopy was open. Of the canopy present, the mean percentages of hardwood and coniferous trees were 31% and 69%, respectively. Graph 9 describes the mean percent canopy in Tank 4 Gulch.

The mean percent canopy density for the stream was 98%. Reach 1 had a canopy density of 97%, Reach 2 had a canopy density of 99%, and Reach 3 had a canopy density of 98%. In general, revegetation projects are considered when canopy density is less than 80%. The percentage of right and left bank covered with vegetation was 100% and 100%, respectively.

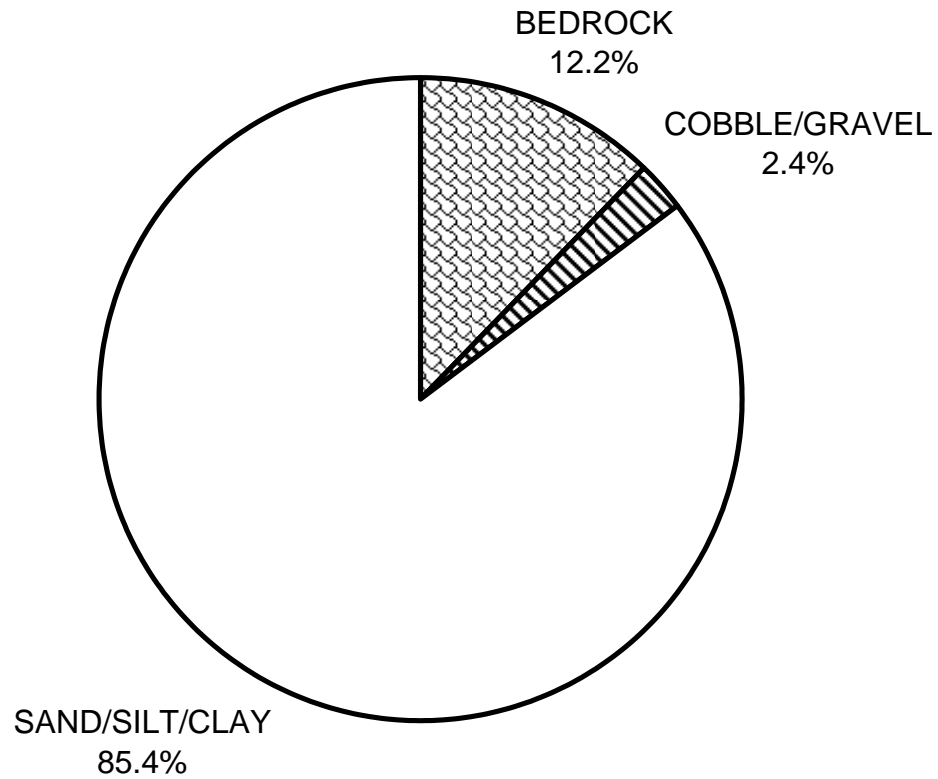
GRAPH 10

For the stream reach surveyed, the mean percent right bank vegetated was 100%. The mean percent left bank vegetated was 100%. The dominant elements composing the structure of the stream banks consisted of 85% sand/silt/clay, 12% bedrock, and 2% cobble/gravel (Graph 10). Coniferous trees were the dominant vegetation type observed in 66% of the units surveyed. Additionally, 27% of the units surveyed had deciduous trees as the dominant vegetation type, and 6% had brush as the dominant vegetation type (Graph 11).
