STREAM INVENTORY REPORT

Unnamed Tributary to Johnson Creek

A stream inventory was conducted on June 5, 2012 on an unnamed tributary to Johnson Creek. The survey began at the confluence with Johnson Creek and extended upstream 0.3 miles.

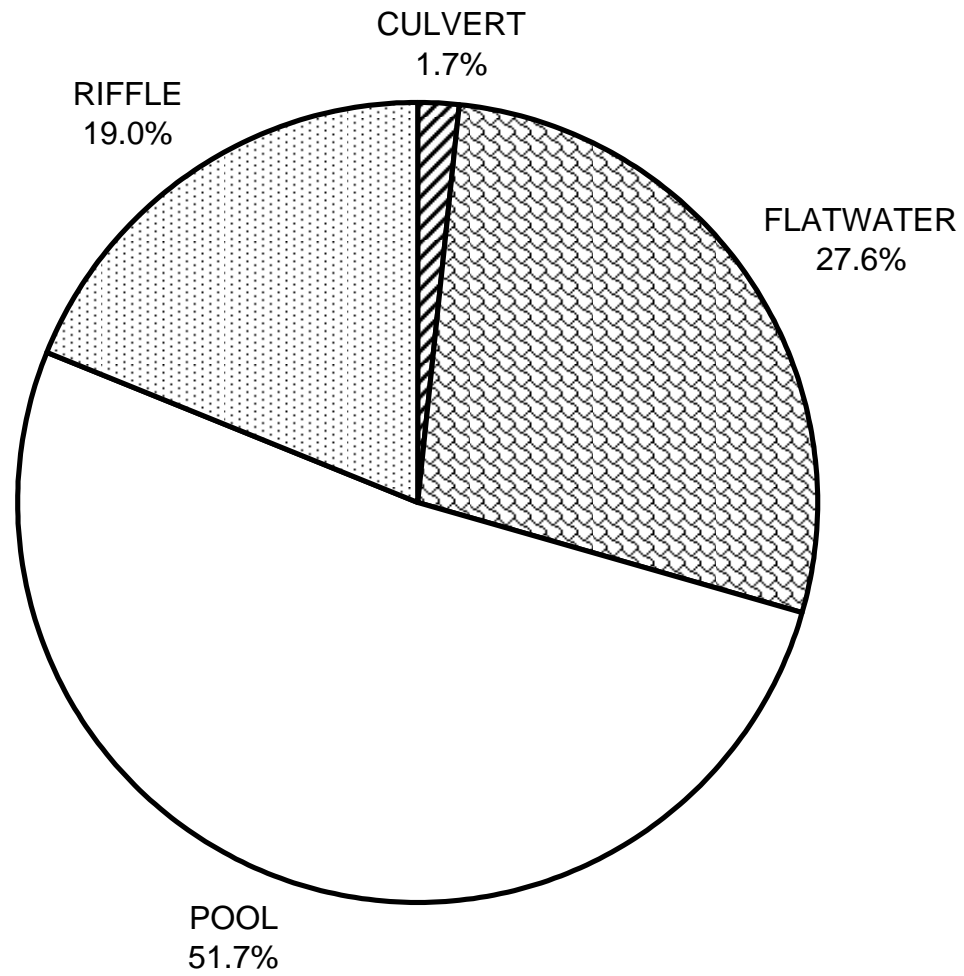
GRAPH 1

Table 1 summarizes the Level II riffle, flatwater, and pool habitat types. Based on frequency of occurrence there were 52% pool units, 28% flatwater units, 19% riffle units, and 2% culvert units (Graph 1). Based on total length of Level II habitat types there were 49% pool units, 39% flatwater units, 11% riffle units, and 2% culvert units (Graph 2).

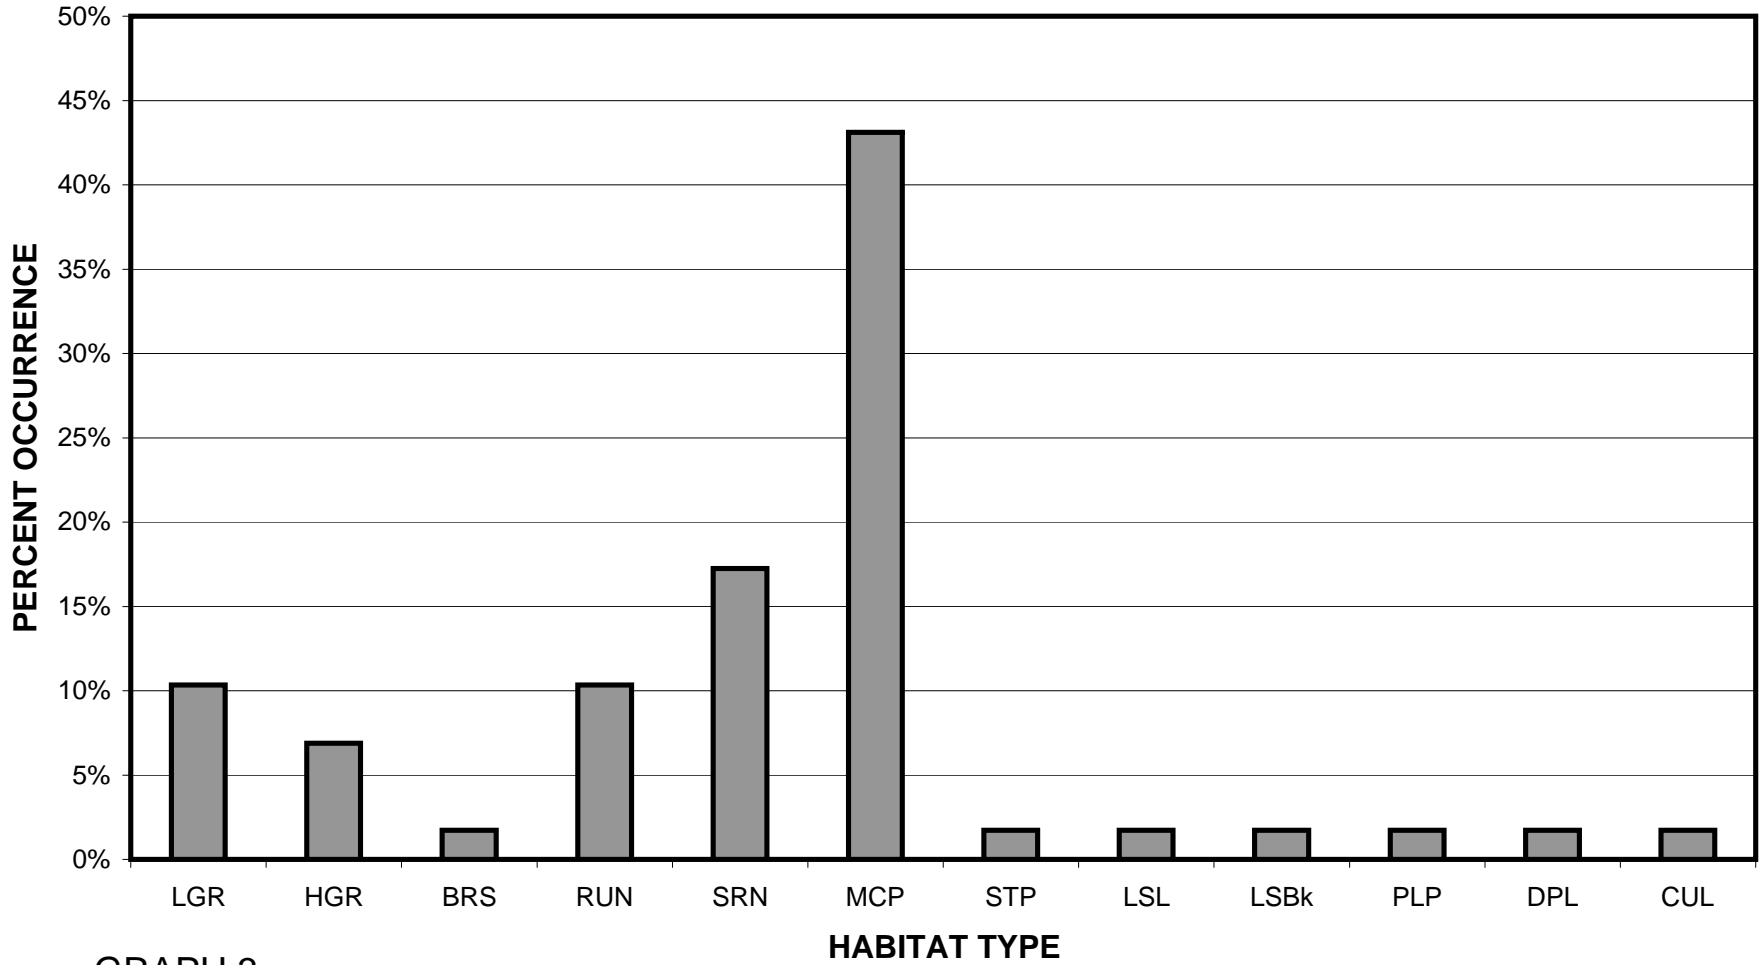
GRAPH 3

Eleven Level IV habitat types were identified (Table 2). The most frequent habitat types by percent occurrence were mid-channel pool units, 43%; step run units, 17%; run units, 10%; and low gradient riffle units, 10% (Graph 3). Based on percent total length, mid-channel pool units made up 42%, step run units 29%, and run units 9%.

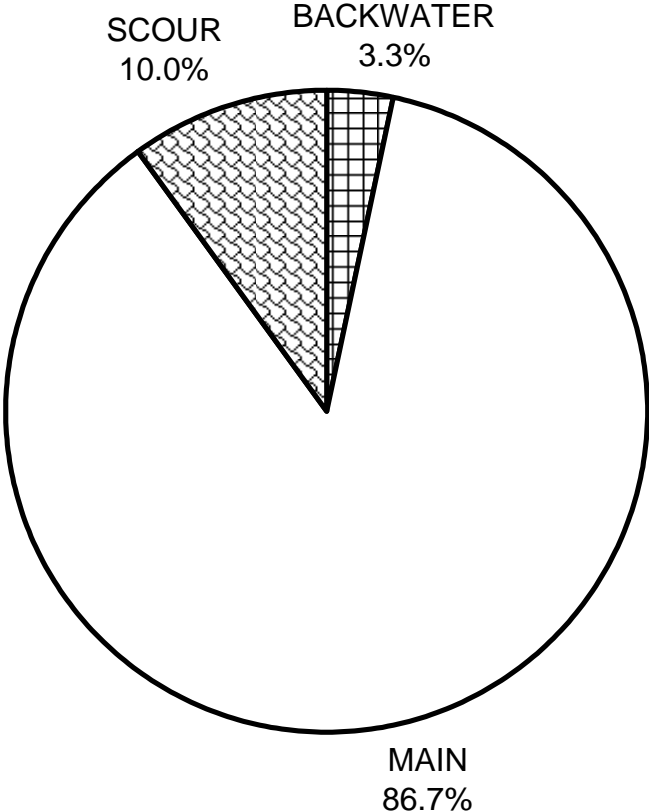
GRAPH 4

A total of 30 pools were identified (Table 3). Main channel pools were the most frequently encountered at 87% (Graph 4), and comprised 89% of the total length of all pools (Table 3).

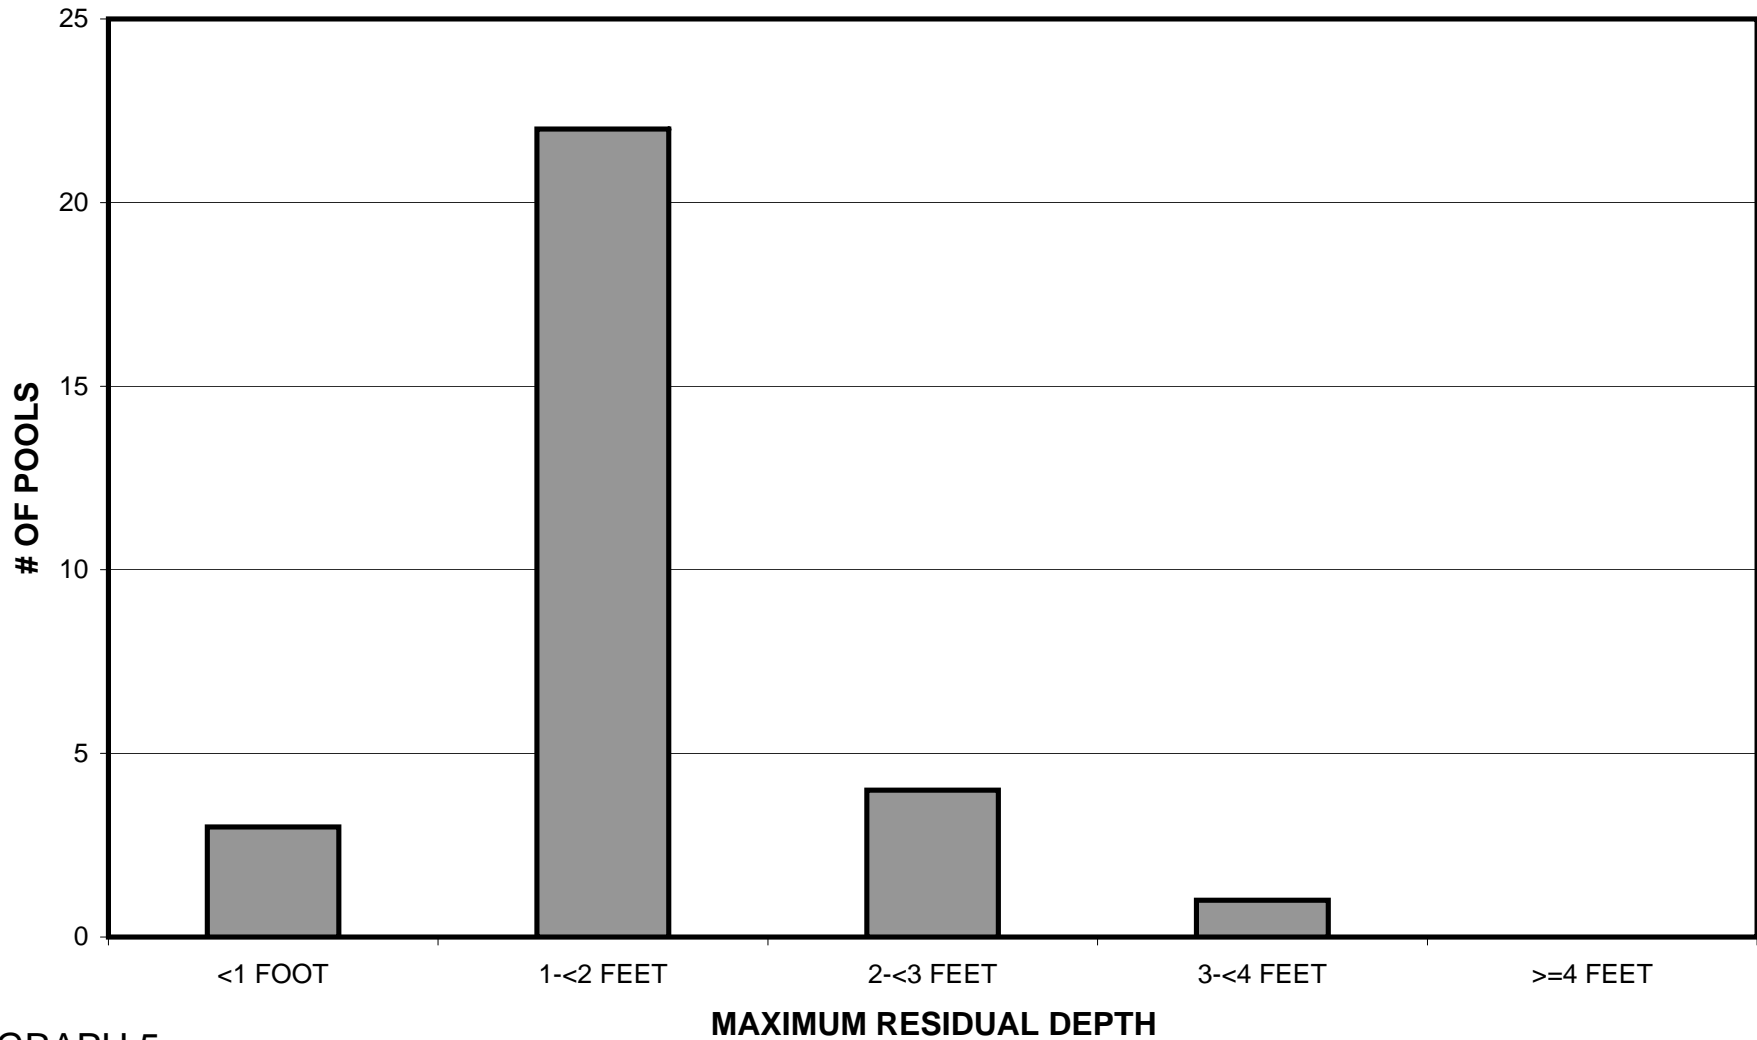
GRAPH 5

Table 4 is a summary of maximum residual pool depths by pool habitat types. Pool quality for salmonids increases with depth. Five of the 30 pools (17%) had a residual depth of two feet or greater (Graph 5).

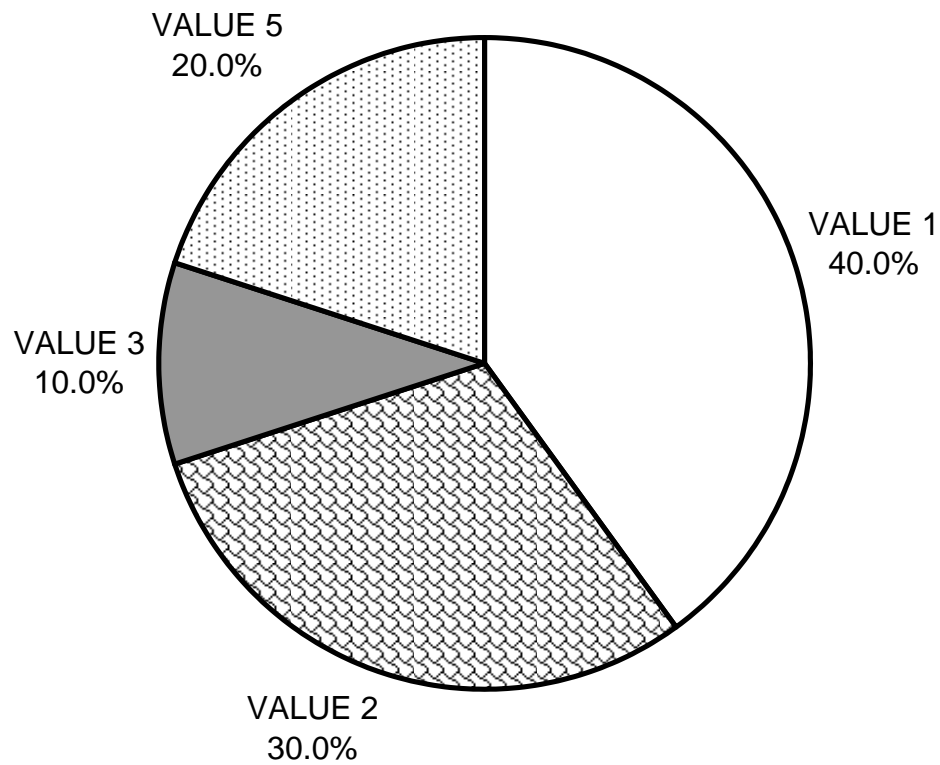
GRAPH 6

The depth of cobble embeddedness was estimated at pool tail-outs. Of the 30 pool tail-outs measured, 12 had a value of 1 (40%); nine had a value of 2 (30%); three had a value of 3 (10%); six had a value of 5 (20%) (Graph 6). On this scale, a value of 1 indicates the best spawning conditions and a value of 4 the worst. Additionally, a value of 5 was assigned to tail-outs deemed not suitable for spawning due to inappropriate substrate such as bedrock, log sills, boulders, or other considerations.

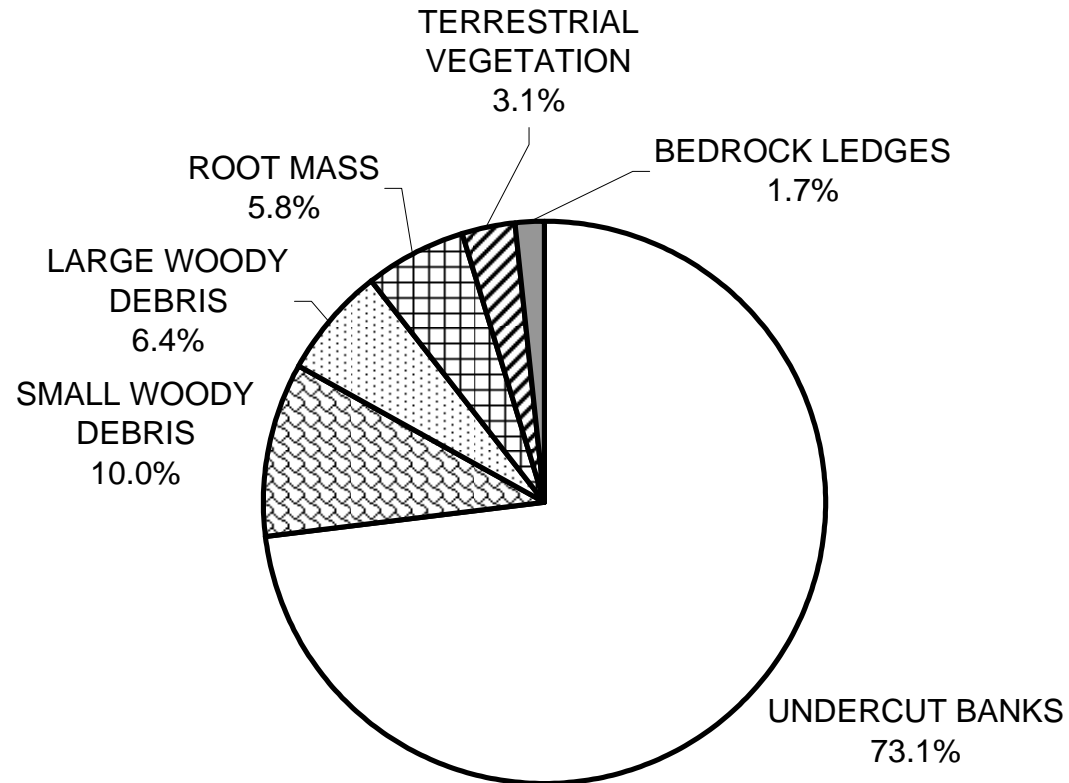
GRAPH 7

Table 5 summarizes mean percent cover by habitat type. Undercut banks are the dominant cover type in the unnamed tributary. Graph 7 describes the pool cover in the unnamed tributary. Undercut banks are the dominant pool cover type followed by small woody debris.

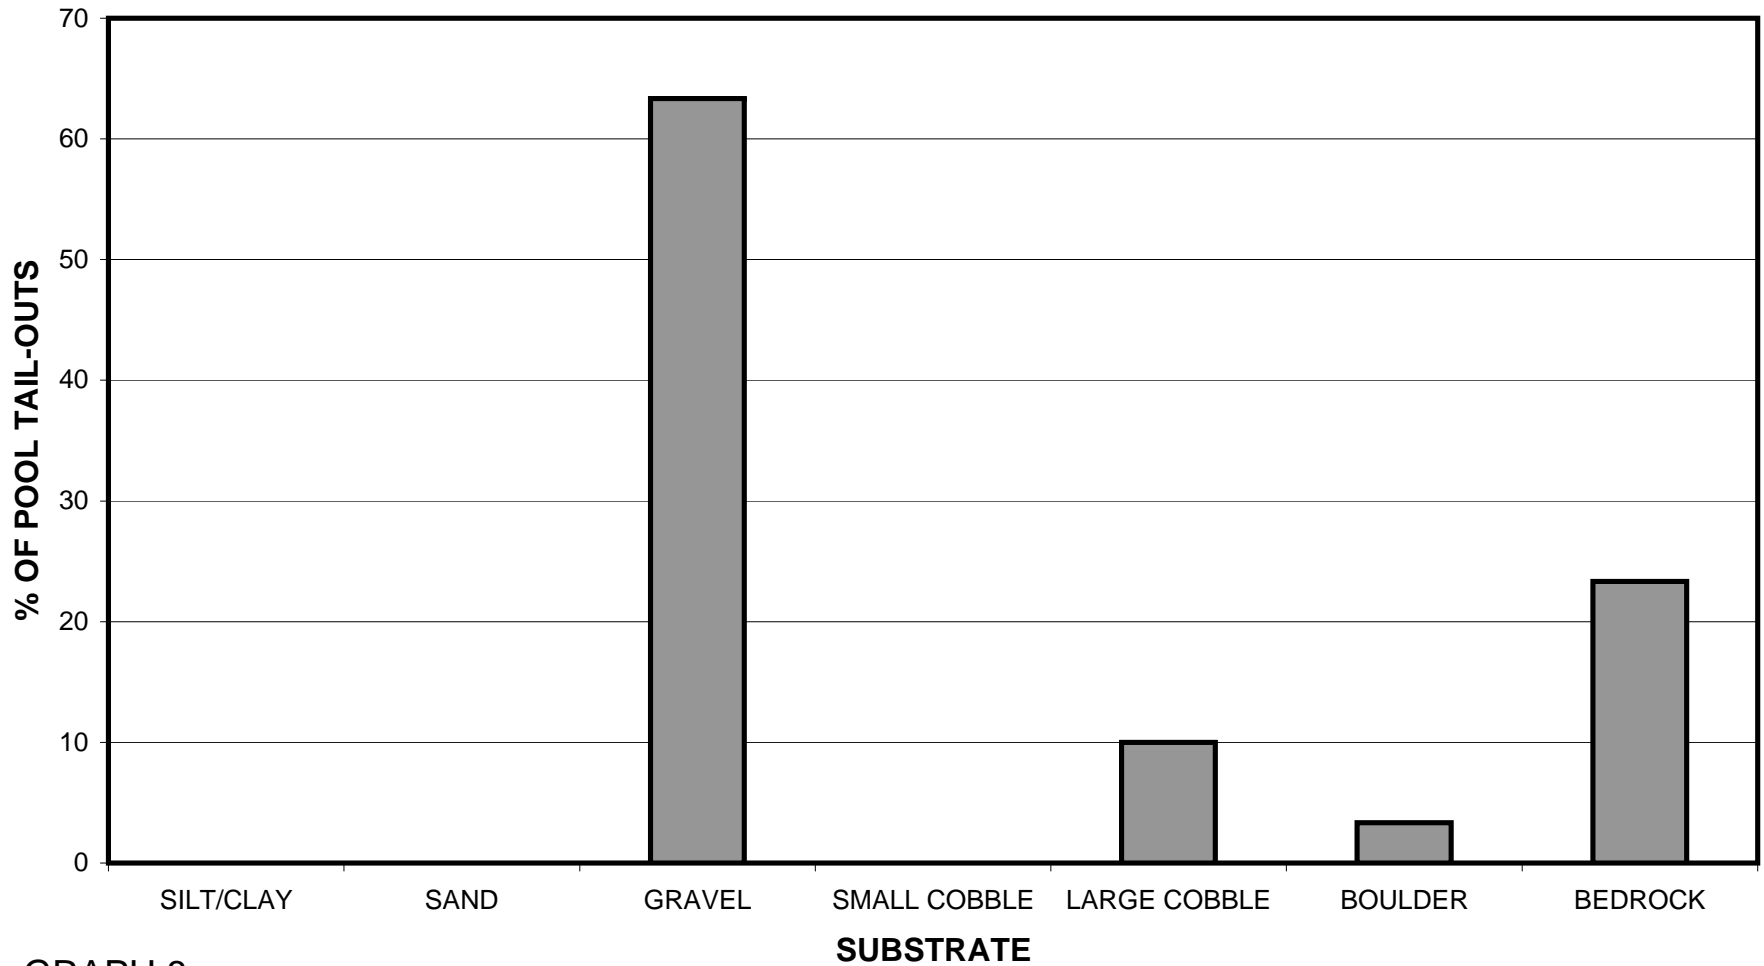
GRAPH 8

Table 6 summarizes the dominant substrate by habitat type. Graph 8 depicts the dominant substrate observed in pool tail-outs. Gravel was the dominant substrate observed in 63% of the pool tail-outs. Bedrock was the next most frequently observed dominant substrate type and occurred in 23% of the pool tail-outs.

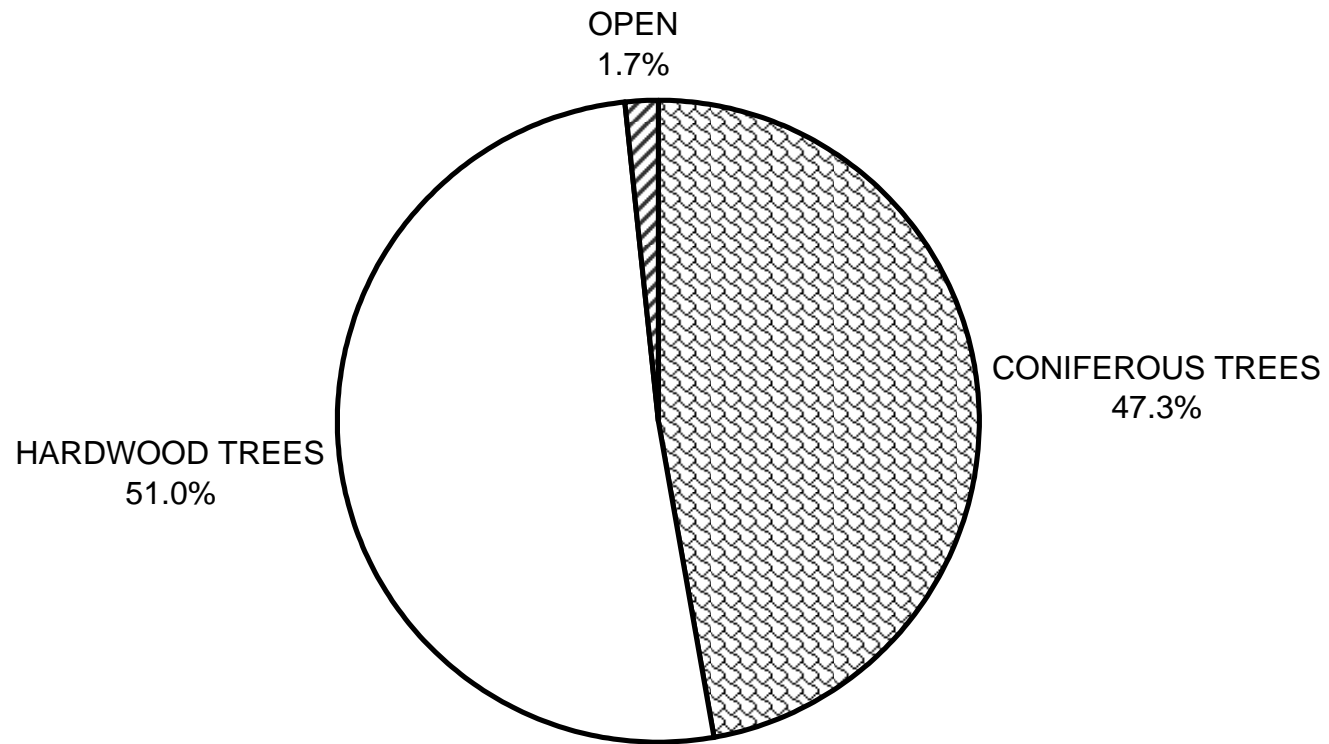
GRAPH 9

The mean percent canopy density for the surveyed length of the unnamed tributary was 98%. Two percent of the canopy was open. Of the canopy present, the mean percentages of hardwood and coniferous trees were 52% and 48%, respectively. Graph 9 describes the mean percent canopy in the unnamed tributary.

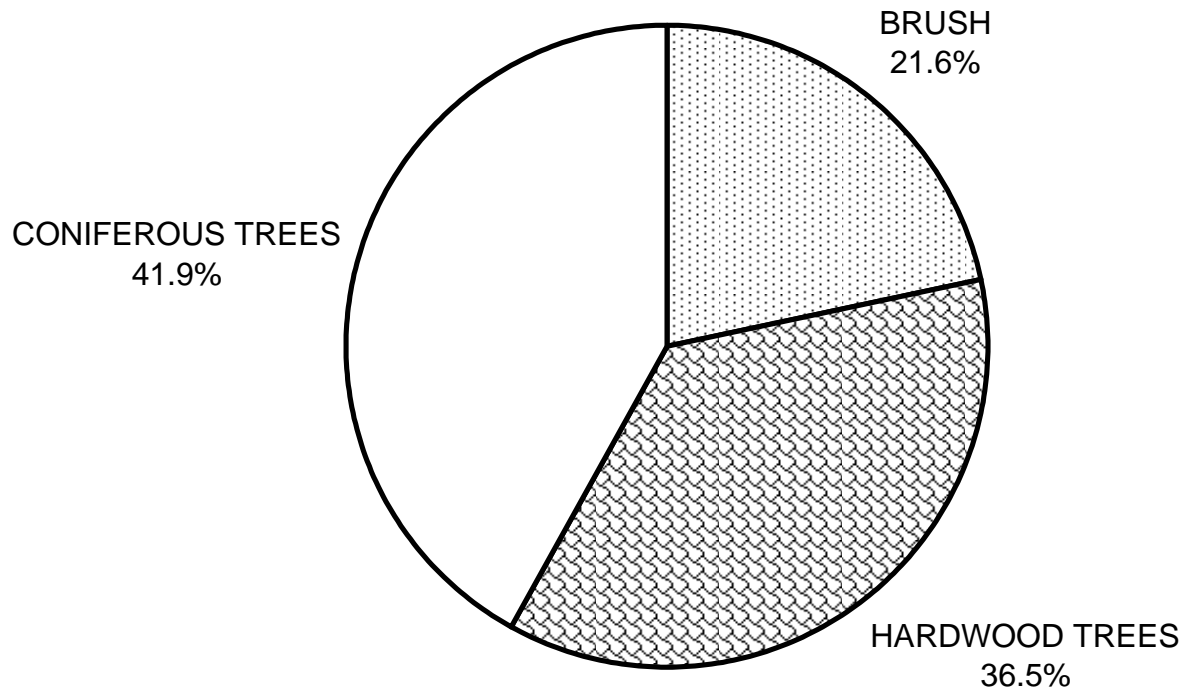
GRAPH 11

For the stream reach surveyed, the mean percent right bank vegetated was 100%. The mean percent left bank vegetated was 100%. The dominant elements composing the structure of the stream banks consisted of 91% sand/silt/clay, 8% bedrock, and 1% cobble/gravel (Graph 10). Coniferous trees were the dominant vegetation type observed in 42% of the units surveyed. Additionally, 37% of the units surveyed had deciduous trees as the dominant vegetation type, and 22% had brush as the dominant vegetation type (Graph 11).
