# STREAM INVENTORY REPORT

## Burbeck Creek

A stream inventory was conducted from May 21 to May 23, 2013 on Burbeck Creek. The survey began at the confluence with the Noyo River and extended upstream 1.2 miles.

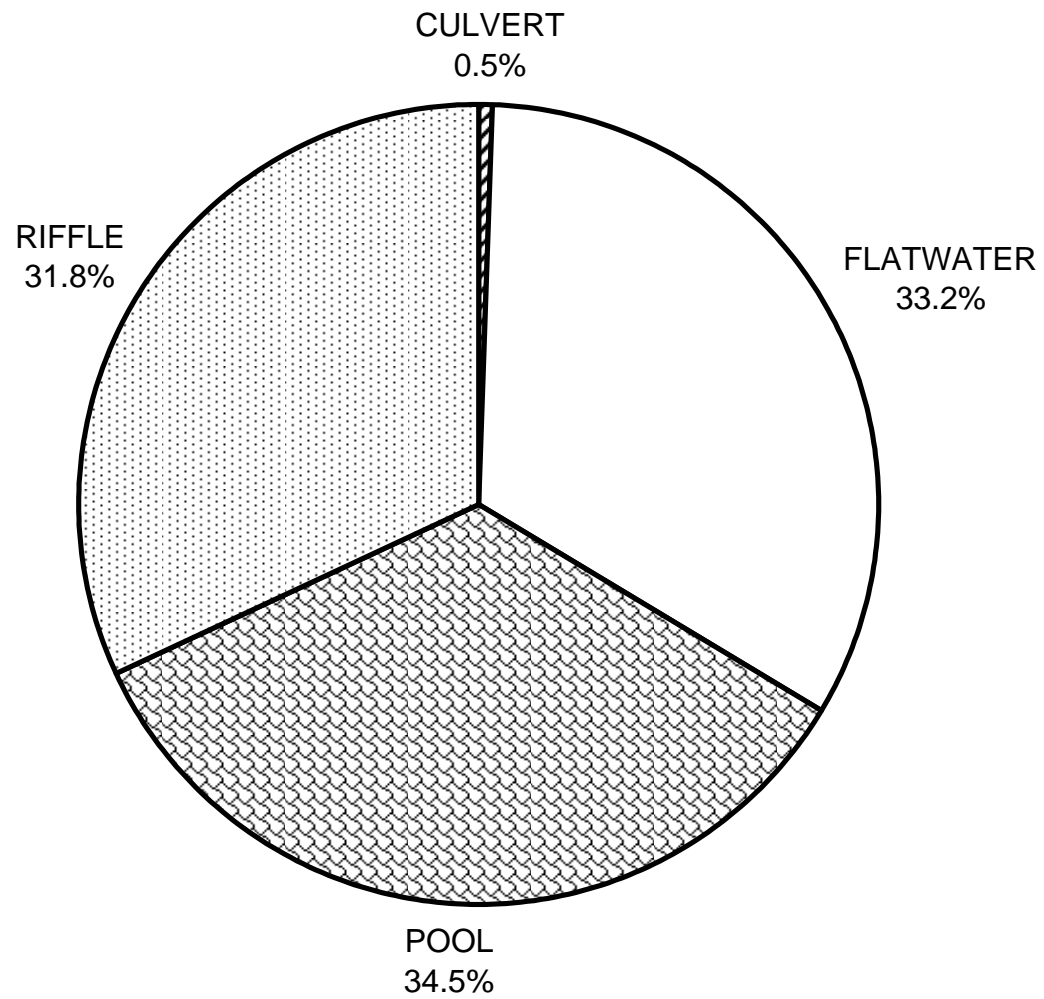
GRAPH 1

Table 1 summarizes the Level II riffle, flatwater, and pool habitat types. Based on frequency of occurrence there were 35% pool units, 33% flatwater units, and 32% riffle units (Graph 1). Based on total length of Level II habitat types there were 55% flatwater units, 23% riffle units, 21% pool units, and 2% culvert units (Graph 2).

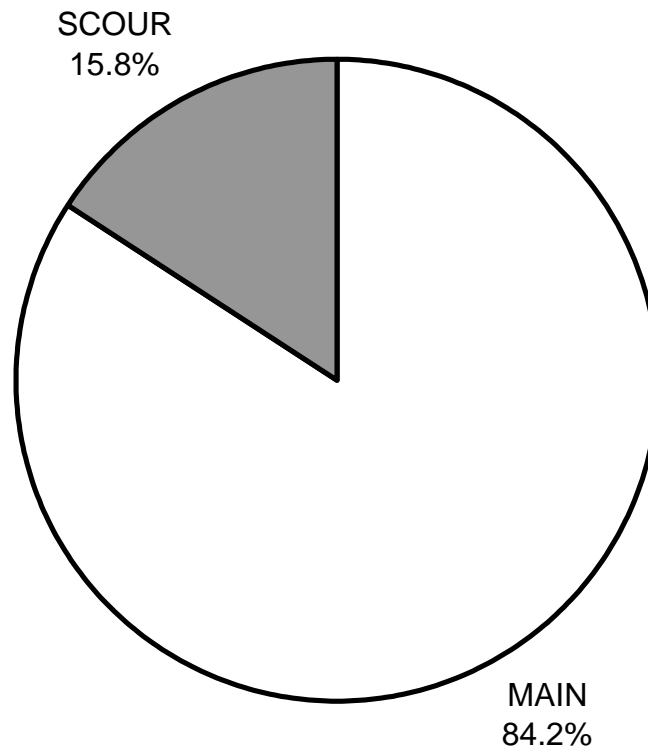
GRAPH 4

A total of 76 pools were identified (Table 3). Main channel pools were the most frequently encountered at 84% (Graph 4), and comprised 84% of the total length of all pools (Table 3).

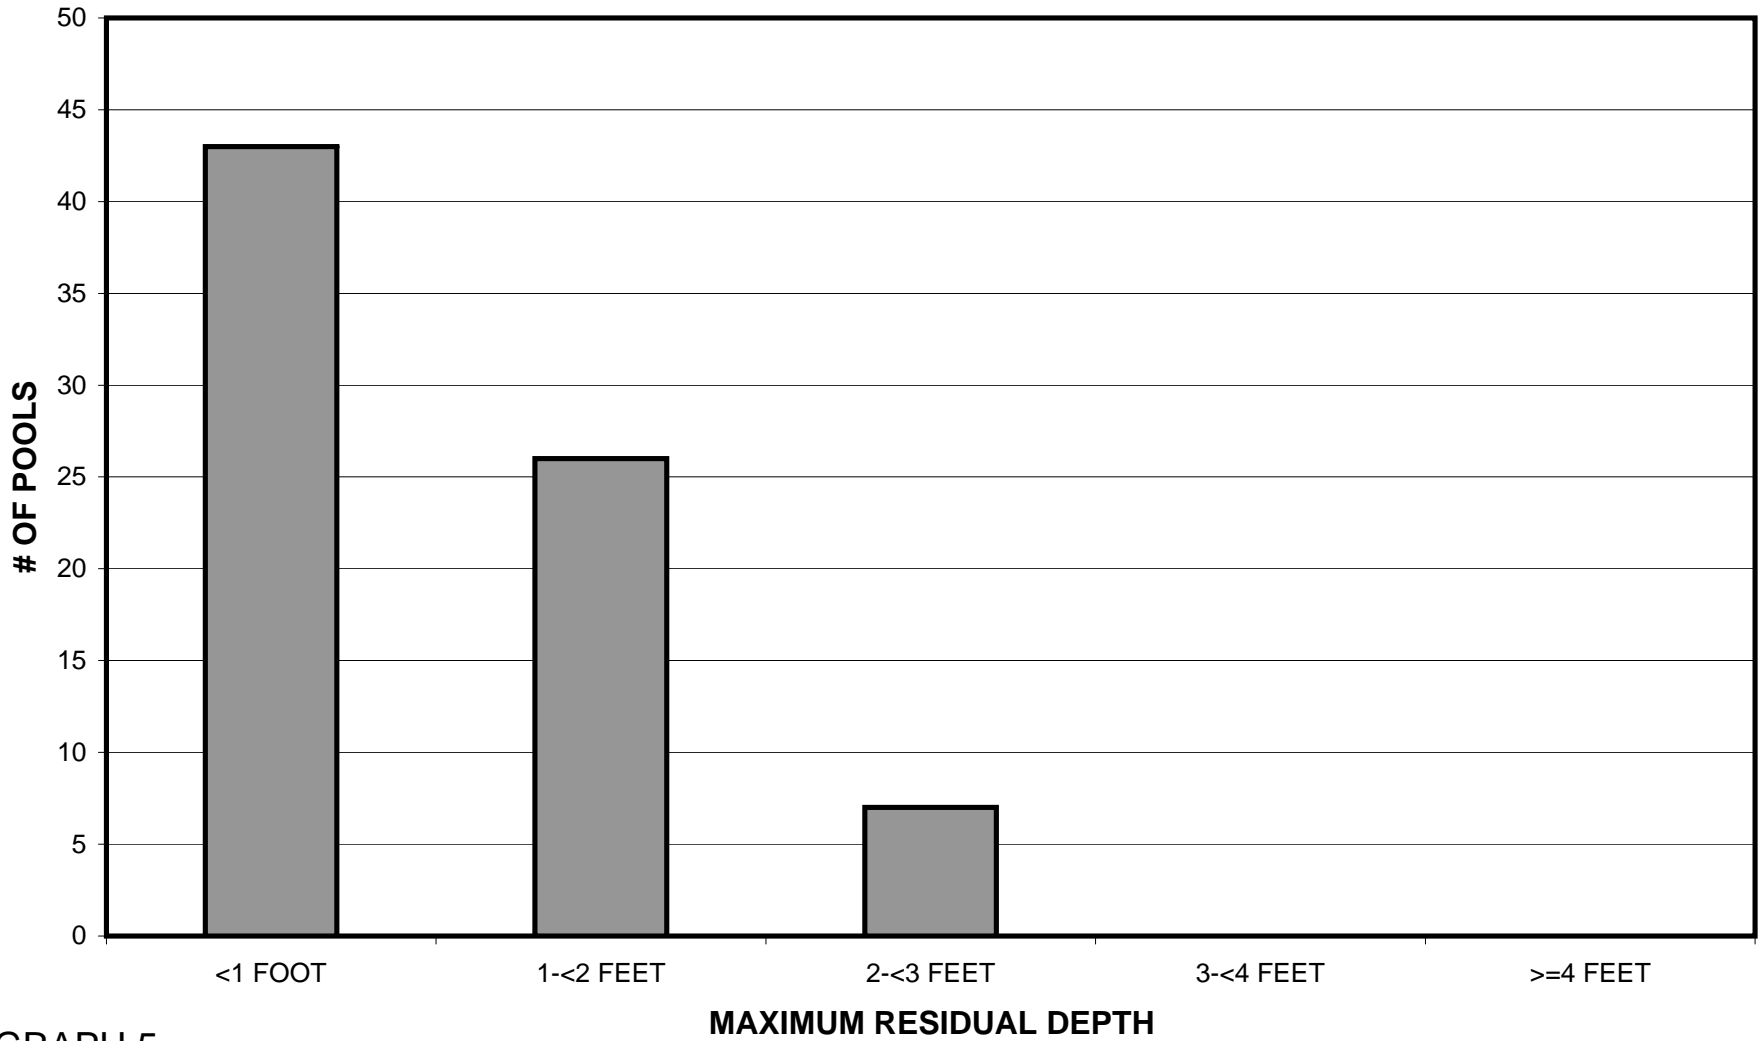
GRAPH 5

Table 4 is a summary of maximum residual pool depths by pool habitat types. Pool quality for salmonids increases with depth. Seven of the 76 pools (9%) had a residual depth of two feet or greater (Graph 5).

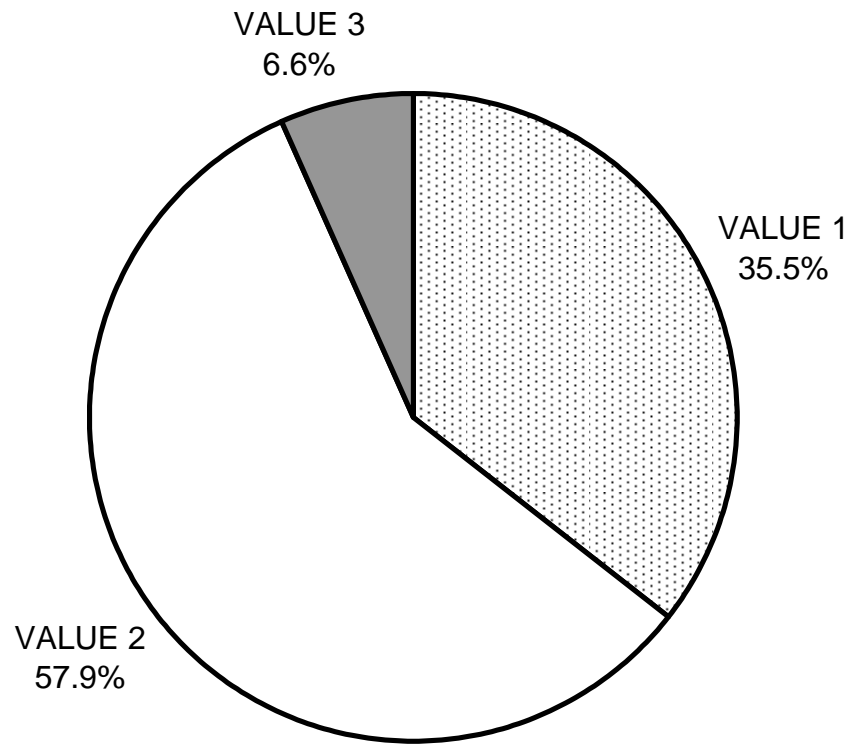
GRAPH 6

The depth of cobble embeddedness was estimated at pool tail-outs. Of the 76 pool tail-outs measured, 27 had a value of 1 (36%); 44 had a value of 2 (58%); five had a value of 3 (7%) (Graph 6). On this scale, a value of 1 indicates the best spawning conditions and a value of 4 the worst. Additionally, a value of 5 was assigned to tail-outs deemed not suitable for spawning due to inappropriate substrate such as bedrock, log sills, boulders, or other considerations.

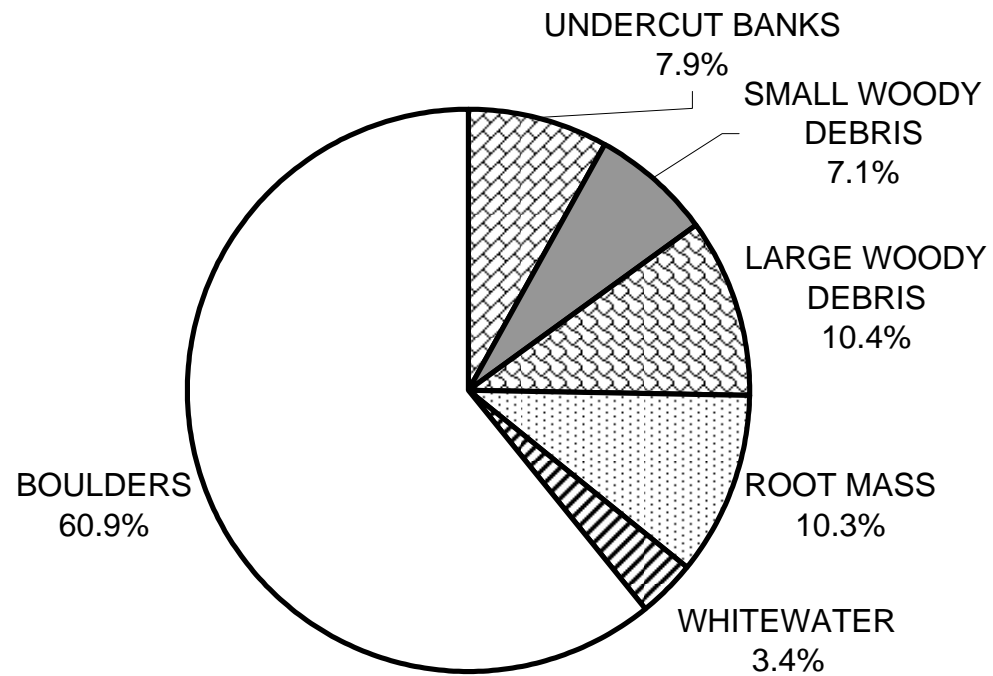
GRAPH 7

Table 5 summarizes mean percent cover by habitat type. Boulders are the dominant cover type in Burbeck Creek. Graph 7 describes the pool cover in Burbeck Creek. Boulders are the dominant pool cover type followed by large woody debris.

- 3) In Reach 1, increase woody cover in the pools and flatwater habitat units. Most of the existing cover in the pools is from boulders. Adding high quality complexity with woody cover in the pools is desirable.

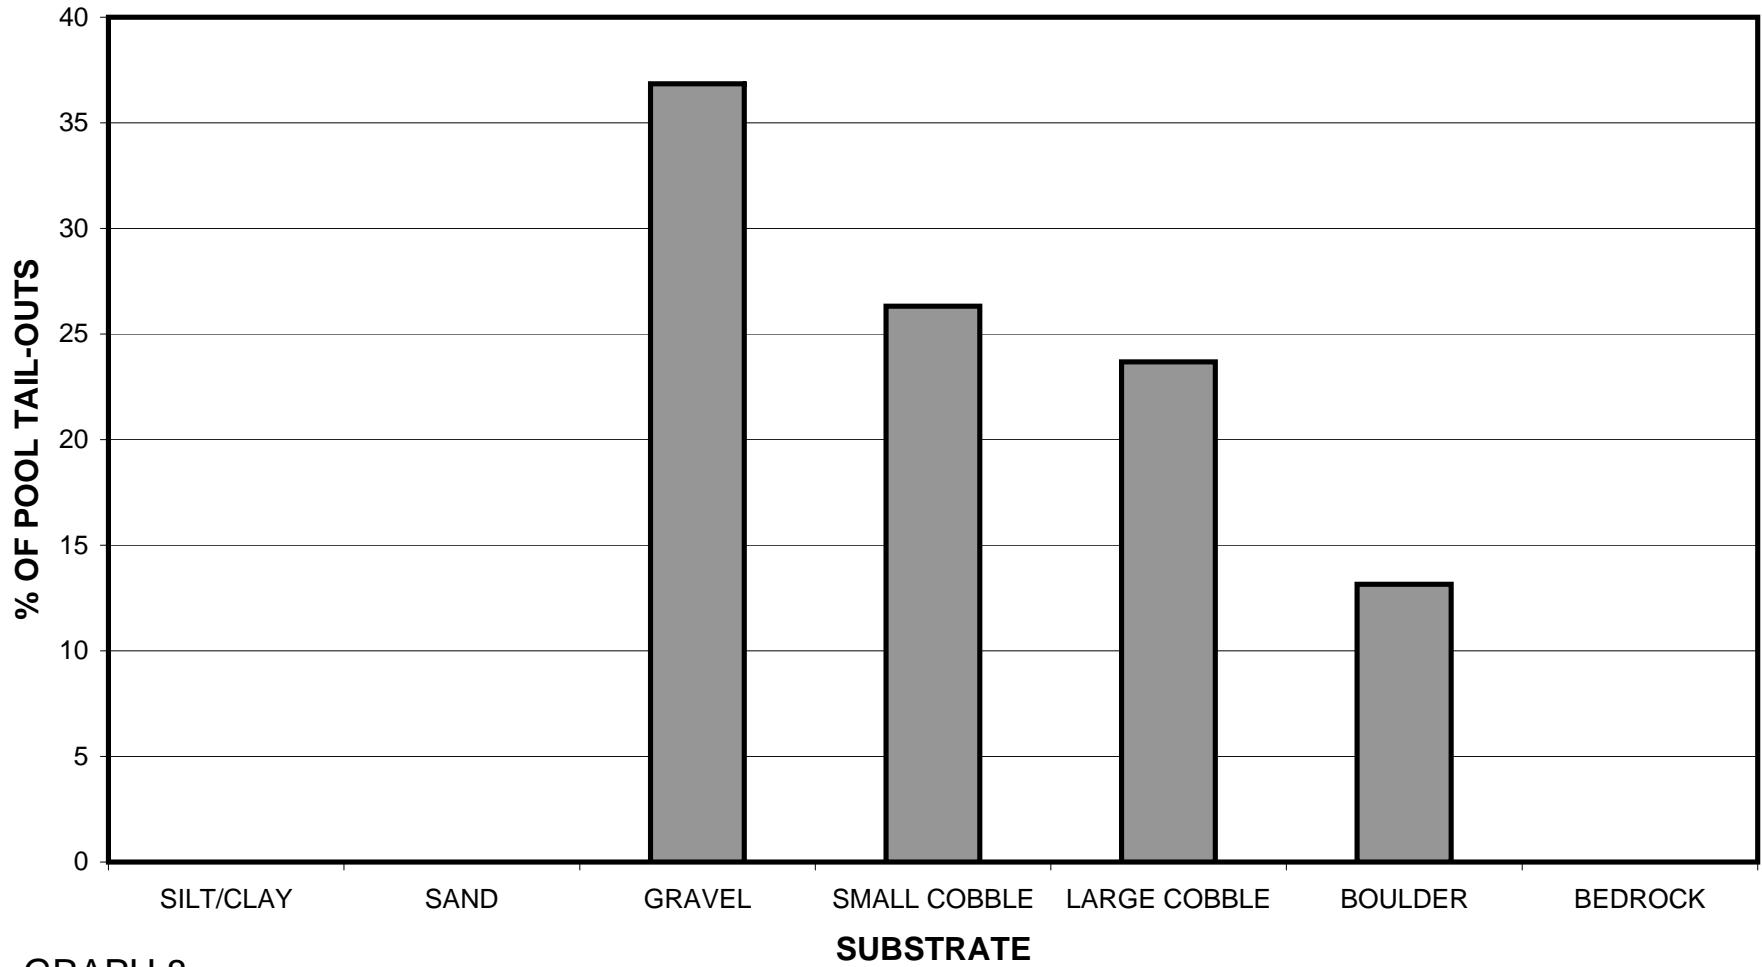
GRAPH 8

Table 6 summarizes the dominant substrate by habitat type. Graph 8 depicts the dominant substrate observed in pool tail-outs. Gravel was the dominant substrate observed in 37% of the pool tail-outs. Small cobble was the next most frequently observed dominant substrate type and occurred in 26% of the pool tail-outs.

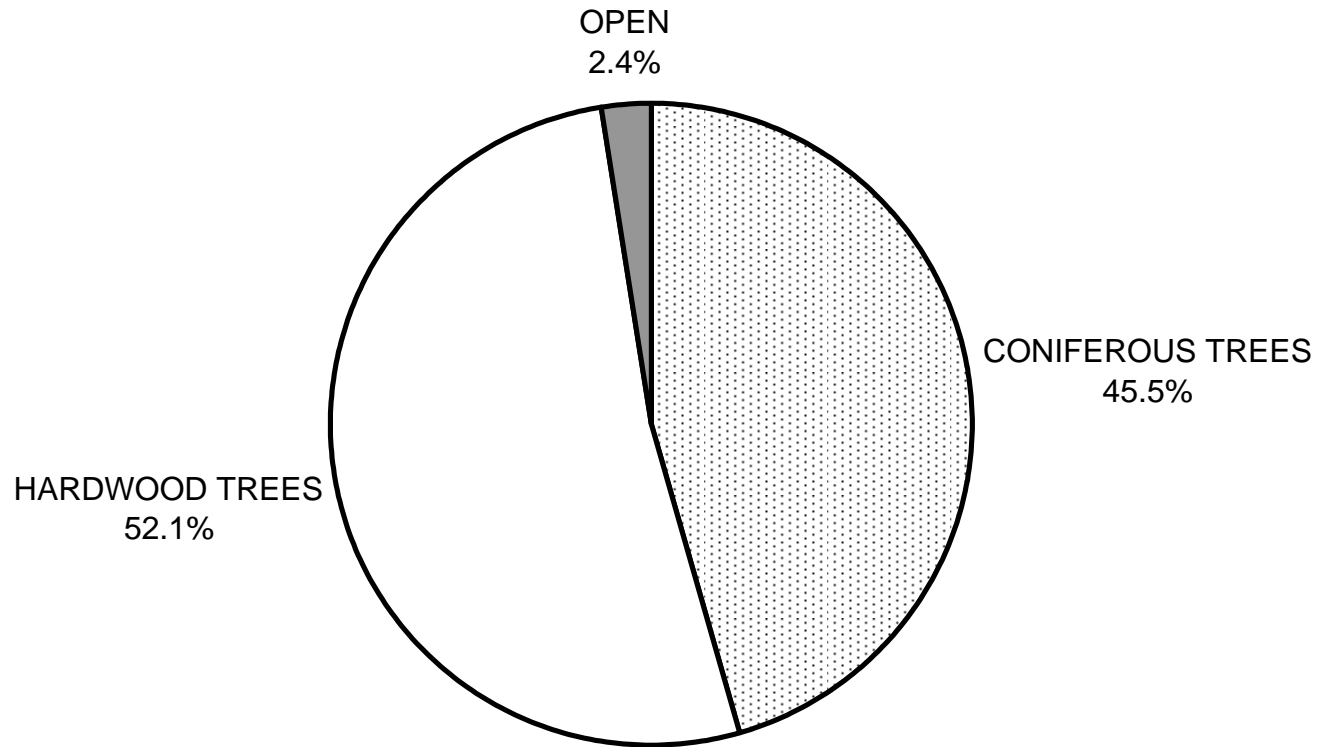
GRAPH 9

The mean percent canopy density for the surveyed length of Burbeck Creek was 98%. Two percent of the canopy was open. Of the canopy present, the mean percentages of hardwood and coniferous trees were 53% and 47%, respectively. Graph 9 describes the mean percent canopy in Burbeck Creek.

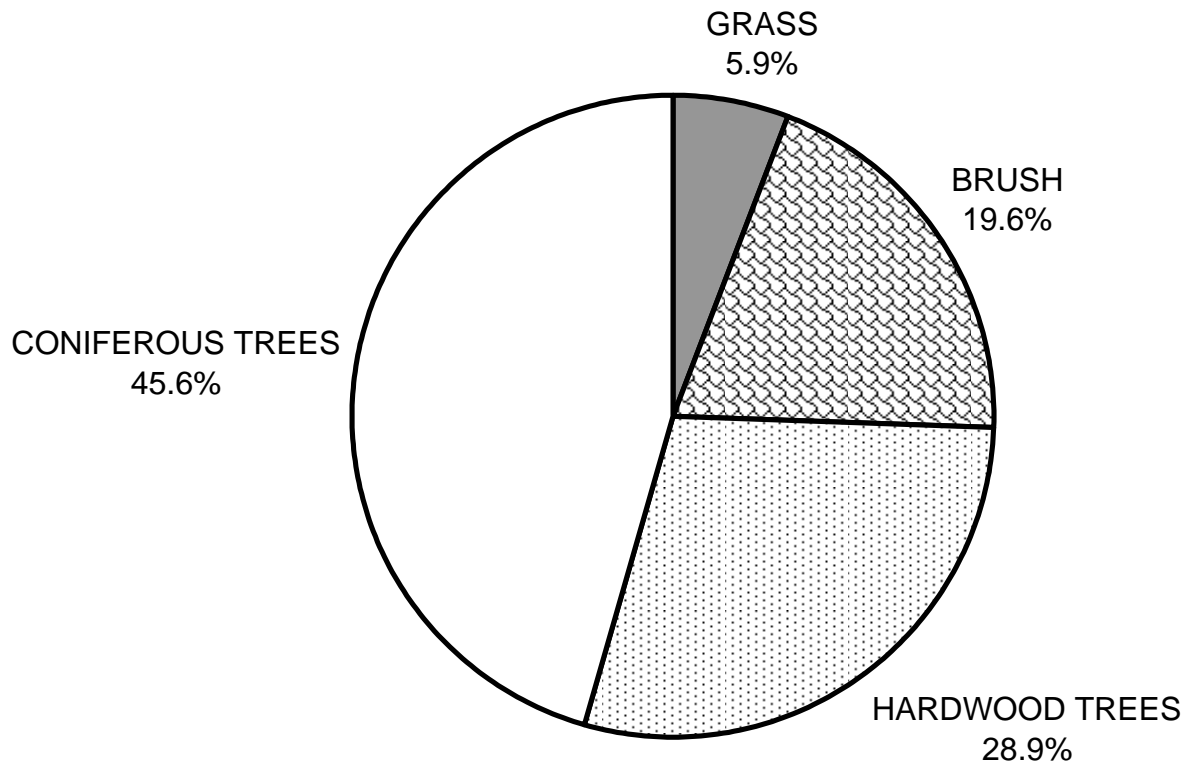
GRAPH 11

For the stream reach surveyed, the mean percent right bank vegetated was 96%. The mean percent left bank vegetated was 91%. The dominant elements composing the structure of the stream banks consisted of 45% cobble/gravel, 32% sand/silt/clay, 21% boulders, and 1% bedrock (Graph 10). Coniferous trees were the dominant vegetation type observed in 46% of the units surveyed. Additionally, 29% of the units surveyed had hardwood trees as the dominant vegetation type, and 20% had brush as the dominant vegetation type (Graph 11).
