STREAM INVENTORY REPORT

“Panther Gulch”

A stream inventory was conducted from July 22 to July 30, 2013 on an unnamed tributary to Hayworth Creek commonly known as, and herein after referred to as, Panther Gulch. The survey began at the confluence with Hayworth Creek and extended upstream 0.8 miles.

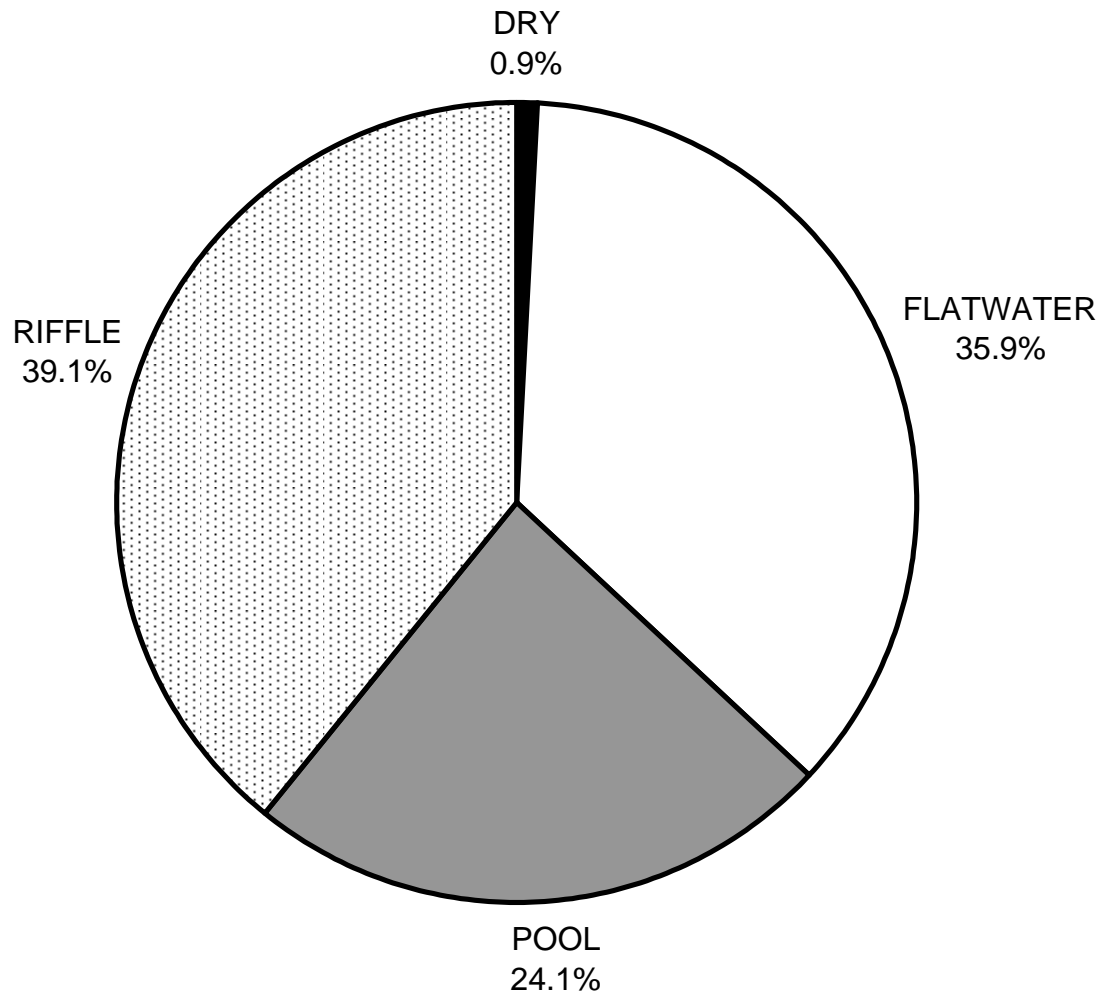
GRAPH 1

Table 1 summarizes the Level II riffle, flatwater, and pool habitat types. Based on frequency of occurrence there were 39% riffle units, 36% flatwater units, 24% pool units, and 1% dry units (Graph 1). Based on total length of Level II habitat types there were 53% flatwater units, 30% riffle units, 17% pool units, and 1% dry units (Graph 2).

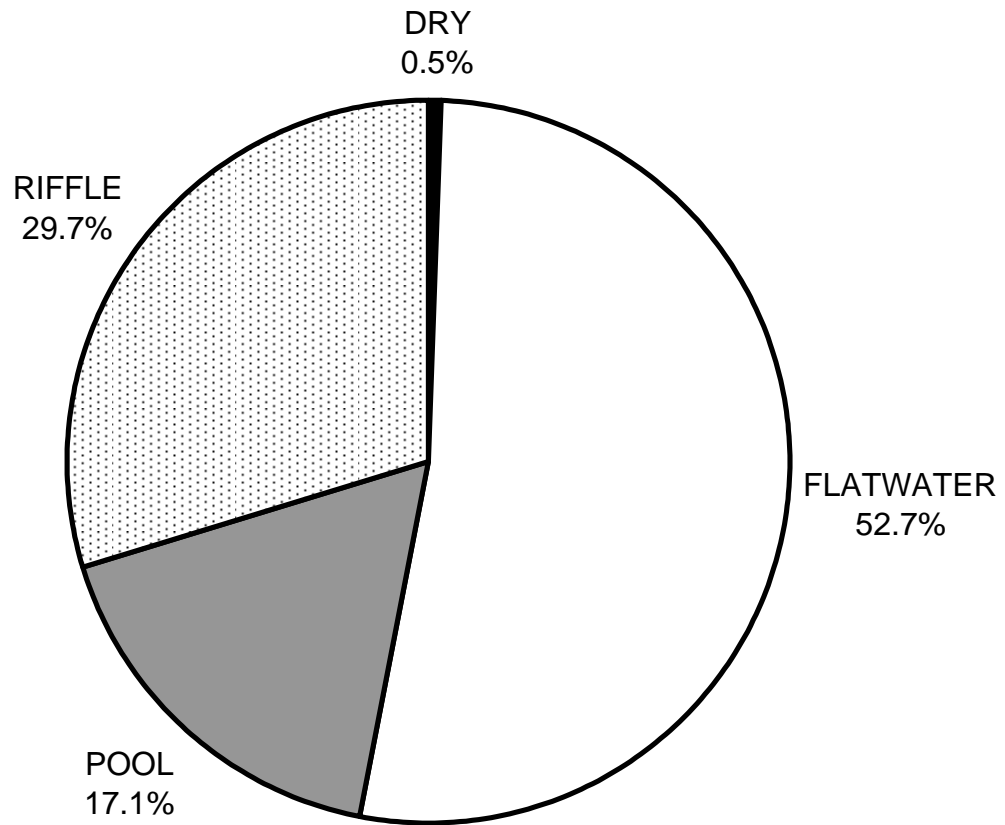
GRAPH 2

Flatwater habitat types comprised 53% of the total length of this survey, riffles 30%, and pools 17%. One of the 53 (2%) pools had a maximum residual depth greater than two feet. In general, pool enhancement projects are considered when primary pools comprise less than 40% of the length of total stream habitat. In first and second order streams, a primary pool is defined to have a maximum residual depth of at least two feet, occupy at least half the width of the low flow channel, and be as long as the low flow channel width. Installing structures that will increase or deepen pool habitat is recommended.

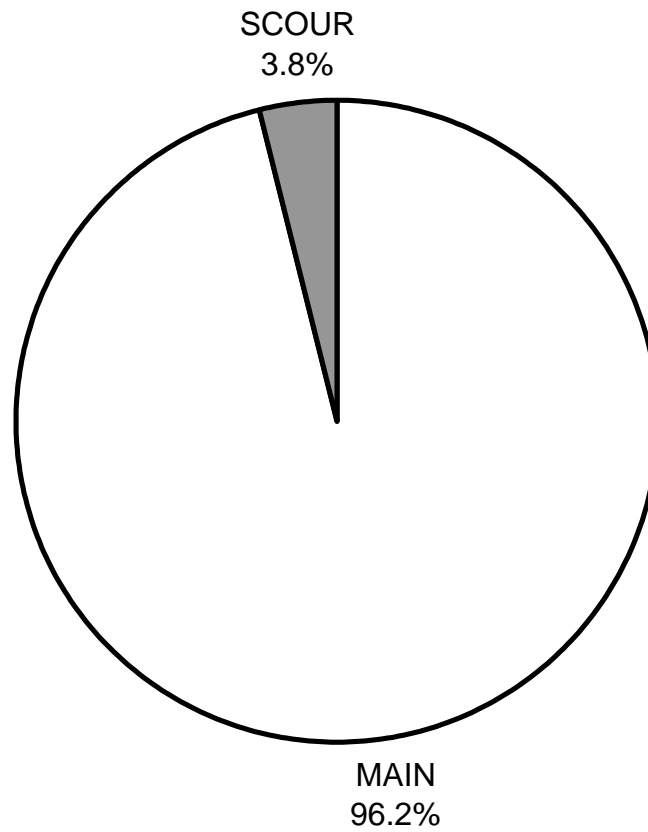
GRAPH 4

A total of 53 pools were identified (Table 3). Main channel pools were the most frequently encountered at 96% (Graph 4), and comprised 96% of the total length of all pools (Table 3).

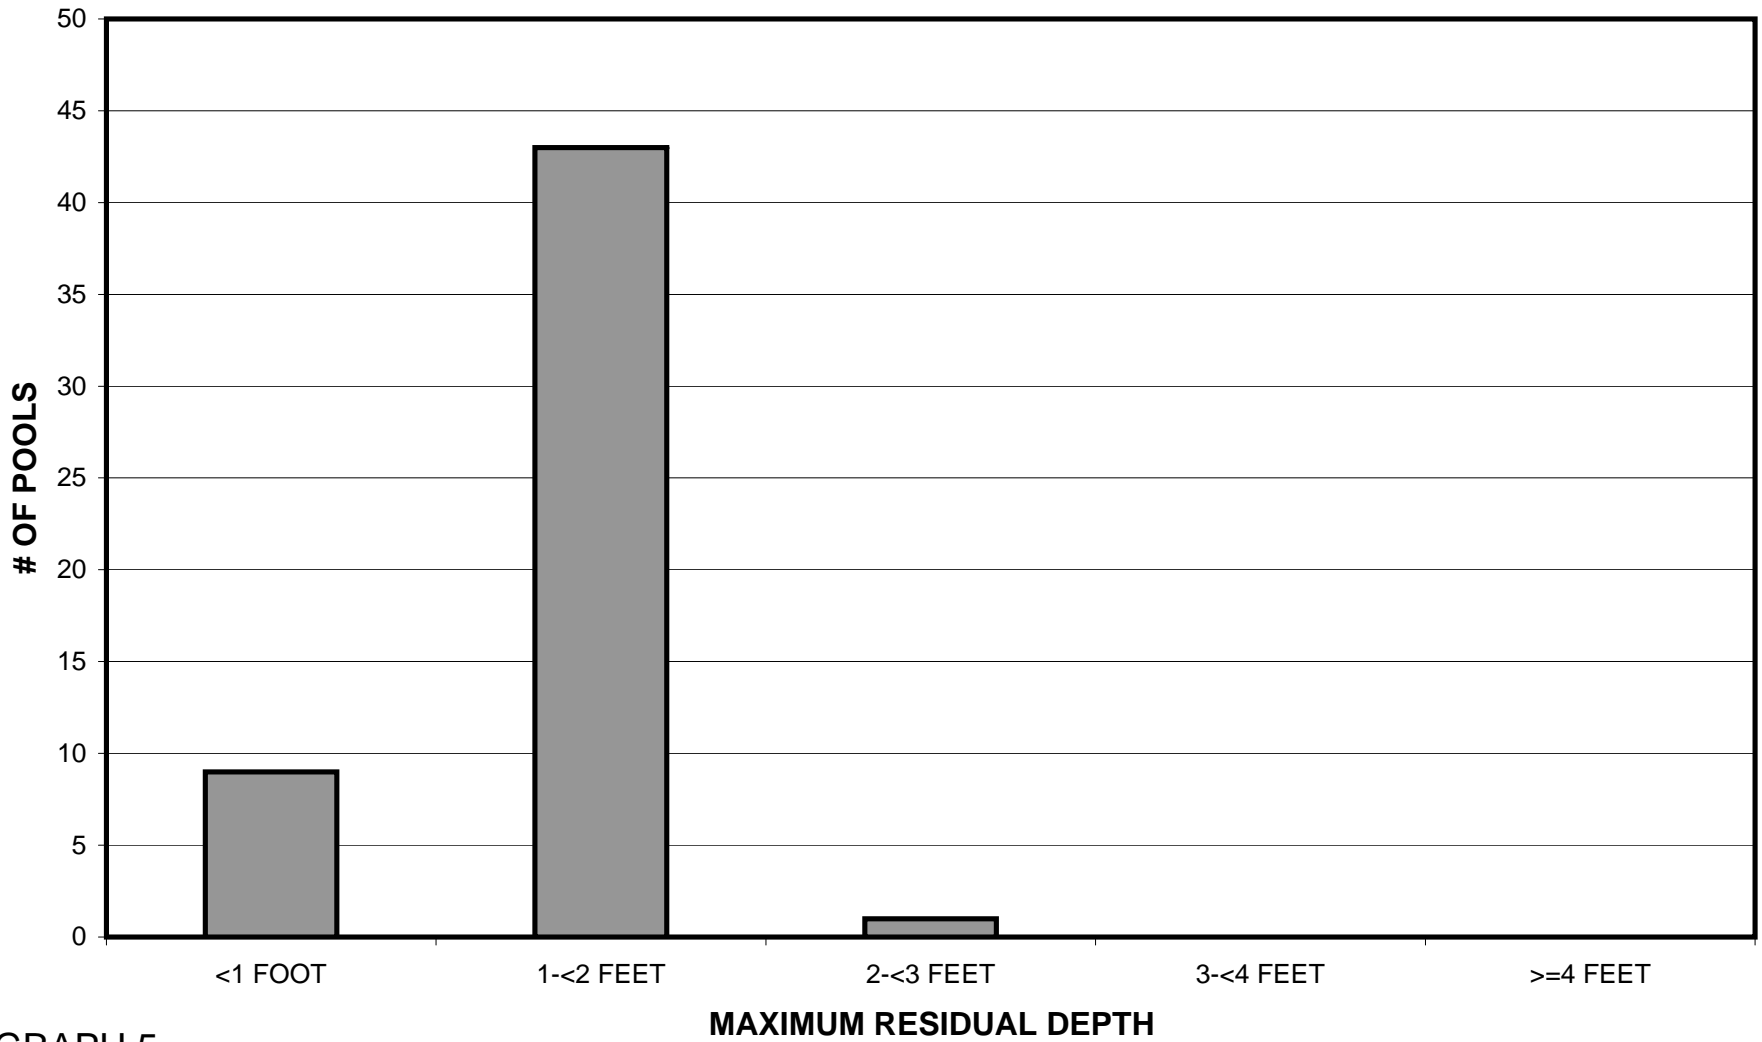
GRAPH 5

Table 4 is a summary of maximum residual pool depths by pool habitat types. Pool quality for salmonids increases with depth. One of the 53 pools (2%) had a residual depth of two feet or greater (Graph 5).

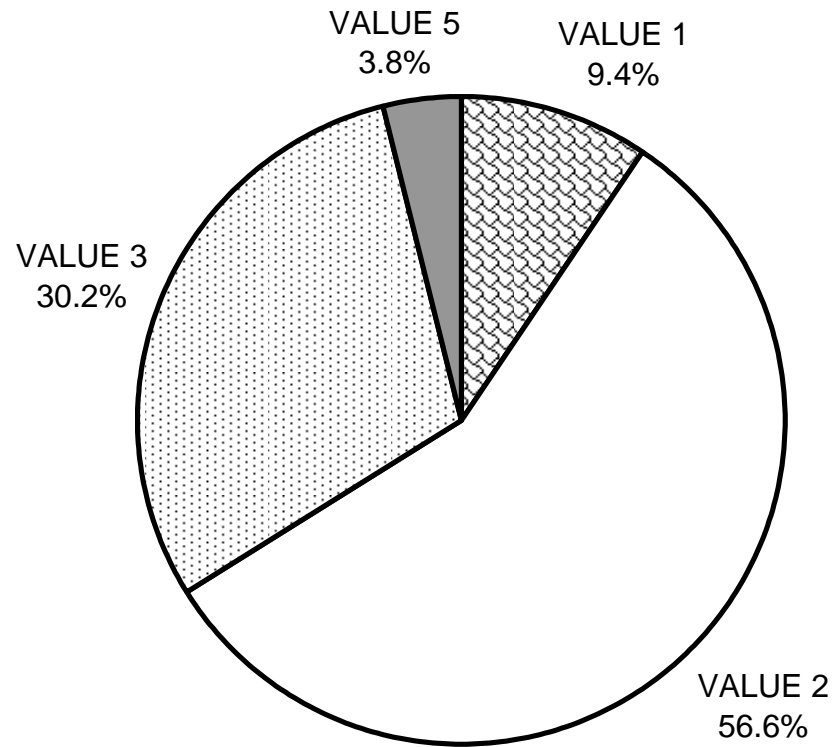
GRAPH 6

The depth of cobble embeddedness was estimated at pool tail-outs. Of the 53 pool tail-outs measured, five had a value of 1 (9%); 30 had a value of 2 (57%); 16 had a value of 3 (30%); two had a value of 5 (4%) (Graph 6). On this scale, a value of 1 indicates the best spawning conditions and a value of 4 the worst. Additionally, a value of 5 was assigned to tail-outs deemed not suitable for spawning due to inappropriate substrate such as bedrock, log sills, boulders, or other considerations.

Thirty-five of the 53 pool tail-outs measured had embeddedness ratings of 1 or 2. Sixteen of the pool tail-outs had embeddedness ratings of 3 or 4. Two of the pool tail-outs had a rating of 5, which is considered not suitable for spawning. Cobble embeddedness measured to be 25% or less, a rating of 1, is considered to indicate good quality spawning substrate for salmon and steelhead.

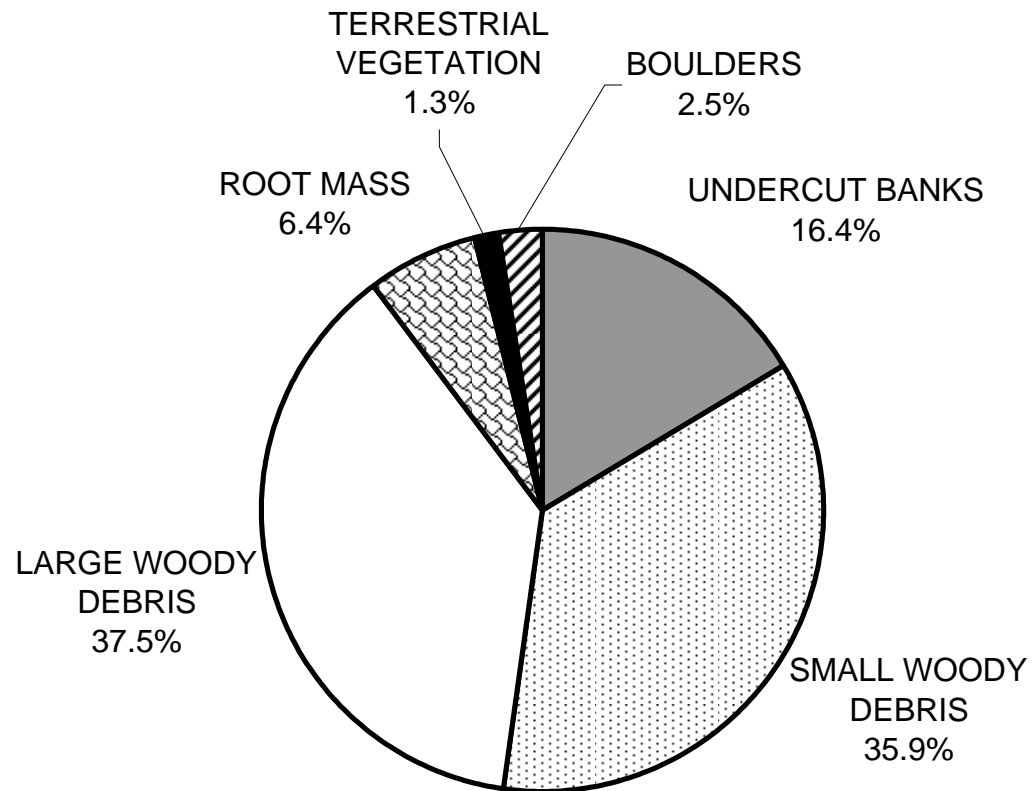
GRAPH 7

Table 5 summarizes mean percent cover by habitat type. Large woody debris is the dominant cover type in Panther Gulch. Graph 7 describes the pool cover in Panther Gulch. Large woody debris is the dominant pool cover type followed by small woody debris.

The mean shelter rating for pools is 37. The shelter rating in the flatwater habitats is 14. A pool shelter rating of approximately 100 is desirable. The amount of cover that now exists is being provided primarily by large woody debris in Panther Gulch. Large woody debris is the dominant cover type in pools followed by small woody debris. Log and root wad cover structures in the pool and flatwater habitats would enhance both summer and winter salmonid habitat. Log cover structures provide rearing fry with protection from predation, rest from water velocity, and also divide territorial units to reduce density related competition.

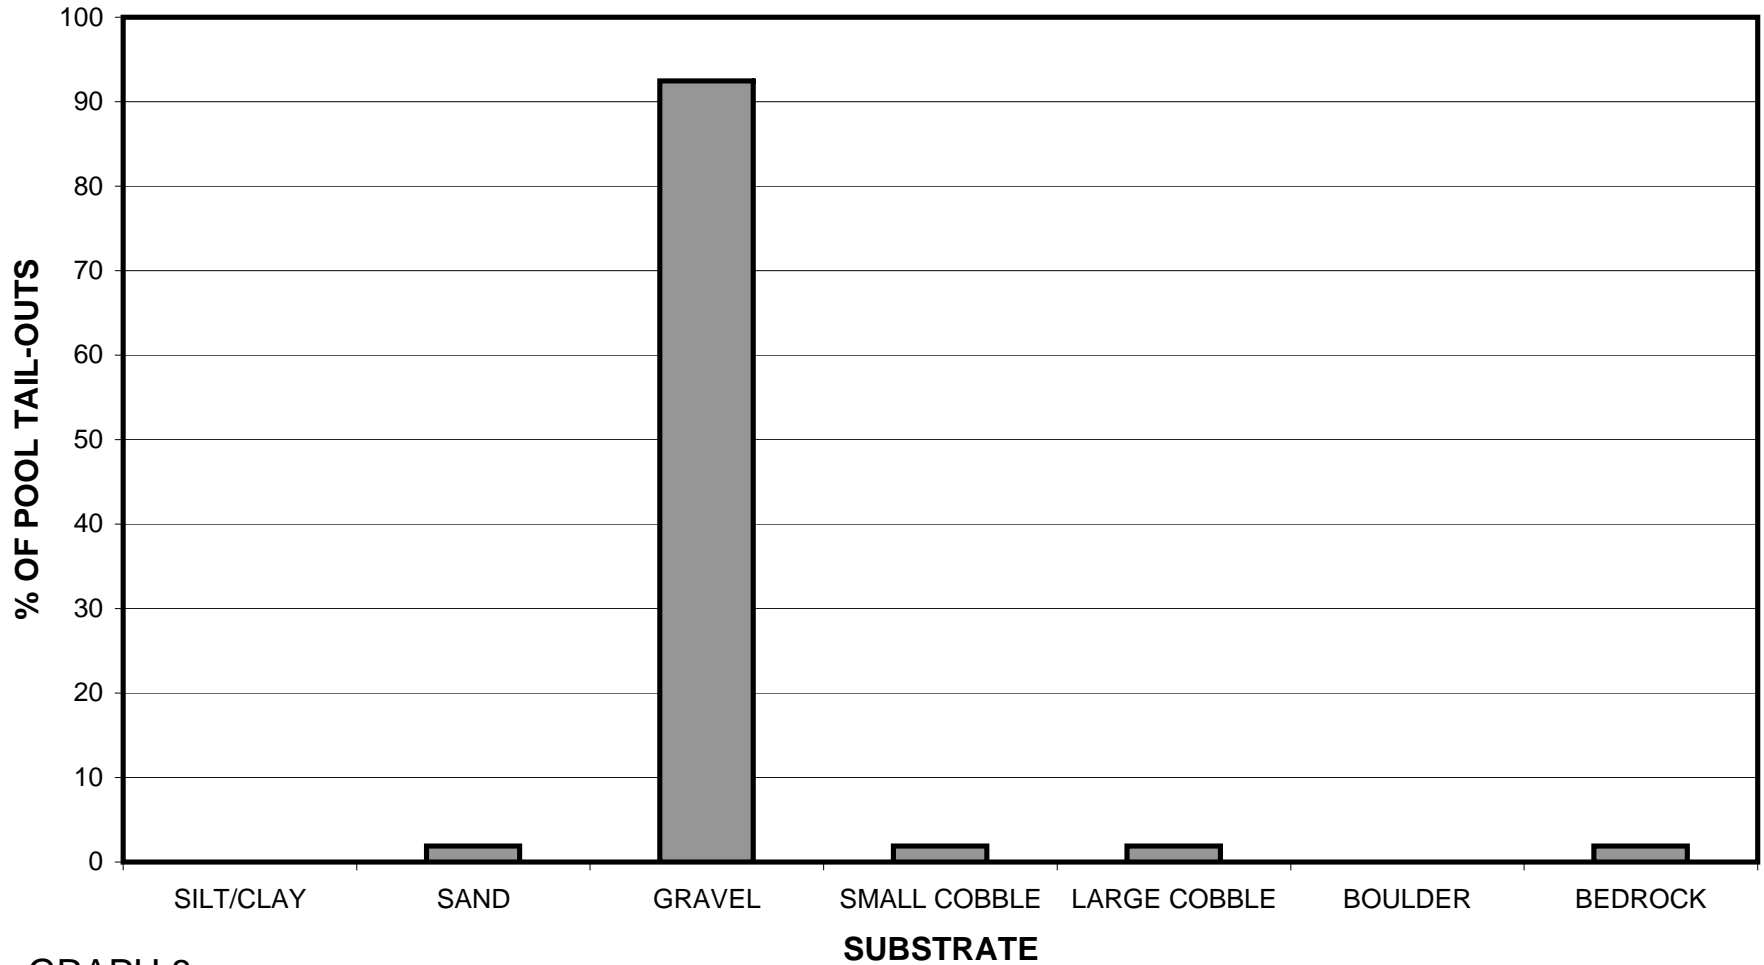
GRAPH 8

Table 6 summarizes the dominant substrate by habitat type. Graph 8 depicts the dominant substrate observed in pool tail-outs. Gravel was the dominant substrate observed in 92% of the pool tail-outs.

Fifty of the 53 pool tail-outs measured had gravel or small cobble as the dominant substrate. This is generally considered good for spawning salmonids.

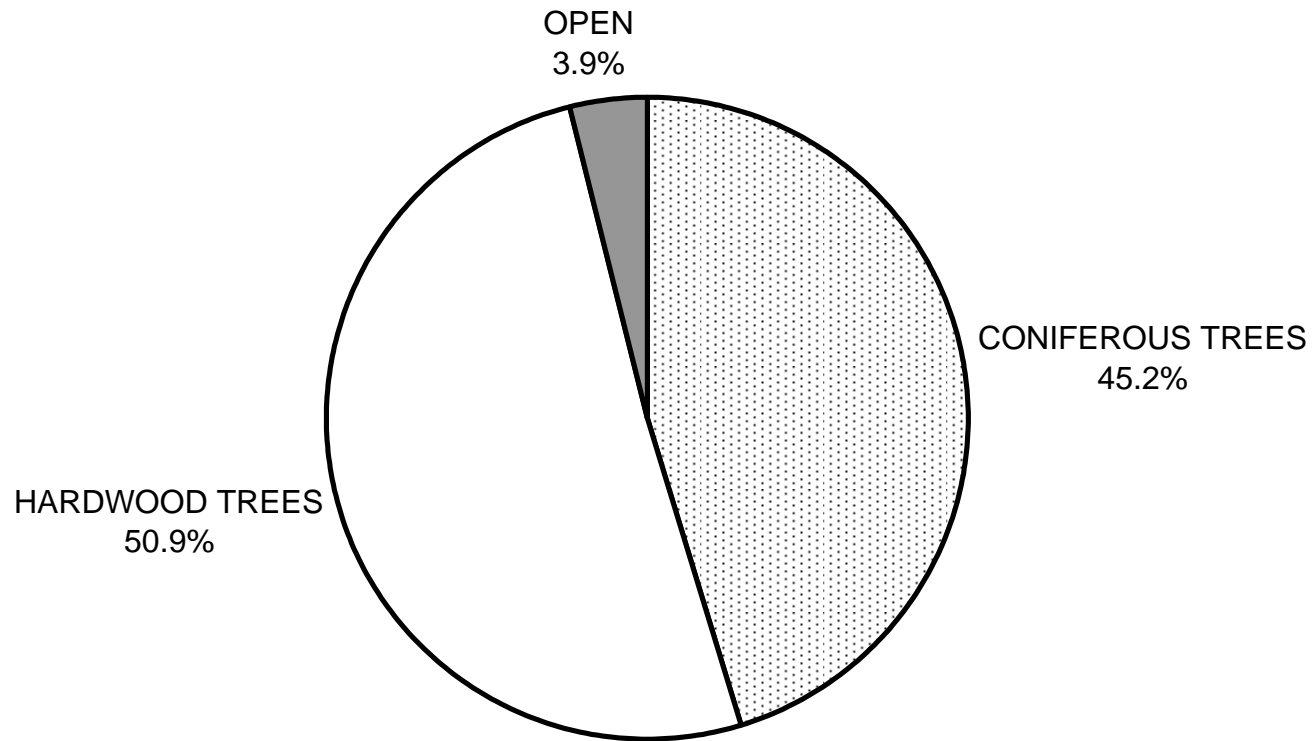
GRAPH 9

The mean percent canopy density for the surveyed length of Panther Gulch was 96%. Four percent of the canopy was open. Of the canopy present, the mean percentages of hardwood and coniferous trees were 53% and 47%, respectively. Graph 9 describes the mean percent canopy in Panther Gulch.

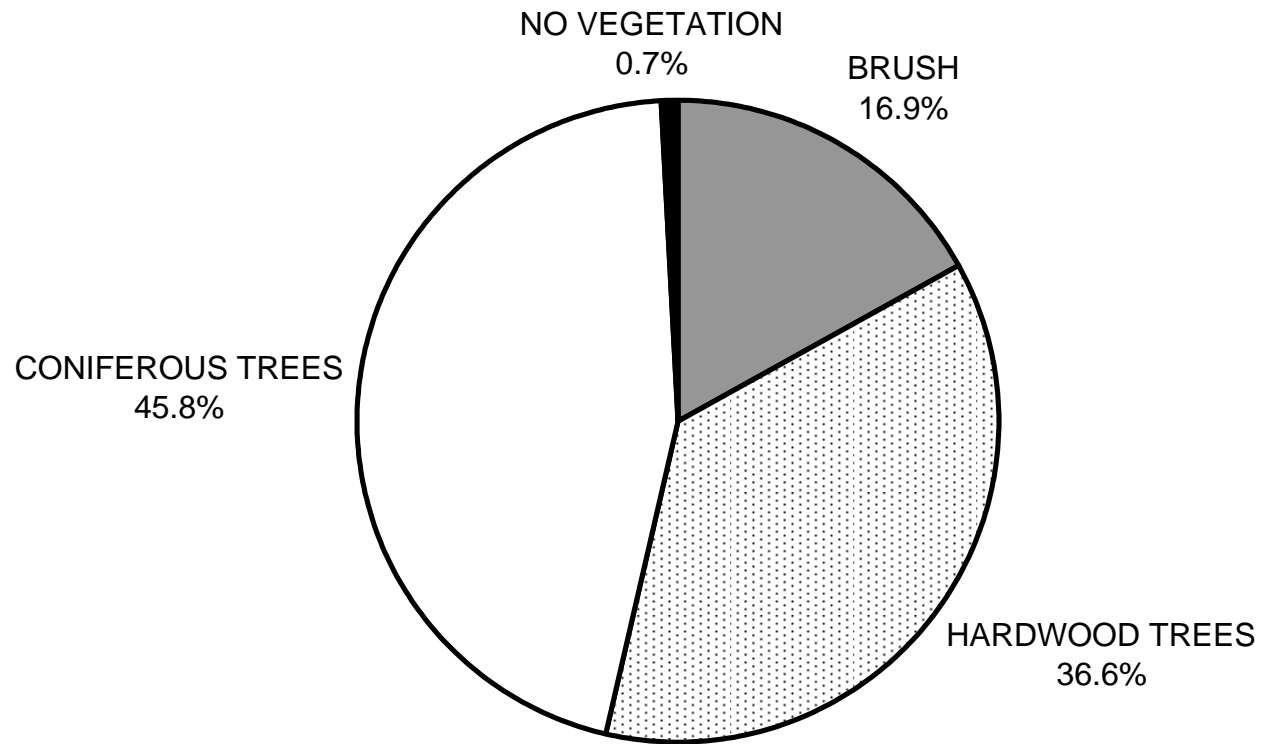
GRAPH 11

For the stream reach surveyed, the mean percent right bank vegetated was 97%. The mean percent left bank vegetated was 96%. The dominant elements composing the structure of the stream banks consisted of 82% sand/silt/clay, 11% cobble/gravel, 6% bedrock, and 2% boulders (Graph 10). Coniferous trees were the dominant vegetation type observed in 46% of the units surveyed. Additionally, 37% of the units surveyed had deciduous trees as the dominant vegetation type, and 17% had brush as the dominant vegetation type (Graph 11).
