STREAM INVENTORY REPORT

Bear Haven Creek

A stream inventory was conducted from September 10 to October 2, 2012 on Bear Haven Creek. The survey began at the confluence with Middle Fork Ten Mile River and extended upstream 5.5 miles. A stream inventory and report was also completed for one tributary to Bear Haven Creek.

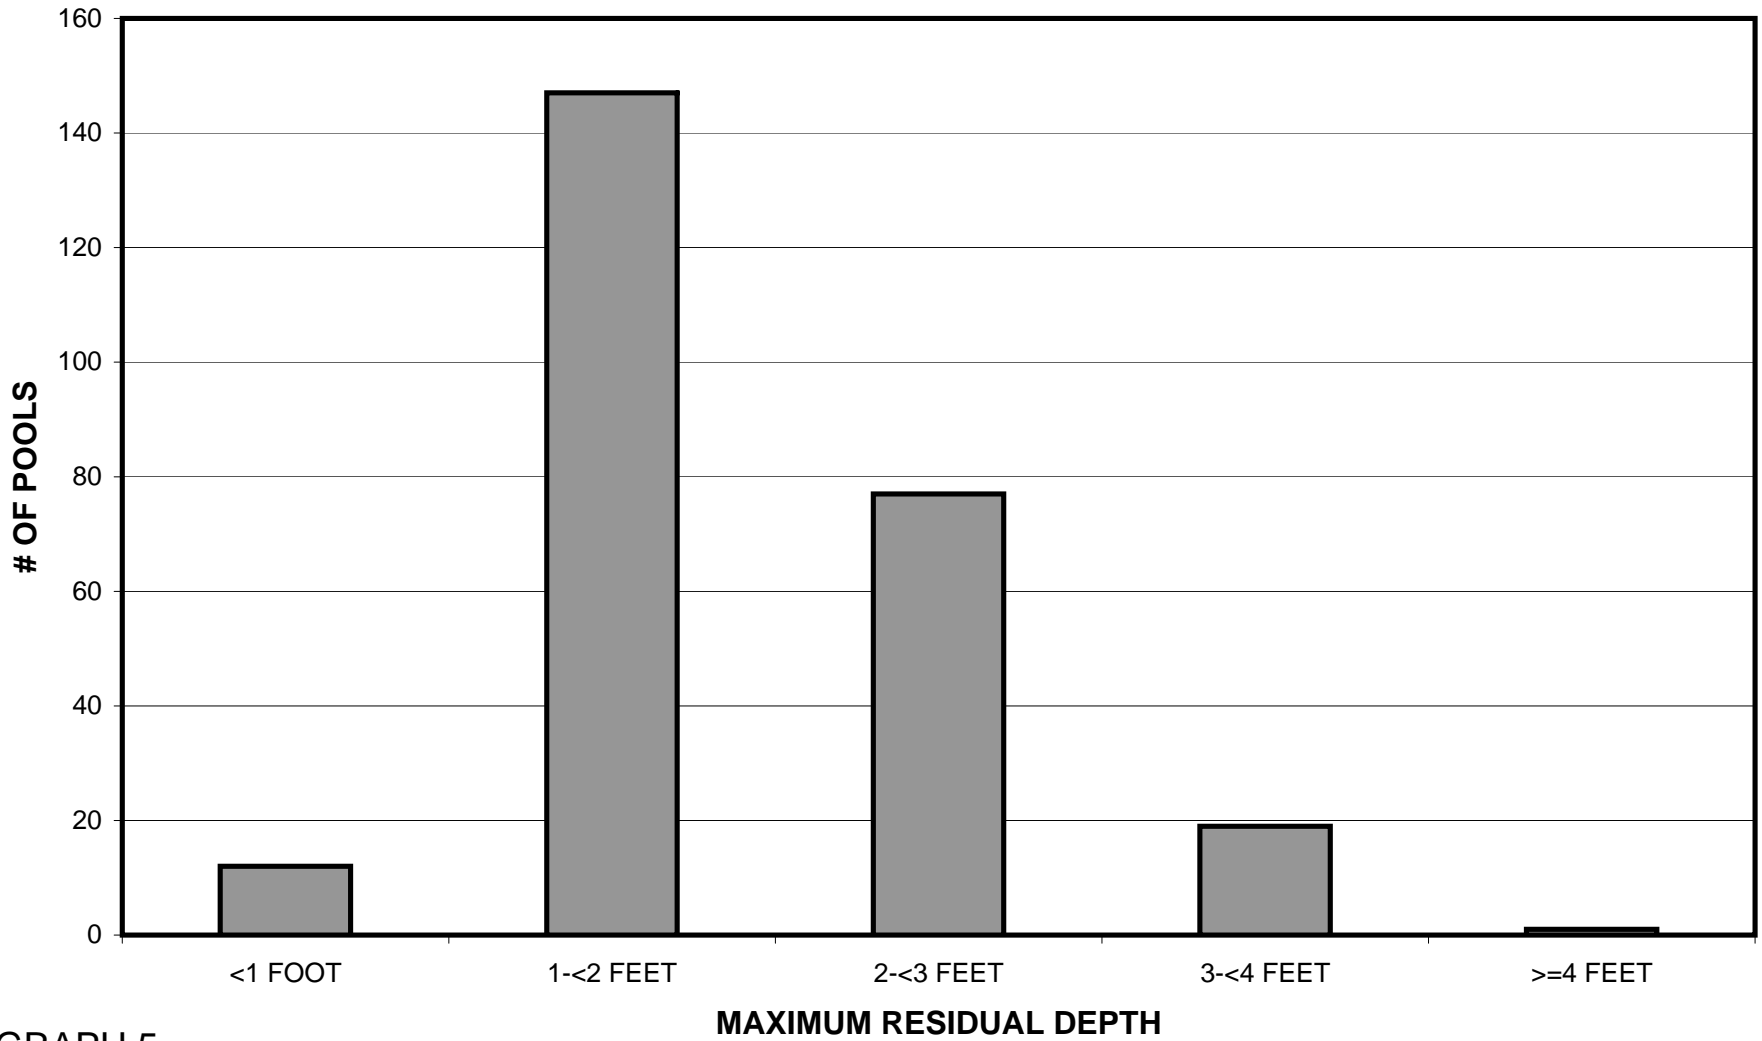
GRAPH 5

Table 4 is a summary of maximum residual pool depths by pool habitat types. Pool quality for salmonids increases with depth. Ninety-seven of the 256 pools (38%) had a residual depth of two feet or greater (Graph 5).

Flatwater habitat types comprised 45% of the total length of this survey, riffles 14%, and pools 38%. Ninety-seven of the 256 (38%) pools had a maximum residual depth greater than 2 feet. In general, pool enhancement projects are considered when primary pools comprise less than 40% of the length of total stream habitat. In first and second order streams, a primary pool is defined to have a maximum residual depth of at least two feet, occupy at least half the width of the low flow channel, and be as long as the low flow channel width.

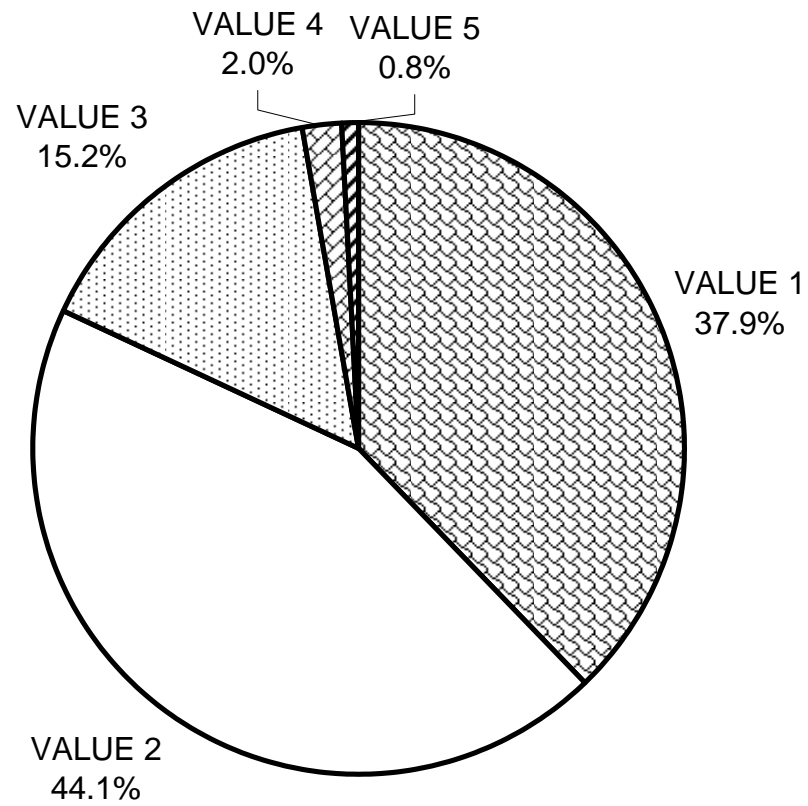
GRAPH 6

The depth of cobble embeddedness was estimated at pool tail-outs. Of the 256 pool tail-outs measured, 97 had a value of 1 (37.9%); 113 had a value of 2 (44.1%); 39 had a value of 3 (15.2%); five had a value of 4 (2%); two had a value of 5 (0.8%) (Graph 6). On this scale, a value of 1 indicates the best spawning conditions and a value of 4 the worst. Additionally, a value of 5 was assigned to tail-outs deemed not suitable for spawning due to inappropriate substrate such as bedrock, log sills, boulders, or other considerations.

Two hundred ten of the 256 pool tail-outs measured had embeddedness ratings of 1 or 2. Forty-four of the pool tail-outs had embeddedness ratings of 3 or 4. Two of the pool tail-outs had a rating of 5, which is considered unsuitable for spawning. Cobble embeddedness measured to be 25% or less, a rating of 1, is considered to indicate good quality spawning substrate for salmon and steelhead.

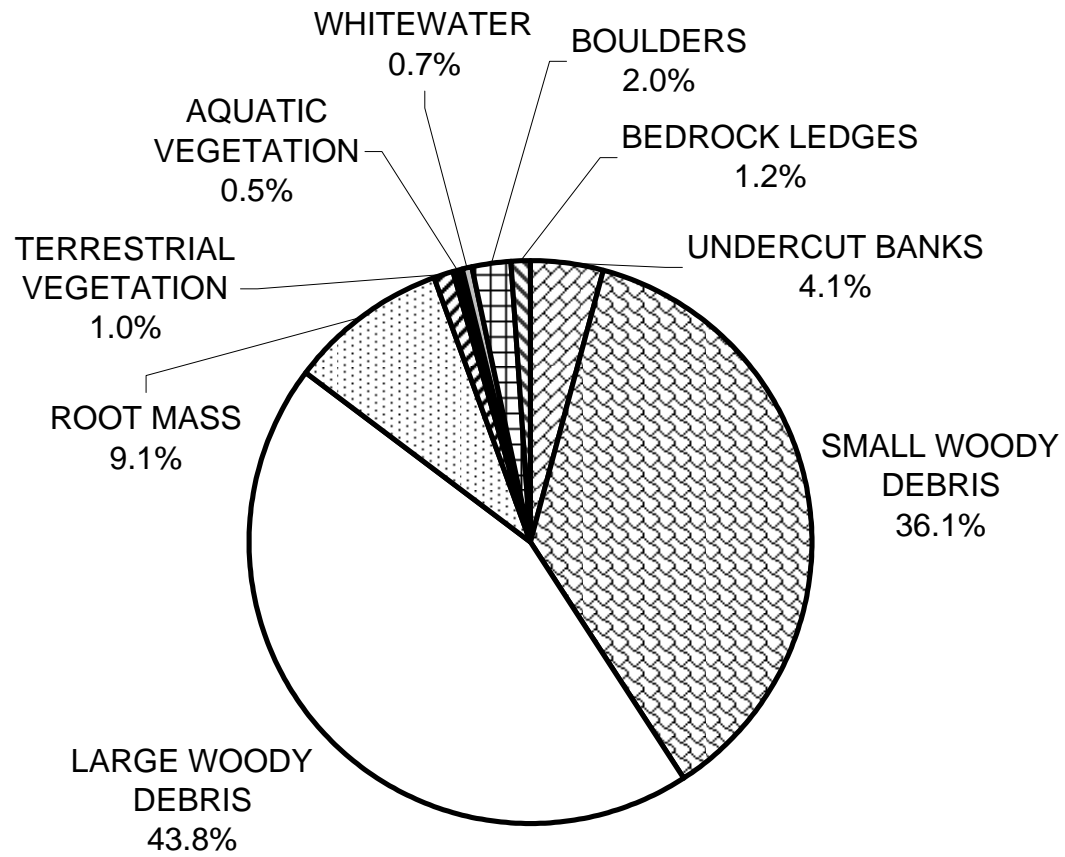
GRAPH 7

Table 5 summarizes mean percent cover by habitat type. Large woody debris is the dominant cover type in Bear Haven Creek. Graph 7 describes the pool cover in Bear Haven Creek. Large woody debris is the dominant pool cover type followed by small woody debris.

The mean shelter rating for pools is 50. The shelter rating in the flatwater habitats is 10. A pool shelter rating of approximately 100 is desirable. The amount of cover that now exists is being provided primarily by large woody debris in Bear Haven Creek. Large woody debris is the dominant cover type in pools followed by small woody debris. Log and root wad cover structures in the pool and flatwater habitats would enhance both summer and winter salmonid habitat. Log cover structures provide rearing fry with protection from predation, rest from water velocity, and also divide territorial units to reduce density related competition.

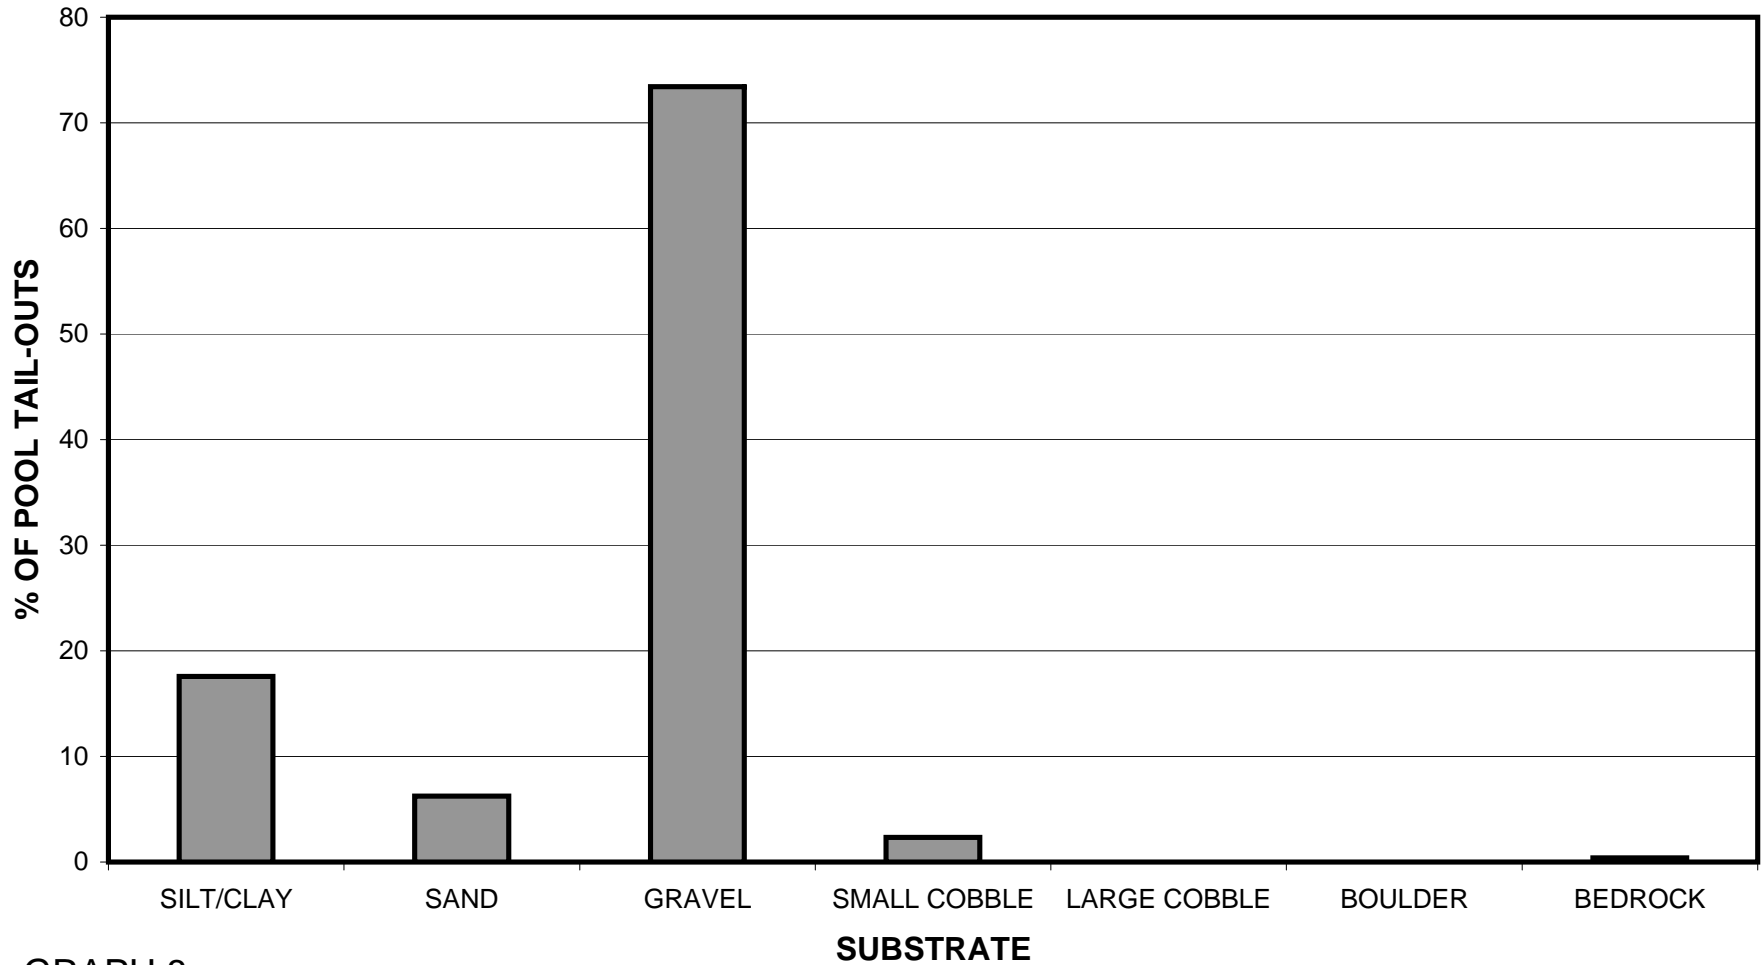
GRAPH 8

Table 6 summarizes the dominant substrate by habitat type. Graph 8 depicts the dominant substrate observed in pool tail-outs. Gravel was the dominant substrate observed in 73% of the pool tail-outs. Silt/clay was the next most frequently observed dominant substrate type and occurred in 18% of the pool tail-outs.

One hundred ninety-four of the 256 pool tail-outs measured had gravel or small cobble as the dominant substrate. This is generally considered good for spawning salmonids.
